Material Behavior of Window 7 Carrier Panel Tiles and Thermal Pane Fragments Recovered from the Space Shuttle Columbia

MATERIAL BEHAVIOR OF WINDOW 7 CARRIER PANEL TILES AND
THERMAL PANE FRAGMENTS RECOVERED FROM THE SPACE
SHUTTLE COLUMBIA

DISSERTATION

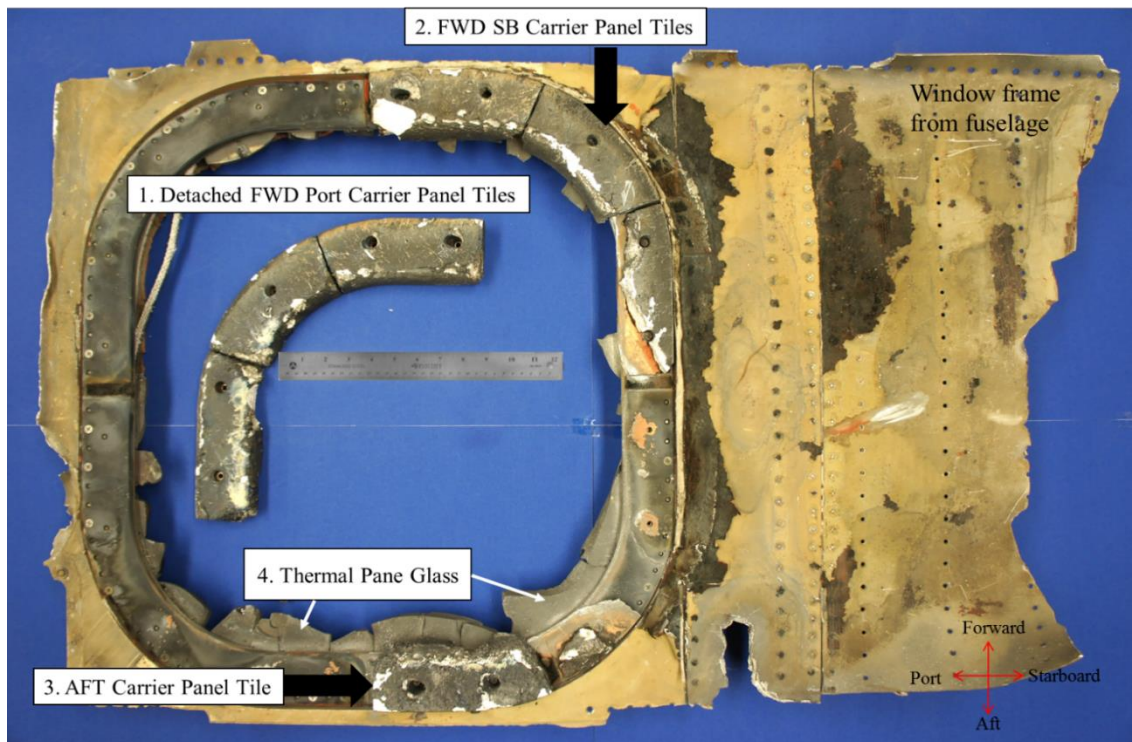
located on the orbiter windows for comparison. The second carrier panel that remained on the window was the forward starboard (right) tiles. On the aft (below) end of the window, one panel is missing while panel 3 contains only one HRSI tile as shown in Figure 4.1. Under the carrier panels as described in Figure 2.6, are the opaque thermal pane remains of the outermost surviving layer of the window. The thermal pane is mostly removed while fractured pieces are located on the aft and the forward end of the window. Larger fragmented pieces of the glass are shown in location 4. A part of the window frame from the aluminum forward fuselage remains attached as shown.

Figure 4.1 Recovered starboard Window 7 from the *Columbia* space shuttle.

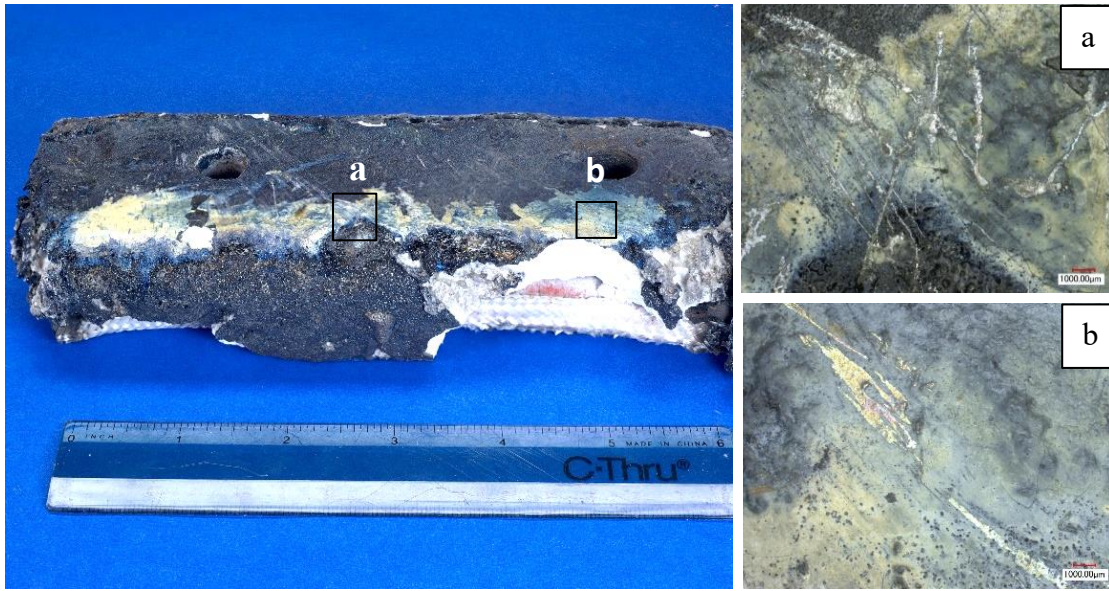
Figure 4.5. Digital microscope images of metallic splats on the yellow and blue deposits on two locations a and b.

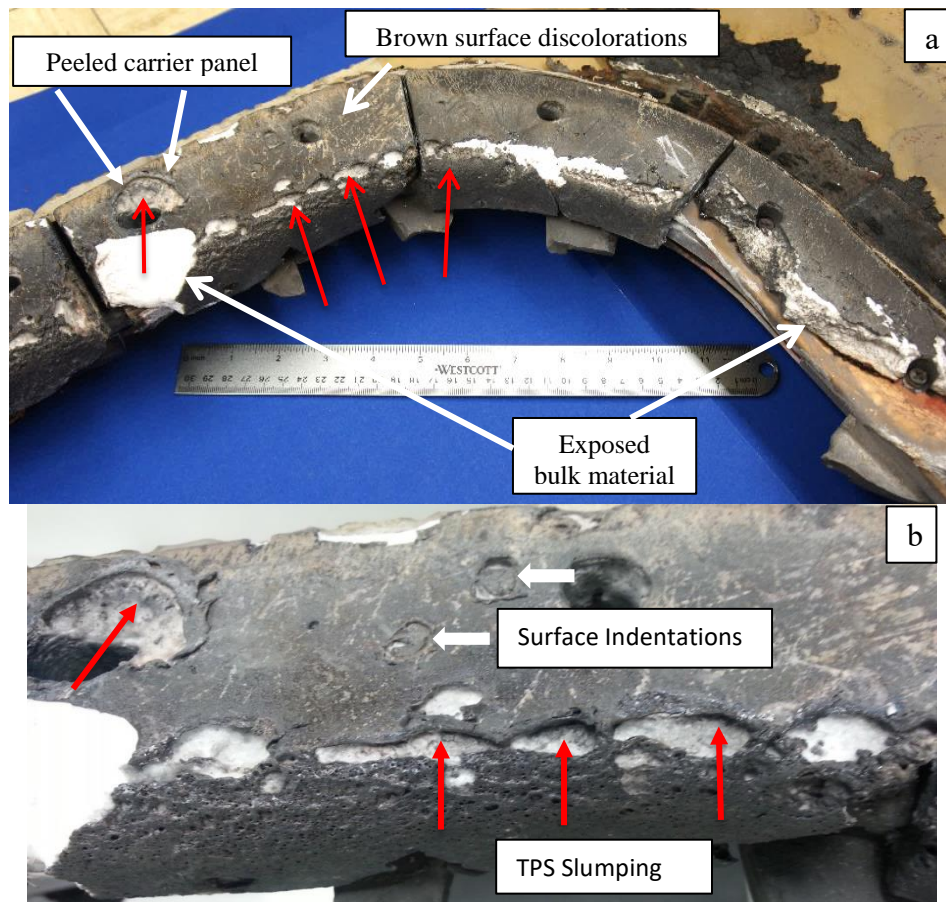
The next carrier panel tile is shown in Figure 4.6 and it is located on the forward starboard side of the window. Similar to the previous carrier panel, all three tiles contained areas damage on the coating including large fractured areas with missing pieces as illustrated on Figure 4.6a. Many areas contained slumping that revealed the foam-like bulk material shown by the red arrows in Figure 4.6a and 4.6b. Severe melting of the coating occurred in one of the exposed holes for threading and began to expose the silica substrate. Flow trajectory may be suspected due to the directionality that is indicated by the coating peeling from the aft to forward direction. Other observations include several brown surface deposits were present on all surfaces, cracks at the coating, and indentations on the coating as shown in 4.6b. The inner lip areas also contained many pits and cracked areas. Slumping can also be distinguished in these areas as they contained exposed fibers and an apparent flow occurring from aft-to-forward.

Figure 4.6 As-received forward starboard carrier panel tiles and surface characteristics (a and b). Red arrows represent suspected flow directions from re-entry plasma. Image (b) is a closeup of the first tile.

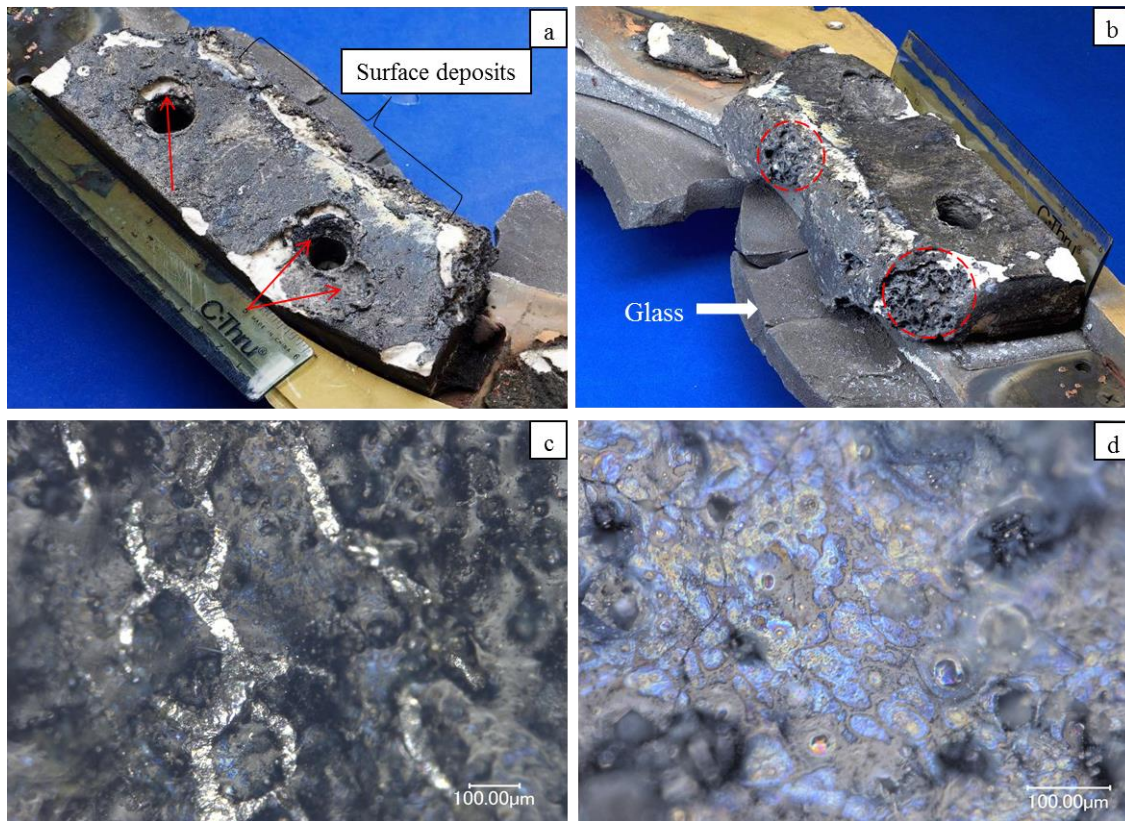
red circles (Figure 4.7b). Figures 4.7 c and d show two digital microscope images of several areas of the surface of the aft tile. Location c showed unique metallic deposits and d shows the mixture of discolorations.

Figure 4.7 Attached tile aft of Window 7 with corresponding surface features. The blue and yellow surface deposits are shown in 16a and flow directionality is shown by the red arrows. Evidence of erosion and remaining thermal pane glass is presented on 16b. Digital microscope images of the surface deposits are shown in 16c and 16d.

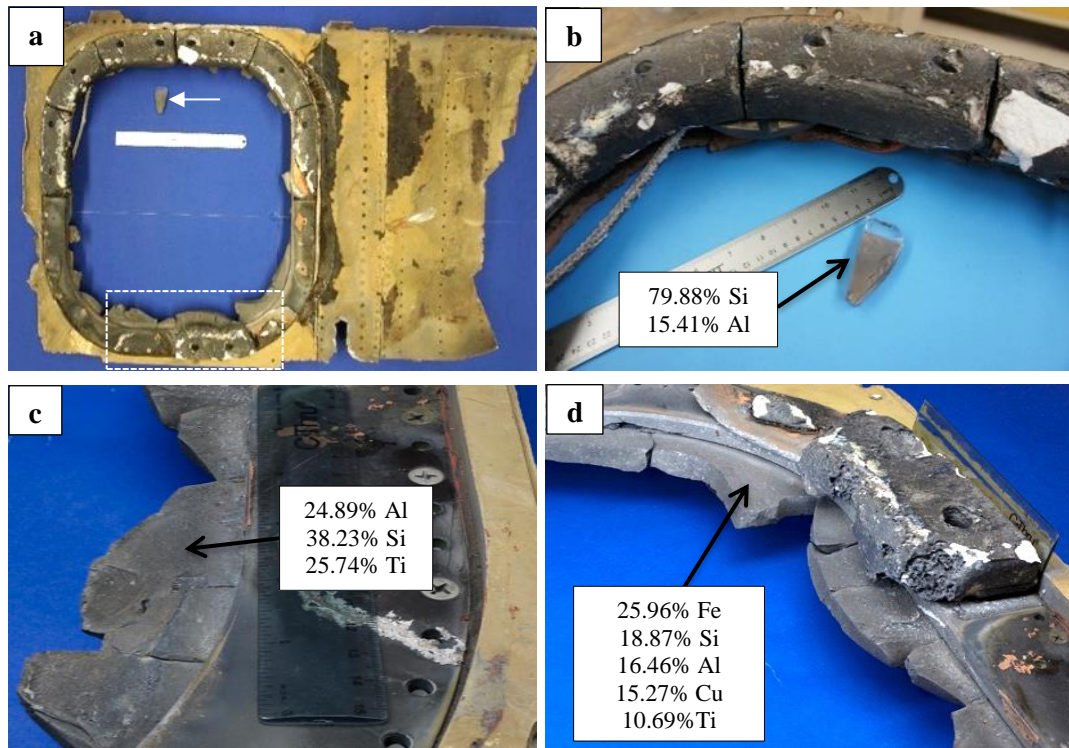
Finally, three thermal pane glass fragments were analyzed on locations at the forward and aft sides of Window 7 (Figure 4.13 a-c). On the aft locations, they contained a variety of major elements with different compositions in Figure 4.13c and 4.13d. The broken thermal pane glass located on the forward side (4.13b) contained a very large amount of silicon at 79.88 wt% while the other two contained much less. Thus, all fragments analyzed possessed various amounts of high elements and the presence of titanium was not as high compared to the percentage found on the carrier panel tiles. It is important to note that the handheld XRF analyzer is not able to distinguish multiple layers, if they exist. Consequently, destructive analysis must be performed in order to obtain detailed composition information.

Figure 4.13 XRF locations and corresponding results of the main elements detected pertaining to thermal pane glass fragments located on the forward and aft portion of window 7 as indicated in a. Fractured fragment in forward side is shown on b, while letters c and d are measurements obtained from the aft region.

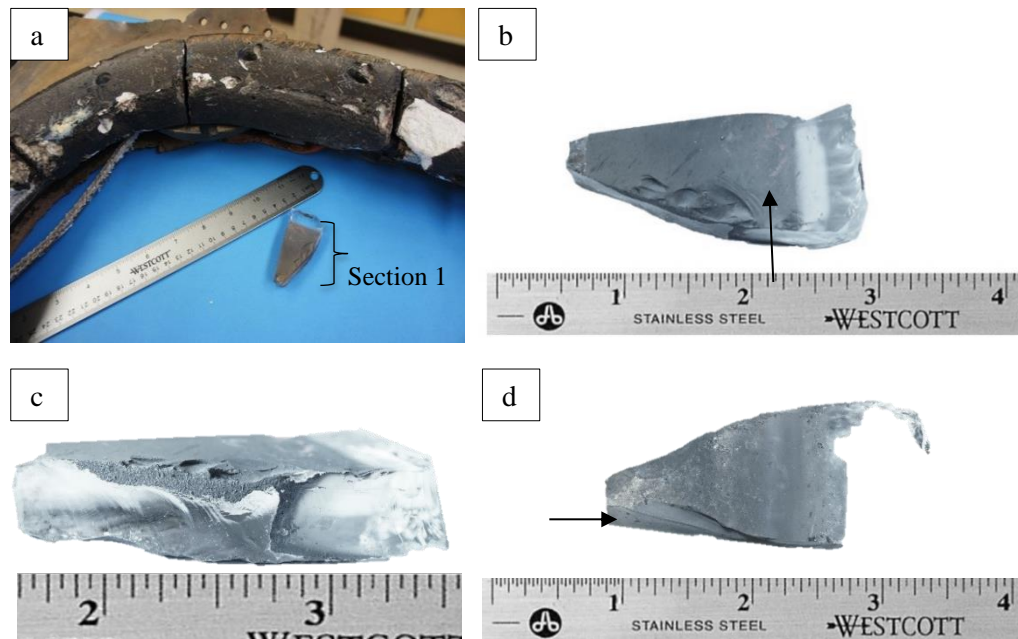
Figure 5.7 As-received thermal pane fragment shown on a. The top (b) and bottom (d) surfaces of the glass are shown along with one side showing the charred layer on the surface (c).

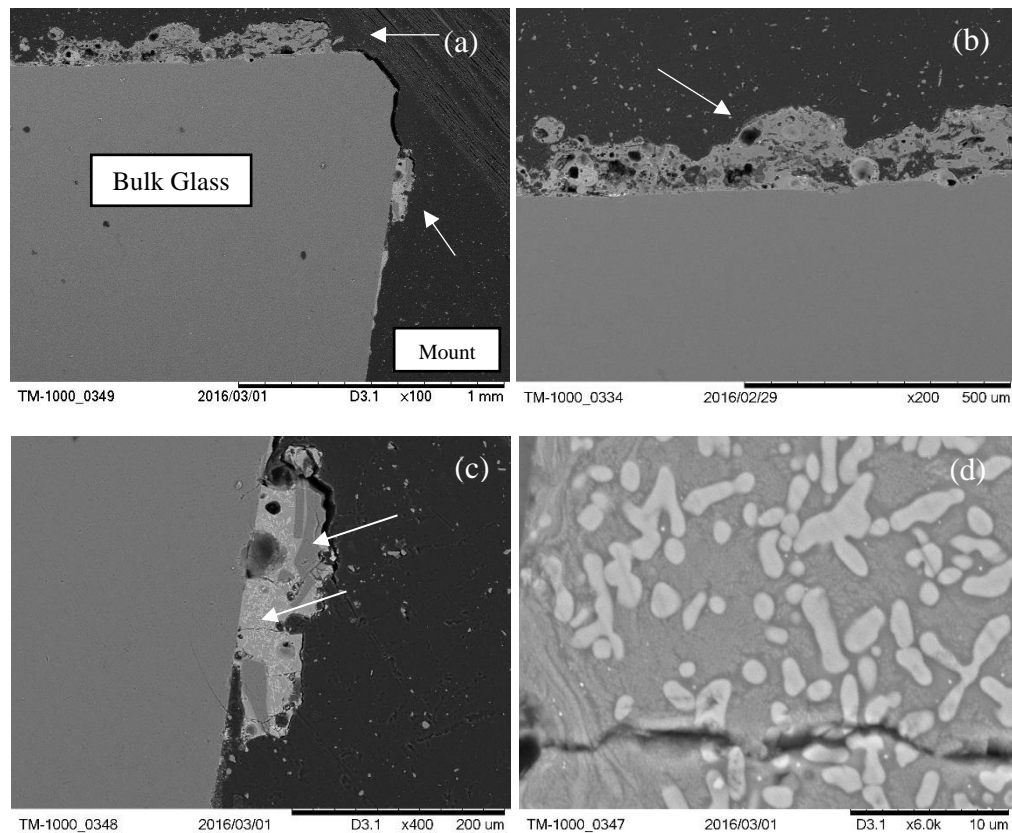
Because smaller Window 7 thermal pane glass fragments were readily available and of proper specimen sizing for all equipment used, the sample was mounted and prepared identical to the Window 8 glass sample. The polished sample is shown on Figure 5.11a-d. The cross-section of the sample at a magnification of 100X demonstrates a deposited film on two sides of the sample. The bulk glass material is shown and the deposits are shown on Figure 5.11a. Observing the deposit at a higher magnification on Figure 5.11b, the deposit itself contains open pores and some areas are not adhered. Another deposit contained a dissimilar morphology with distinct phases as illustrated on Figure 5.11c and d. The deposit contained dark gray areas within a eutectic-like structure. It also contained evidence of spallation. The microstructure is shown in 11d with a light gray phase and a gray structure.

Figure 5.11 SEM image cross-sections of (a) the small Window 7 glass sample, (b) evidence of deposit, (c) a deposit with microstructure shown on (d).

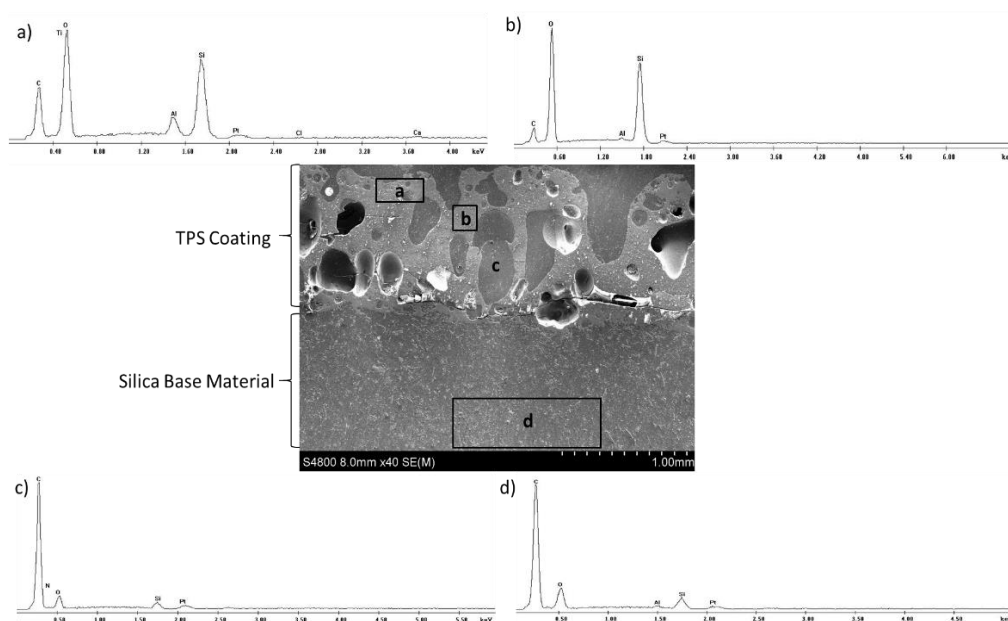
observe changes in the coating. The TPS coating exhibited heavy porosity and severe cavities present throughout the coating and between the interface. Figure 5.14 also provides several areas selected for EDS measurements, light gray areas (a and b), dark gray area in c, and d represents an area analyzed of the silica base material. Most of the areas were consistent with aluminum, oxygen, and silicon. The major difference is that the light gray area on the upper surface of the coating (a) contained titanium oxide (TiO) whereas the areas below did not.

Figure 5. 14 A cross-section of the mounted TPS specimen along with selected areas for EDS measurements.

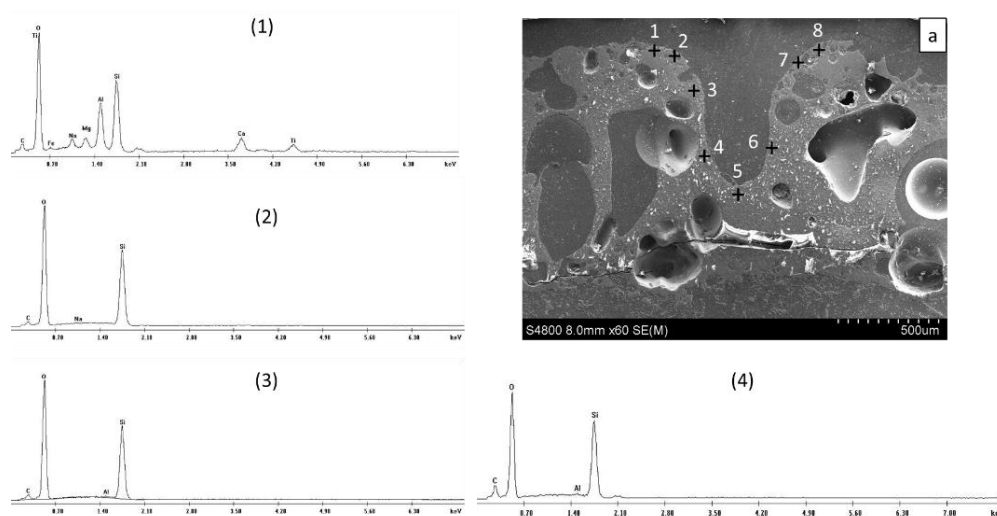
The TPS coating contained degradation given that the upper surface appeared to be highly disordered. An example of the damaged surface is shown in Figure 5.15 and Figure 5.16 along with EDS spot readings along the edges of a deep “valley” in the coating. Most of the locations also contained similar peaks of oxygen, silicon, aluminum, and traces of carbon. Readings closest to the concave area (2-6), all exhibited similar EDS peaks. The upper surfaces in spots 1, 7, and 8 contained other unique constituents such as titanium oxide (TiO) and smaller intensity peaks of sodium, magnesium, and calcium. Elemental titanium was also found in these three areas from 1.82wt% to 5.75wt% including traces of iron and vanadium.

Figure 5.15 SEM image depicting the irregular upper surface of the TPS coating and EDS measurements of spots 1 through 4.

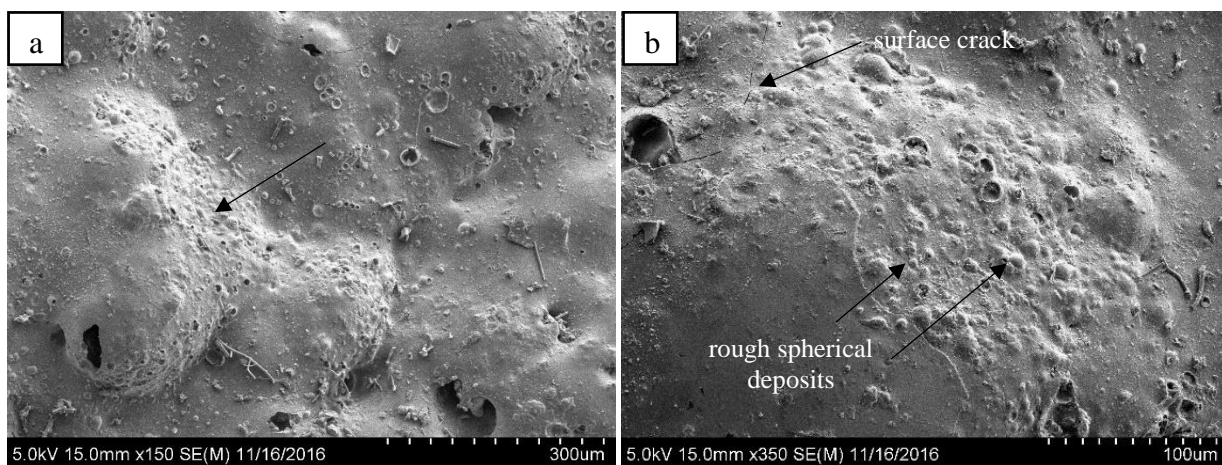
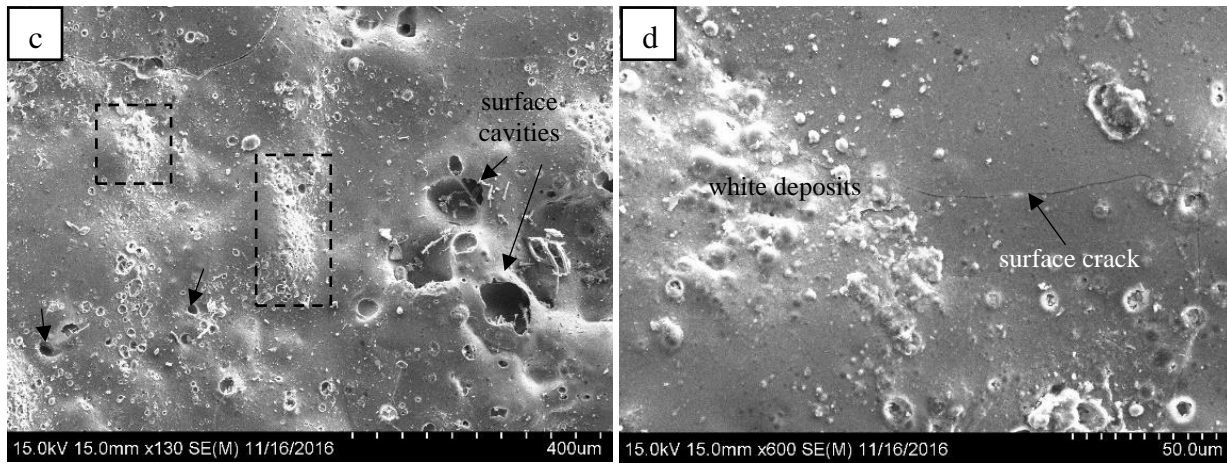
The morphology of the TPS samples was first examined for indications of deposits or effects resulting from the re-entry plasma. From the visual inspection, sample 1.1A and 1.1B contained few visible deposits. Only a faint metallic and yellow discolorations were present. When observing sample 1.1A under the SEM, several unique surface details were observed. Figure 6.4 shows four areas along the sample with marked surface features. The sample contained a rough surface with elevated areas of the coating as indicated on Figure 6.4a. There were other smaller spherical deposits comparable to blistering and are pointed out in Figure 6.4a. Cracks at the coating surface and small pores were frequently present. Signs of deposits on the coating are shown in Figure 6.4c where several distinct and bright areas were present. This image also shows larger surface cavities. Additional deposits were present as white particulates on Figure 6.4d. It was clear that the surface of this sample contained evidence of deposits at the surface.

Figure 6.4 Surface characteristics of sample 1.1A at surfaces a-d.

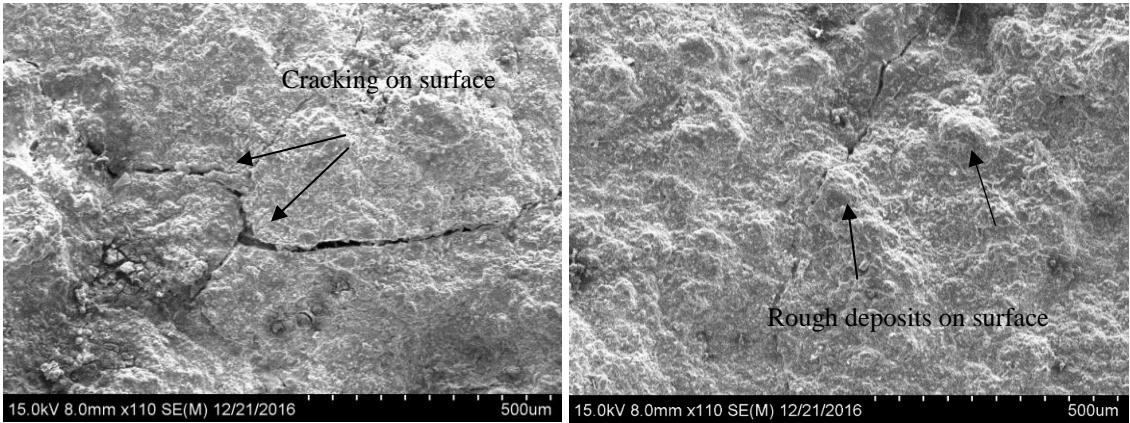
Figure 6.7 Surface condition of sample 1.1B

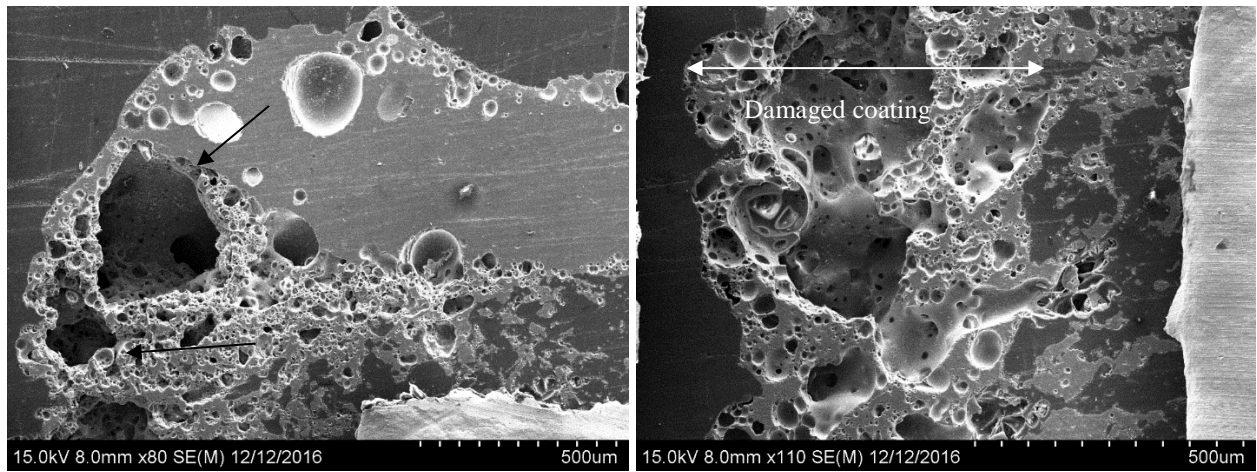
Figure 6.15 Outer edge of sample 1.1A with severe damage at the coating.

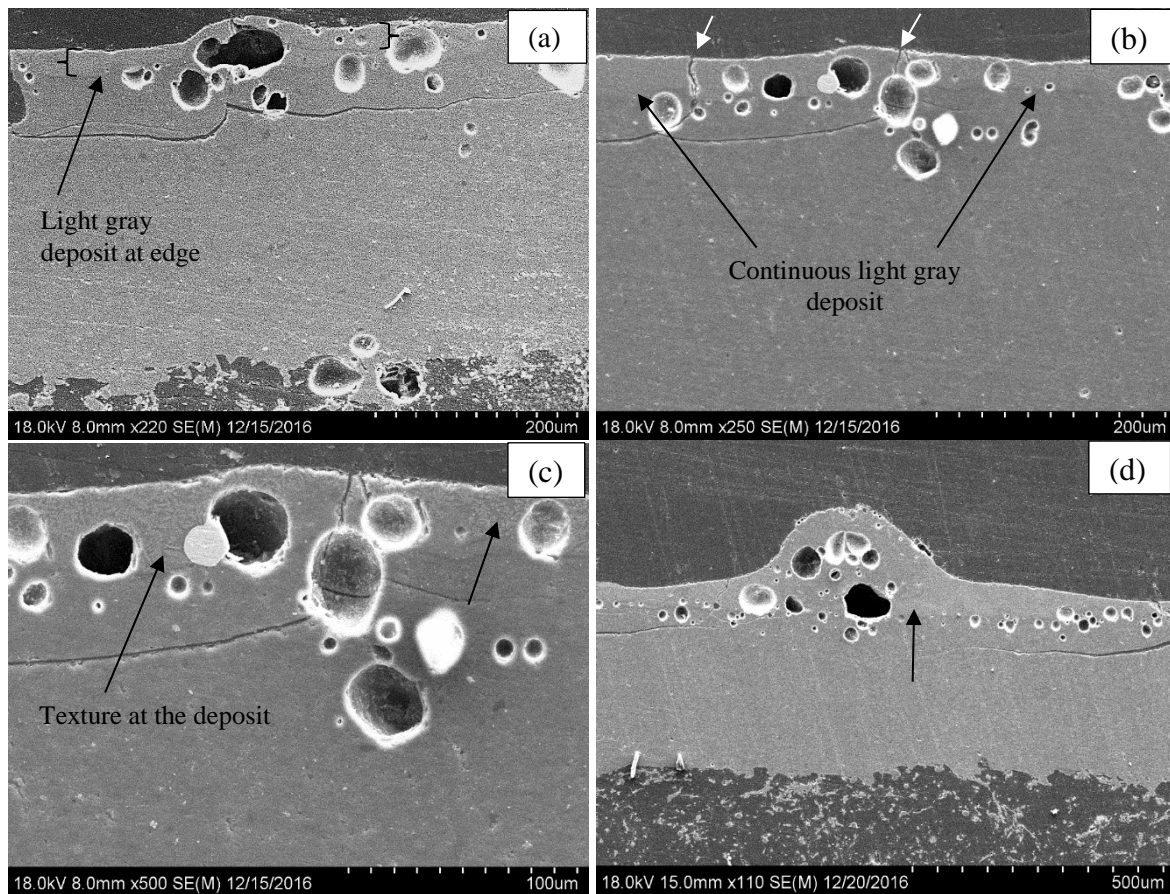
Figure 6.30 Sample 1.3 cross-sections (a) and (b) are shown with a continuous light gray deposit. Area (c) shows the deposit line with texturing and area (d) shows a large deposit formation.

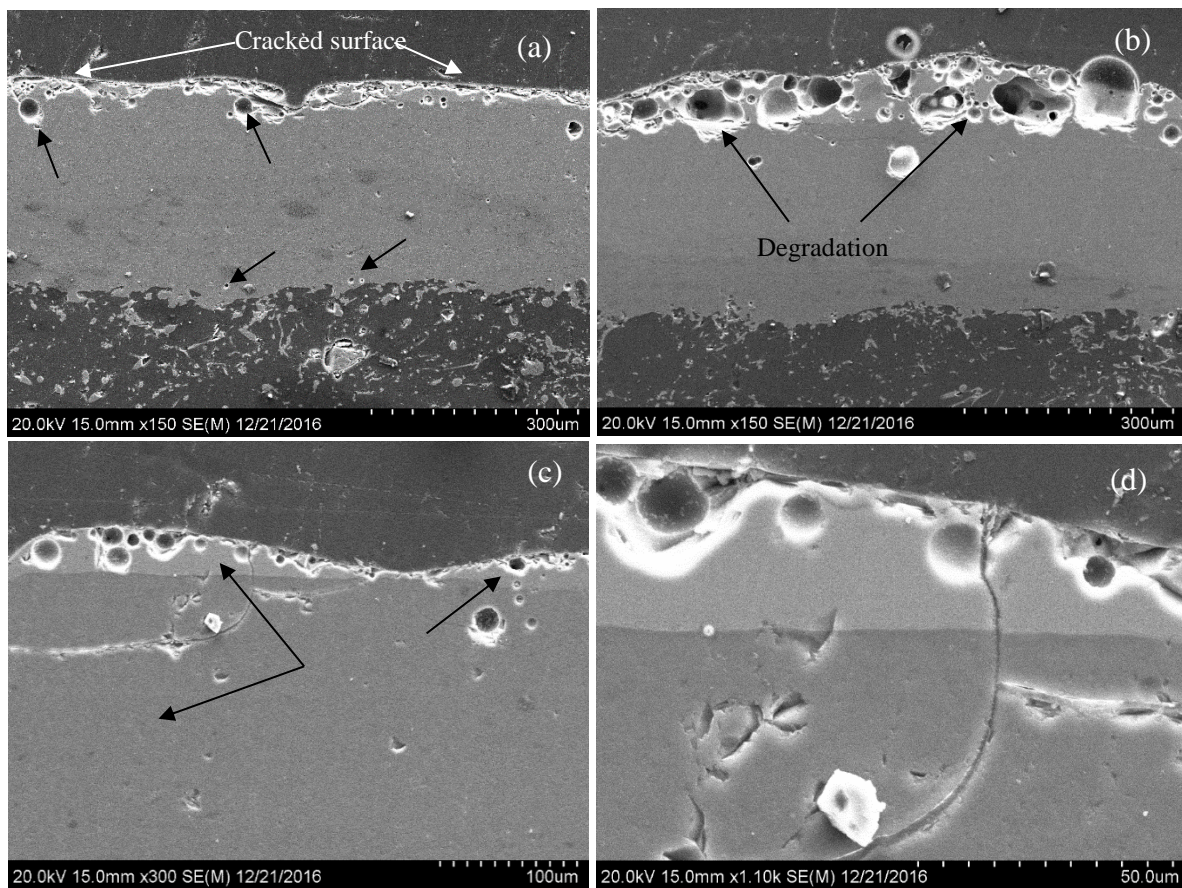
Figure 6.44 Several cross-sections of sample 2.1.1A. Images a and b show the entire cross-section with degradation at the surface. Images c and d show a difference in contrast from the top layer.

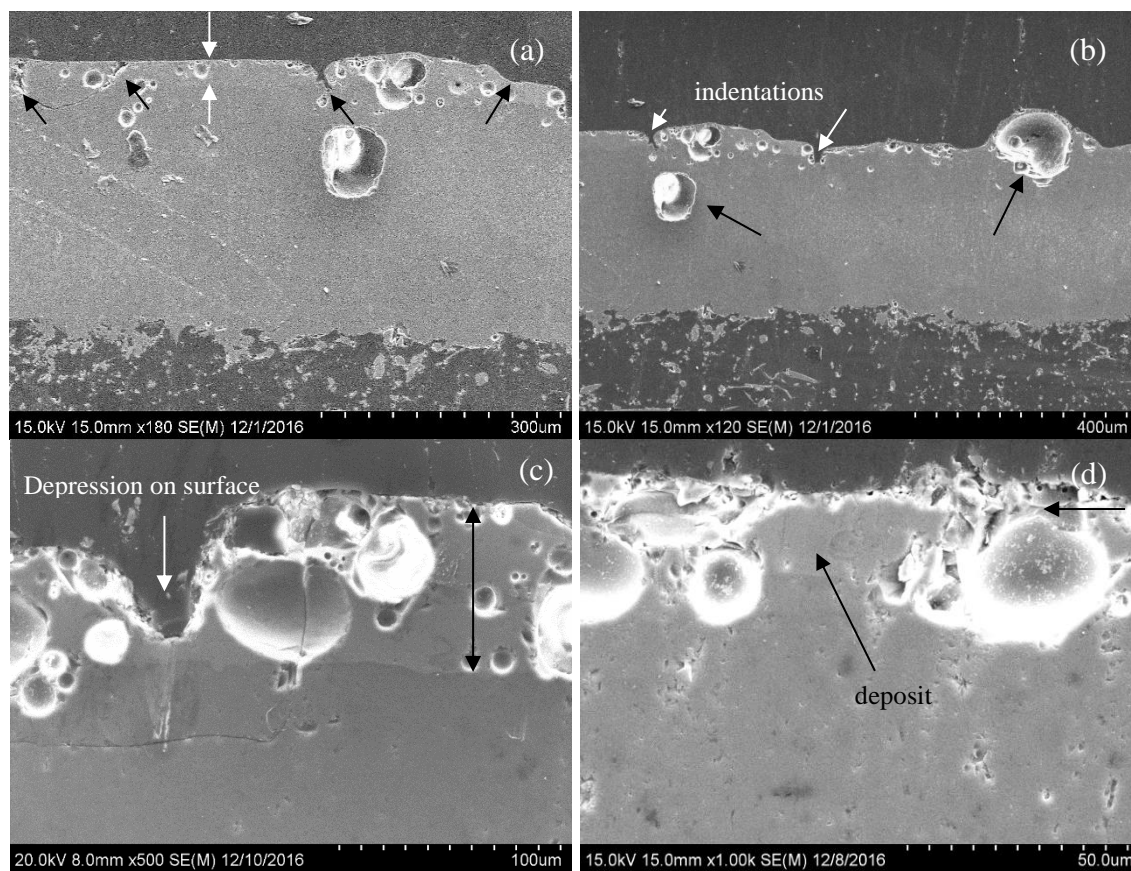
Figure 6.52 Cross-sections of sample 2.1.3 where (a) shows a possible deposit line and surface cracks. Image b shows surface indentations and large cavities near the surface and in the cross-section. Images (c) and (d) show additional damages and evidence of a deposit layer.

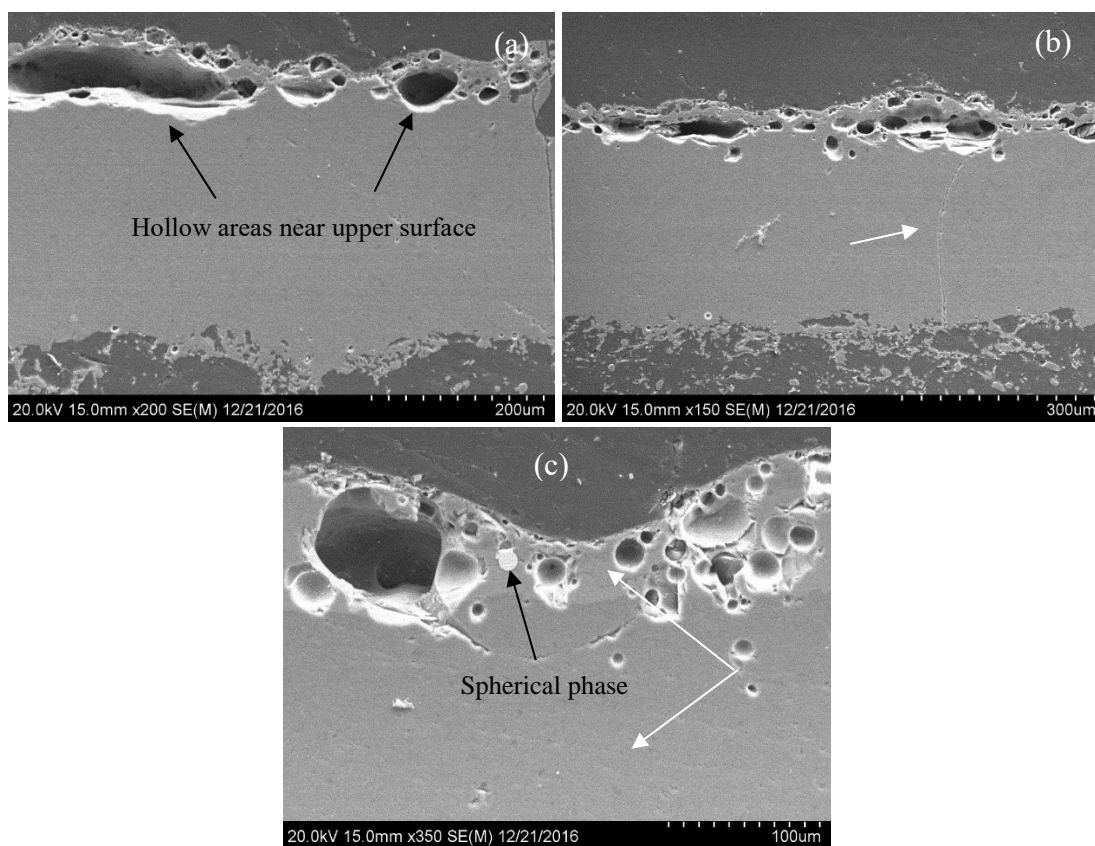
Figure 6.55 Three cross-sectional areas exhibiting severe degradation with porosity and cavities (sample 2.1.4). Image (c) shows a possible deposition layer and a spherical white phase.

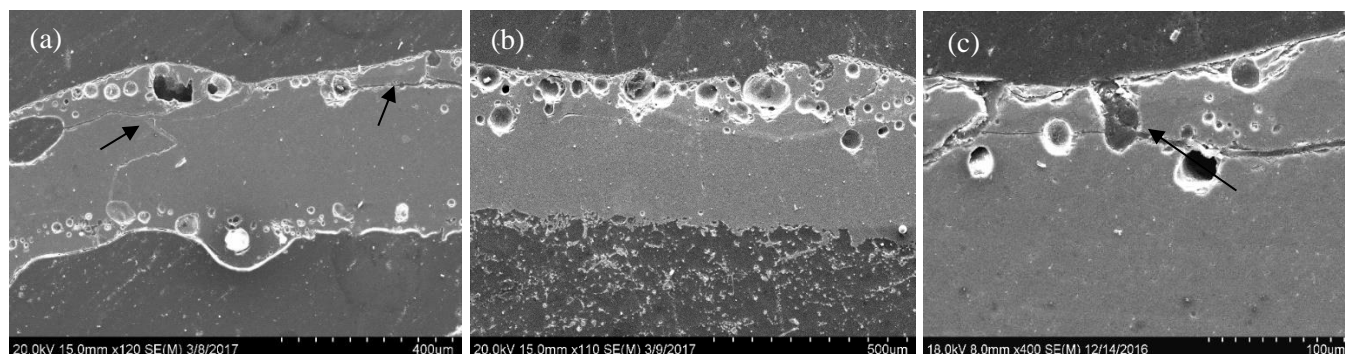
Figure 6.66 Cross-sectional images of sample 3.1A. Image (a) shows continuous open pores and cavities, (b) illustrates increasing cavities, and (c) shows a light gray layer.

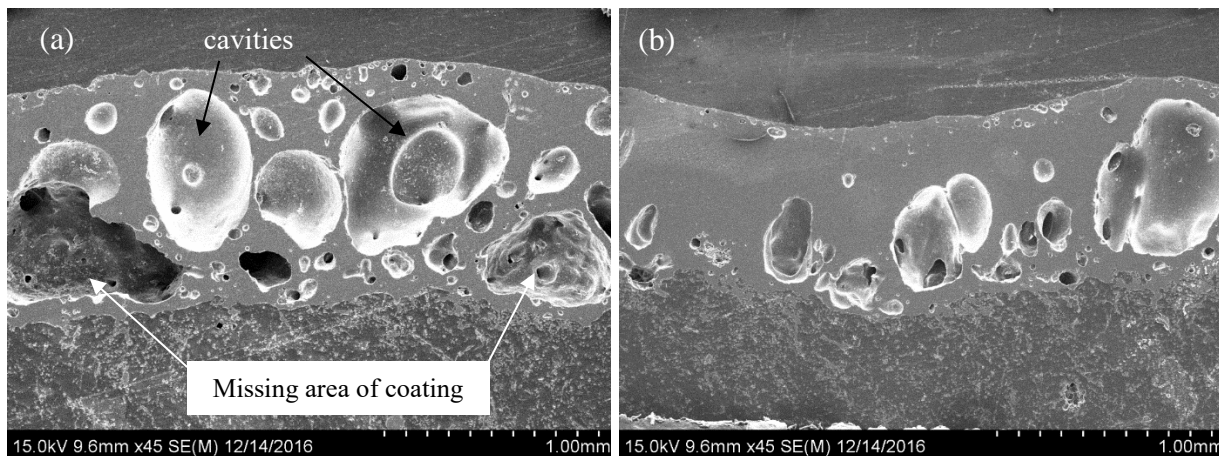
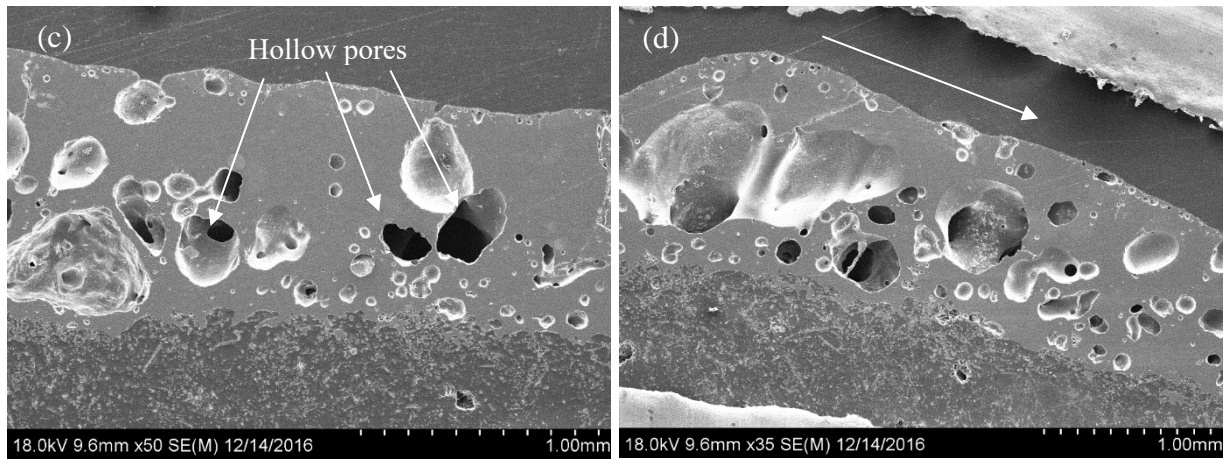
Figure 6.76 Images of sample 3.2 showing the large number and sizing of cavity damage in (a), the cavities and pores also are present near the interface on (b), deep pores are shown on (c), and a decrease in coating is shown on (d).

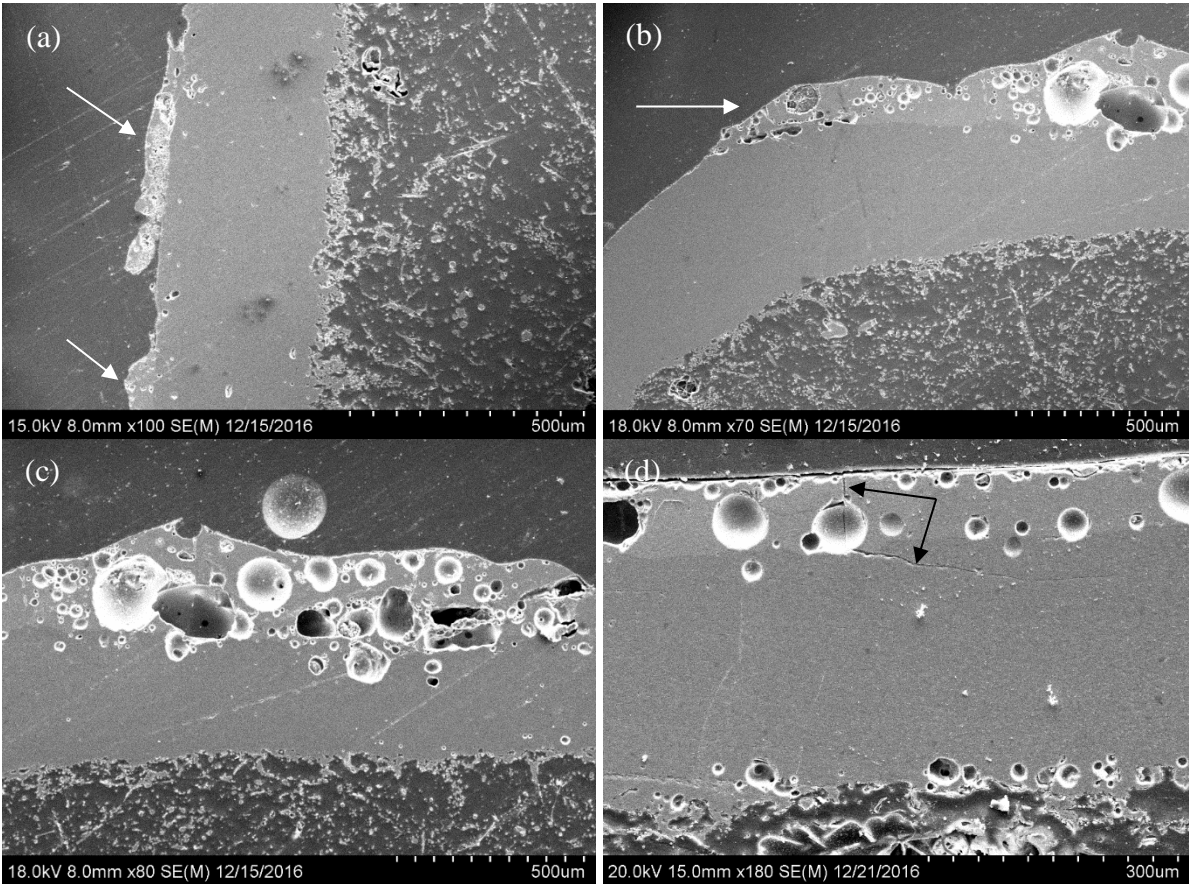
Figure 6.80 Cross-sectional images of sample 4.1 where (a) is taken at the left vertical side of the sample leading to the top surface on (b). Area (c) shows degradation concentrated at the upper surface the coating. Image (d) shows a deposit line with cracking.

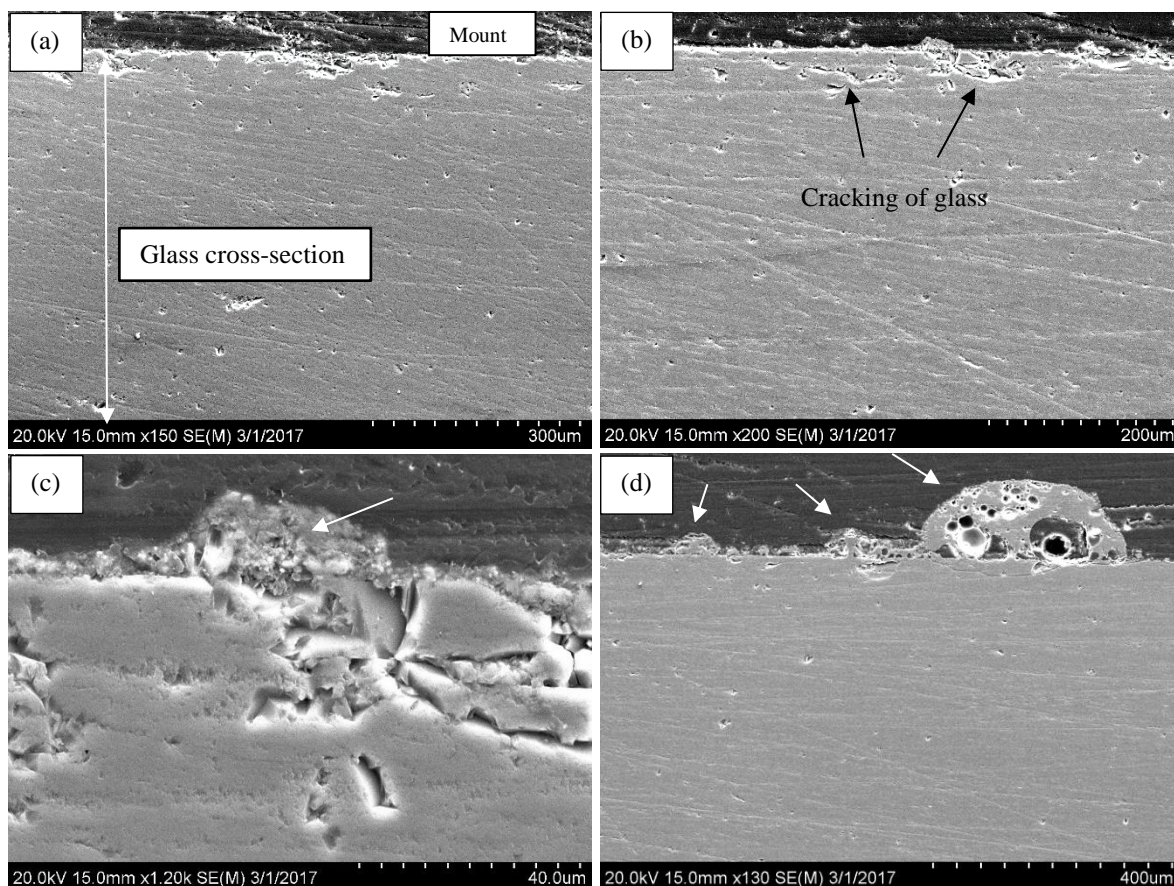
Figure 6.89 Mounted glass shard and polished at the cross-section. SEM images a through d show several features seen at the surface.
