Materials Characterization of Deposits on Starboard (Inboard) Elevon Actuator Shaft Recovered from Space Shuttle Columbia

MATERIALS CHARACTERIZATION OF DEPOSITS ON STARBOARD
(INBOARD) ELEVON ACTUATOR SHAFT RECOVERED FROM SPACE
SHUTTLE *COLUMBIA*

DISSERTATION

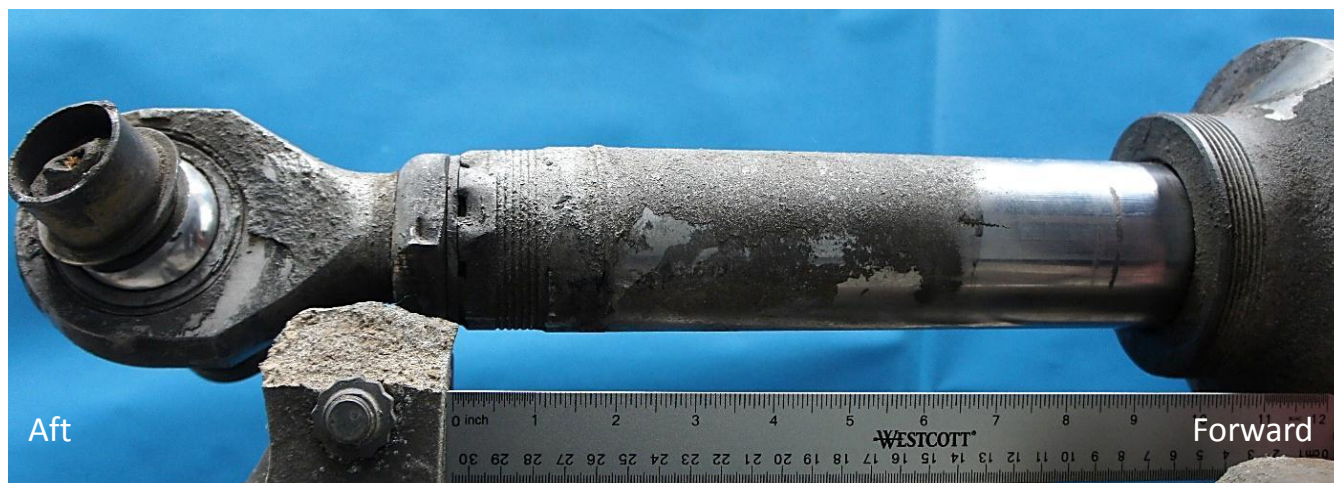
Figure 1.2 Starboard-side of starboard (inboard) elevon actuator shaft showing significant amounts of deposits.

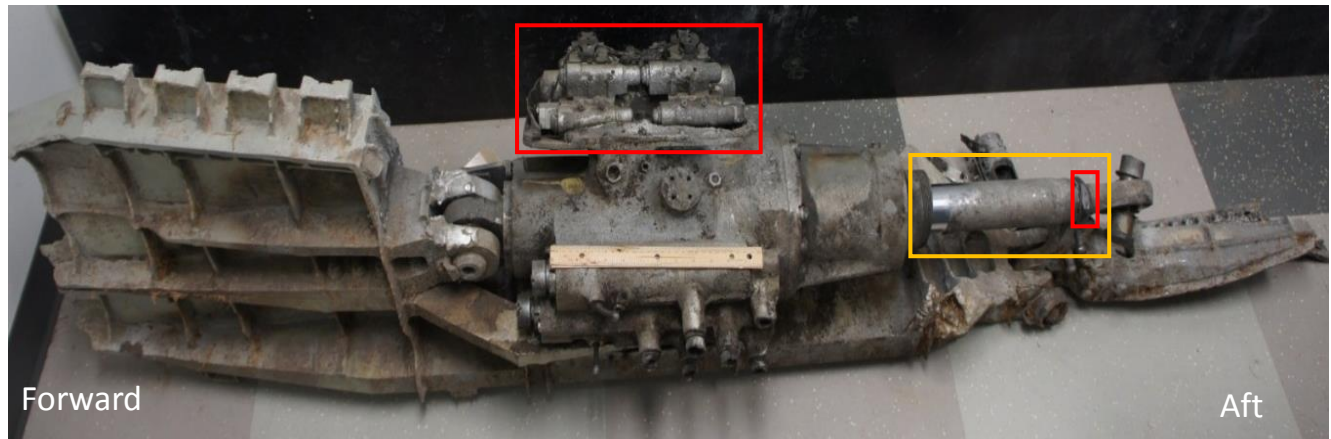
Figure 3.1 Starboard (inboard) elevon actuator. Orange box indicates location of elevon actuator shaft and red boxes show position of electrical junction box and locking nut where possible evidence of reverse flow occurred.

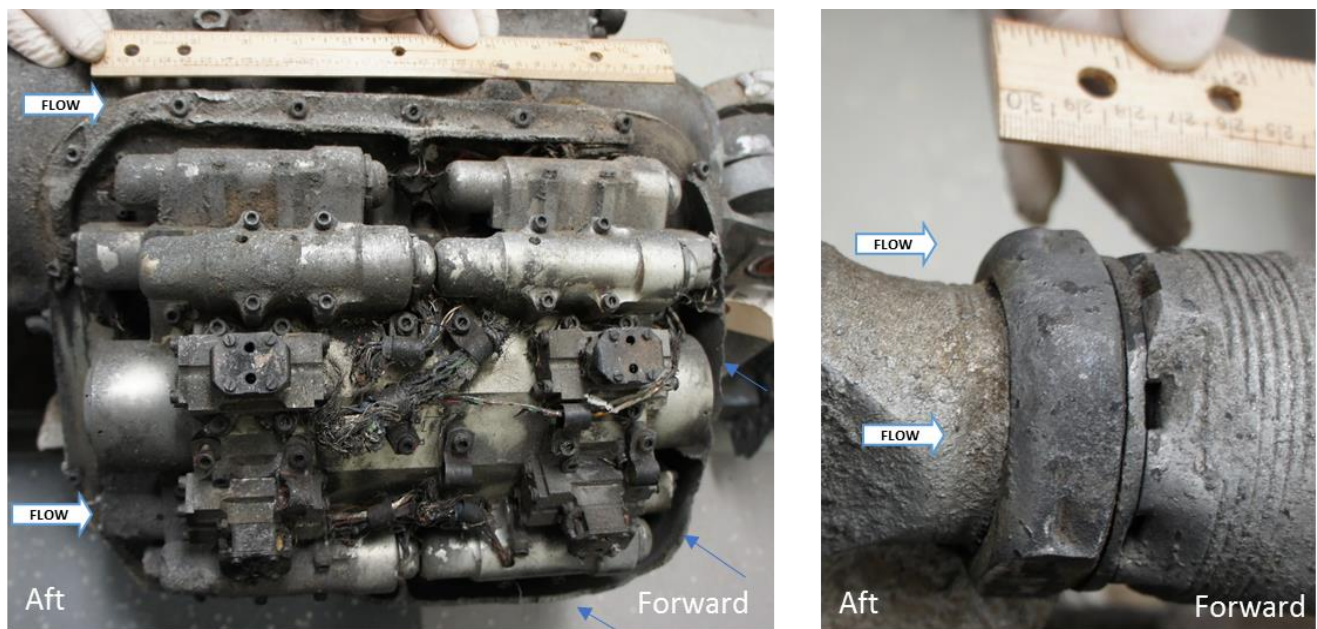
Figure 3.2 Left. Electrical control module with housing component mostly gone. **Right.** Locking nut of elevon actuator shaft showing erosion. White arrows indicate suspected direction of flow.

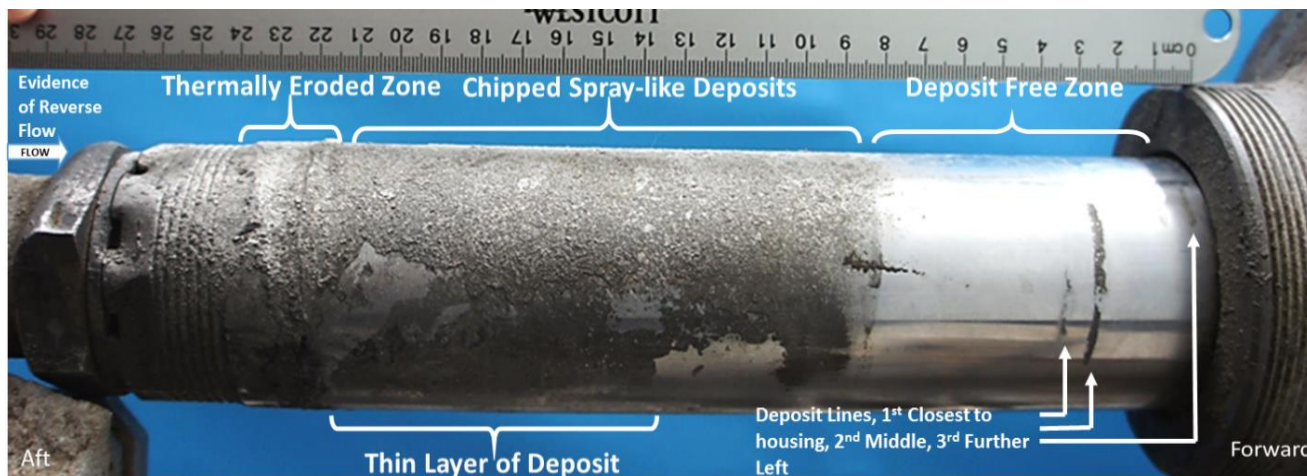
Figure 3.4 Starboard-side of starboard (inboard) elevon actuator shaft pointing out several areas of interest along the shaft.

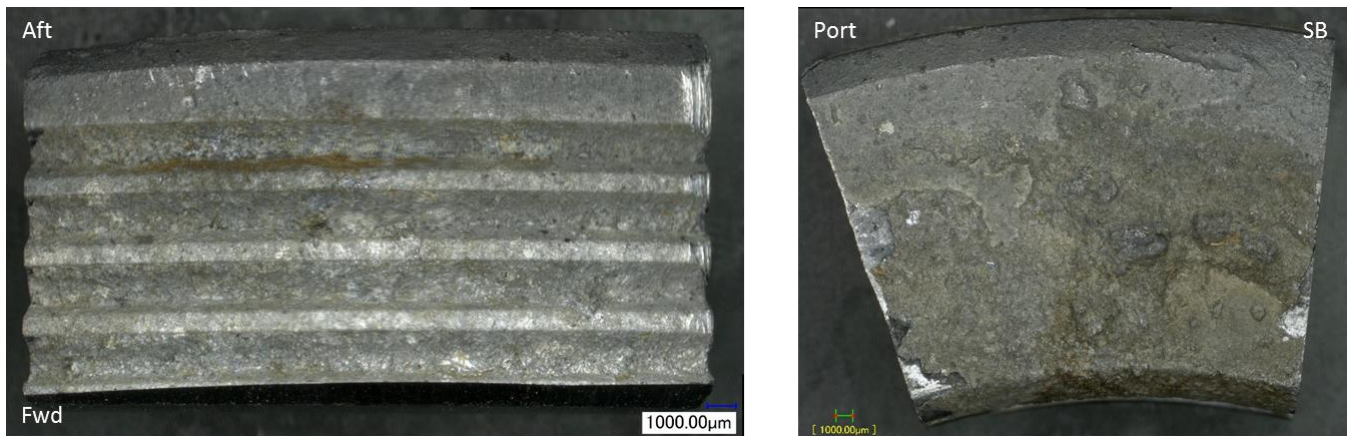
Figure 4.1 Sample used from Area 1 showing deposits on the surface of the threaded region (Left) and on the aft-facing side (Right). 30X.

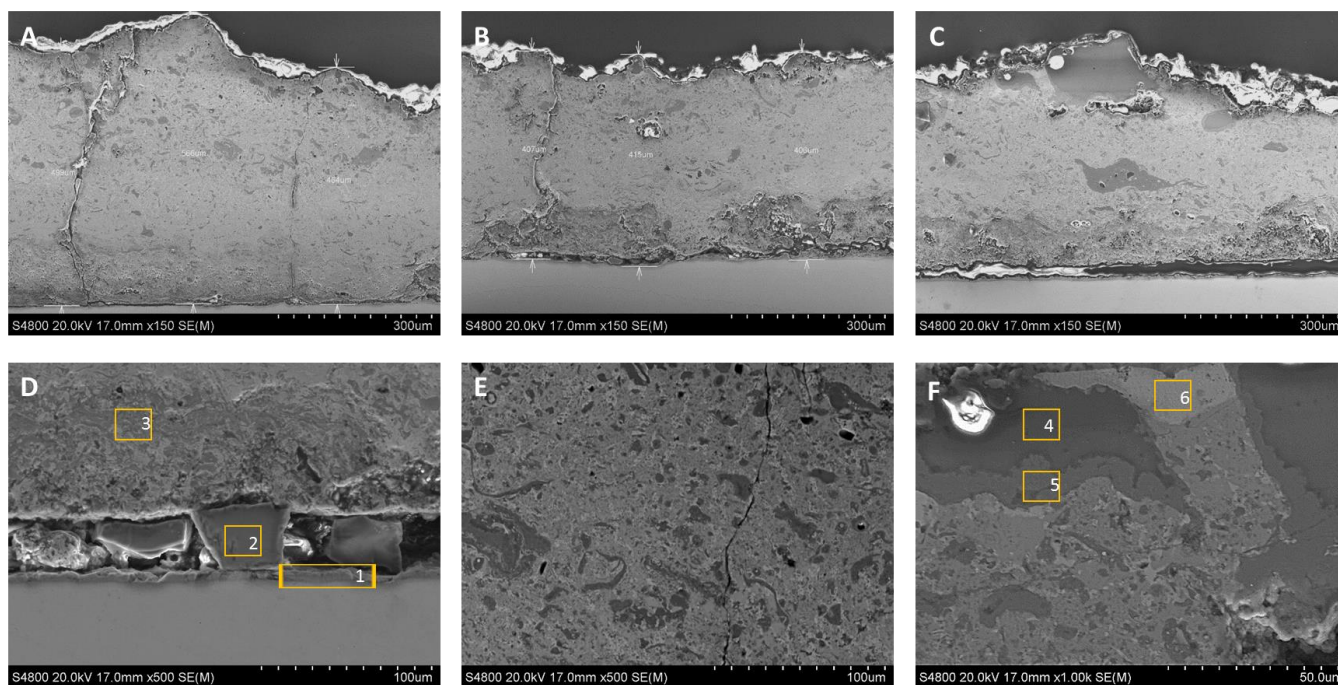
Figure 4.7 SEM images of the cross-sectional view of aft-facing side in Area 1. A through C show deposit as well as some measurements of the height of the deposit. D through F show magnified images of several regions found throughout the deposit. Yellow boxes show area where EDS spot analysis was conducted. These results are shown in Figure 4.8.

Just above this particles and hollow tunnels, the third layer can be found. This layer is shown as a dark gray area on A, B, C, and D in Figure 4.7 and consists of a light and dark gray matrix where the latter

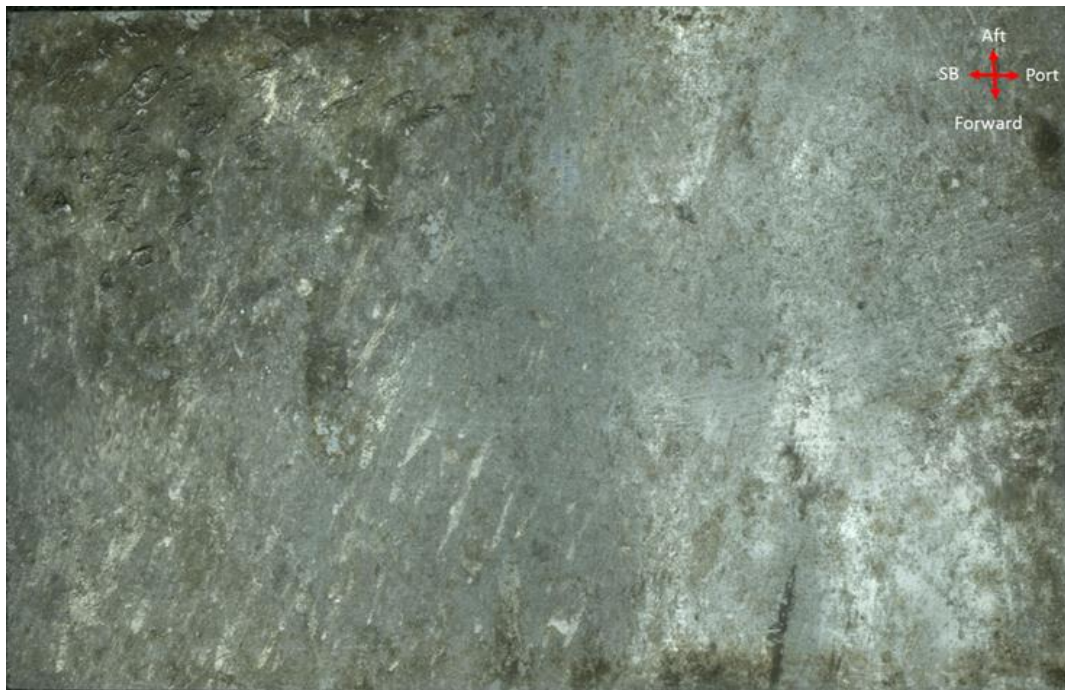
Figure 4.17 Sample A3.1 belonging to Area 3 where metallic streaks and heavier deposits can be seen at the starboard-side of the sample. (30X)

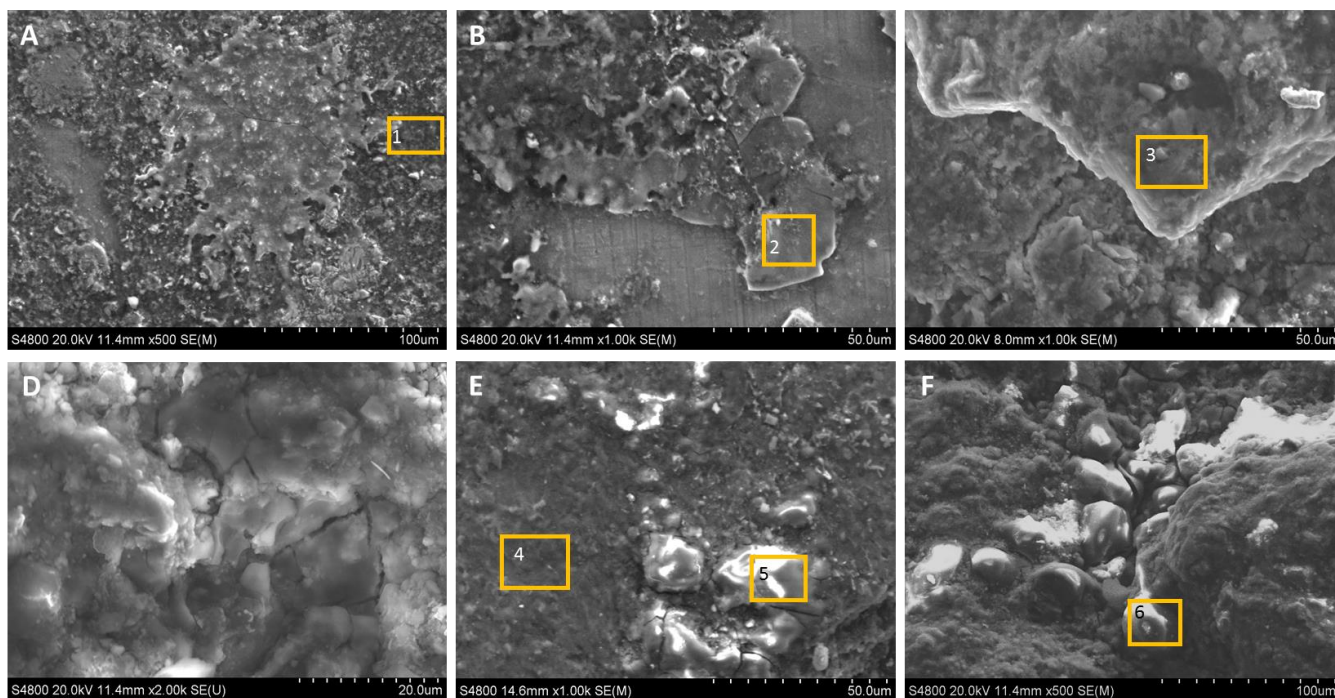
Figure 4.22 SEM surface analysis of sample A3.2 showing different regions throughout the sample including splats, cracking of deposits, and globular metallic droplets. Yellow squares indicated EDS spot analysis shown on Figure 4.23.

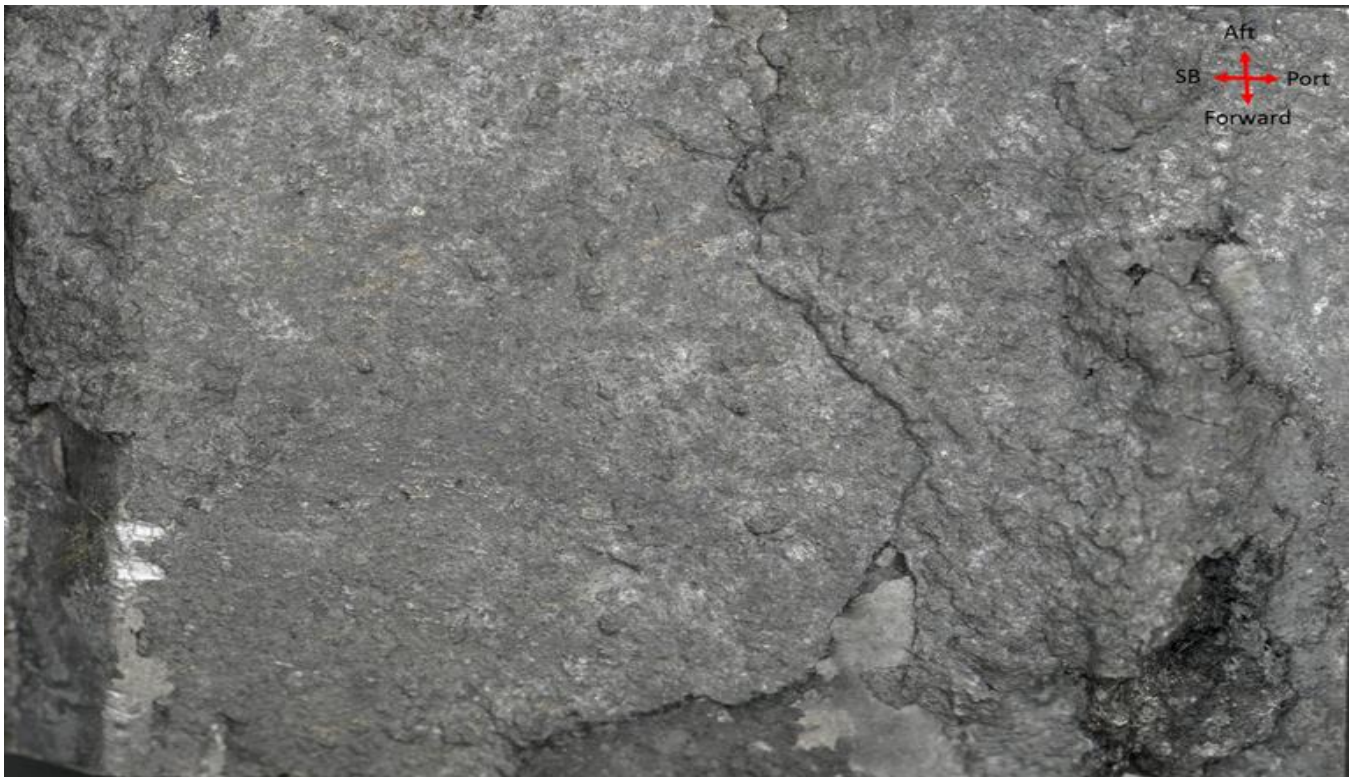
Figure 4.30 Sample A4.1 belonging to Area 4 showing heavy rough deposits in the port side of the sample where thermal erosion is also observed. Cracked deposits can also be seen in the forward bottom portion of the sample. (30X).

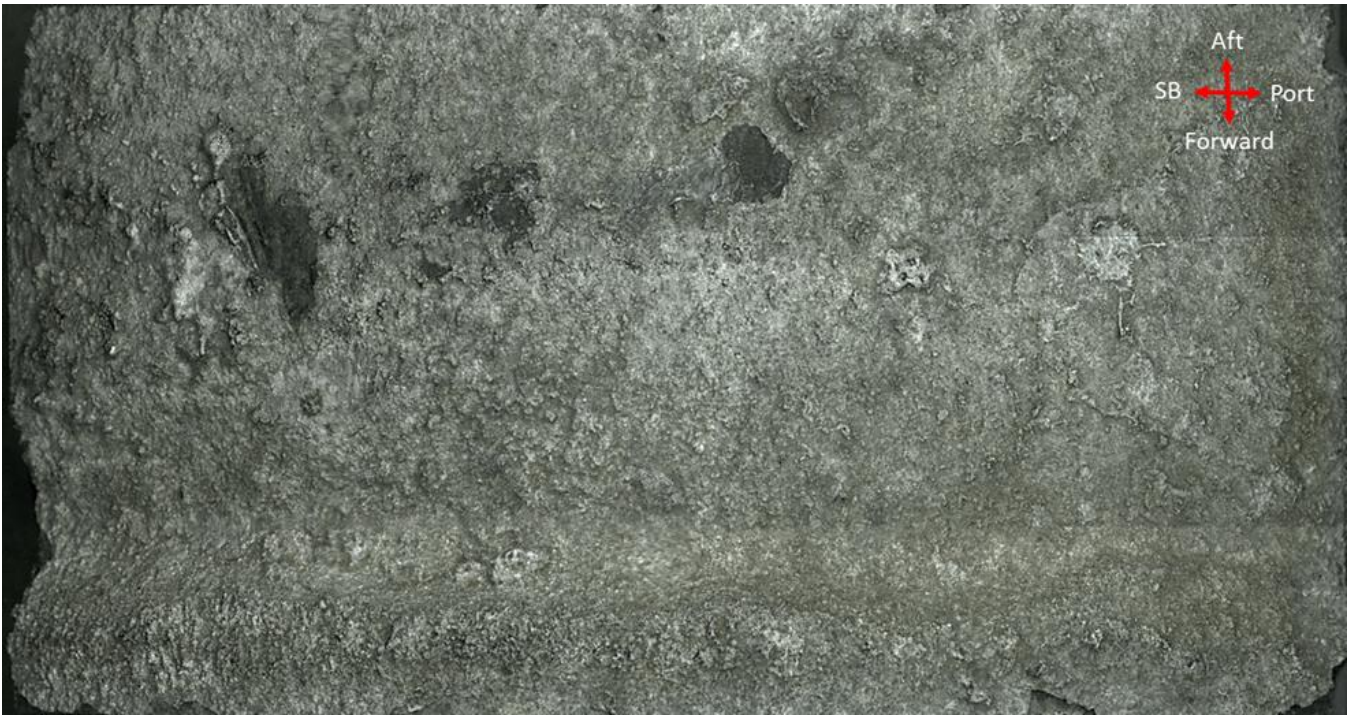
Figure 4.31 Sample A4.2 belonging to Area 4 where metallic splats can be seen throughout the sample as well as black spots that correspond to oil stains. Seen in the lower forward edge is the dent where possible thermal erosion of base metal might have occurred. (30X).

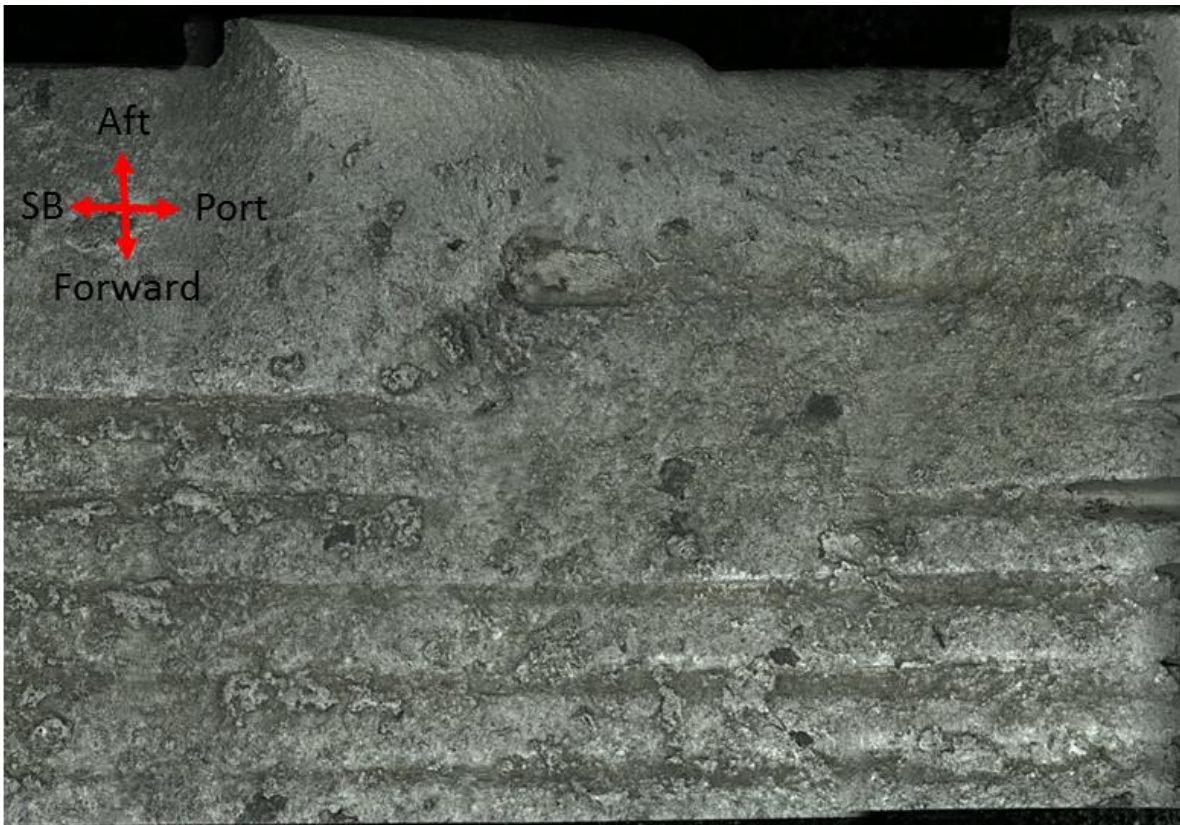
Figure 4.32 Sample A4.3 belonging to Area 4 showing threaded area which has multiple metallic deposits, black oil stains, and thermal damage. (30X).

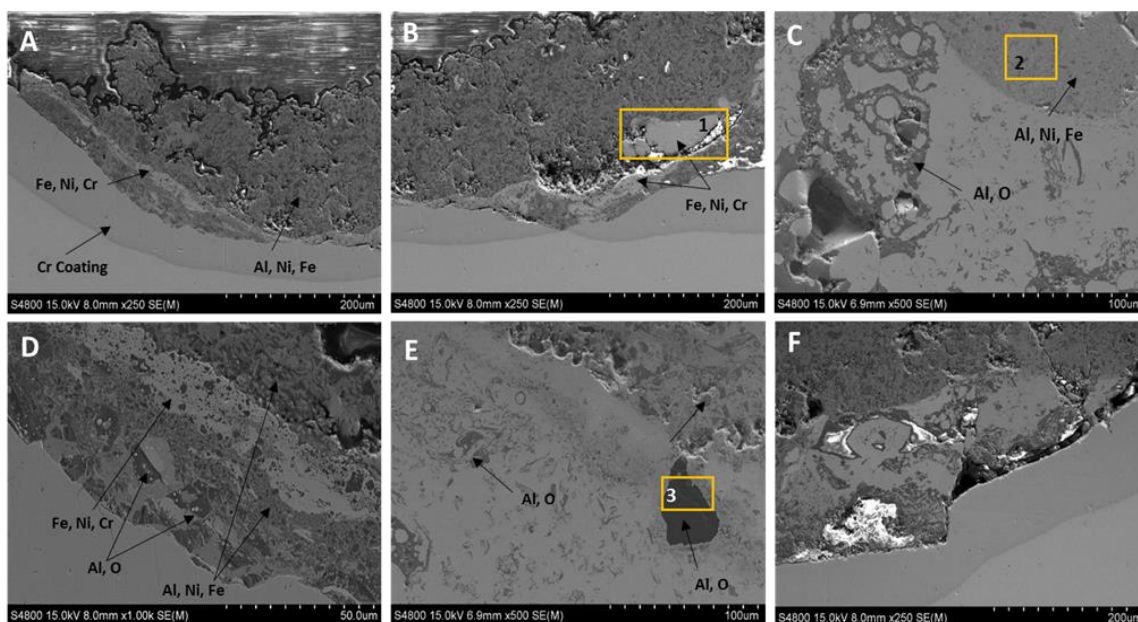
Figure 4.39 SEM images of the cross-sectional view of sample A4.1 on Area 4. (A-B) Slugging of chromium coating can be seen along with deposits. (C-D) Deposits present in the thermal eroded area.

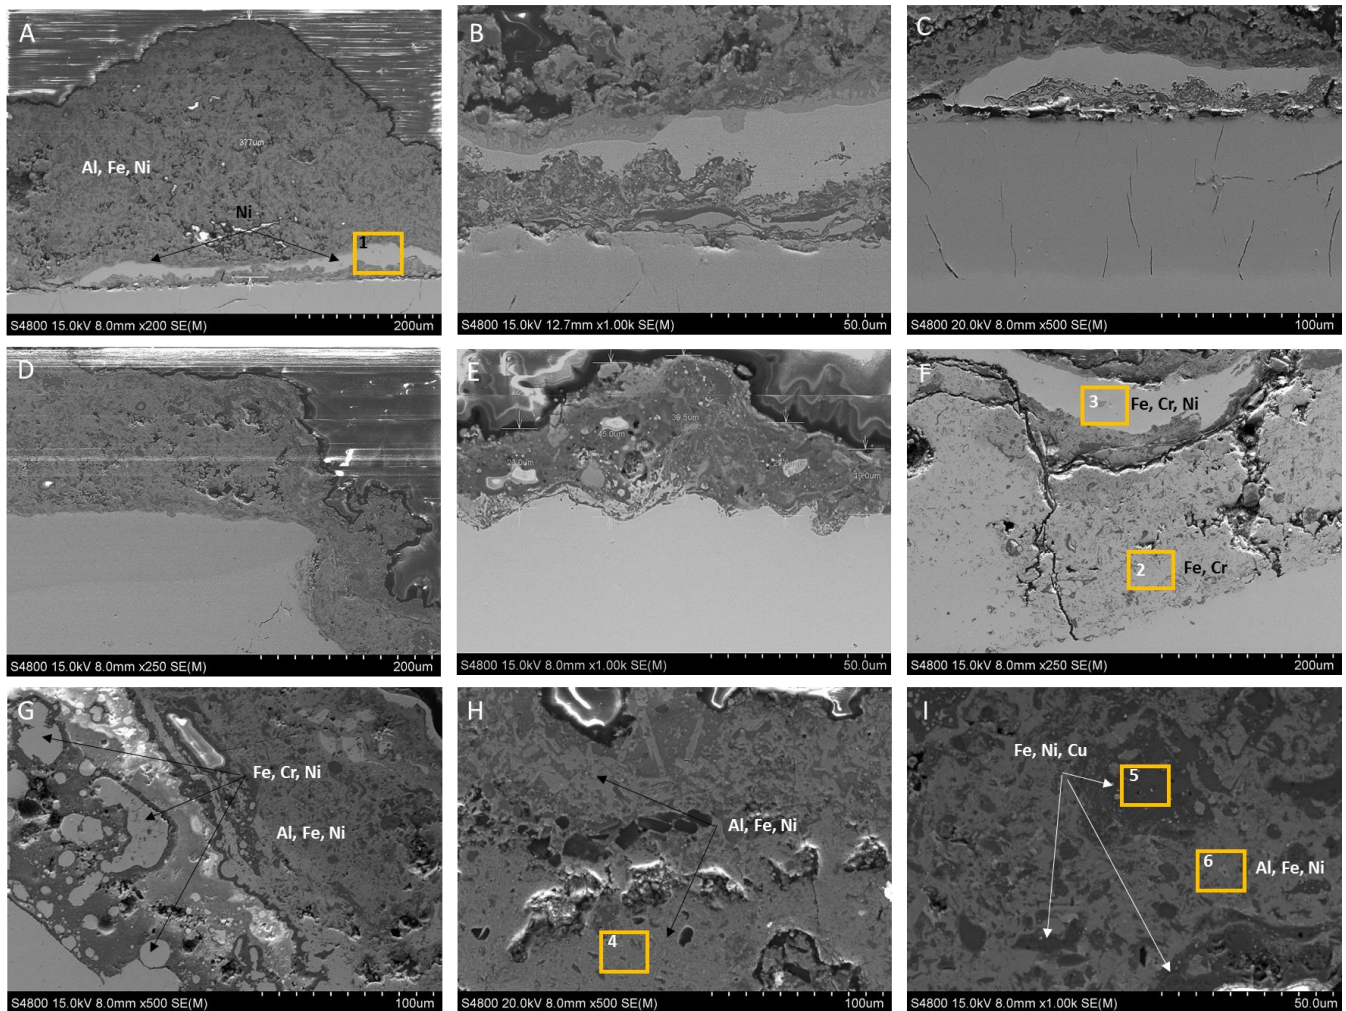
Figure 4.41 SEM images of the cross-sectional view of sample A4.2 on Area 4. (A-C) Area showing deposits as well as chromium coating indicating not thermal erosion in this section. (D-I) Deposits found in the thermal eroded area.

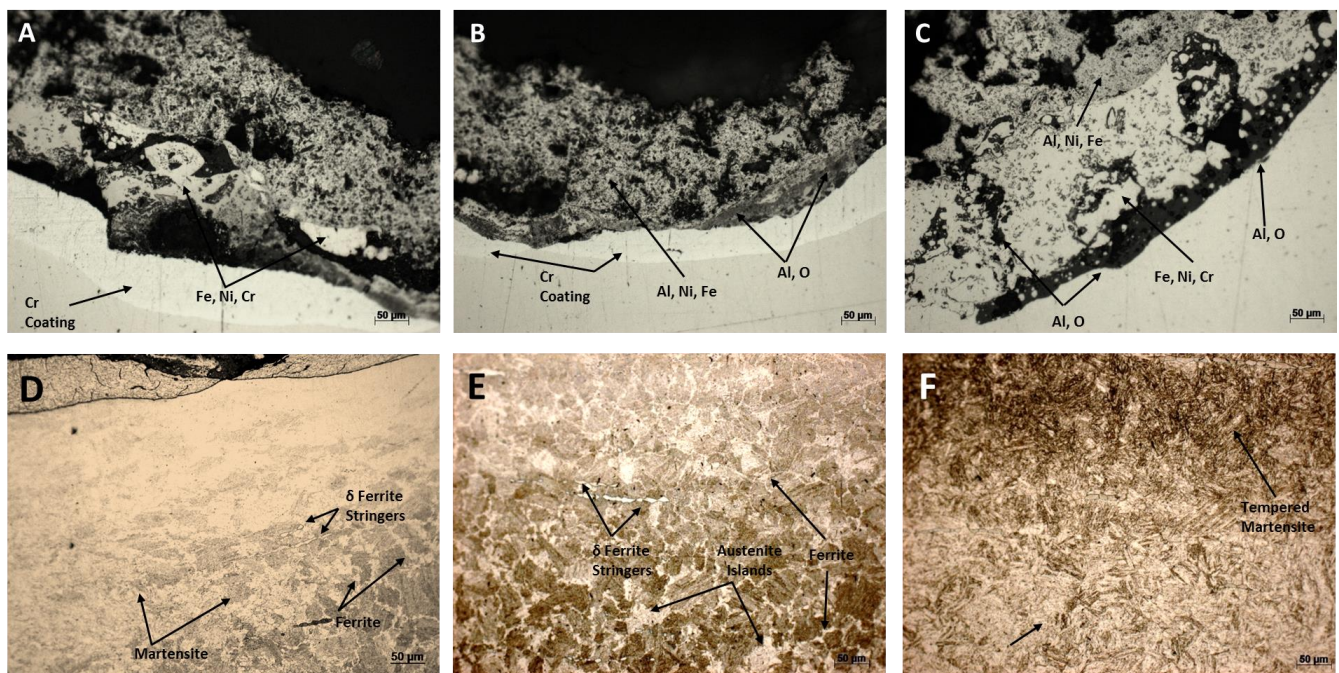
Figure 4.63 (A-C) Optical micrographs of sample A4.1 on Area 4 showing compromised Cr coating along with Ni deposits and an Al, Fe, and Ni matrix. (D-F) Microstructural changes seen in sample A4.1. Magnification of (A-F) is 200X.

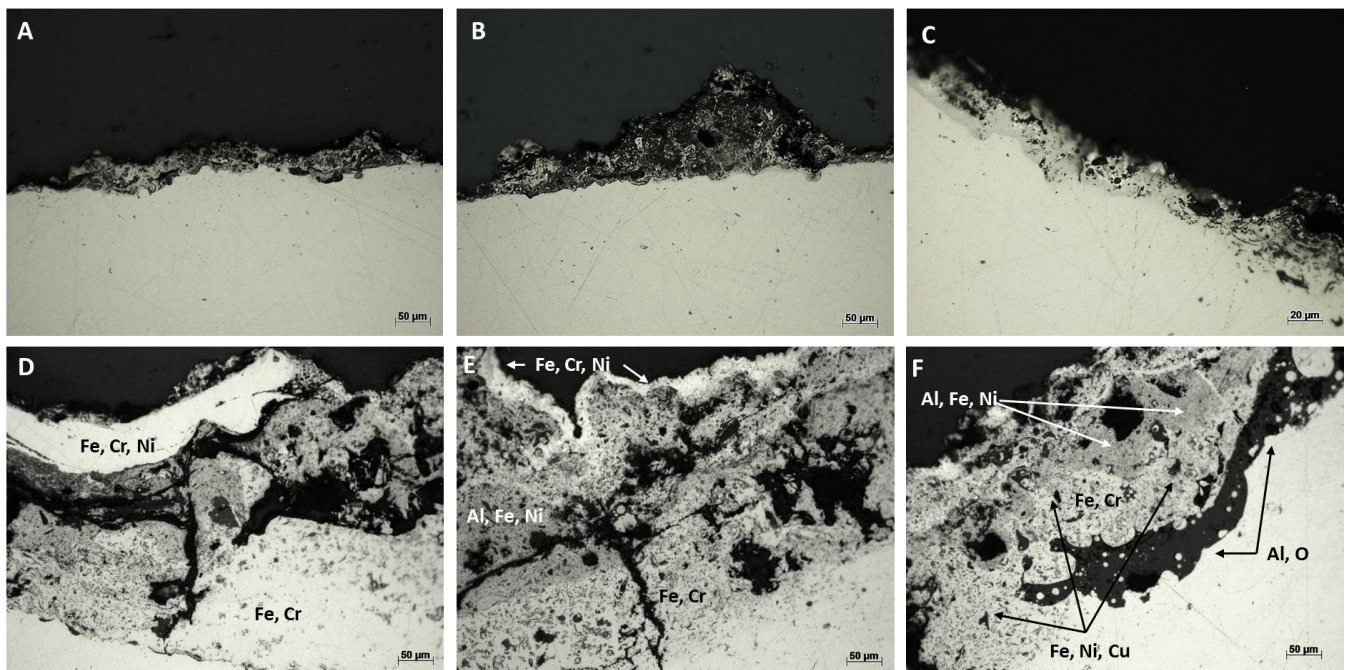
Figure 4.65 (A-C) Optical micrographs of sample A4.2 on Area 4 showing areas in the sample where not much deposits accumulated but erosion did occur. Magnification of (A-B) is at 200X and (C) is at 500X. (D-F) Magnified images of deposits found in eroded area. Magnification of (D-F) is 200X.

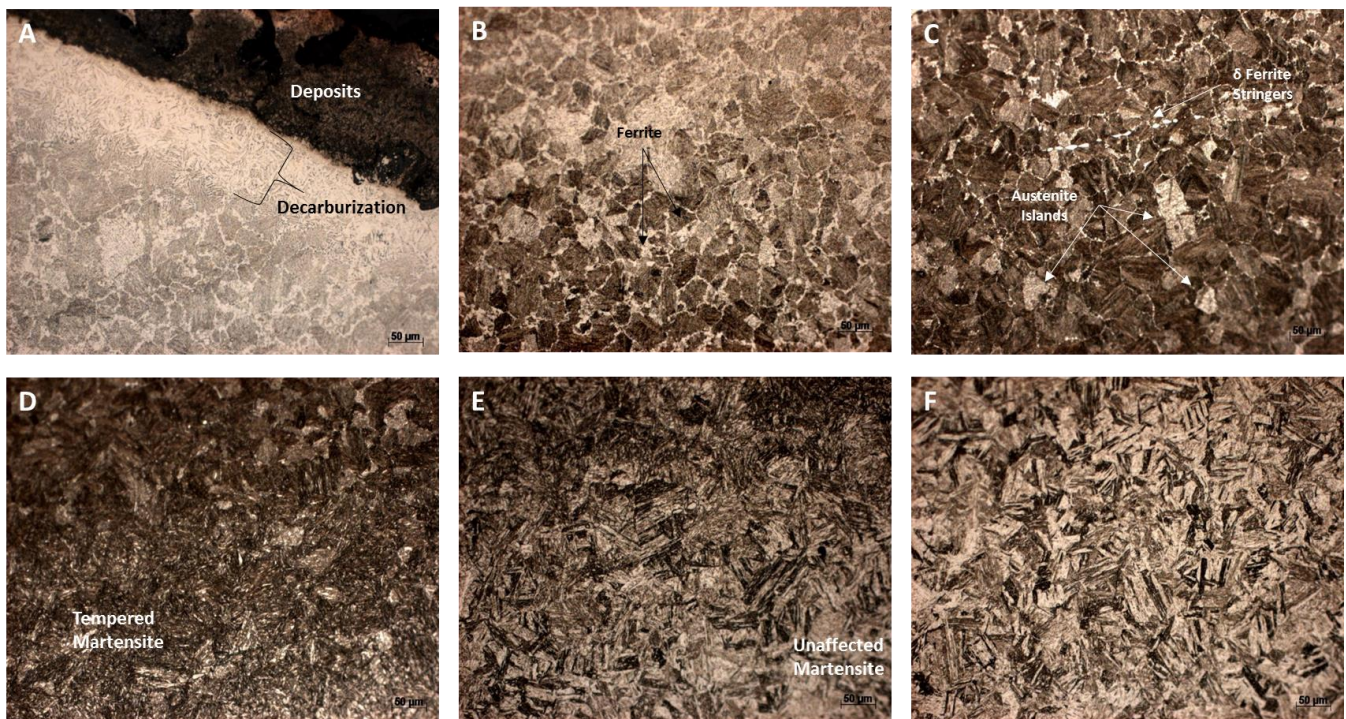
Figure 4.66 Microstructural changes occurring in the radial orientation of the base material. A) Decarburization proceeding deposit layer B) Mixed microstructure of austenite, delta-ferrite, and martensite C) Austenite patches with delta-ferrite stringers D) Tempered martensite E) Mixed microstructure of tempered and complete transformation of martensite F) Unaffected microstructure

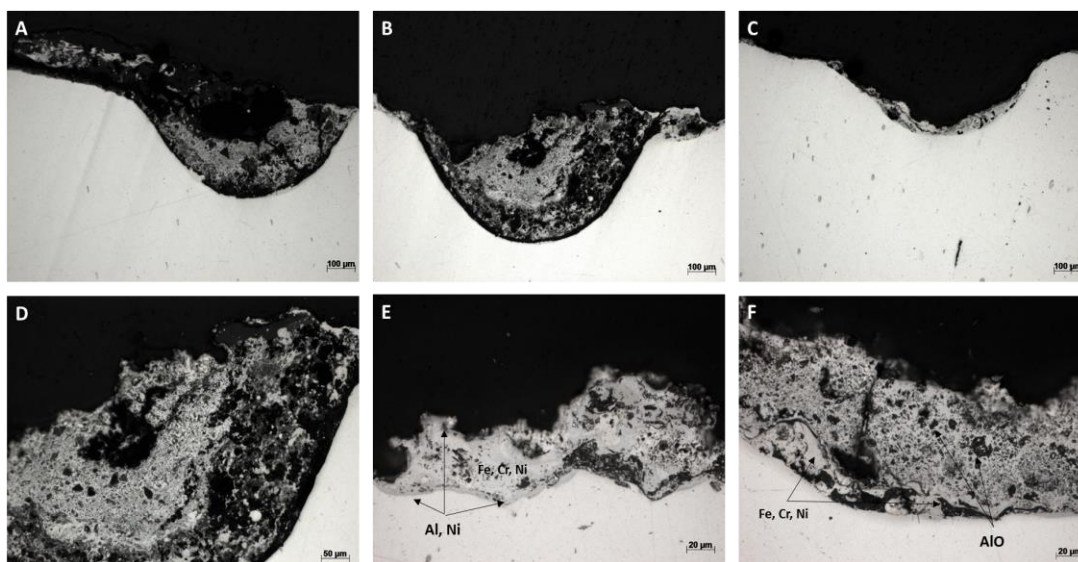
Figure 4.67 (A-C) Optical micrographs of sample A4.3 on Area 4 showing how the threads suffered from thermal erosion. Magnification of (A-C) is at 50X. (D-F) Magnified images of deposits found on the crests and roots of the threads. Magnification of (D) is 200X and (E-F) is 500X.

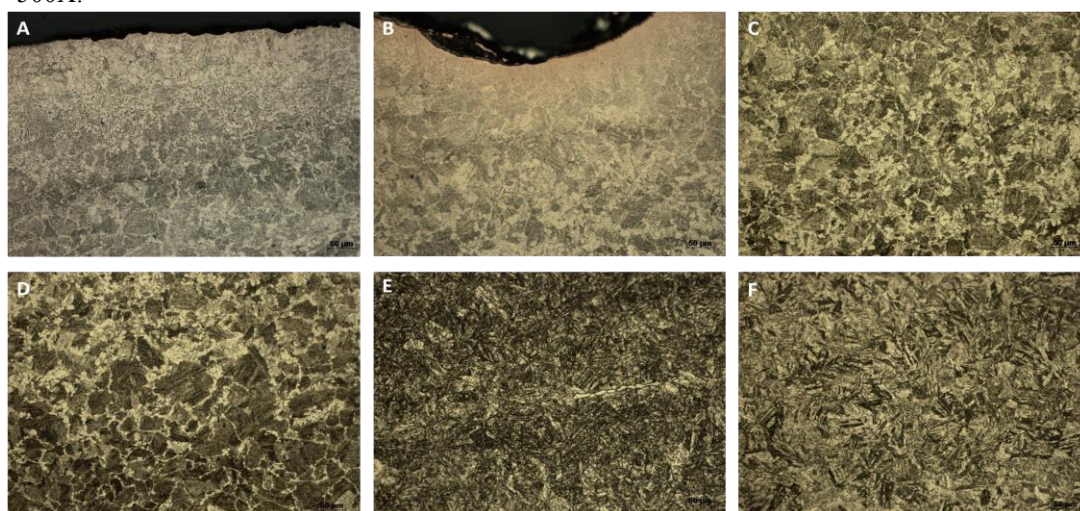
Figure 4.68 (A-F) Microstructural changes seen on sample A4.3 from Area 4 due to excessively high temperatures.
