Microstructural Investigation Of Vintage Pipeline Steels Highly Susceptible To Stress Corrosion Cracking

DISSERTATION

Metallurgical and Materials Engineering
THE UNIVERSITY OF TEXAS AT EL PASO

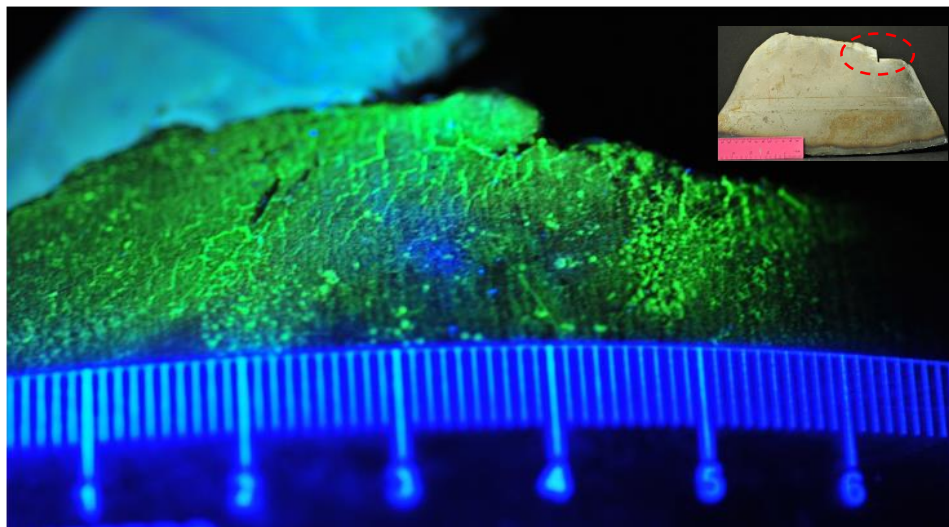
WMPI performed on section 1 from Pipeline #2, revealed multiple secondary cracks in the region adjacent to main fracture, as shown in Figure 15. Cracks exhibited multiple branching and were oriented perpendicular to the longitudinal axis.

Figure 15. Wet fluorescent magnetic particle inspection revealed multiple cracks oriented perpendicularly to main fracture. Cracks exhibited extensive branching.

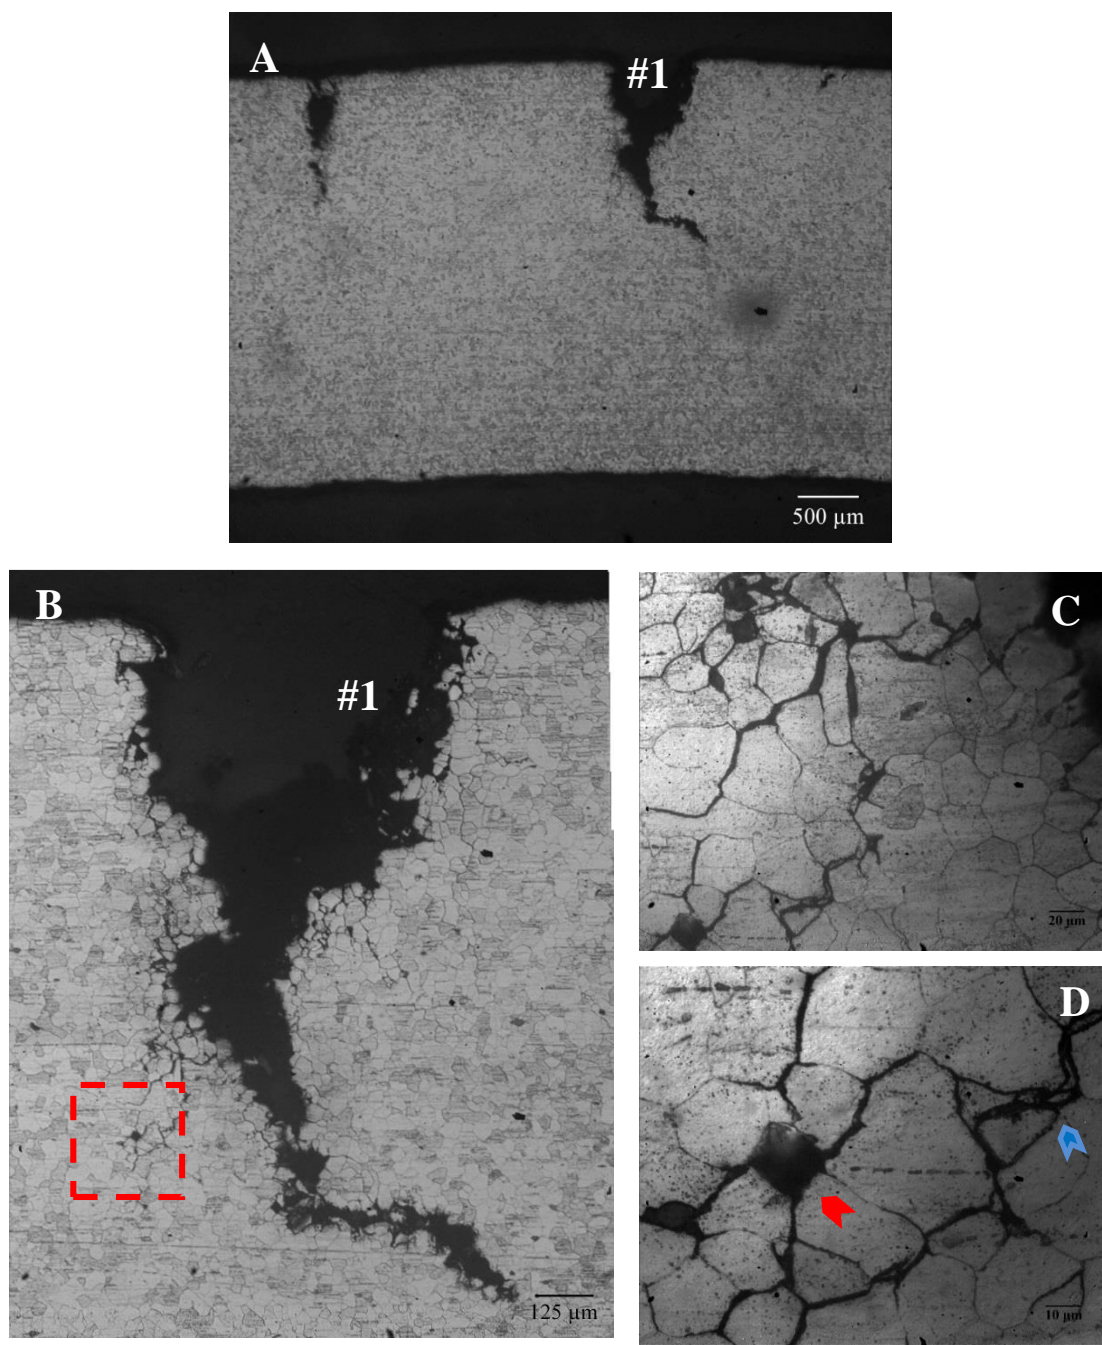
Figure 19. Optical micrographs showing stress corrosion secondary cracks for Pipeline #2. Higher magnification images indicate (B) extensive wall corrosion, (C-D) mix mode crack propagation (blue arrow) and what appears to be missing grains (red arrow). 2% Nital.

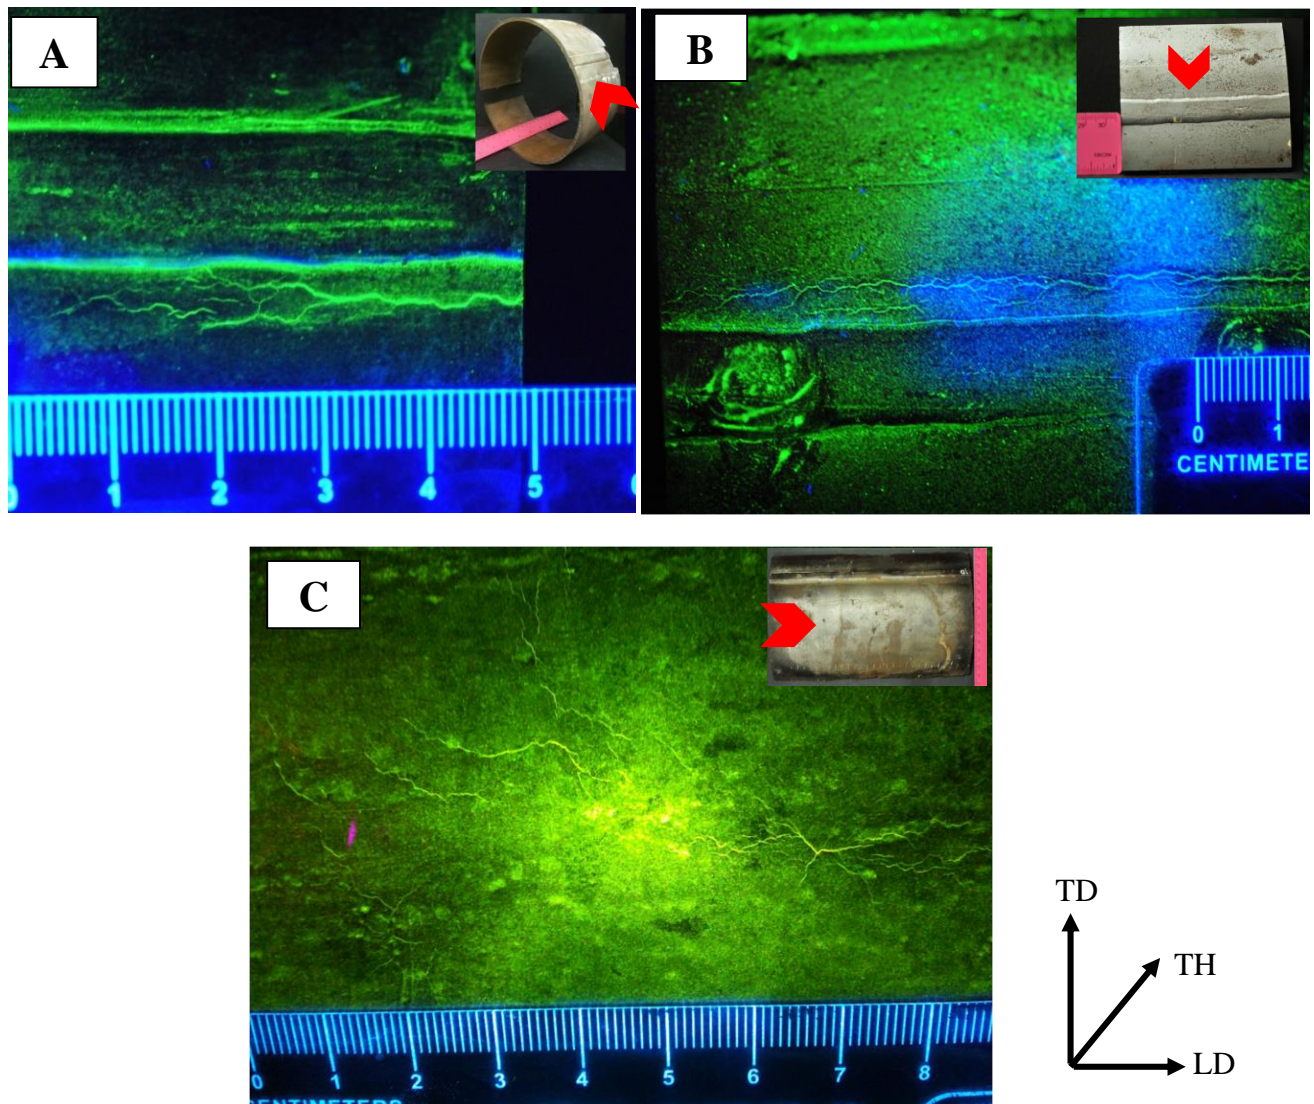
Figure 25. WMPI macrographs showing (A-B) longitudinal SCC cracks along weld seam and (C) "non-classical" SCC colony oriented in both the transverse and the longitudinal direction.

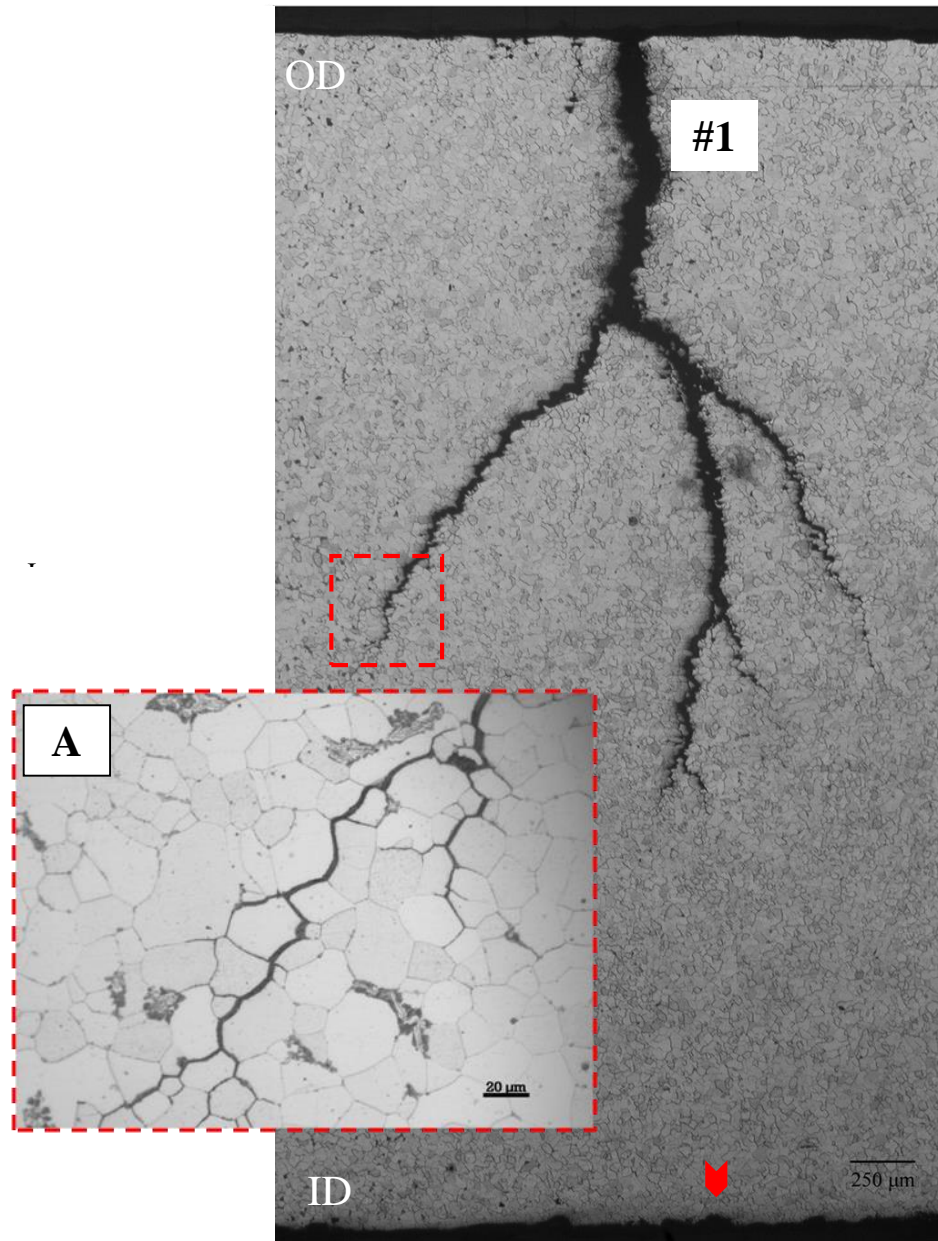
Figure 29. Optical view from intergranular SCC cracks along the weld zone. Crack #1 exhibited extensive branching and crack wall corrosion. A magnified view from one of the crack branches is shown in A. The arrow indicates pitting on the inner diameter. 2% Nital.

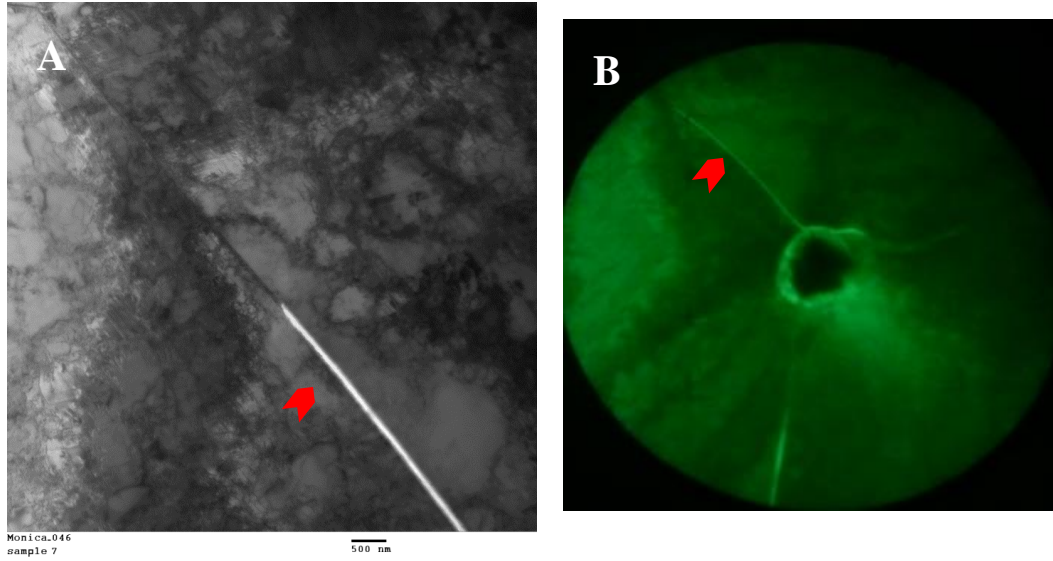
Figure 33. Bright TEM micrograph showing (A) dislocation structures and (A-B) an intergranular crack segment near a particle at a triple point grain boundary.

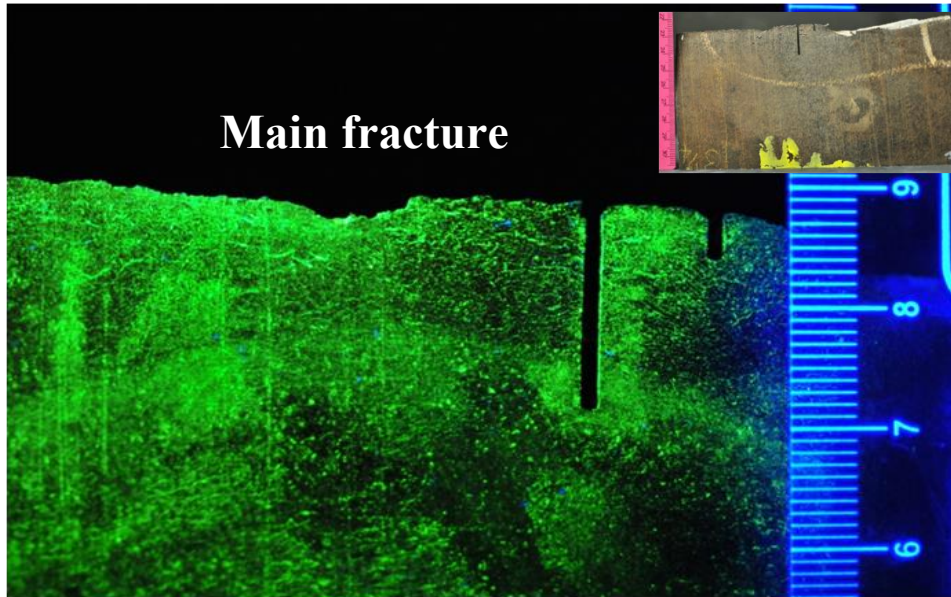
Wet magnetic particle inspection revealed multiple stress corrosion cracks with little branching. Cracks were oriented parallel to a main fracture surface, as shown in Figure 35.

Figure 35. Presence of SCC adjacent the fracture interface revealed by WMPI.

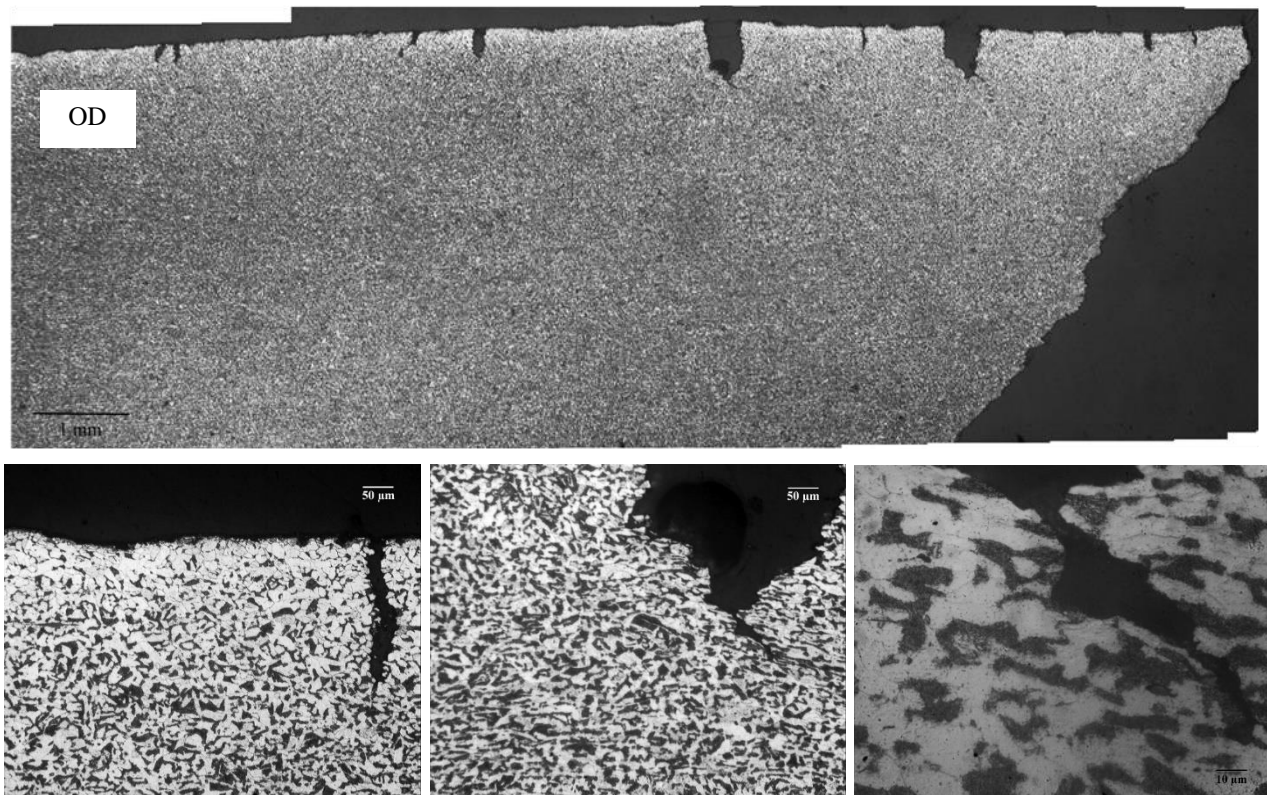
Figure 39. Light micrographs showing very wide stress corrosion cracks (result of hydrotesting) on pipeline #3 samples.

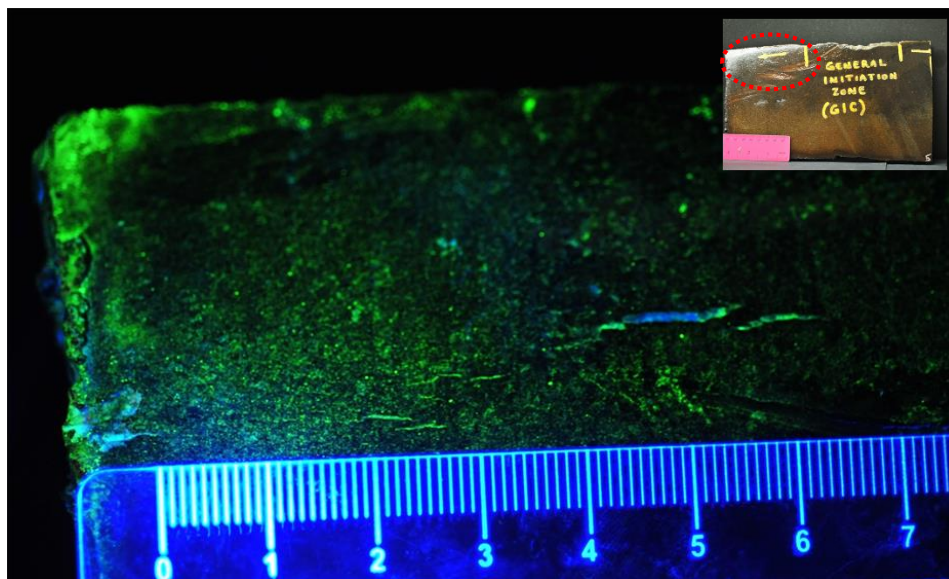
Figure 44. WMPI revealed multiple axially oriented stress corrosion cracks with little branching.

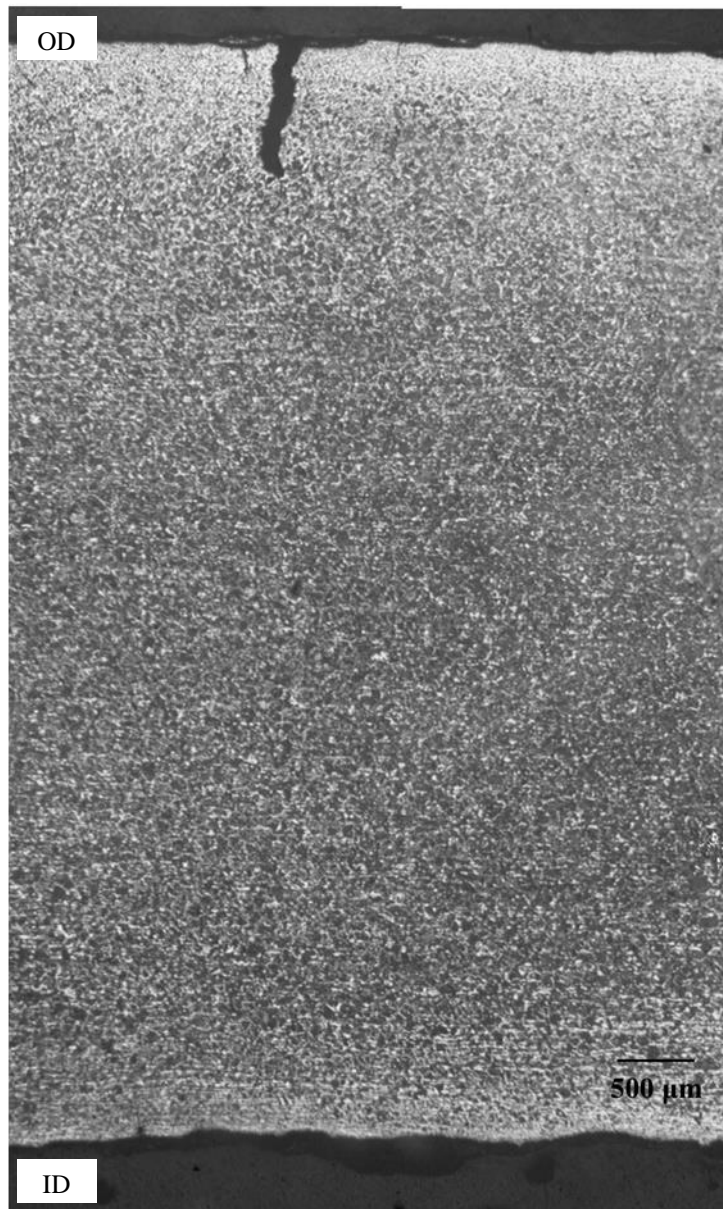
Figure 48. Light micrographs showing SCC cracks on pipeline #4. 2% Nital.

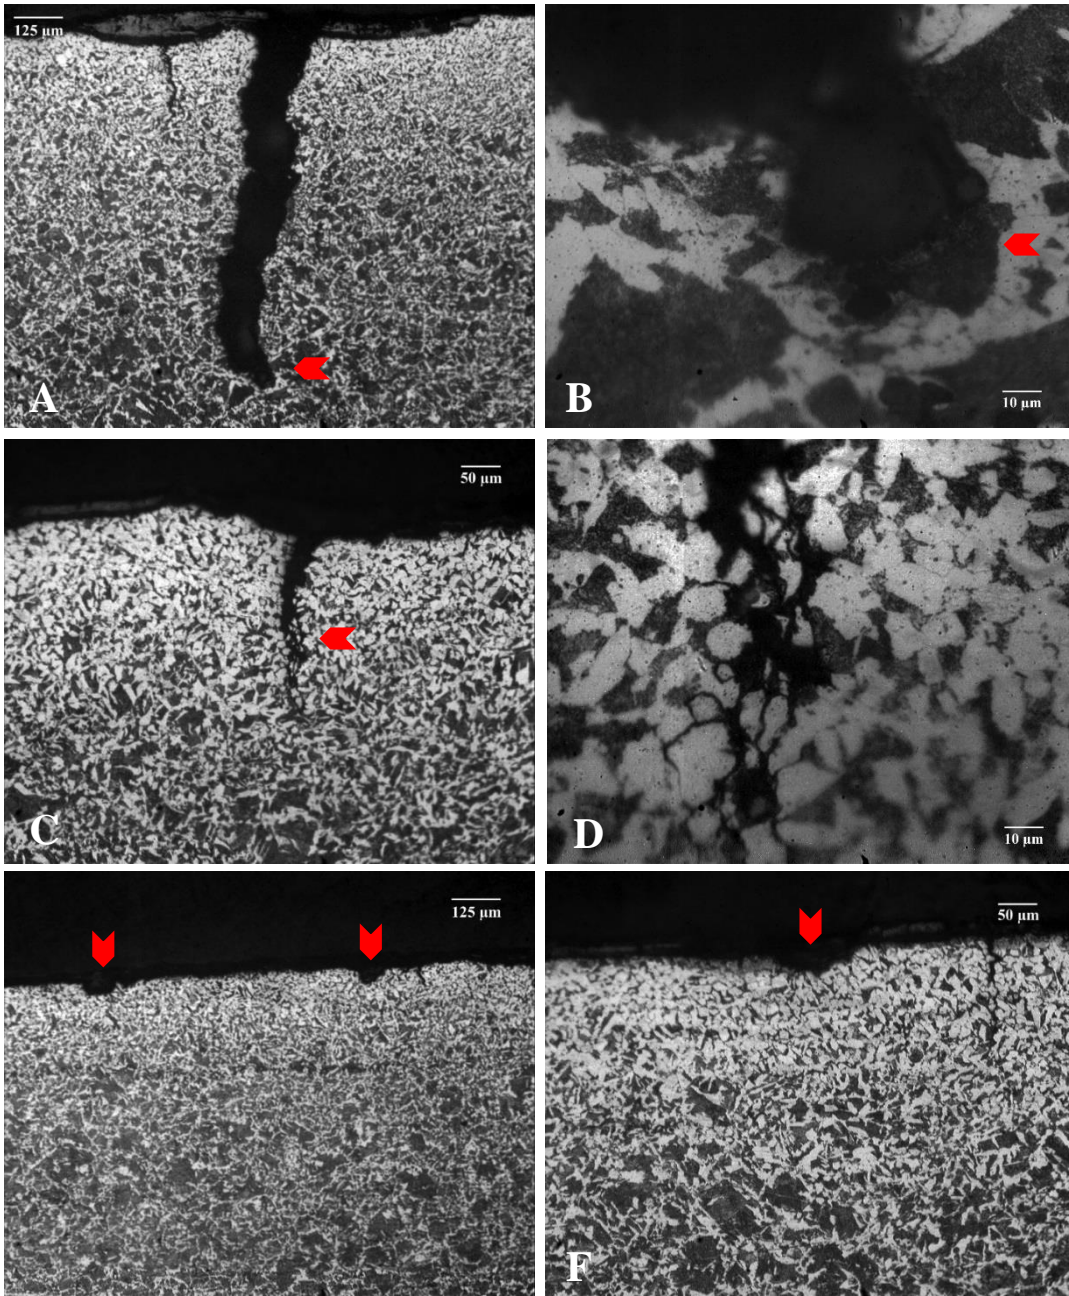
Figure 49. Details on SCC crack morphology on pipeline #4 revealed (A) very wide cracks (C-D) with a mix mode crack propagation, and (E-F) evident pitting on the OD. (B) Detail of crack tip, which appears to terminate in a pearlite colony. 2% Nital.

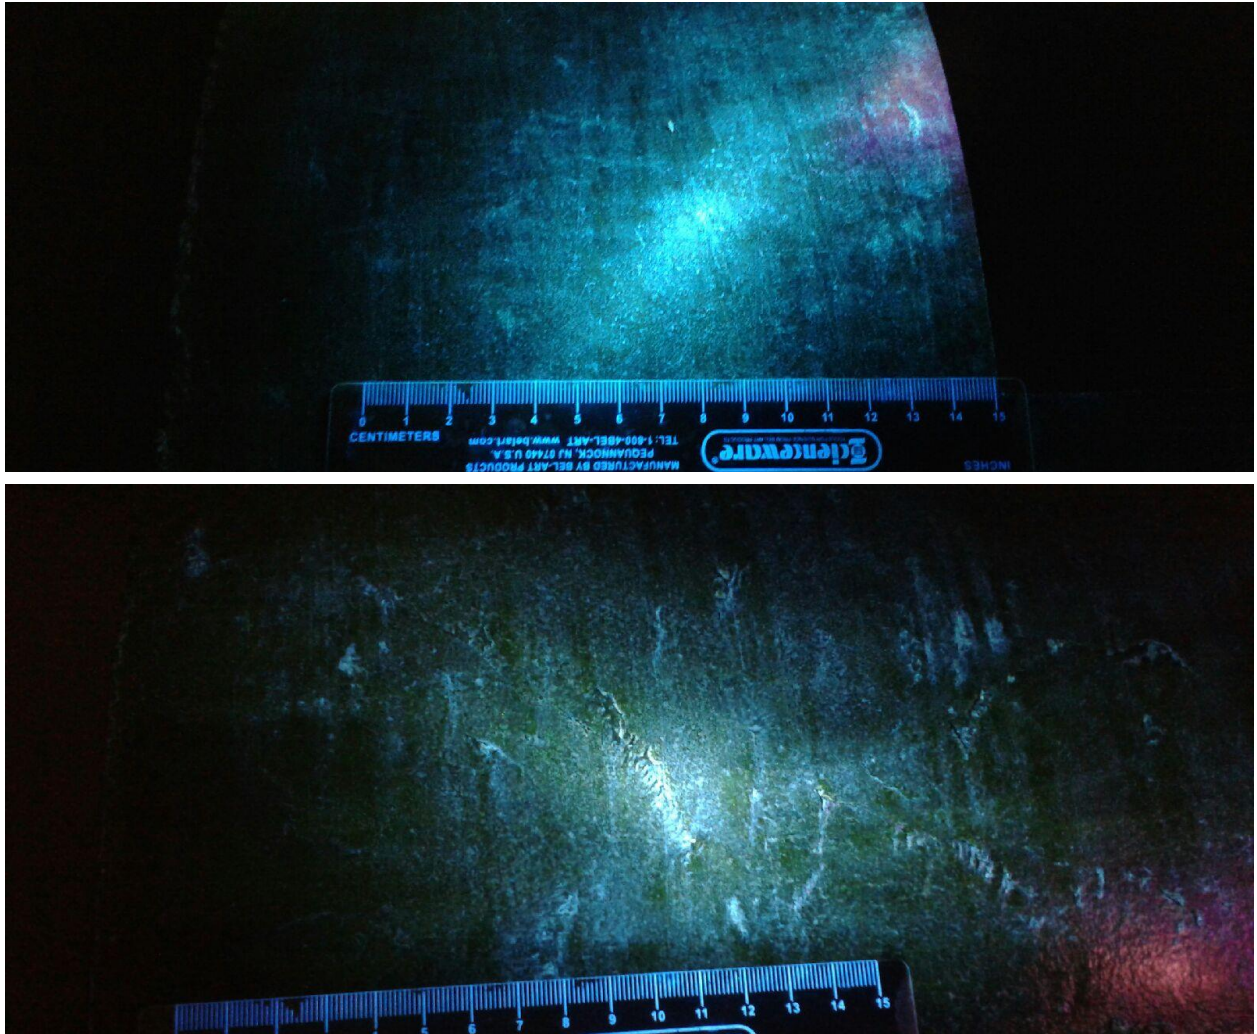
Figure 57. Wet magnetic particles inspection revealed some surface discontinuities on pipeline #5 but no evidence stress corrosion cracks.

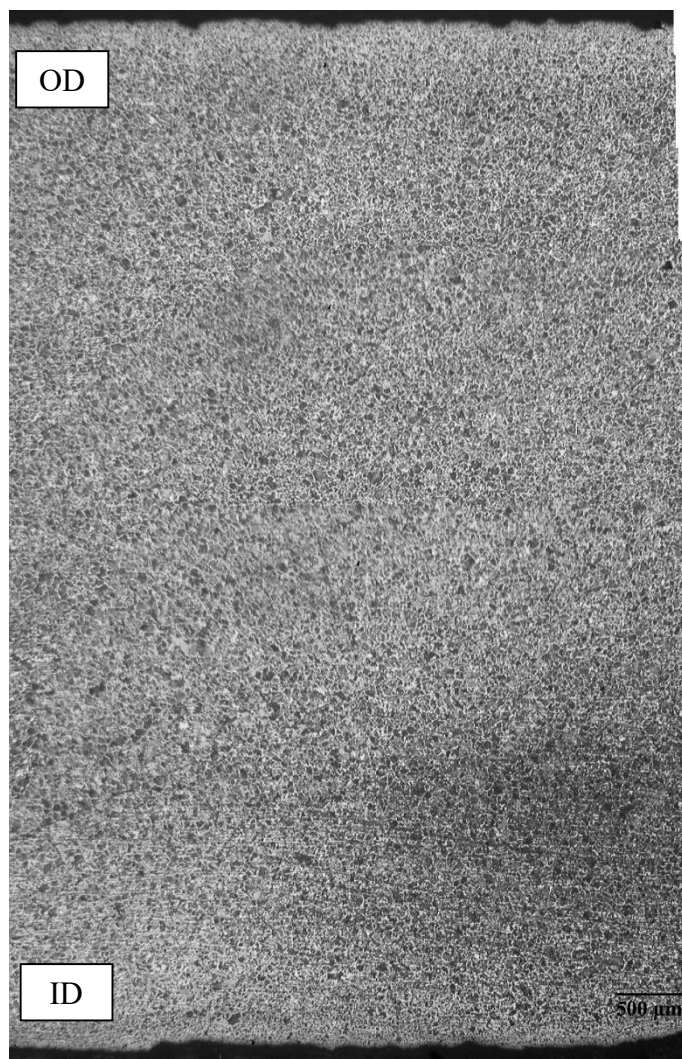
Figure 61. Low magnification light micrograph from pipeline #5 showing a fairly uniform microstructure and evident pitting on the OD and the ID. 2% Nital.

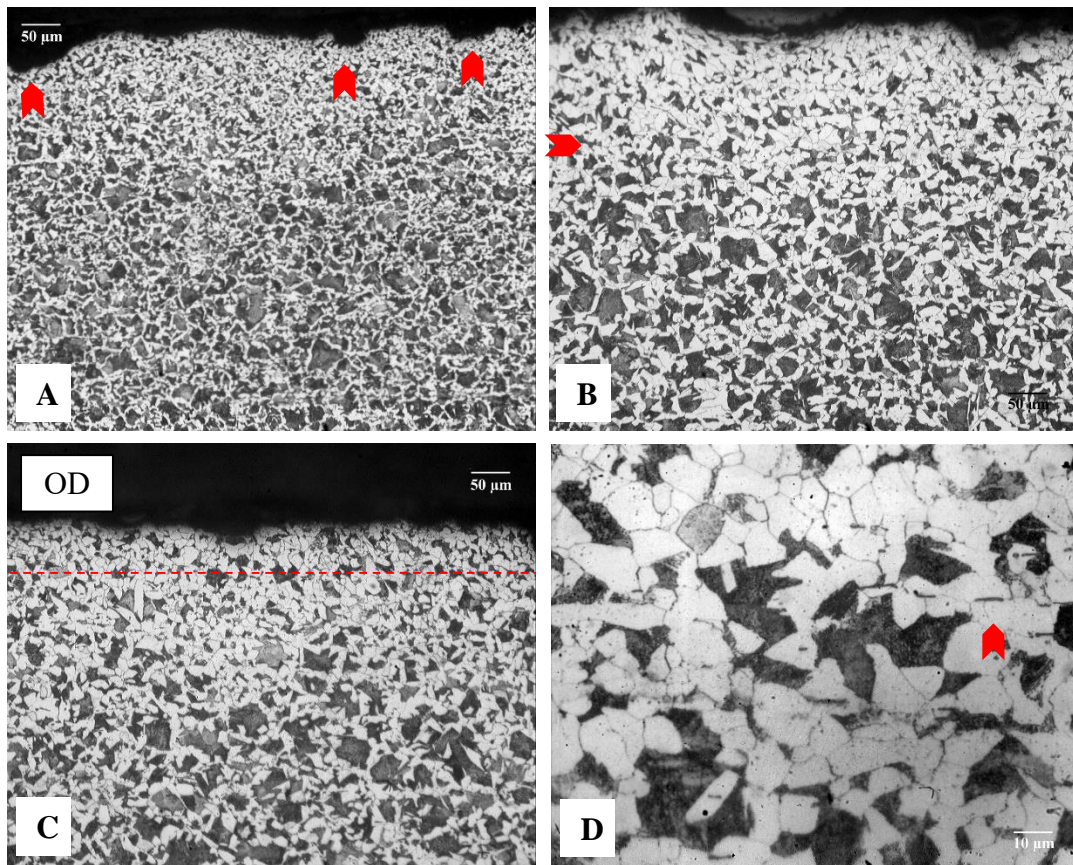
Figure 62. Light micrographs from the region near the OD of pipeline #5 exhibiting (A) pitting, (B) a decarburized layer (indicated by arrow), (C) very fine grains, and (D) polygonal ferrite with disconnected inclusions (arrow) and pearlite colonies (dark constituent). 2% Nital.

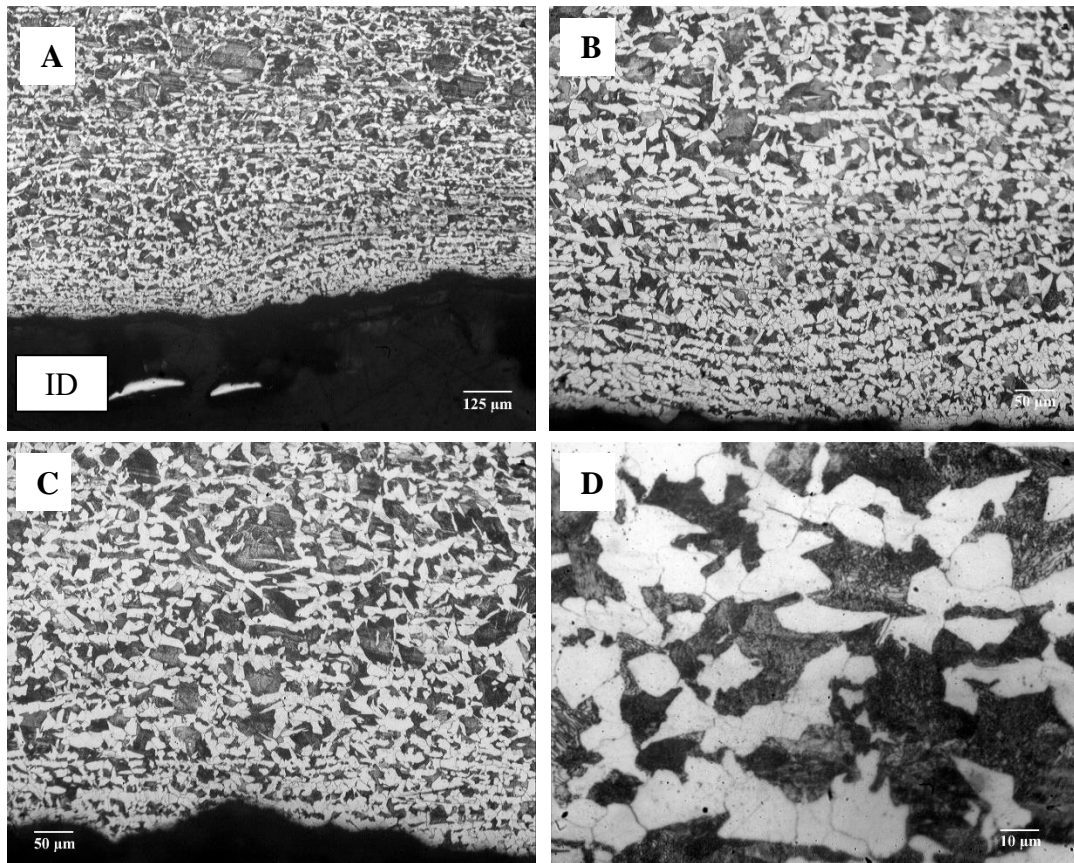
Figure 63. Light micrographs from the region near the ID of pipeline #5 showing (A-B) deformed banding, (B) grain refinement, (C) pitting and (D) a polygonal/quasi-polygonal ferrite morphology and pearlite. 2% Nital.
