Failure Analysis and Materials Characterization of Hip Implants

FAILURE ANALYSIS AND MATERIALS CHARACTERIZATION
OF HIP IMPLANTS

Department of Metallurgical and Materials Engineering

THESIS

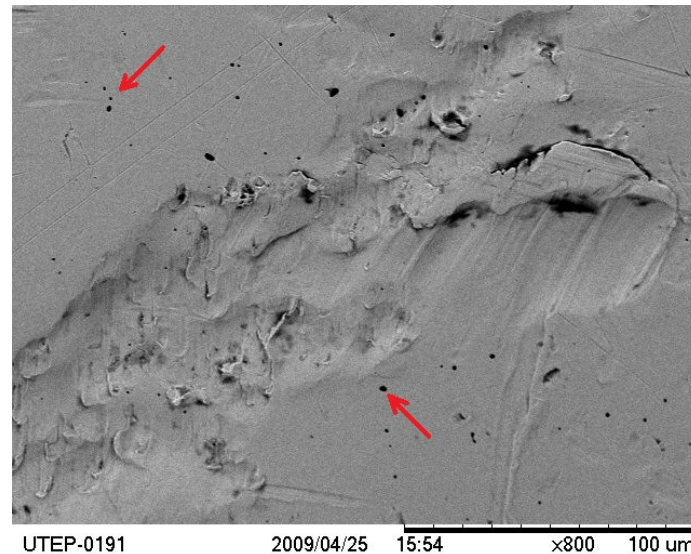
Figure 2.15, pitting can be observed in the outer regions of the plastic deformation indicated by the red arrows.

Figure 2.15: Patient U femoral head with pits at a magnification of 800x.

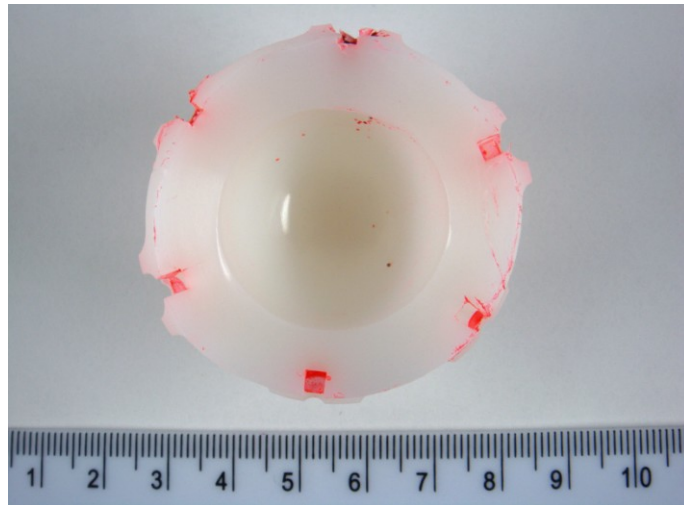
Figure 4.6: Patient E liner with dimensional reference

Completely unnoticeable during the initial visual examination, indentations were found in the socket region of the liner, Figures 4.6 and 4.7. Each indentation had a similar diameter and depth. Upon further investigation, two small metallic “rods” were situated inside of the PE. It is possible that these metallic rods are actually wear particles that became entrapped in the interface between the PE liner and the femoral head.

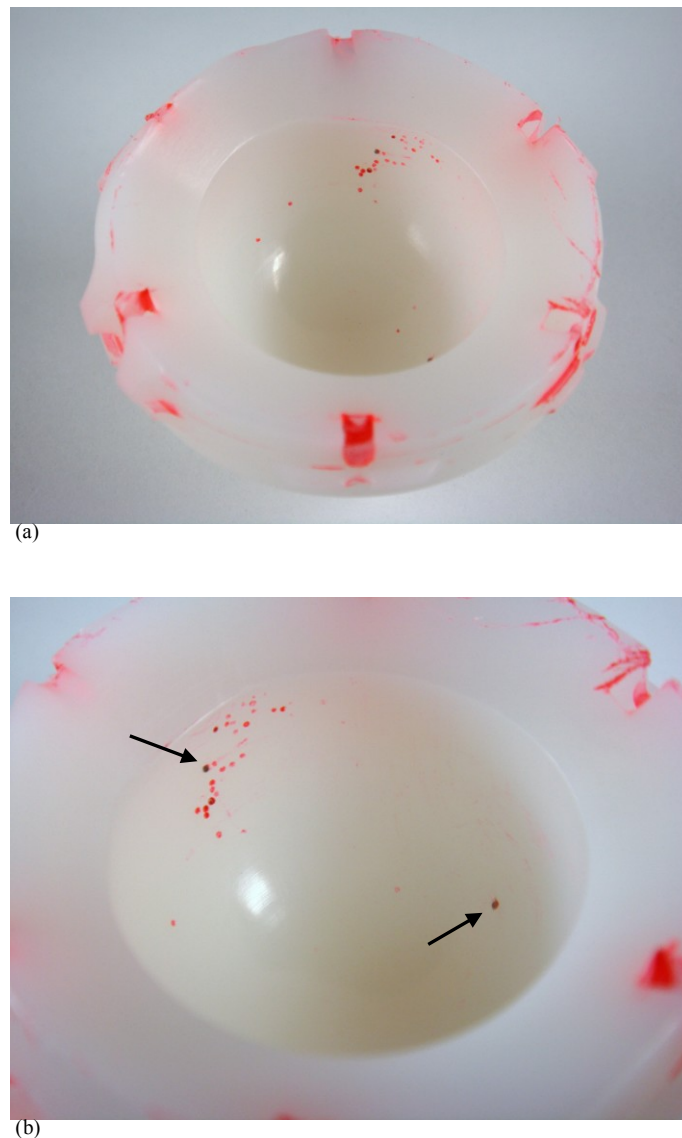
Figure 4.7: Patient E liner: (a) indentations, (b) close up image of indentations and two foreign, metallic particles indicated with arrows.

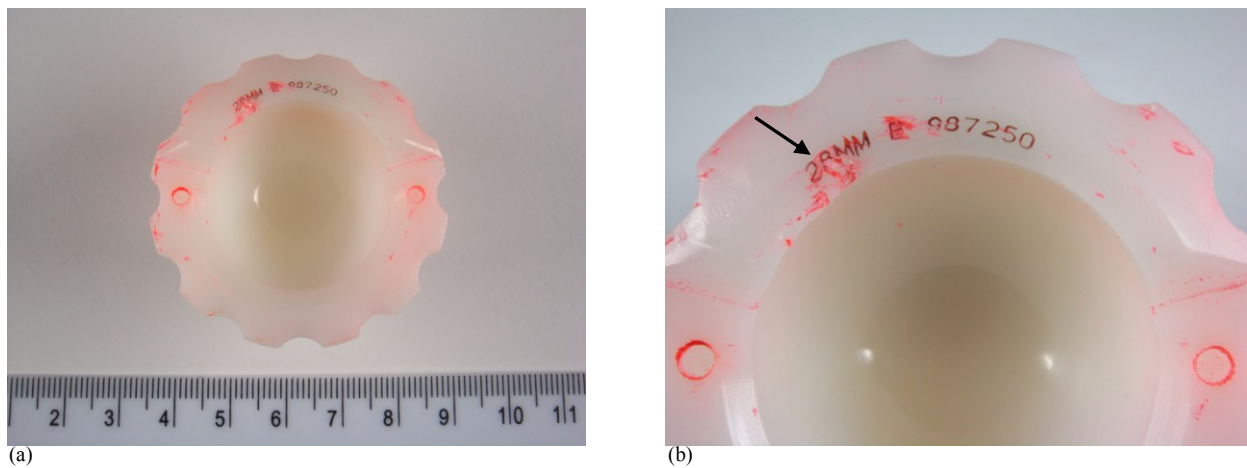
The largest amount of damage sustained was on the proximal region of the Patient W liner. As indicated by the arrow in Figure 4.9b, the deformed area is in a place that makes no contact with the femoral head. On the underside, where the liner makes contact with the acetabular shell, DPI revealed a deep crack which is pointed by the arrow in Figure 4.10.

Figure 4.9: Patient W liner: (a) with dimensional reference, (b) closer image of surface deformation.

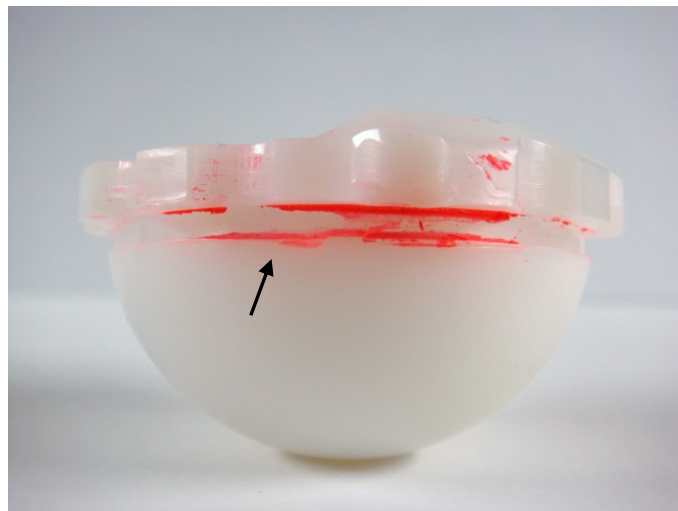
Figure 4.10: Patient W liner with radial crack

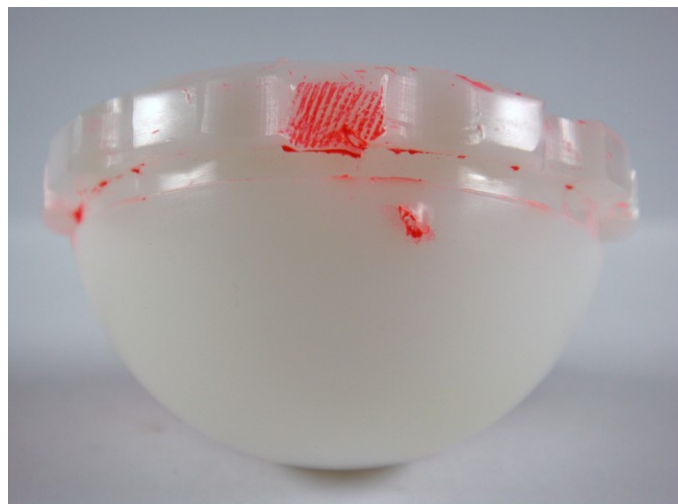
Similar to Figure 4.10, more rim damage was found on the other side of the component, Figure 4.11. The capillary action of the red dye clearly presents hash marks in at least 3 directions. It is obvious that the deformed area sits lower than the surrounding “sprocket” arms. Plastic flow of the PE is also evident in the downward sloping crack. Beneath the hash marks is a puncture in the PE. As the PE and acetabular shell are only in contact with the bone/cement, the damage sustained may have been due to implant insertion or retrieval by the surgeon.

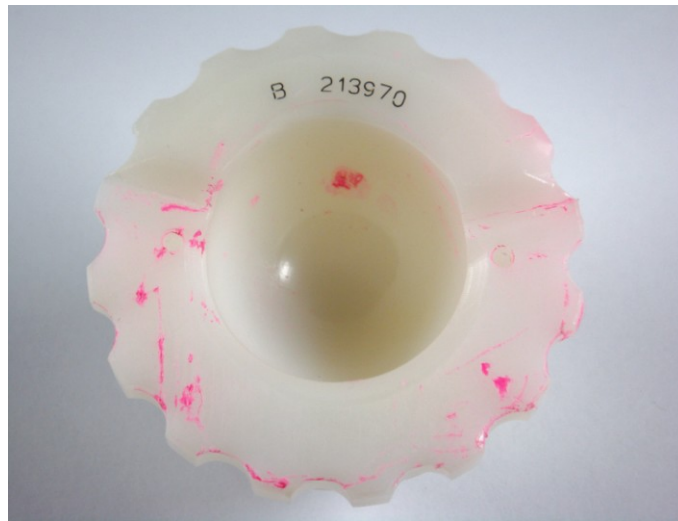
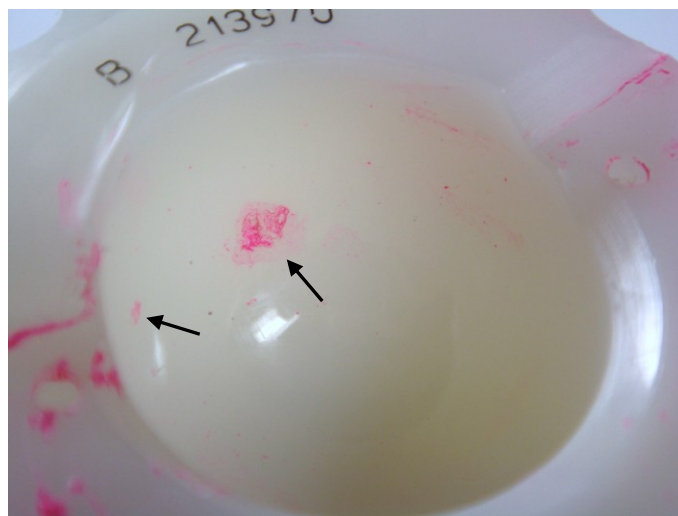
Scratches and plastic flow of the rim can be seen in Figure 4.12a. The Patient H liner was the component that truly displayed abrasive wear of the socket. Clearly visible throughout the visual examination, the dye brings more focus to the large wear spot indicated in Figure 4.12b. To the left of this defect and closer to the rim, is a smaller wear spot. The Patient H liner had the largest amount of surface scratches, abrasions, and plastic flow.

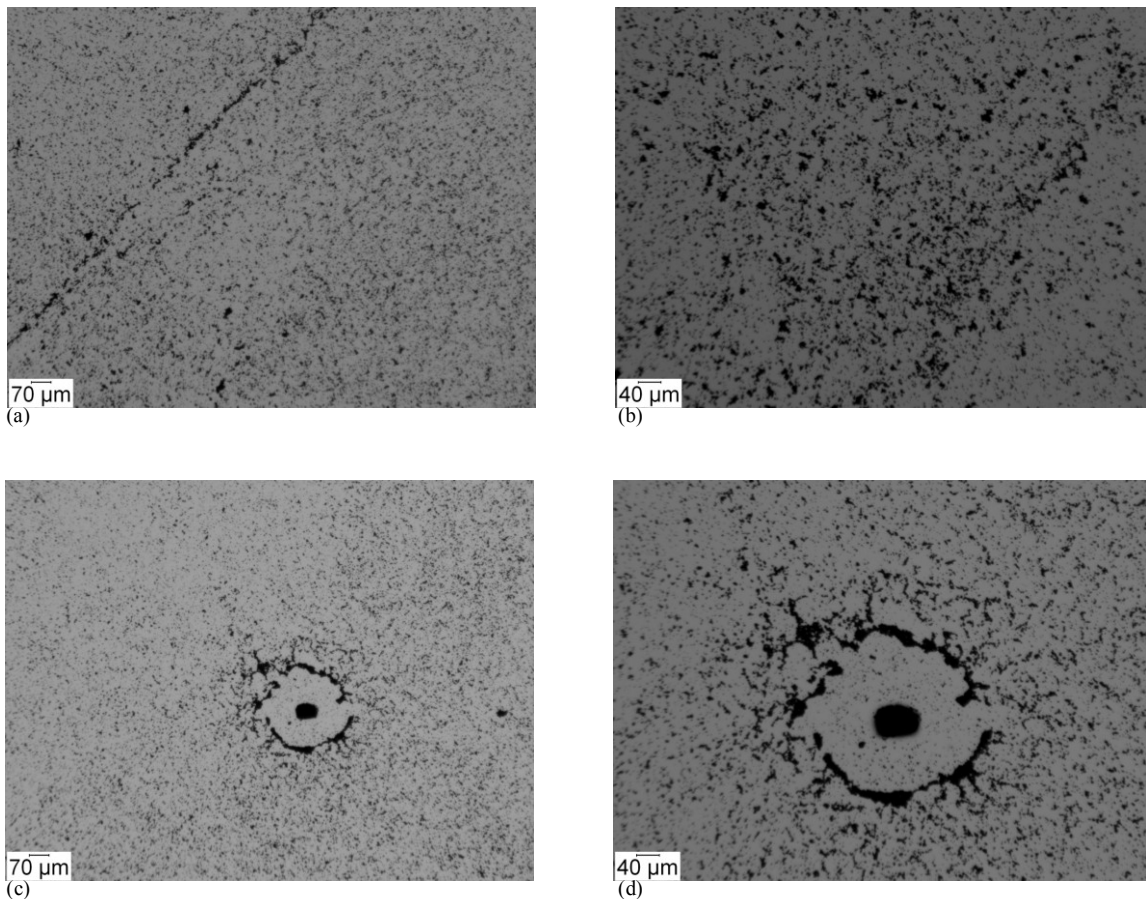
As three of the four femoral heads were cobalt-based alloys, one implant was selected to present the microstructure. Based upon the elemental weight percentages in the compositions acquired by XRF, the three femoral heads fell under the ASTM designation of an F75 casting alloy. Characteristic to the F75 specification, the microstructure for the Patient E section of the femoral head displayed dispersed carbides, Figure 4.14a and b. As casting defects are known to arise in cast products, Figure 4.14b and c displays a fairly large casting defect of densely connected carbides.

Figure 4.14: Patient E cobalt-alloy femoral head: (a) and (b) dispersed carbides, (c) and (d) casting defect.

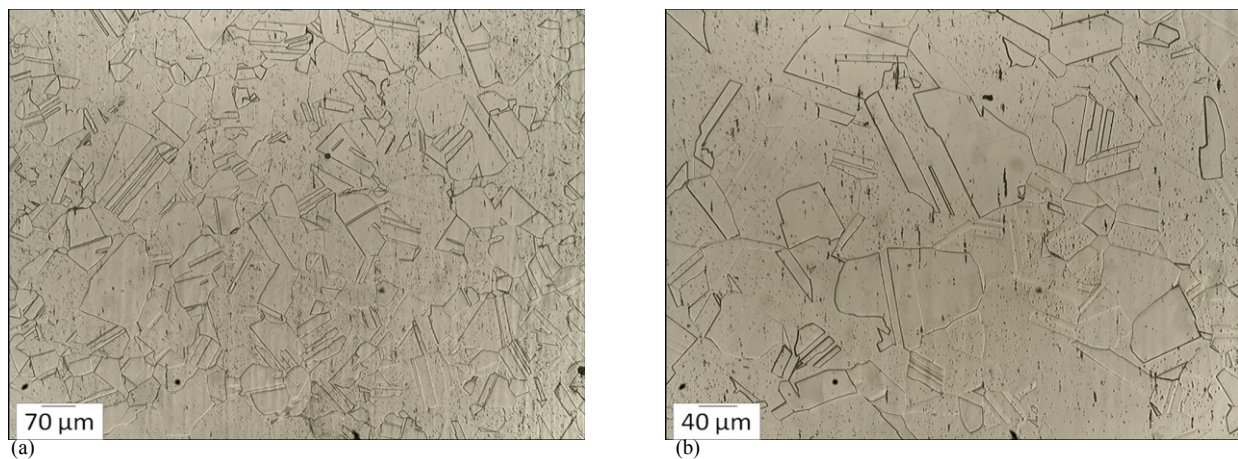
Initially found during the visual examination of the components, the engravings on the Patient U femoral head, Figure 3.4a, indicated the component as a 316L stainless steel. The composition produced by XRF confirmed the elemental weight percentages with 316L. As seen in Figure 4.16, the microstructure for this surgical alloy consisted of variable grain sizes with annealing twins. In order for the formation of twins, the alloy must have undergone an annealing heat treatment.

Figure 4.15: Patient U stainless steel femoral head with variable grain sizes and annealing twins at a magnification of: (a) 200x, (b) 400x.

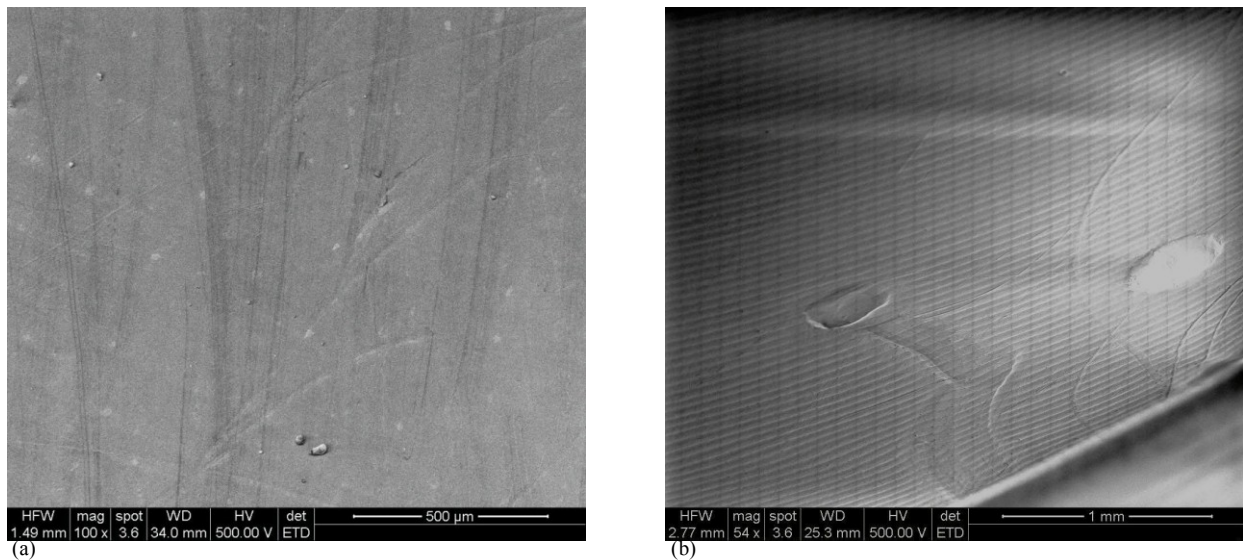
Figure 4.16: Patient E liner: (a) wear tracks and surface debris, (b) impressions with wear tracks.

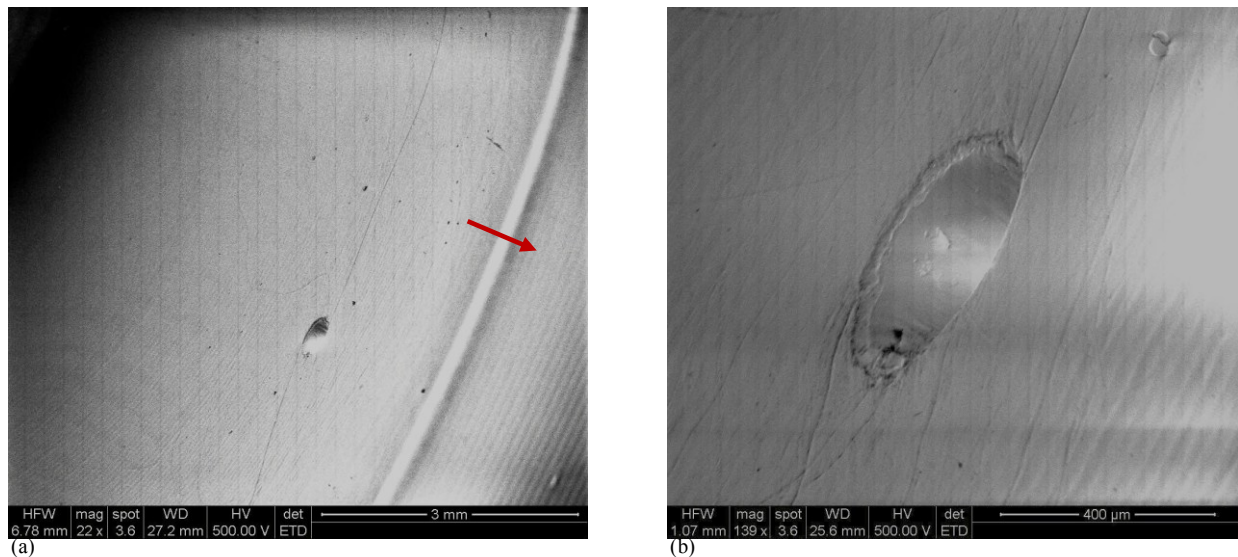
Figure 4.17: Patient E liner: (a) indentation, (b) closer image of indentation with plastic flow.

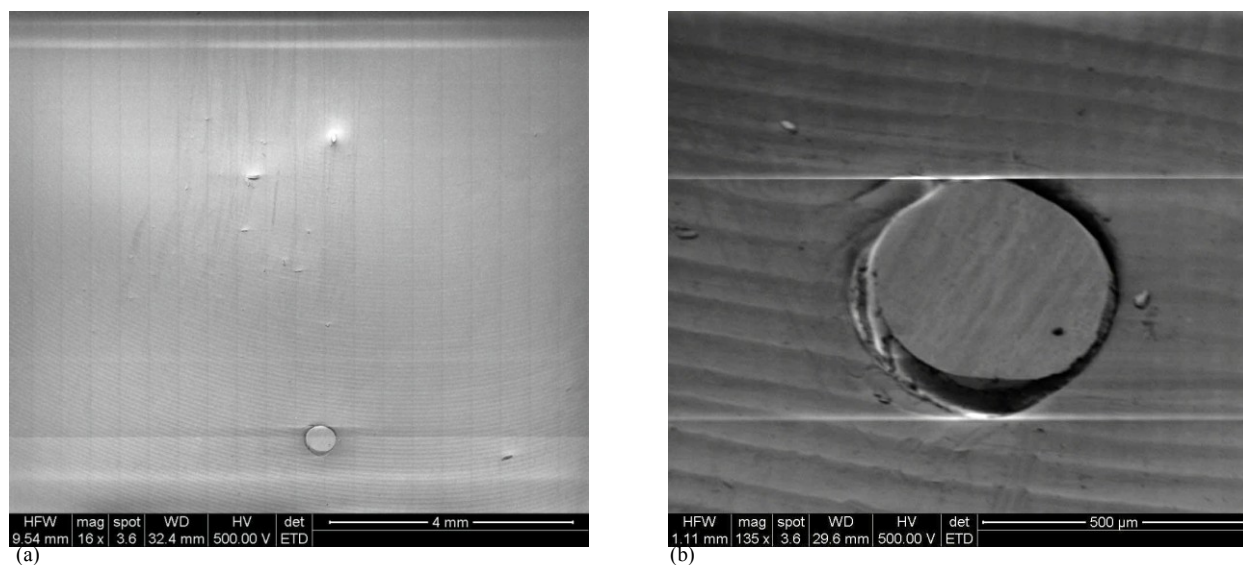
Figure 4.18: Patient E liner: (a) surface debris, wear tracks, and foreign particle, (b) foreign particle with wear tracks

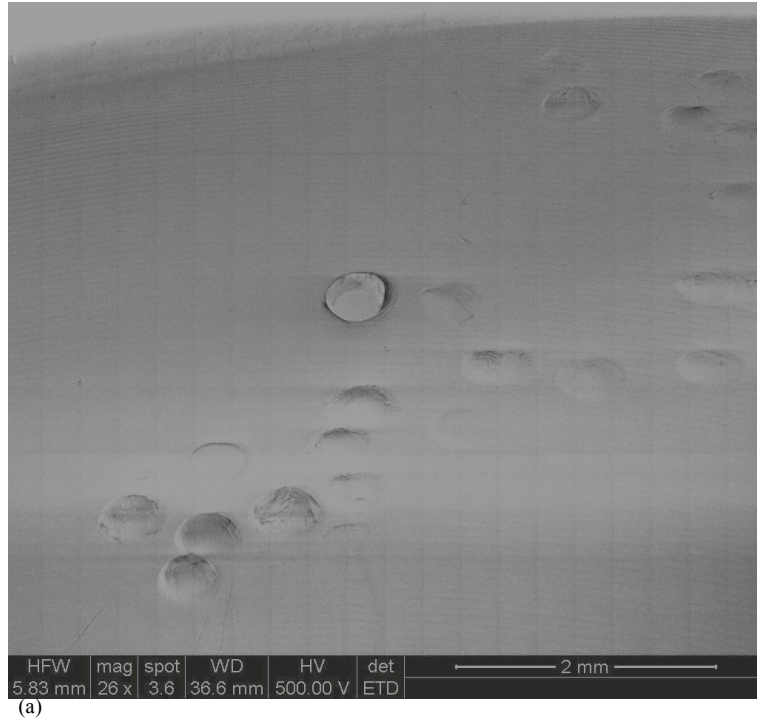
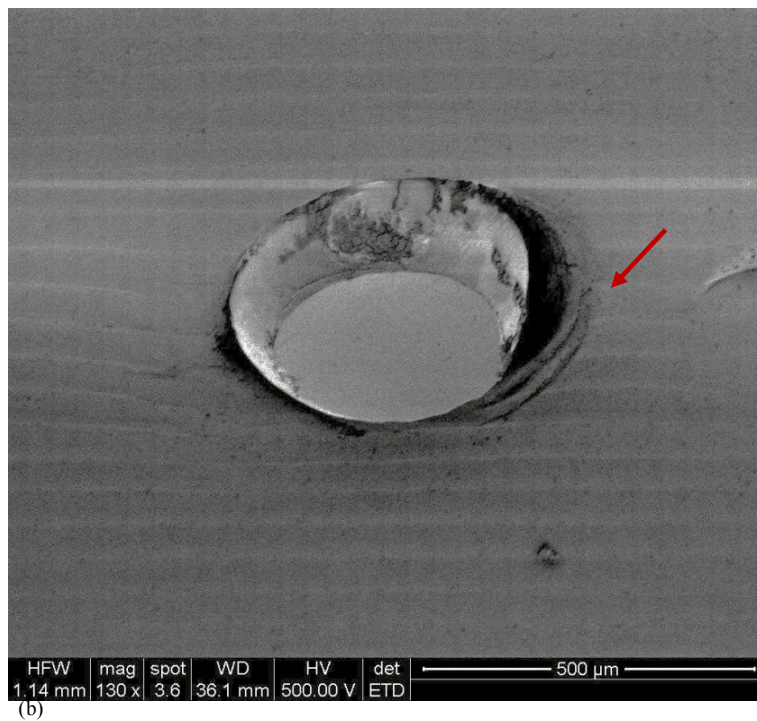
Figure 4.19: Patient E liner: (a) indentations and foreign particle, (b) foreign particle with plastic flow.

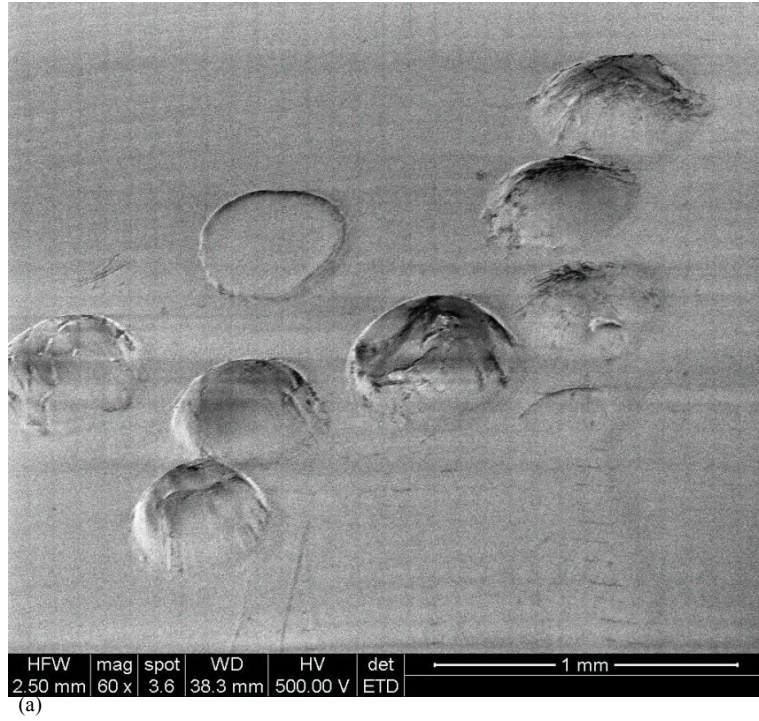
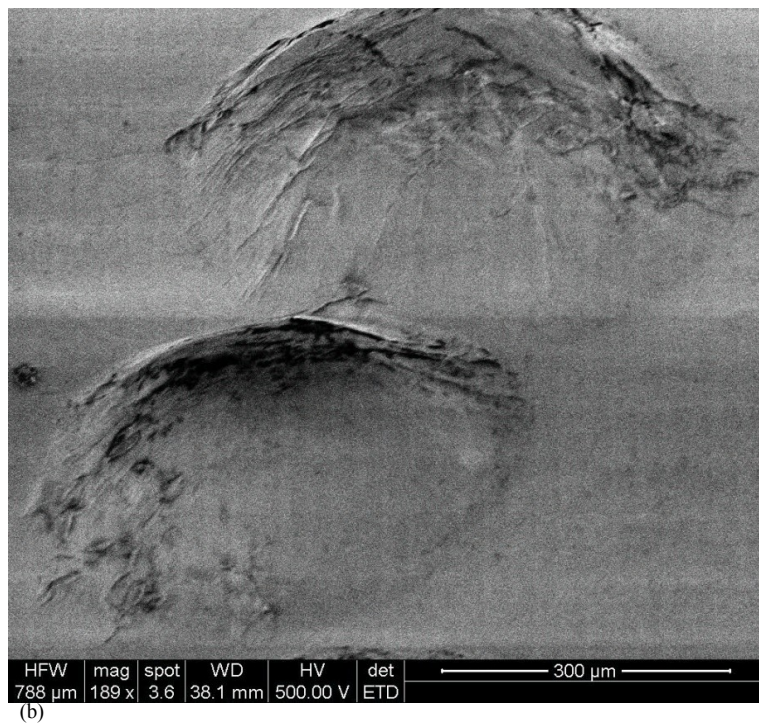
Figure 4.20: Patient E liner: (a) indentations and wear tracks, (b) complex morphology of indentations.

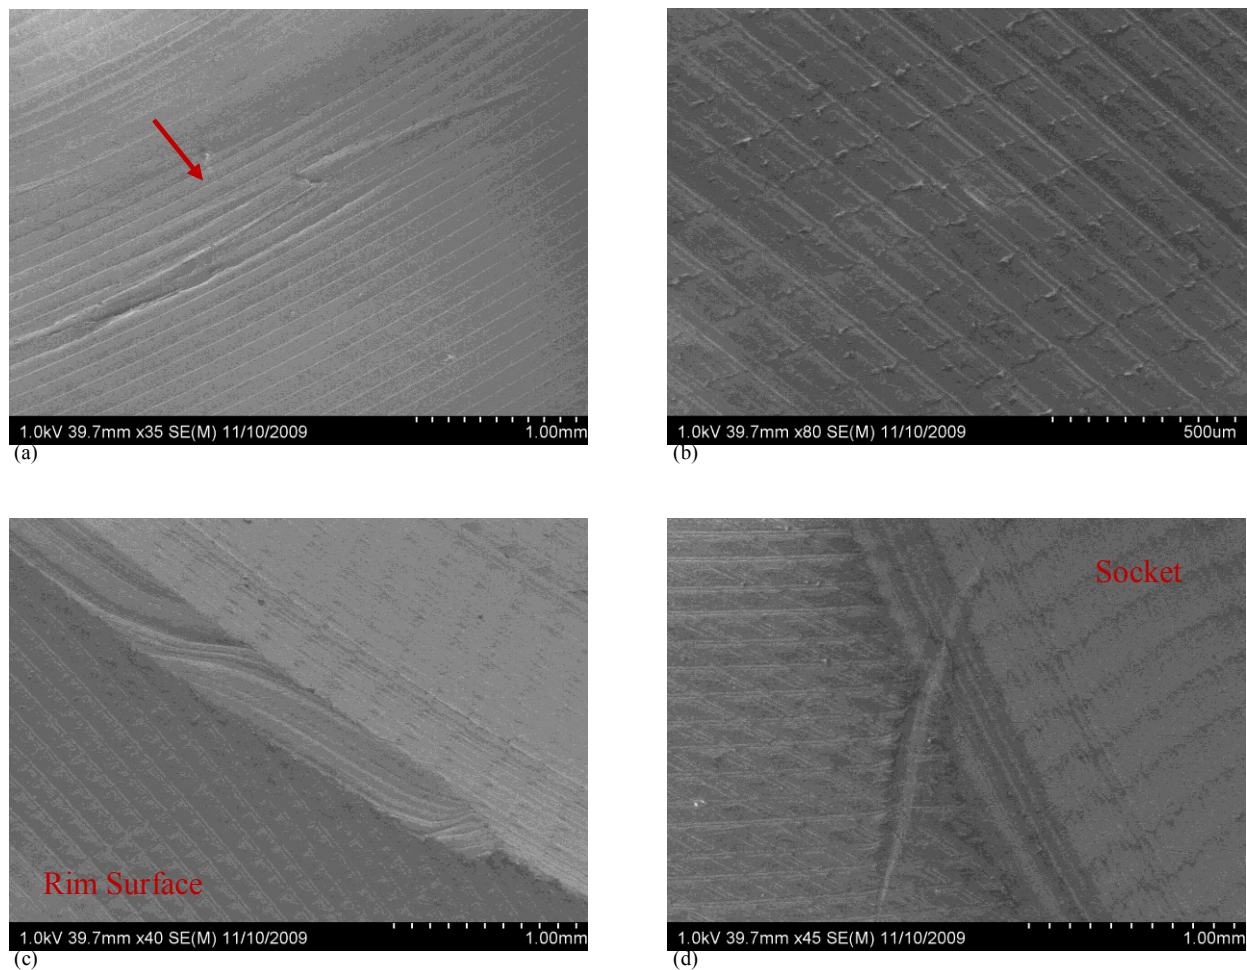
Figure 4.21: Patient W liner: (a) machine marks above PE fold, (b) two sets of evenly spaced machine marks, (c) and (d) abrasion on the interface of the rim surface and downward slope of the socket.

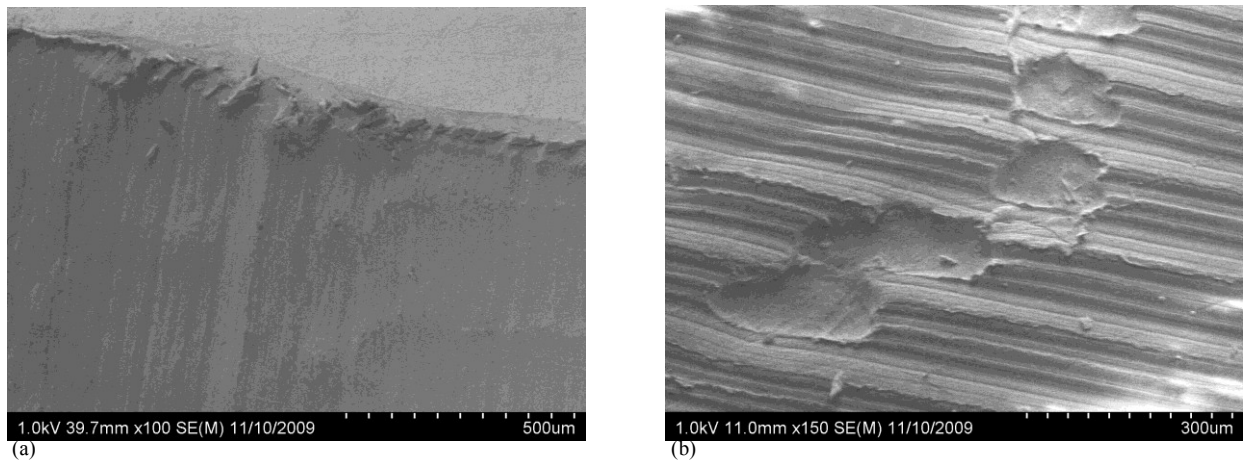
Figure 4.22: Patient W liner: (a) plastic flow, (b) surface indentations.

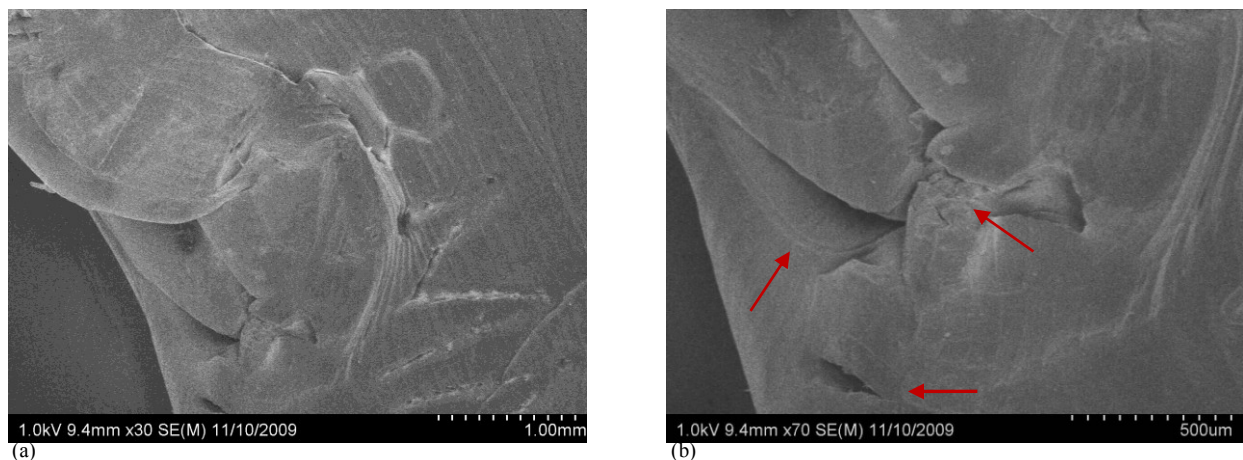
Figure 4.23: Patient W liner: (a) topographical deformation, (b) multiple damage modes.

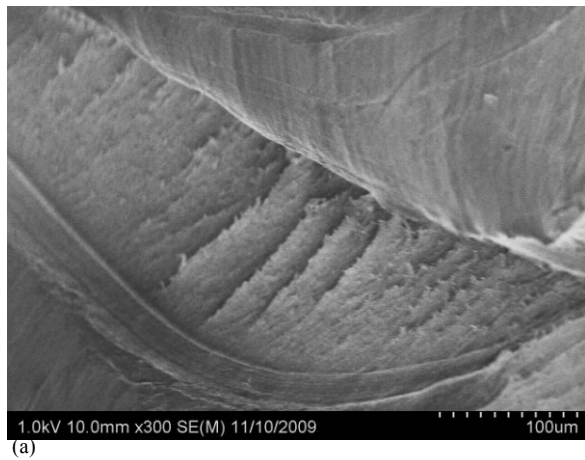
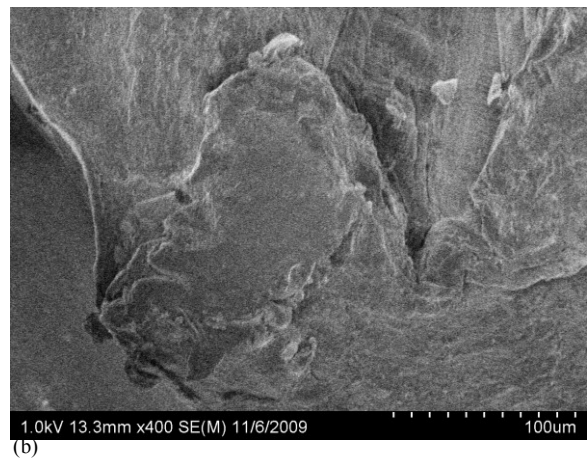
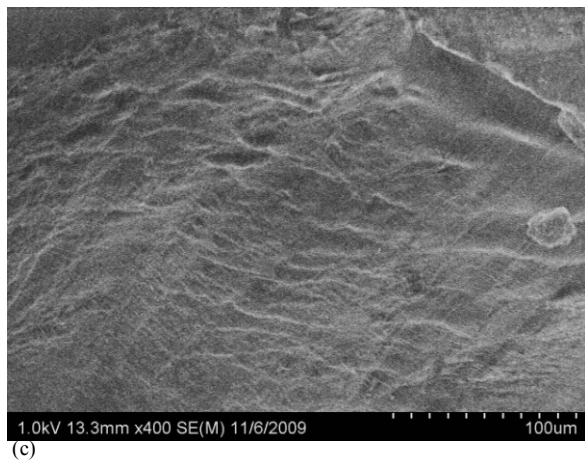
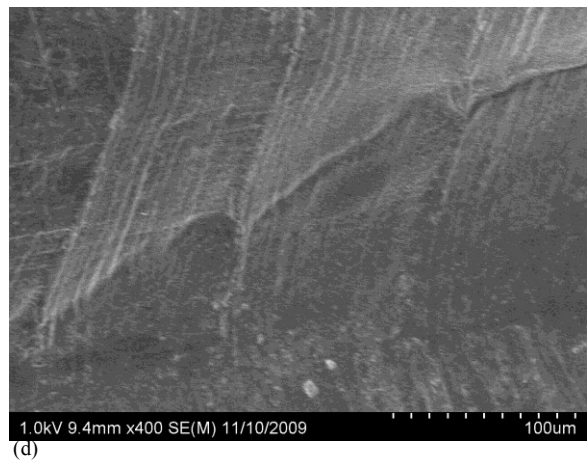
Figure 4.24: Patient W liner: (a) ripped layer of PE revealed a ductile fracture surface, (b) deformation containing PE surface debris and plastic flow, (c) close-up image of plastic flow lines, (d) more plastic flow lines with folded PE.

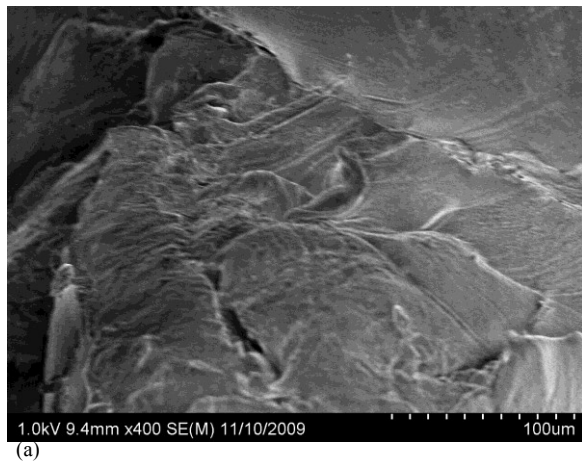
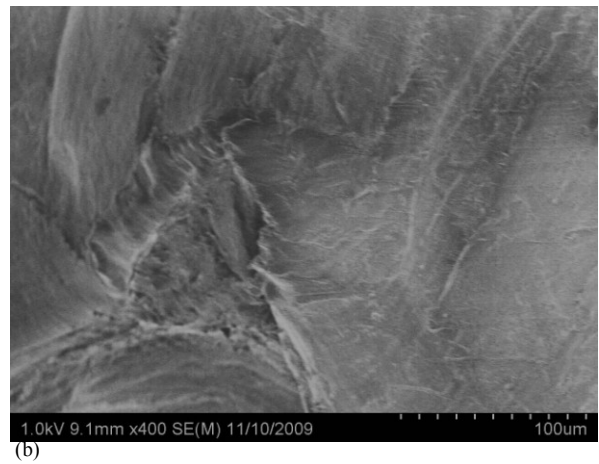
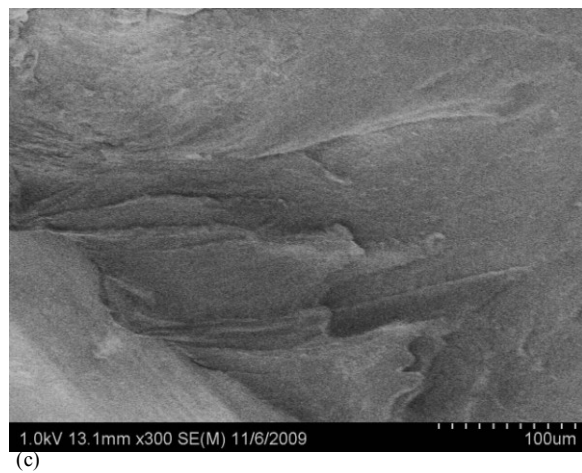
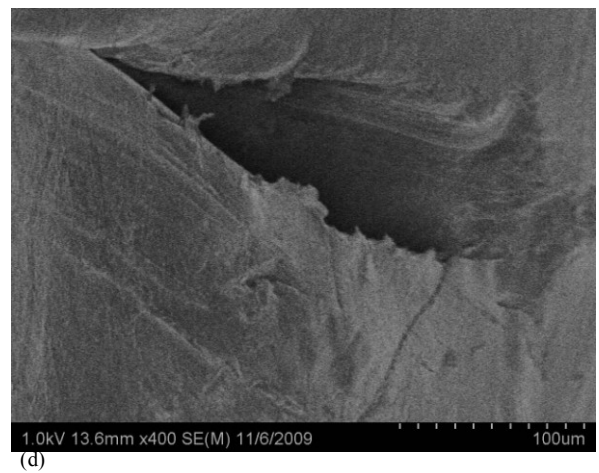
Figure 4.25: Patient W liner: (a) and (b) plastic flow in multiple directions with plastic flow lines, (c) and (d) PE that has been stretched and pulled apart.

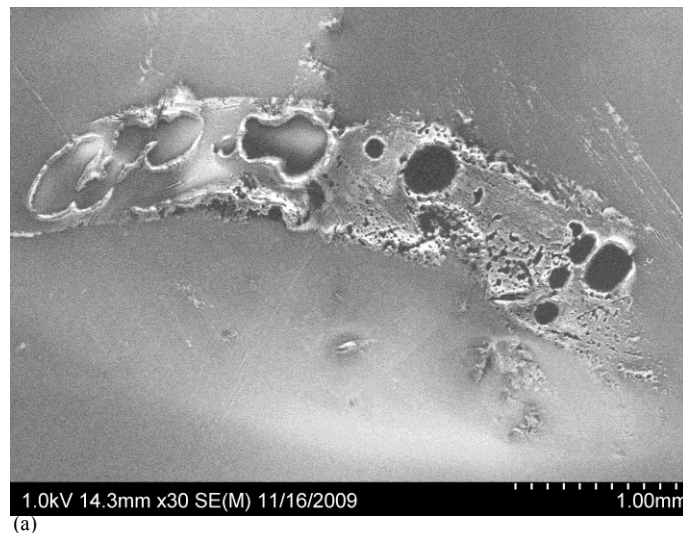
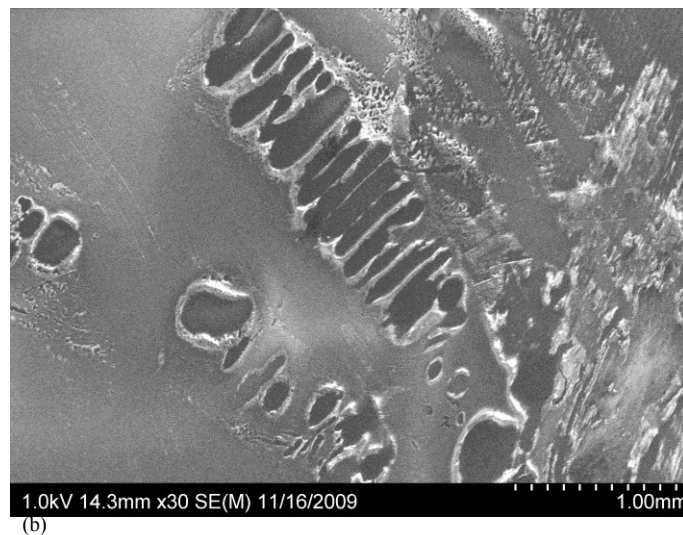
Figure 4.26: Patient H liner: (a) and (b) burnishing.

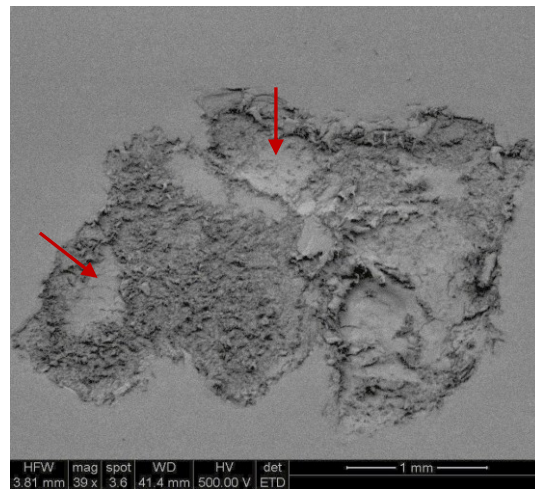
Figure 4.27: Patient H liner, abrasive wear of the socket.

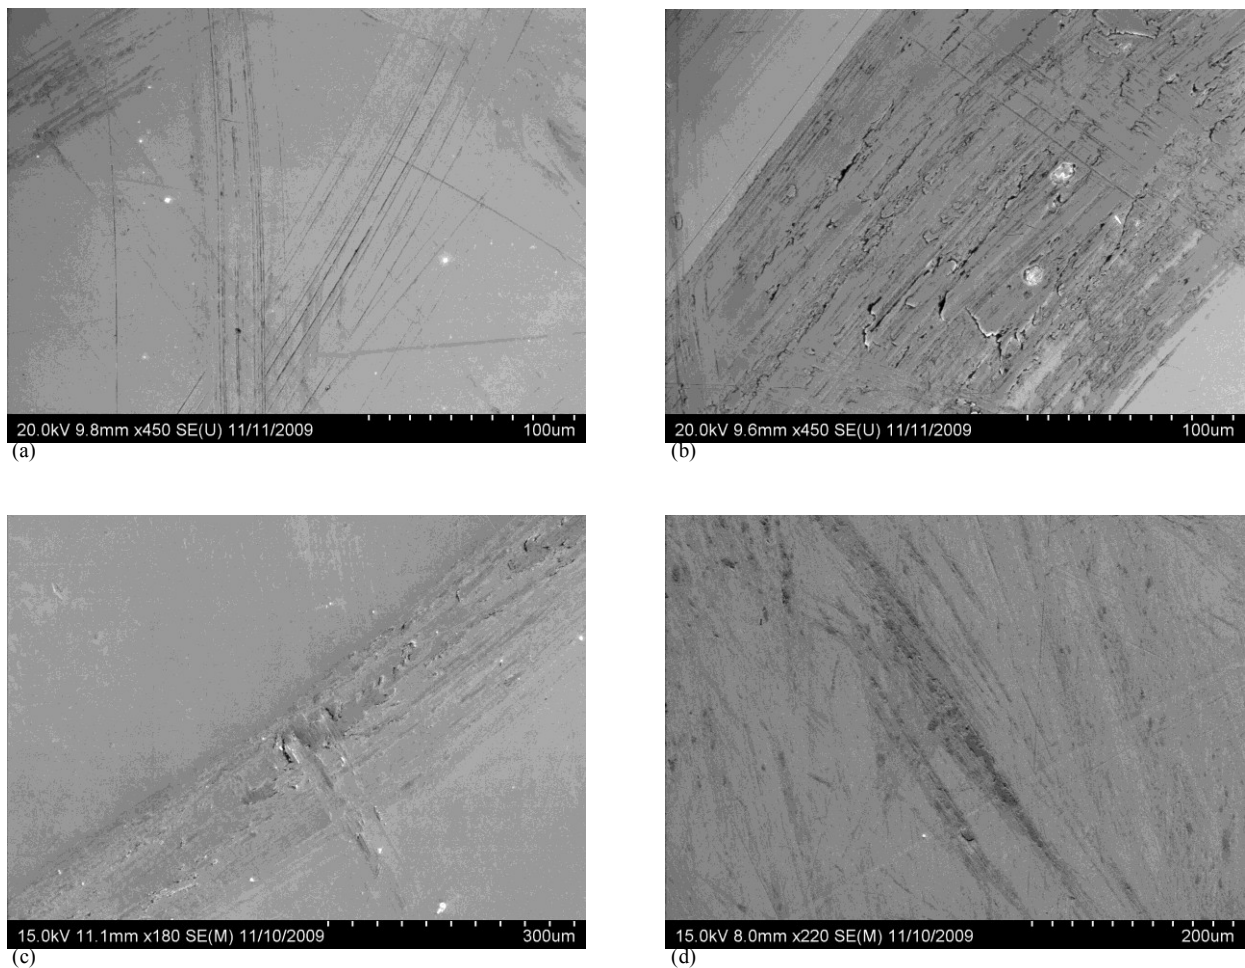
Figure 4.29: Patient E femoral head: (a) wear tracks and surface debris, (b) large streak of product deposit, (c) deposit and unimpaired surface, (d) wear tracks and product deposit.

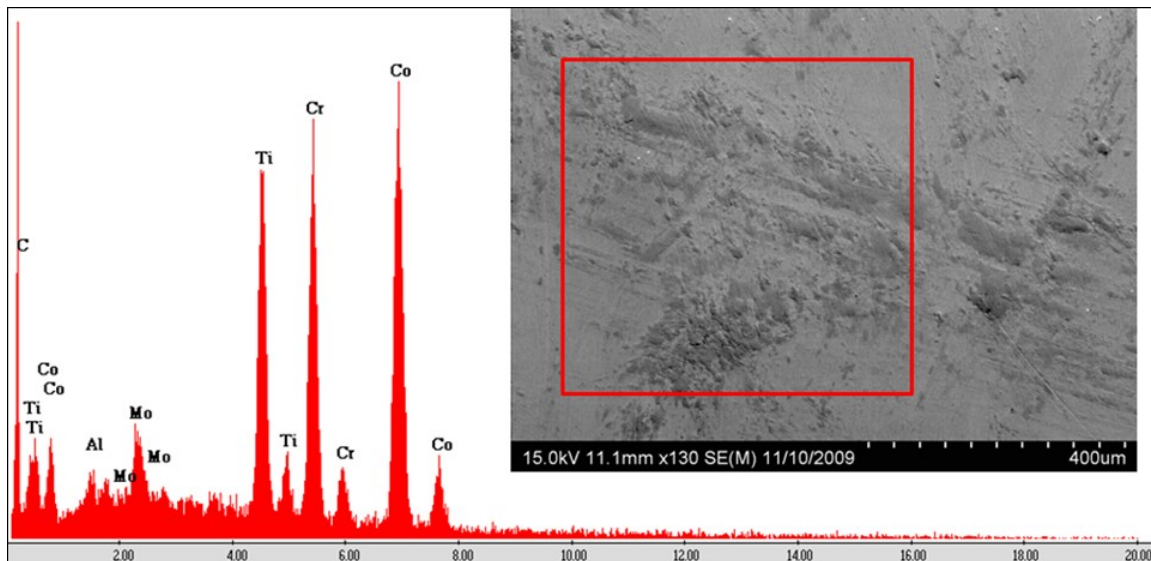
Figure 4.30: Patient E femoral head, EDS area analysis spectrum of surface deposit.

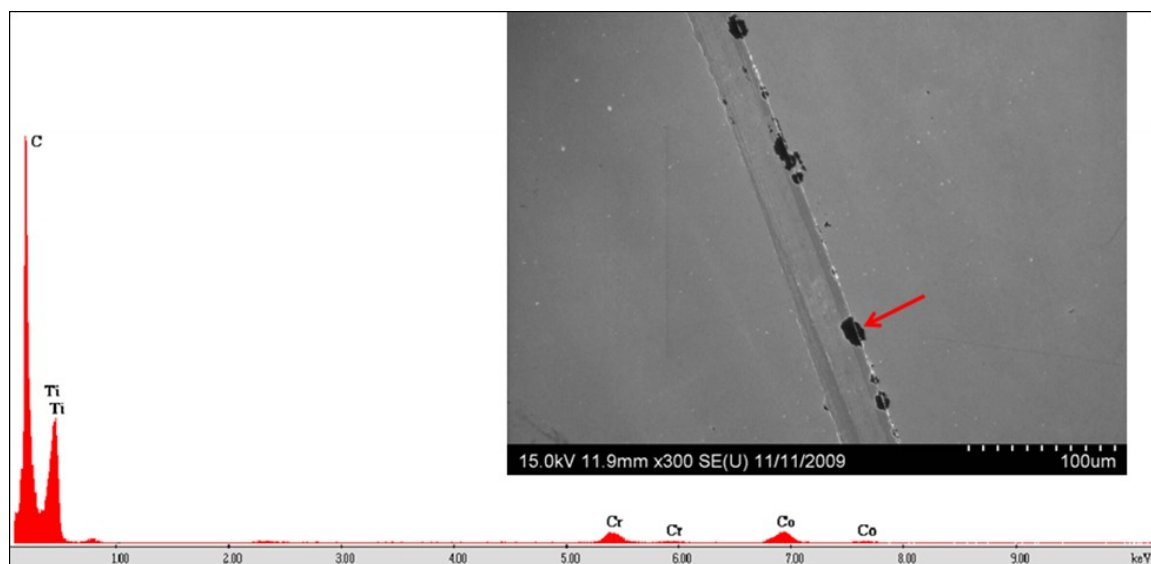
Figure 4.31: Patient E femoral head, EDS spot analysis spectrum of unknown product.

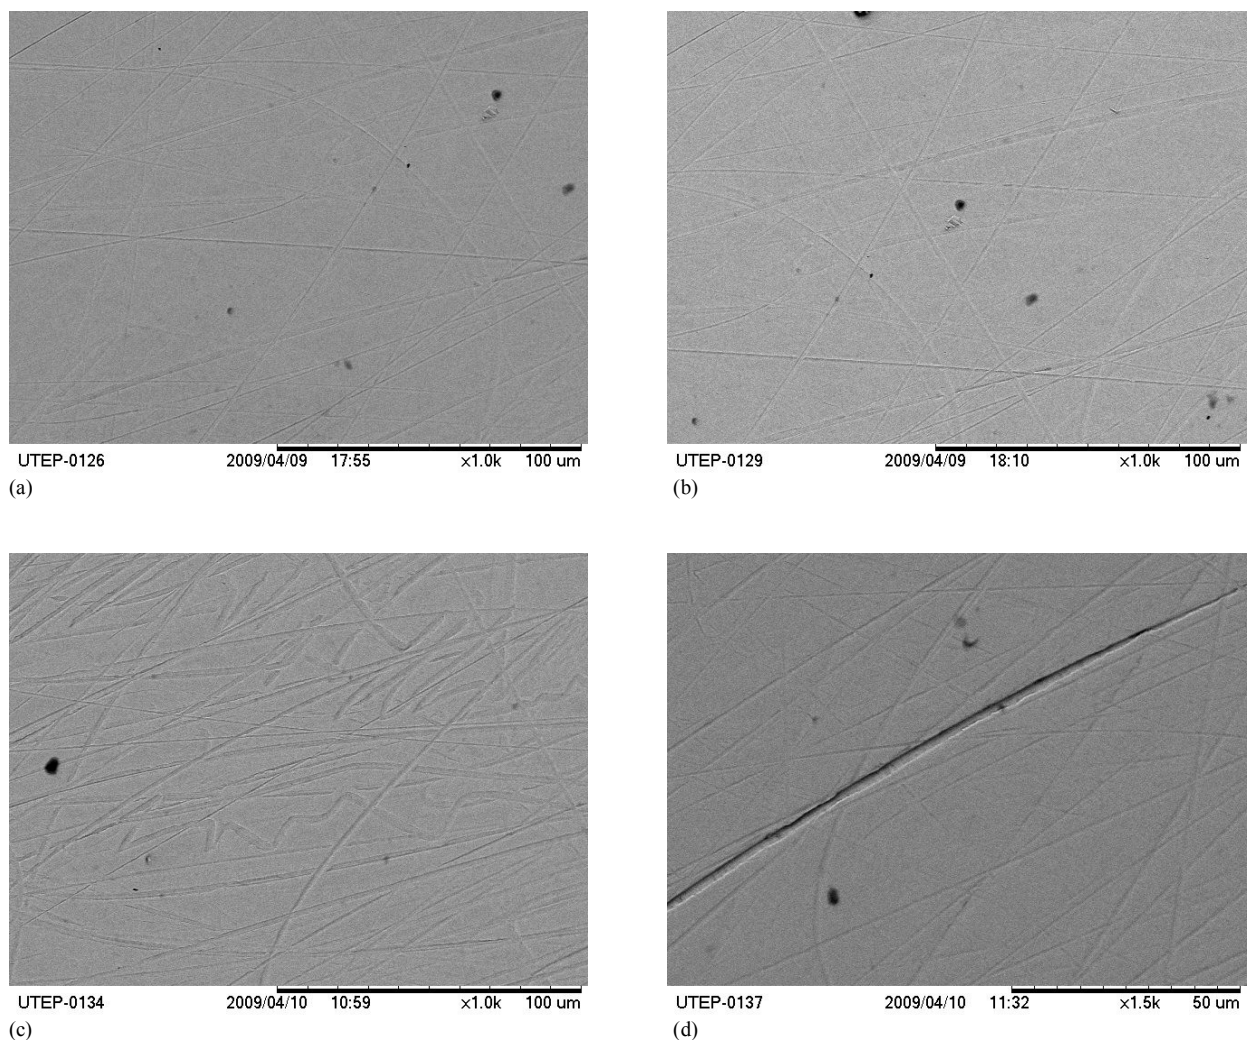
Figure 4.32: Patient W femoral head: (a) and (b) wear tracks and pits, (c) abnormal wear tracks, (d) large wear track.

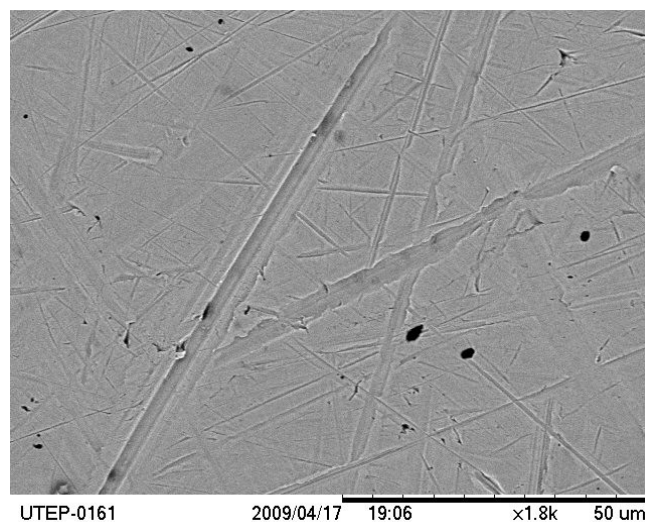
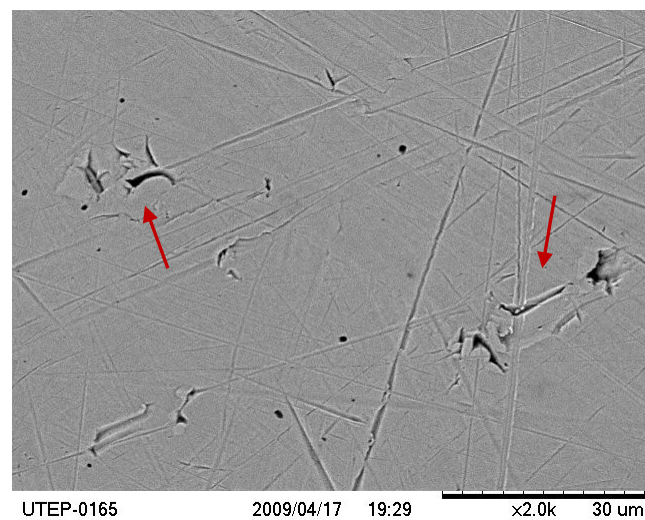
Figure 4.33: Patient U femoral head: (a) variable wear track sizes, (b) crevices.

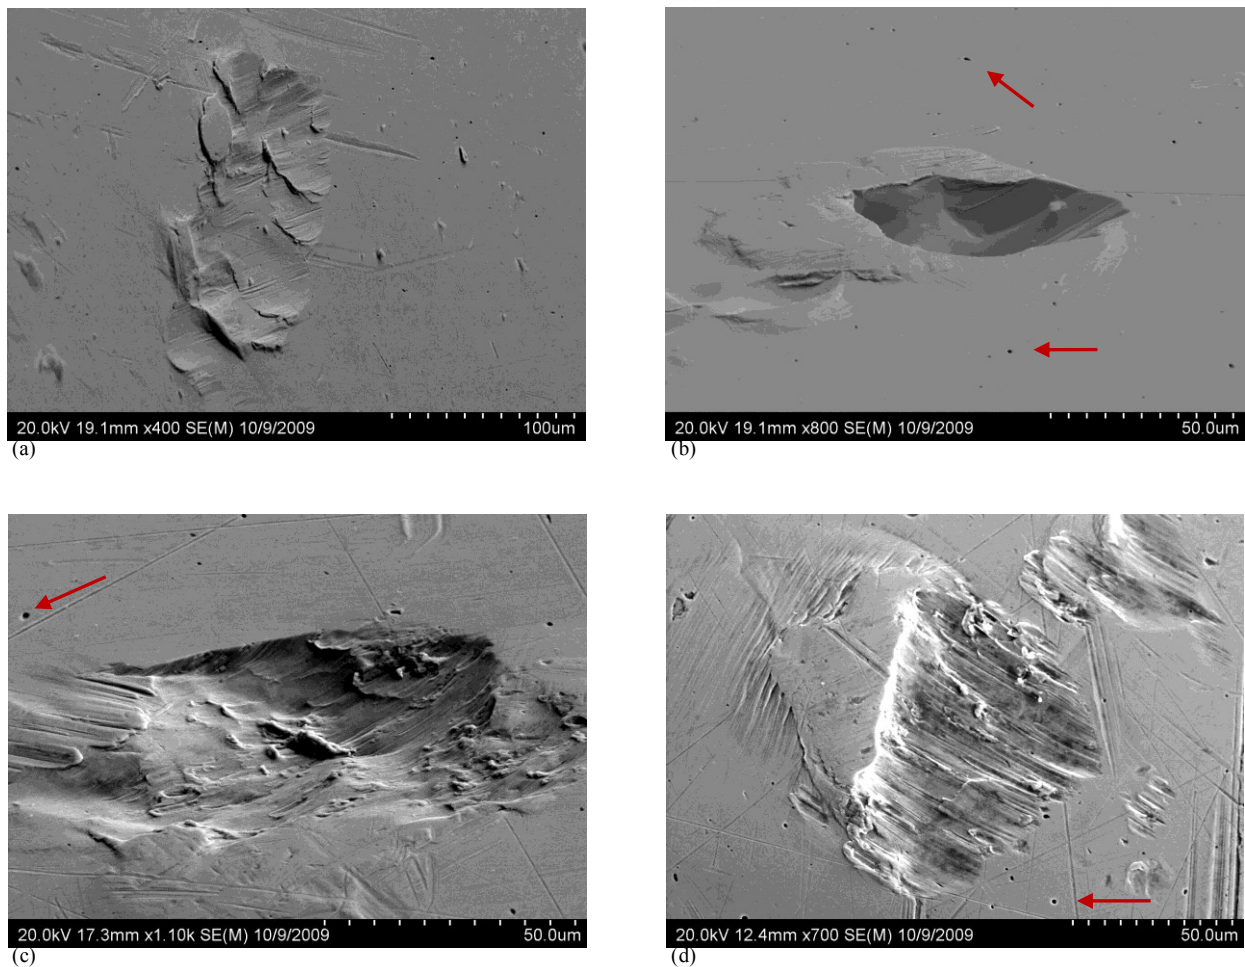
Figure 4.34: Patient U femoral head: (a)-(d) plastic flow and neighboring pits.

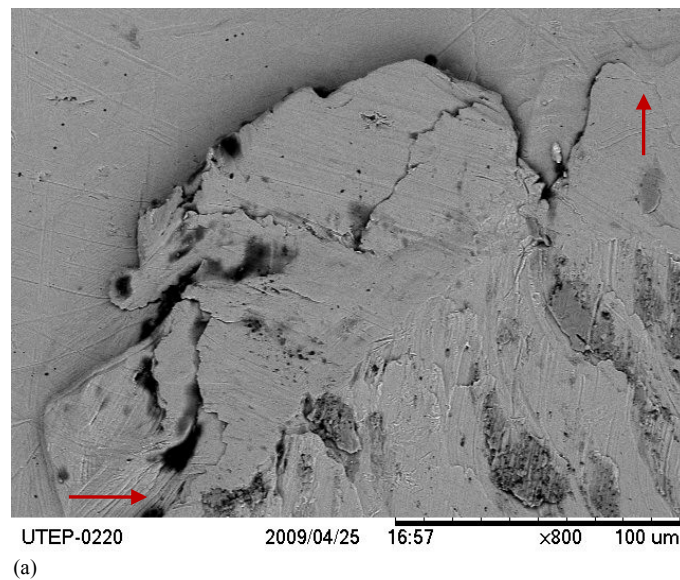
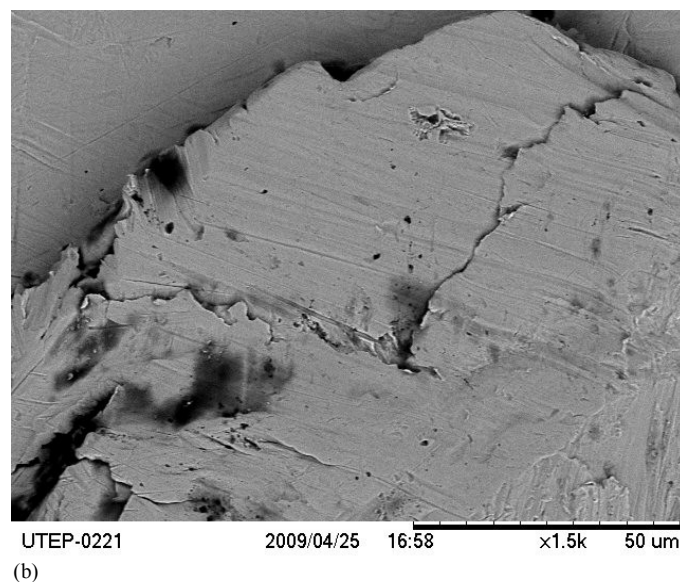
Figure 4.35: Patient U femoral head: (a) severe deformation and plastic flow, (b) crack and unknown black product.
