Failure Analysis and Materials Characterization of Hip Implants

FAILURE ANALYSIS AND MATERIALS CHARACTERIZATION
OF HIP IMPLANTS

Department of Metallurgical and Materials Engineering

THESIS

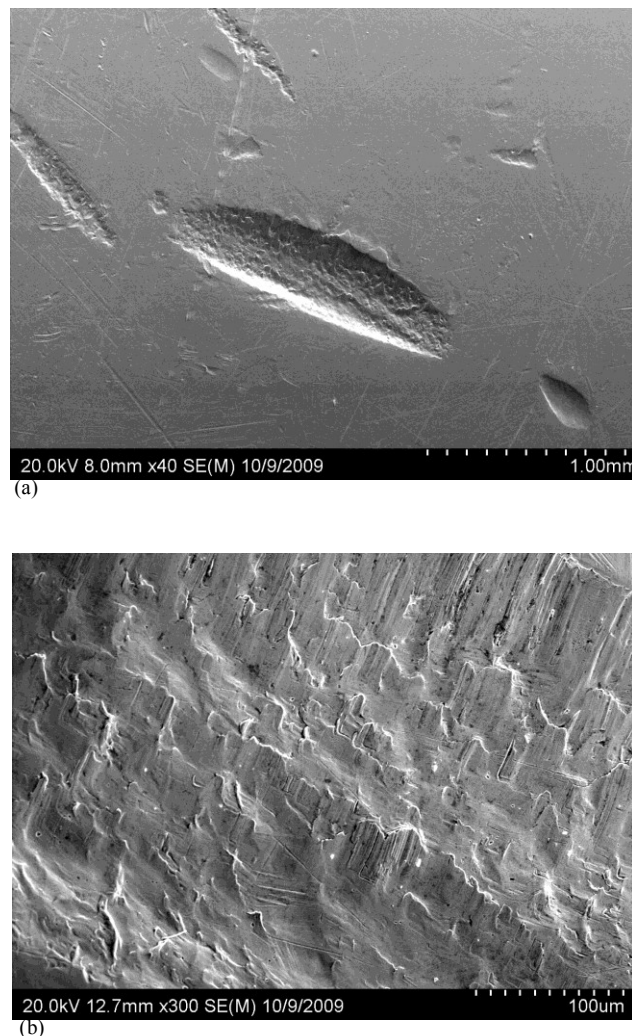
Figure 4.36: Patient U femoral head: (a) significant amount of large crevices (visible to the naked eye), (b) crevice scars.

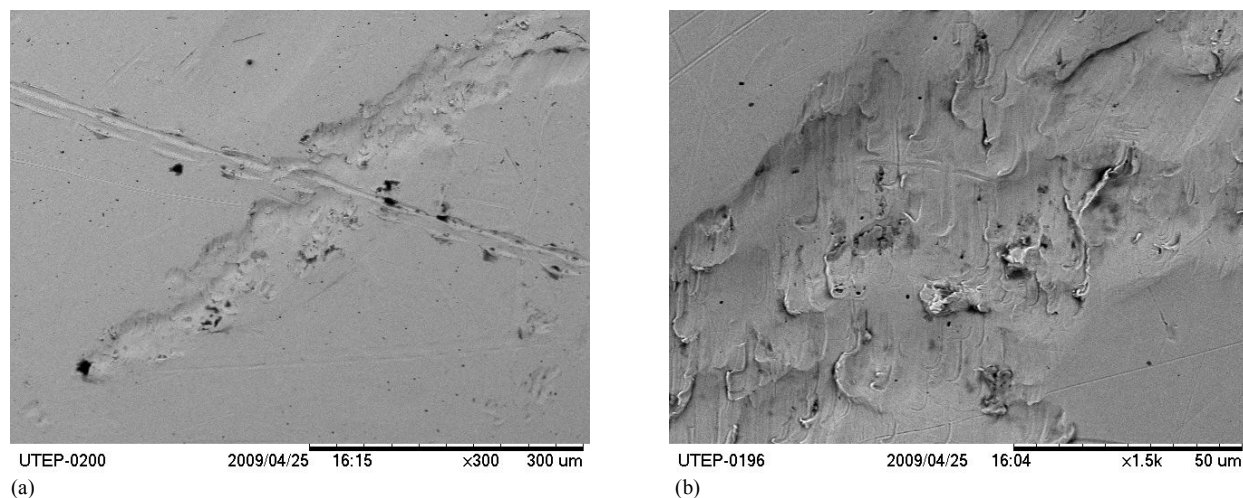
Figure 4.39: Patient U femoral head: (a) crevice with unknown product, (b) wear scars.

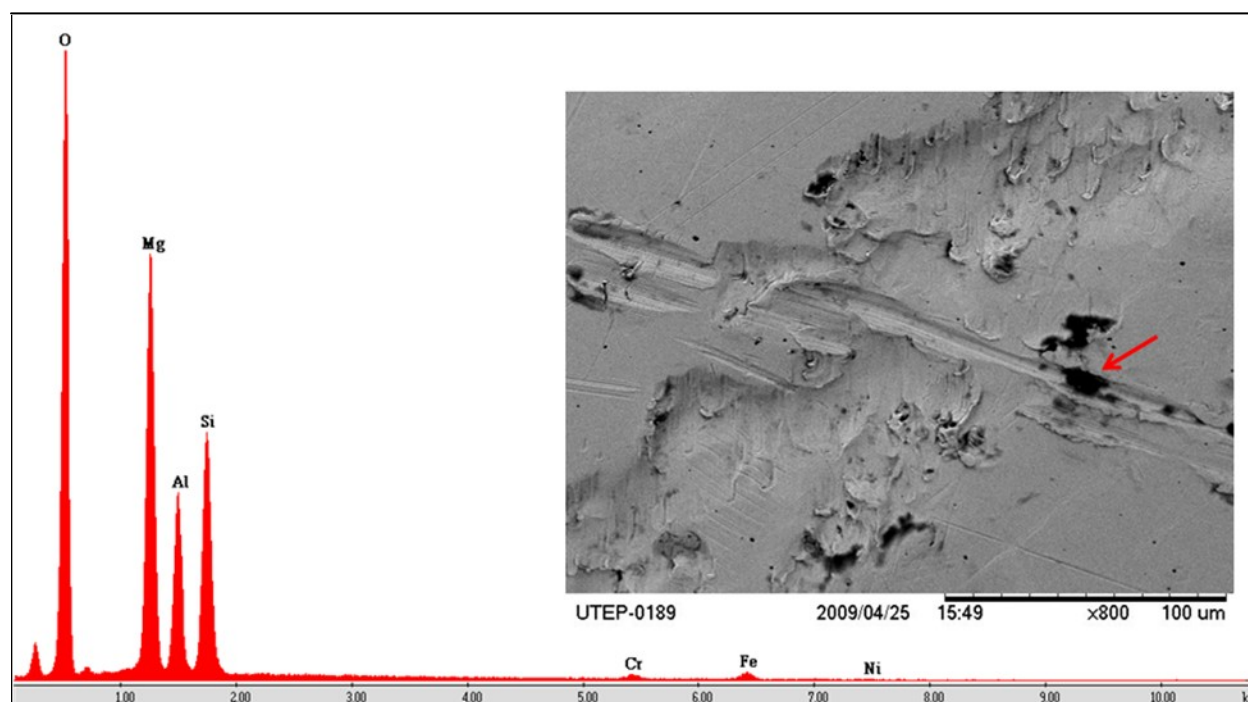
Figure 4.40: Patient U femoral head, EDS area analysis spectrum of unknown product.

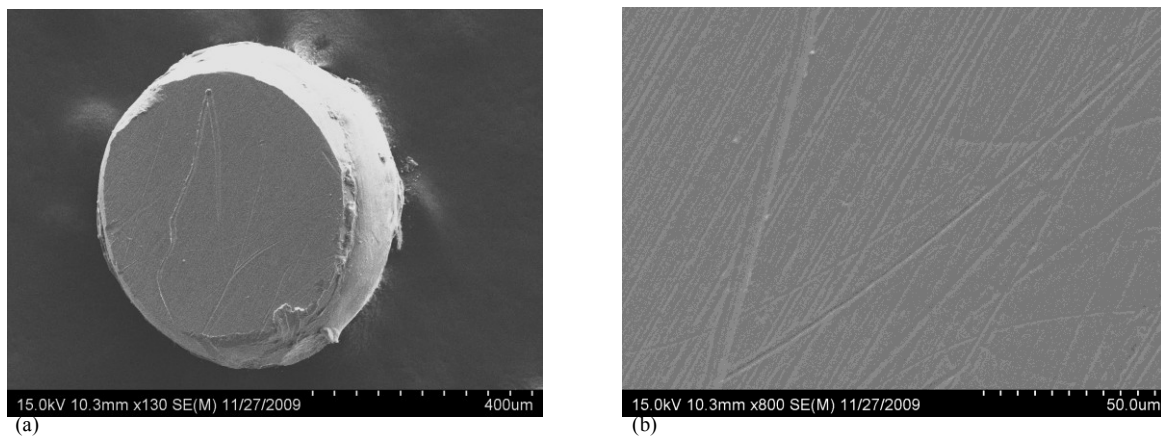
Figure 4.41: Patient E foreign particle: (a) round particle with flattened surface, (b) wear tracks.

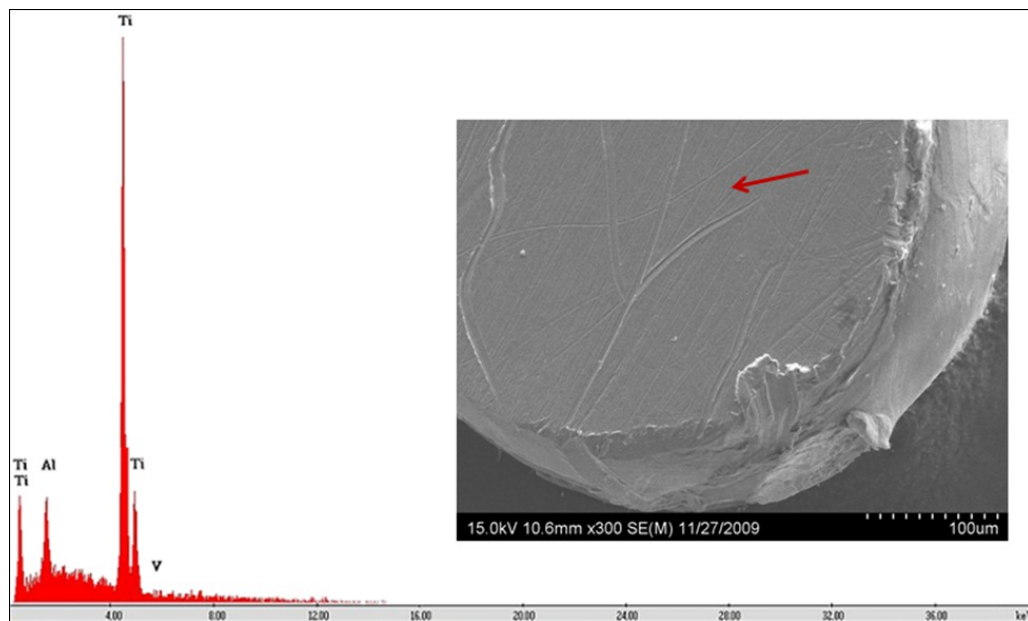
Figure 4.42: Patient E foreign particle, EDS spot analysis spectrum of foreign particle.
