# Assessing Delamination Of Concrete Bridge Decks With Aging In Arid Regions Using Nondestructive Testing Methods

Master's Program in Civil Engineering

THESIS

The University of Texas at El Paso

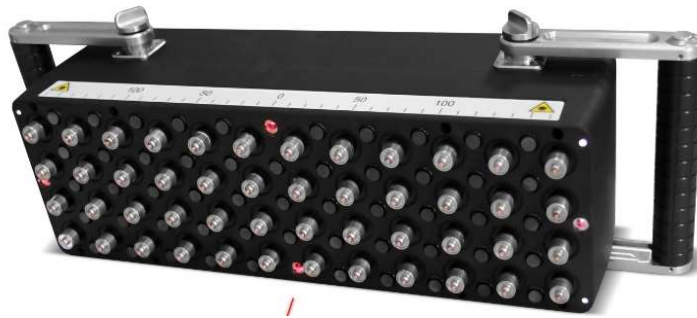
An ultrasonic tomographer known as the MIRA (Figure 2.2), allows for the determination of various properties of a concrete including the thickness, detection of delamination and debonding, and determination of the depth and location to reinforcement. The MIRA system is based on the ultrasonic pitch-catch method, where the ultrasonic energy is transmitted at a certain angle to the surface of the material, and received as reflected energy returning at the reflected angle. The device consists of an array of dry point contact (DPC) transducers arranged into 12 blocks, each block possessing 4 transducers. The transducers emit shear waves into the material.

Figure 2.2 – MIRA Device (transducers shown)

The transducers impact the surface, providing wave front penetration that diagnose the concrete structure up to a depth of 3 ft. The transducer array permits many pitch-catch, time-of-flight measurements to be made in a short period of time. The onboard computer controls which block of transducers acts as the transmitters, while the remaining blocks act as receivers. Figure 2.3 shows the multiple ray paths involved during a test with MIRA. The array is processed within the system providing a 2-D image of the concrete cross section. The 2-D scans are then analyzed with appropriate software to reconstruct a 3-D image of the structure, including B-scans, C-scans and D-scans of the structure (see Figure 2.4) (Popovics et al., 2017).

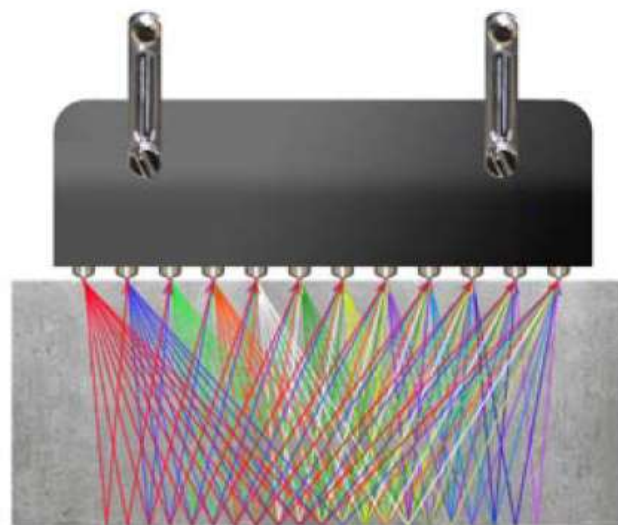
Figure 2.3 – Multiple ray paths involved during MIRA testing

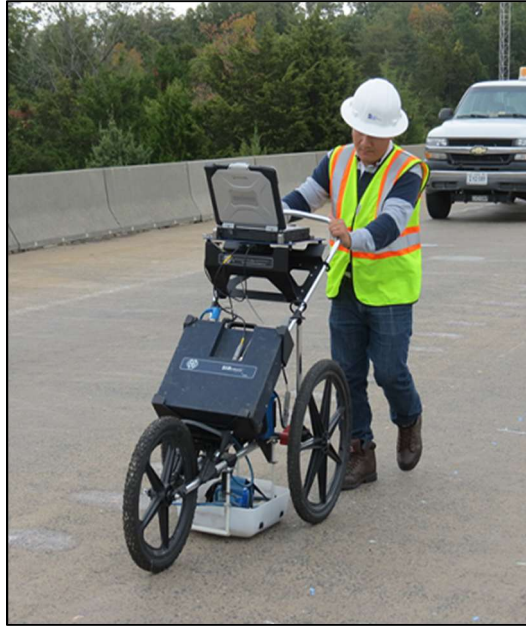
The Ground Penetrating Radar (GPR) is a NDT technique that is based on the principle of sending short pulses of low-level electromagnetic (EM) energy into the material. Simultaneously, the GPR system measures the effects that the material has on the reflection of the transmitted pulse. From the received reflections, the layer boundaries can be deduced, and various characteristics and assumptions can be formulated about the material. Often utilized to obtain layer thickness, the GPR measures this by sending a pulse into the material and measuring the travel time between the reflection at the top of the pavement and the reflection at the bottom of the pavement (Romero and Roberts, 2002). A typical ground-coupled GPR device setup is displayed in Figure 2.5.

Figure 2.5 – Ground Penetrating Radar (GPR)
