Evaluation of Residual, Post-Service Creep-Rupture Properties of S-816 Turbine Buckets

EVALUATION OF RESIDUAL, POST-SERVICE CREEP-RUPTURE
PROPERTIES OF S-816 TURBINE BUCKETS

THESIS

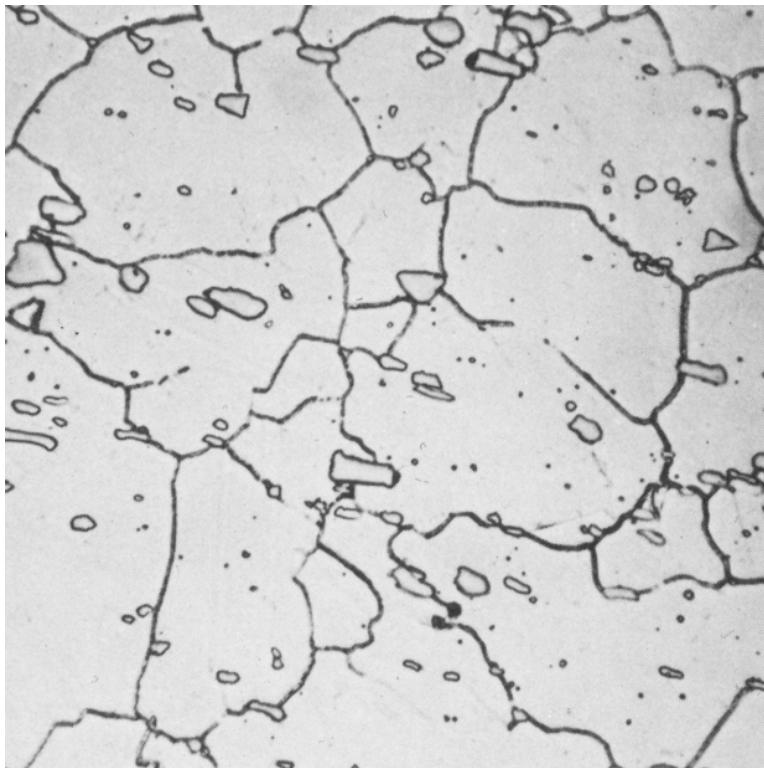
Figure 2. S-816 solution annealed at 2150 °F (1177 °C), aged for 16 hrs. at 1400 °F (760 °C), and air cooled. The FCC matrix contains blocky, primary MC carbides in the form of CbC (NbC) and grain-boundary precipitates primarily in the form of Cr_{23}C_6 . Etched with a solution of 92 mL HCl, 5 mL H_2SO_4 , and 3 mL HNO_3 . 500 X original magnification [5].

the melting point of S-816 [2]. Niobium, the third refractory element addition to S-816, is a stronger MC carbide former than molybdenum or tungsten and hence forms the very stable MC carbide in S-816; figure 2 provides testament to this statement, as large blocky MC carbides are identified as CbC (NbC) in a representative micrograph of an S-816 specimen that was solutionized and subsequently aged [5].

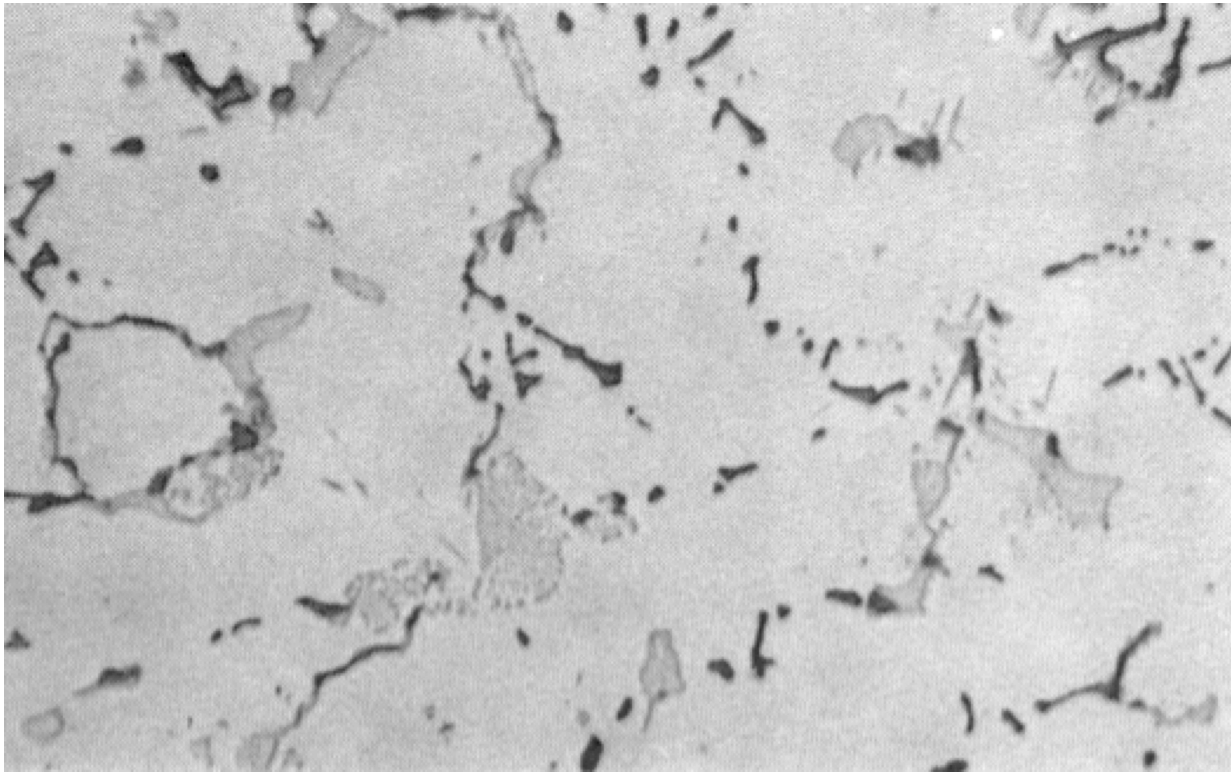
Figure 13. Characteristic MC carbides in as-cast MM-509 Co-base superalloy; original magnification: 375X [2].

It is generally accepted that all turbine bucket or blade alloys form two types of carbide precipitates: primary and secondary. As Benac and Swaminathan [11] indicate, primary carbides form when carbon reacts with strong carbide-forming elements, such as chromium, niobium, molybdenum, or tungsten, during the solidification of the molten alloy; these carbides will usually have the formula MC, where M is the metallic element that is forming the carbide. These carbides tend to have blocky or Chinese-script morphologies, as well as large sizes, as seen in the micrograph of figure 13 [2]. Secondary carbides tend to form at lower temperatures (during the solidification of the molten alloy) from the remaining carbon that is dissolved in the matrix as well as from the dissolution of primary MC carbides.

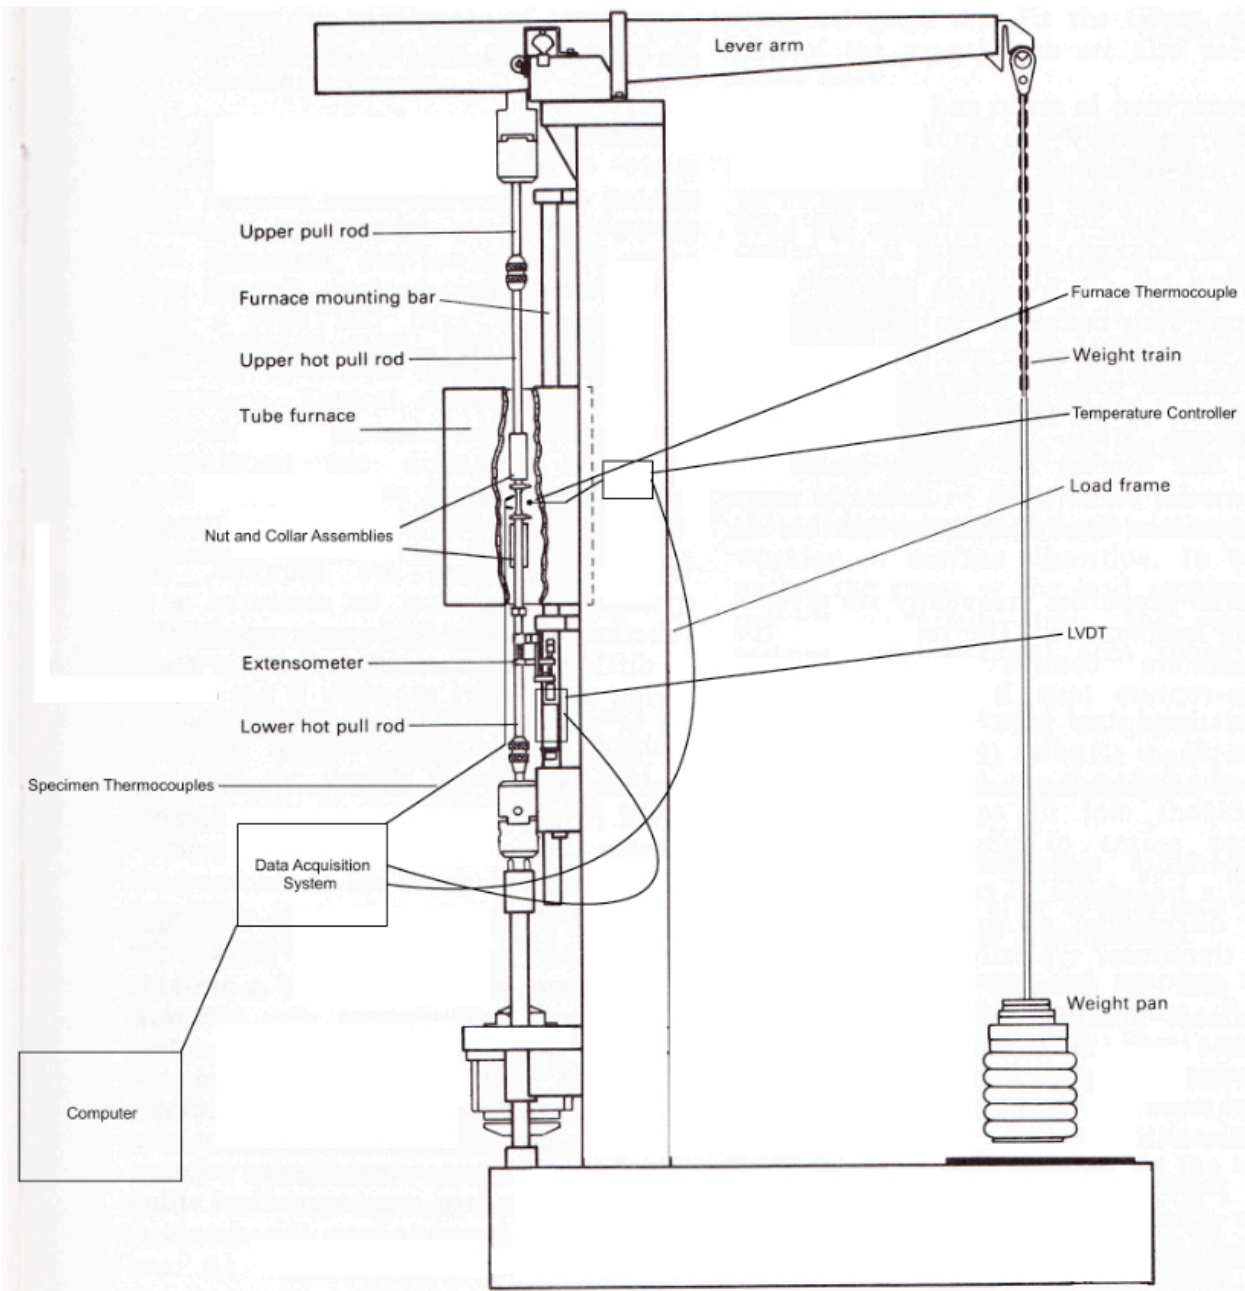
Figure 14. Schematic drawing of creep-rupture testing apparatus [14]; modified from original to depict actual testing assembly used in this research investigation.

The application of the desired uniaxial tensile *load* (constant load, static stress testing) was accomplished via the following loading assembly: dead weights on a weight pan, a weight train which connected the pan to a lever arm with a mechanical advantage ratio of 20:1, an upper pull rod that screwed into the lever arm, a specimen holder assembly that connected both upper and lower pull rods, and a stationary lower pull rod. Calibrated dead weights in increments of 5, 10, 20, and 30 lbf were incrementally added (to avoid shock loading) in order to create the desired load for each test; 15% of the test force was applied during the one hour pre-heat period of testing in order to mitigate the effect of non-axial forces on the pull rods from the packed-in furnace insulation. Figure 14 demonstrates a schematic of the entire testing apparatus [14].

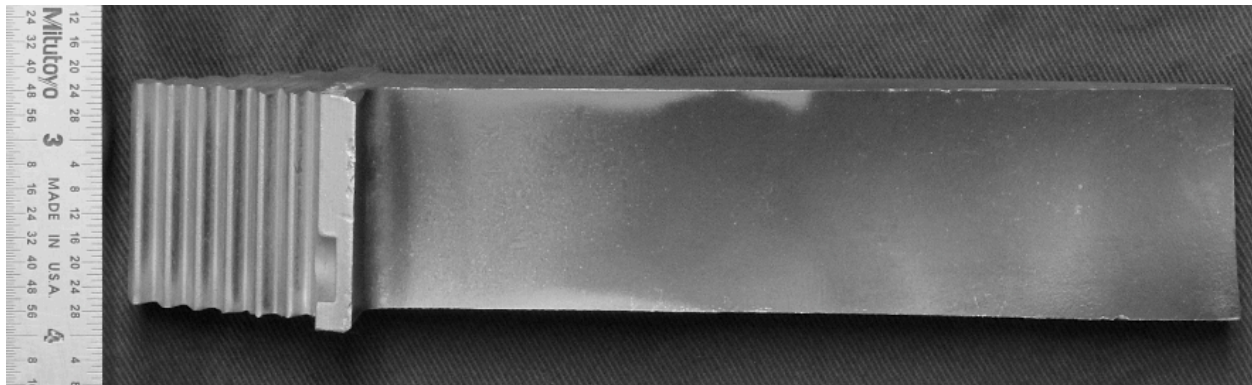
Figure 19. Core produced from sectioning of turbine bucket.

1. Sectioned top of bucket, in a transverse orientation, approximately 4.75 inches from the bottom of the bucket; the upper portion of this cross-section was too thin and variable in thickness for derivation of a specimen.
2. Sectioned sides of bucket, in longitudinal orientations, approximately 1.25 inches from the side ends of the bucket platform.
3. The core of turbine bucket material produced as a result of steps 1 and 2 (as seen in figure 19) was placed on a lathe, rounded, and machined to the specimen dimensions demonstrated in figure 20. It was possible to derive only one creep-rupture specimen from every one core of turbine bucket material.

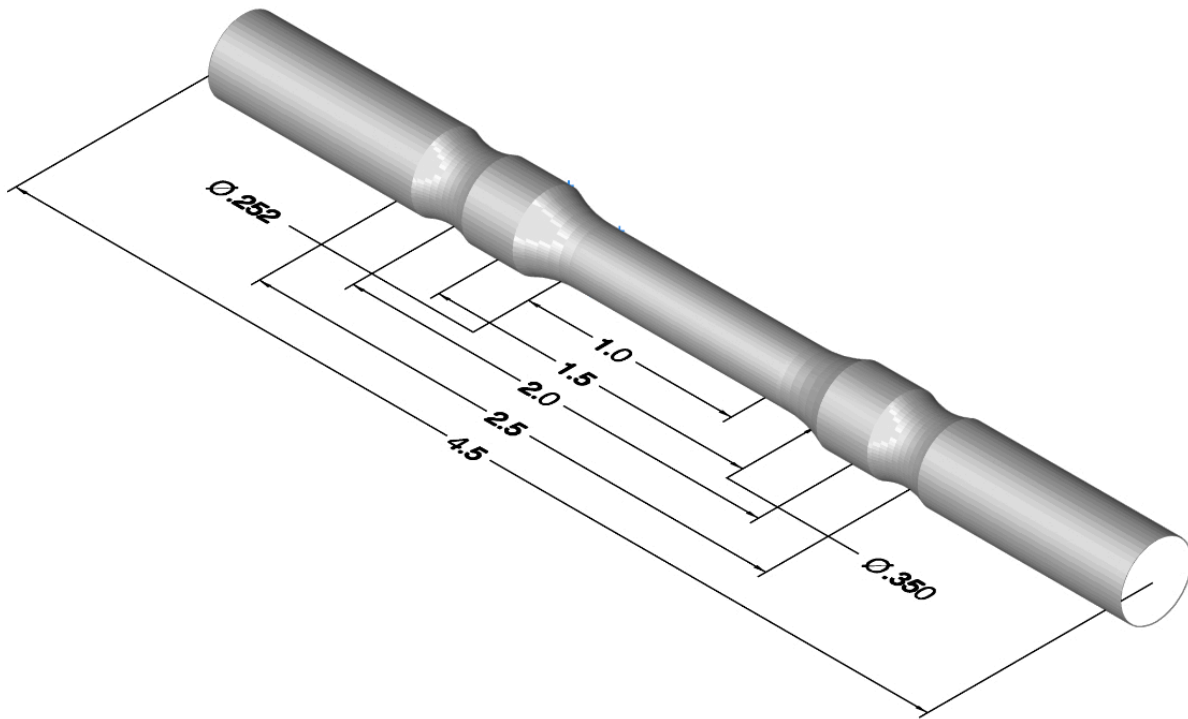
Figure 20. Schematic drawing of creep-rupture specimen produced for this research investigation; specimen dimensions are in inches.

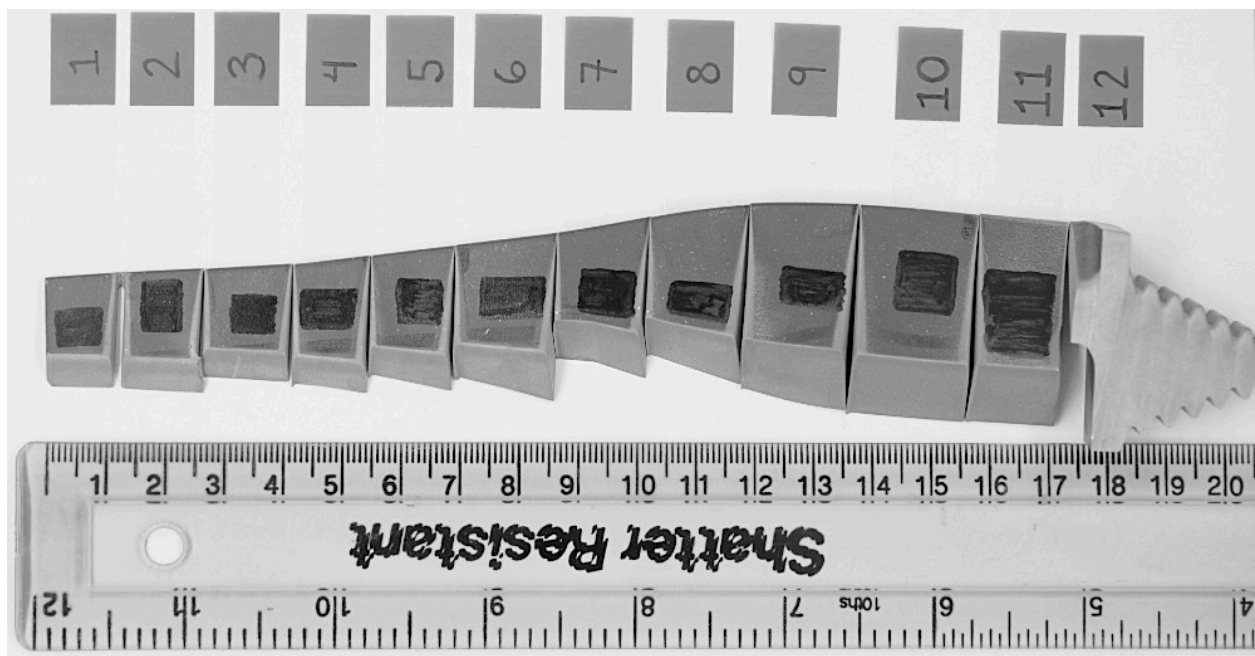
Figure 21. Photographic image of the twelve specimens used for metallographic analysis of a bucket from set 128; the longitudinally-cut specimen surfaces (light grey in coloration) were mounted face-down in resin and metallographically prepared.

At the onset of this research investigation, a bucket from set 128 was longitudinally sectioned via water-jet cutting; the resulting piece was transversely sectioned along eleven different planes in order to produce specimens for metallographic analysis of the as-received state of a bucket from set 128. Figure 21 demonstrates the twelve metallographic specimens that were produced as a result of these sectioning procedures, which were longitudinally mounted in resin, except for the dovetail section (specimen 12 in figure 21); the size of this specimen allowed for grinding and polishing to be conducted without the need of a mount.

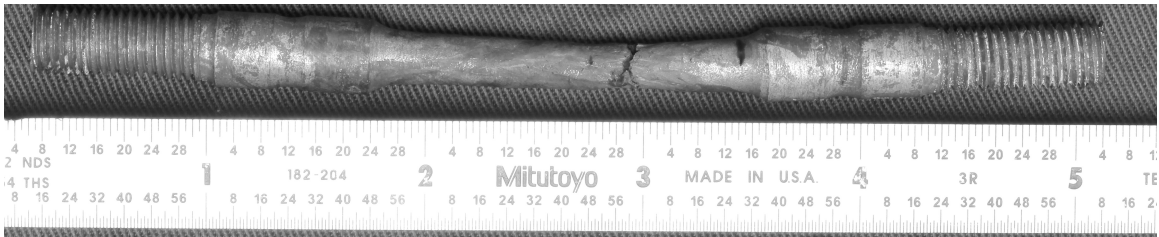
Figure 22. Photographic image of the entirety of specimen S1 in the post-ruptured state.

Figures 22 and 25 demonstrate that the outer surface of the gauge length in specimen S1 exhibits features that are indicative of plastic deformation that occurred during creep-rupture testing; these features consist of a textured elongation of the specimen's body and exposed ruptures or bursts along the specimen's body. Figures 23 and 24 demonstrate that the fracture surface of specimen S1 exhibits large cratering and appears topographically irregular; these large macroscopic features are consistently seen throughout the entirety of the surface.

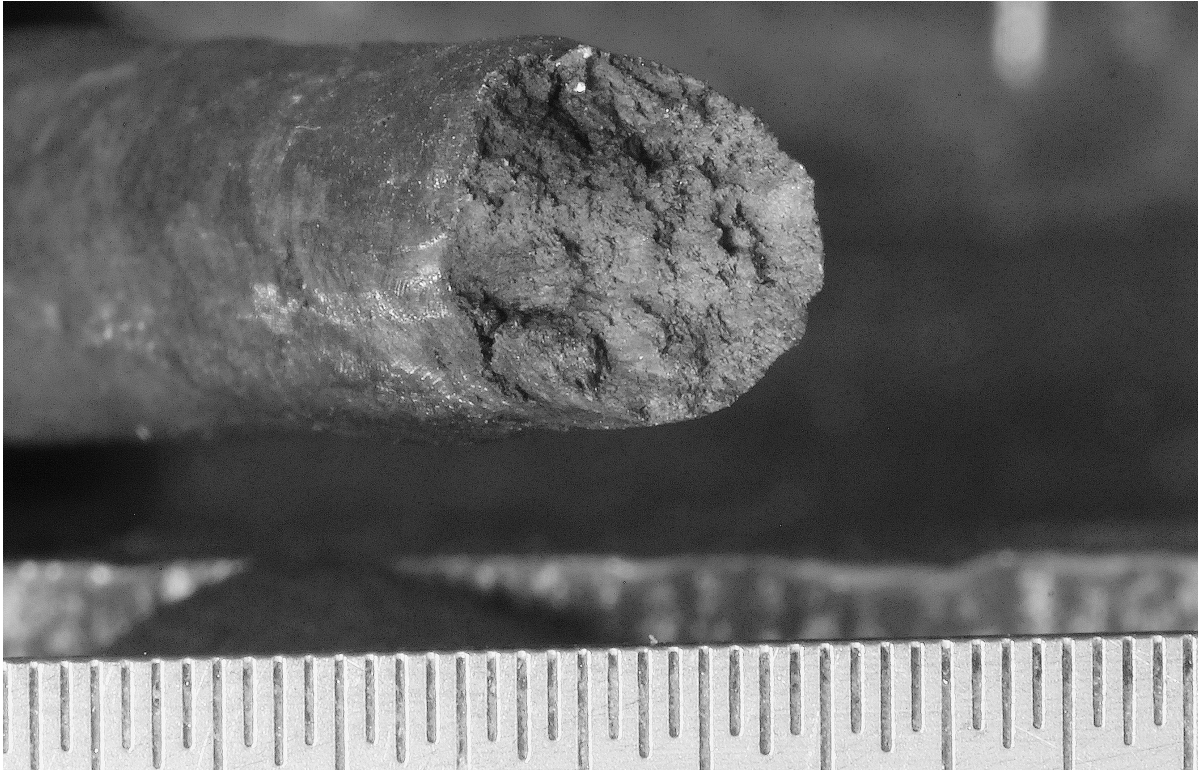
Figure 24. Macro-photographic image of the fracture surface of the specimen S1 halve demonstrated on the left-hand side in figure 22.

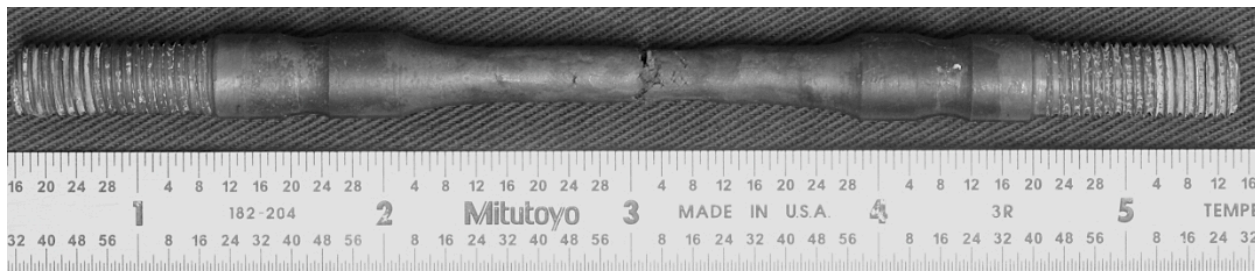
Figure 26. Photographic image of the entirety of specimen S2 in the post-ruptured state.

Figures 26 and 29 demonstrate that the outer surface of the gauge length in specimen S2 exhibits features that are indicative of plastic deformation that occurred during creep-rupture testing; these features consist of a textured elongation of the specimen's body and exposed ruptures or bursts along the specimen's body. The degree of textured elongation is *less* than that exhibited by specimen S1; the presence and size of exposed ruptures or bursts along the specimen's body is observed to be *more or less equal* to that exhibited by specimen S1. Figures 27 and 28 demonstrate that the fracture surfaces of specimen S2 appear granular and are less topographically diverse than the fracture surface of specimen S1; these macroscopic features are consistently seen throughout the entirety of both surfaces.

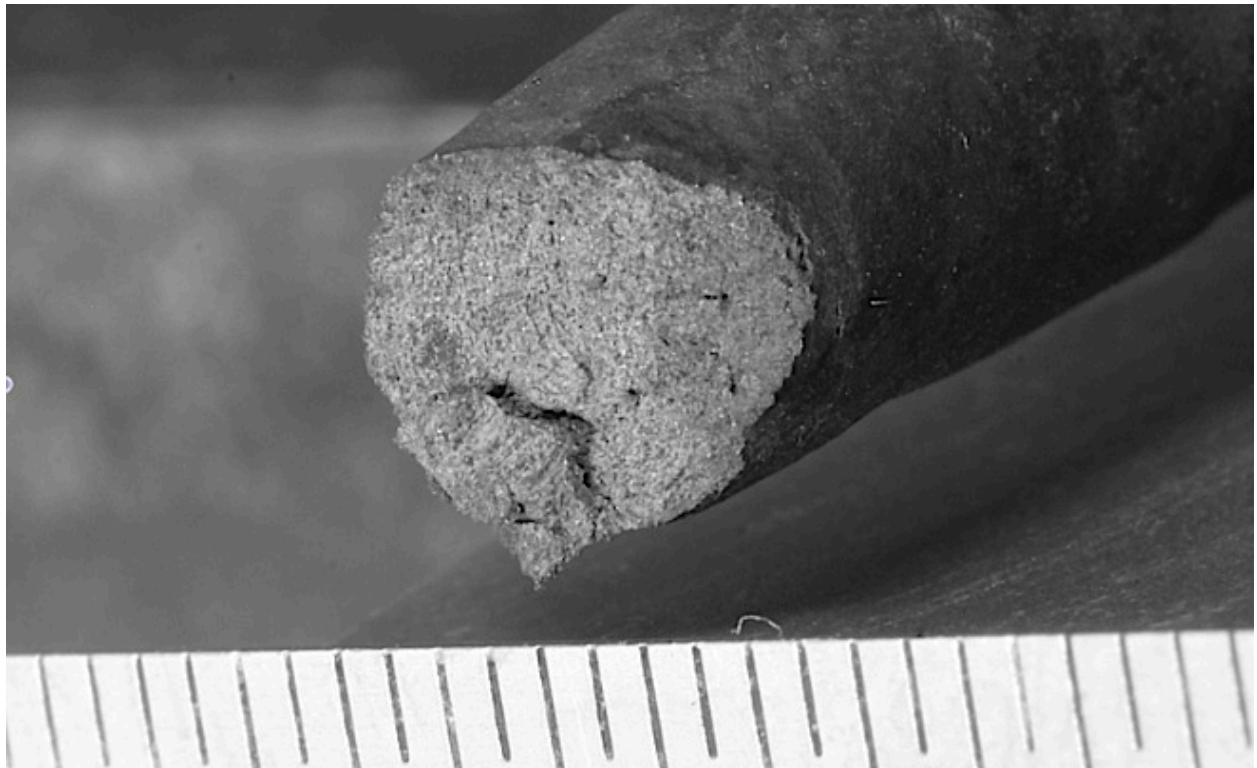
Figure 28. Macro-photographic image of the fracture surface of the specimen S2 halve demonstrated on the right-hand side in figure 26.

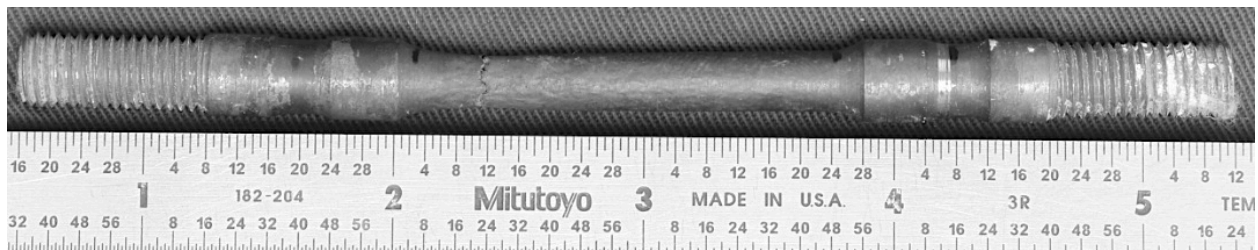
Figure 30. Photographic image of the entirety of specimen S4 in the post-ruptured state.

Figures 30 and 33 demonstrate that the outer surface of the gauge length in specimen S4 exhibits features that are indicative of plastic deformation that occurred during creep-rupture testing; these features consist of a textured elongation of the specimen's body and exposed ruptures or bursts along the specimen's body. The degree of textured elongation is comparable to that exhibited by specimen S1; the presence of exposed ruptures or bursts along the specimen's body is observed to be *greater* than that exhibited by specimens S1 and S2, while the size of these features is *smaller* than those exhibited by specimens S1 and S2. Figures 31 and 32 demonstrate that the fracture surface of specimen S4 exhibits large cratering and appears topographically irregular, in a manner similar to the fracture surface of specimen S1; these macroscopic features are consistently seen throughout the entirety of the surface.

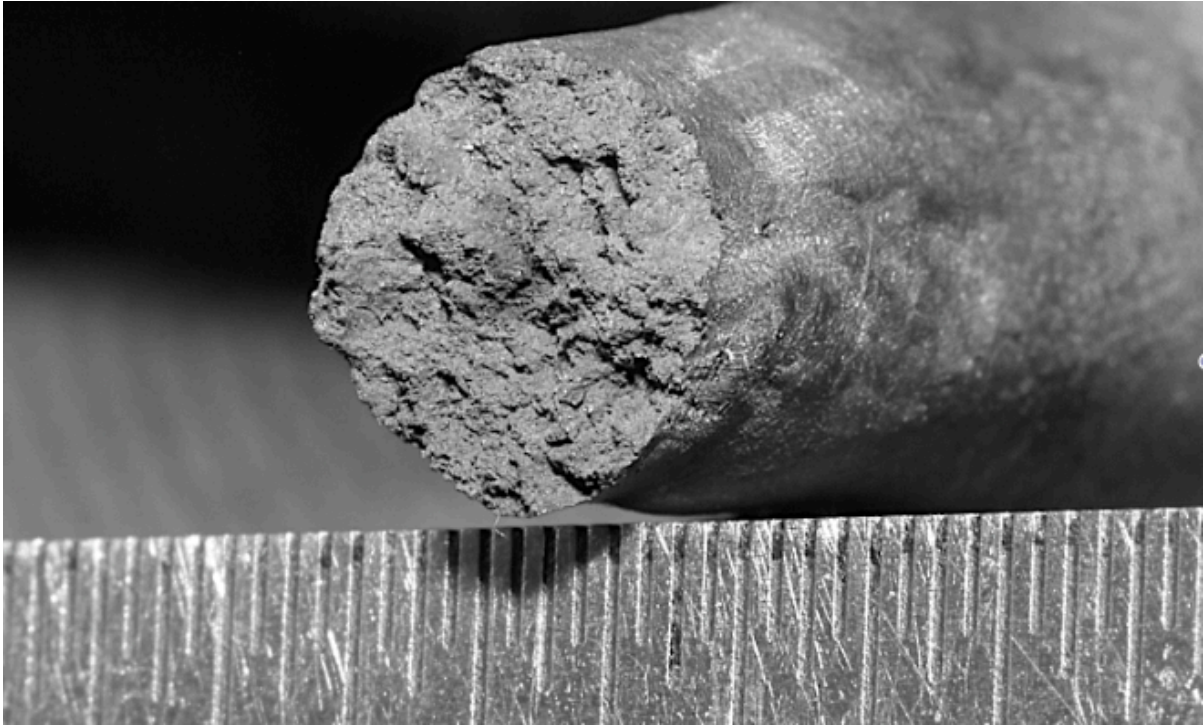
Figure 31. Macro-photographic image of the fracture surface of the specimen S4 halve demonstrated on the left-hand side in figure 30.

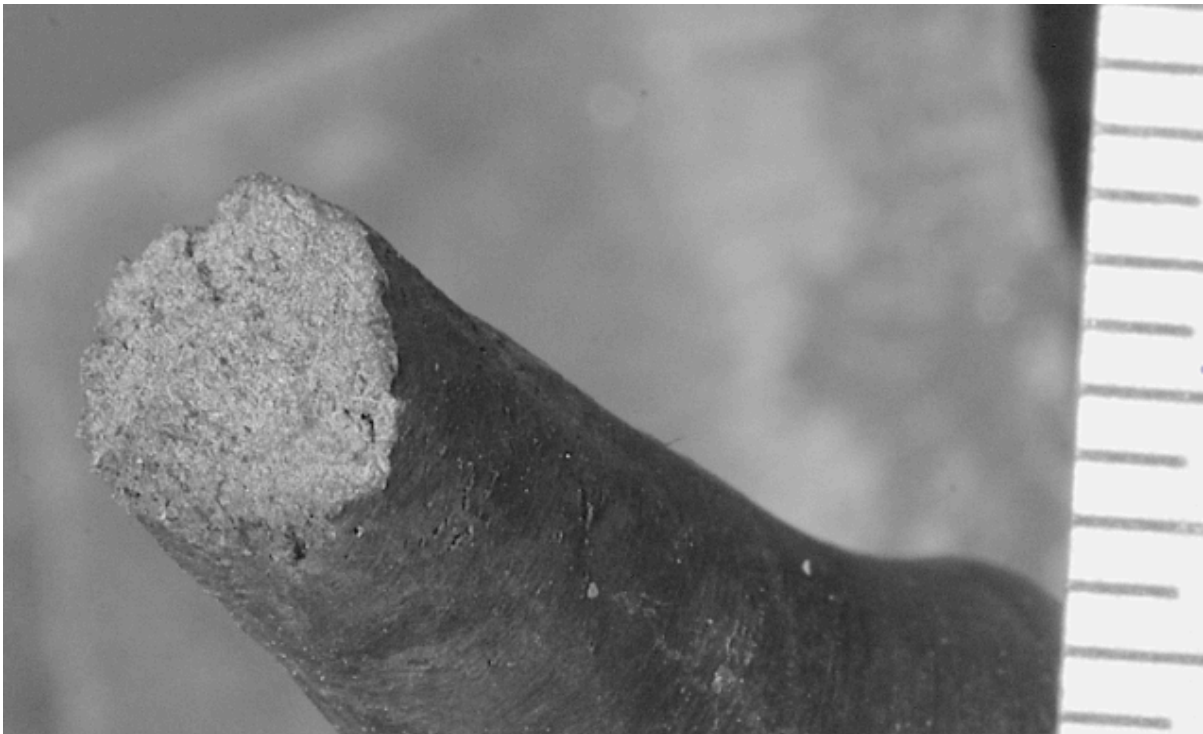
Figure 40. Macro-photographic image of the fracture surface of the specimen S5 (set 821) halve demonstrated on the right-hand side in figure 38.

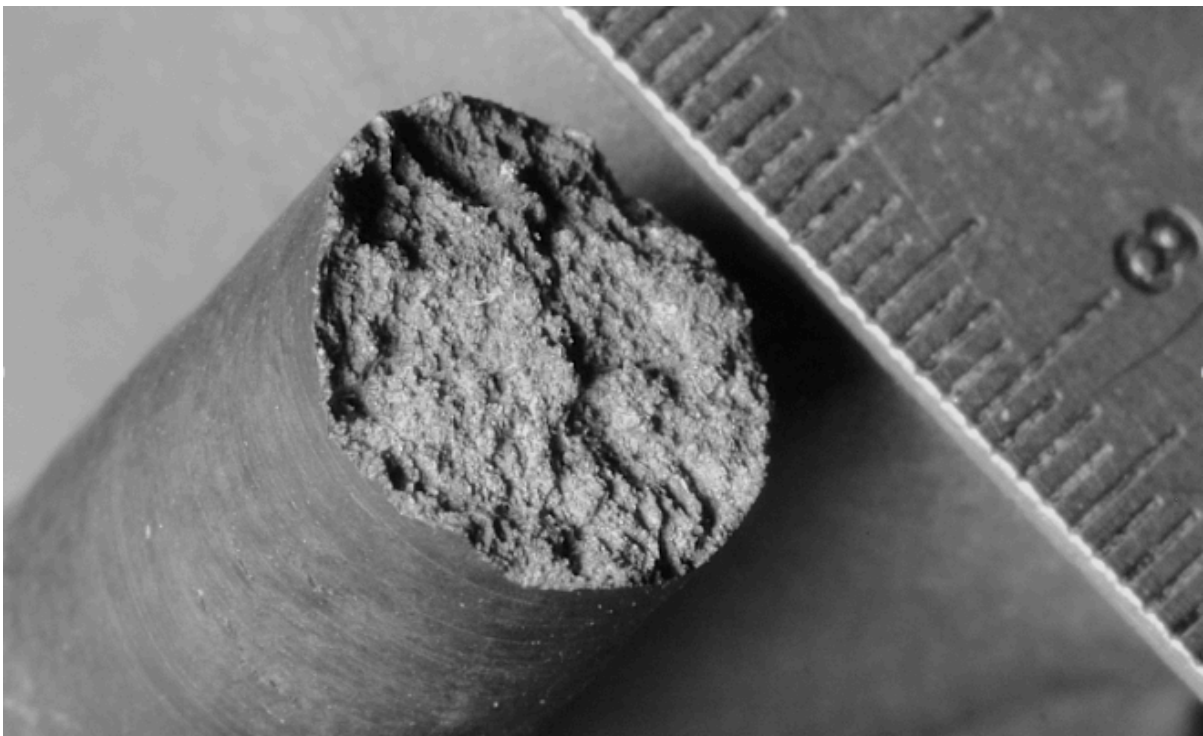
Figure 48. Macro-photographic image of the fracture surface of the specimen S9 halve demonstrated on the right-hand side in figure 46.

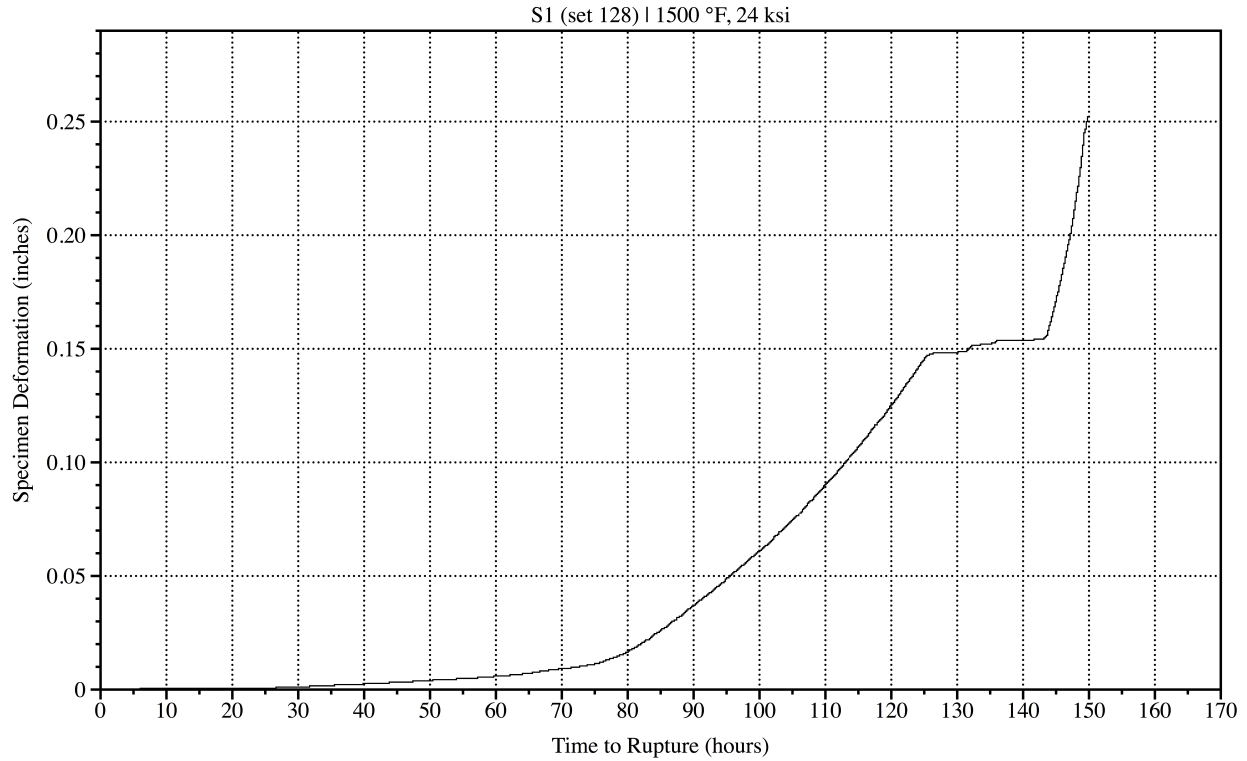
Figure 51. Plot of S1 deformation (inches) as a function of time to rupture (hours).

Figure 51 demonstrates that specimen S1 did not exhibit any primary creep behavior at the onset of the testing procedure; instead, it initially demonstrated secondary creep behavior and then transitioned into tertiary creep behavior after approximately 79.6 hours of testing. The specimen then transitioned from tertiary creep behavior back into secondary creep behavior after approximately 125 hours of testing; then, a second shift from secondary creep behavior back into tertiary creep behavior occurred after approximately 144 hours of testing. The specimen sustained this second phase of tertiary creep behavior for approximately 6 hours before finally rupturing after a total of 149.6 hours at 1500 °F and under a constant load of 24 ksi.

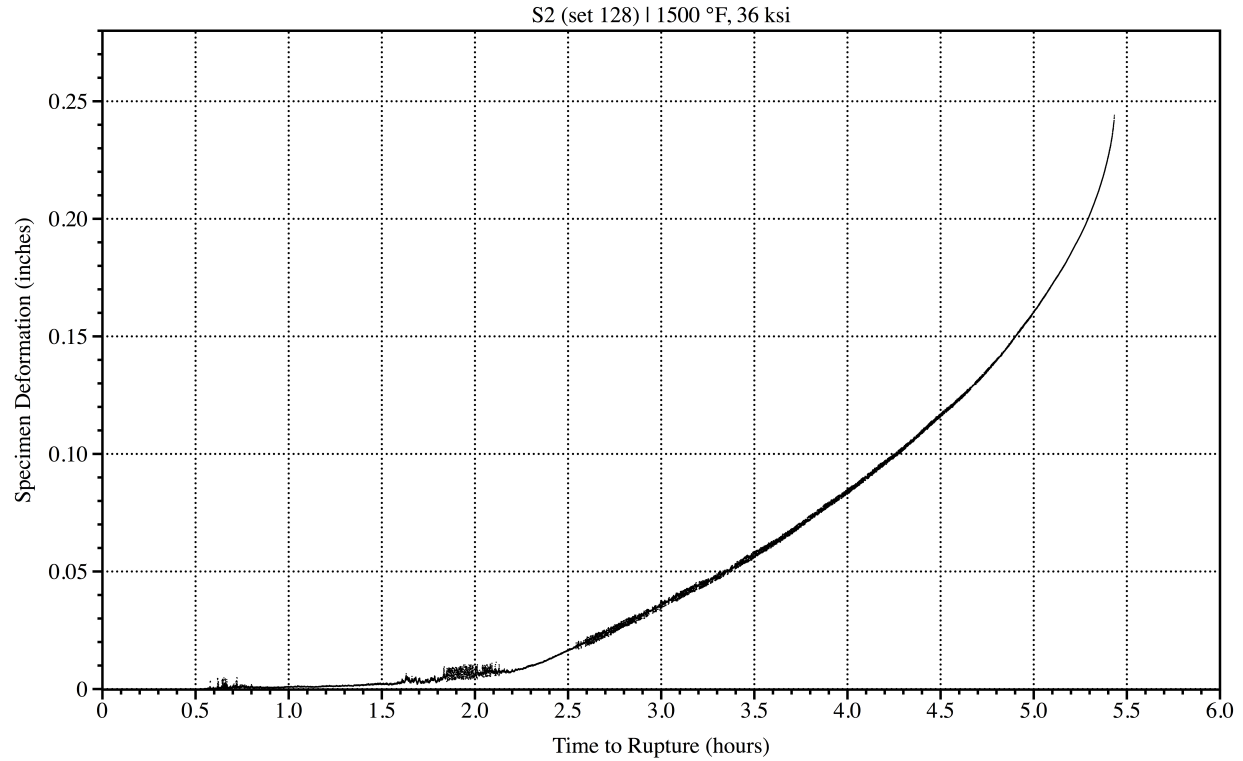
Figure 52. Plot of S2 deformation (inches) as a function of time to rupture (hours).

Figure 52 demonstrates that specimen S2 did not exhibit any primary creep behavior at the onset of the testing procedure; instead, it initially demonstrated secondary creep behavior and then transitioned into tertiary creep behavior after approximately 2.3 hours of testing. The specimen sustained tertiary creep behavior for approximately 3.1 hours before finally rupturing after a total of 5.4 hours at 1500 °F and under a constant load of 36 ksi.

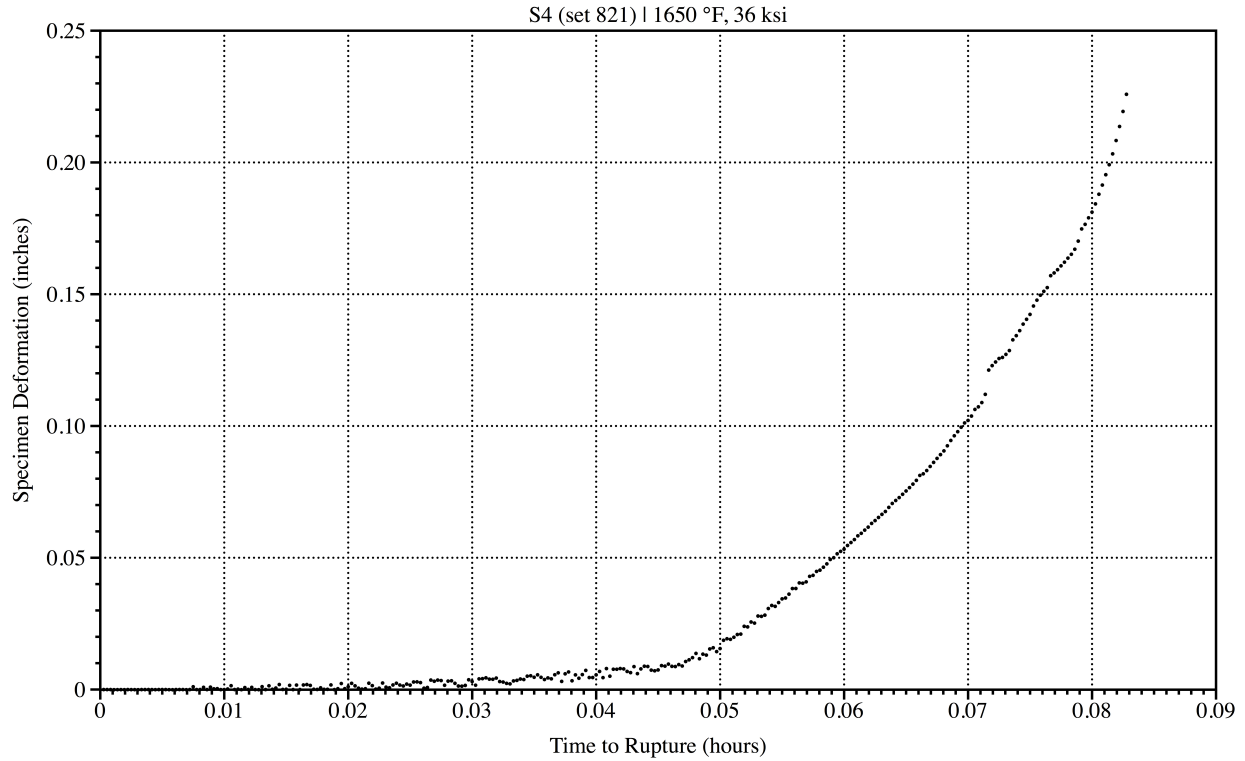
Figure 53. Plot of S4 deformation (inches) as a function of time to rupture (hours).

Figure 53 demonstrates that specimen S4 did not exhibit any primary creep behavior at the onset of the testing procedure; instead, it initially demonstrated secondary creep behavior and then transitioned into tertiary creep behavior after approximately 0.047 hours (169.2 seconds) of testing. The specimen sustained tertiary creep behavior for approximately 0.036 hours (129.6 seconds) before finally rupturing after a total of 0.083 hours (298.8 seconds) at 1650 °F and under a constant load of 36 ksi.

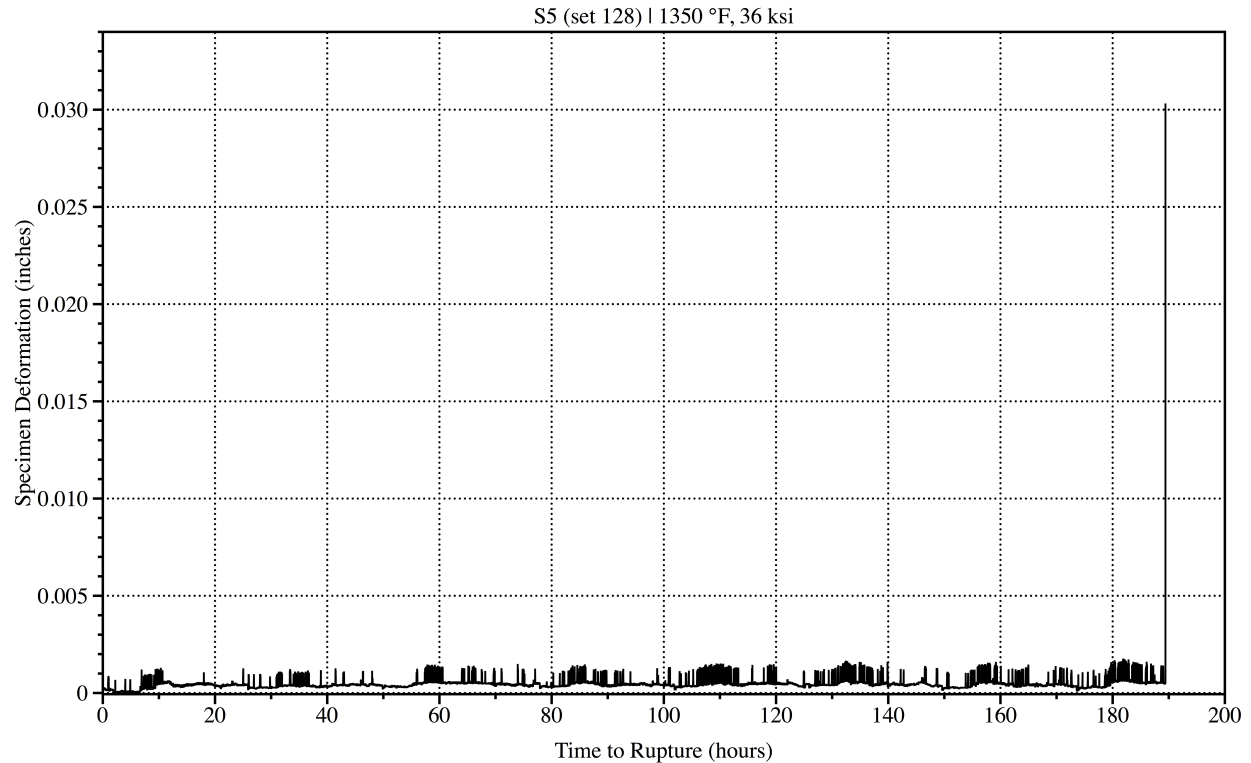
Figure 54. Plot of S5 (set 128) deformation (inches) as a function of time rupture (hours).

Figure 54 appears to demonstrate that specimen S5 (set 128) did not exhibit any classical creep behavior; instead, acceptable LVDT output noise (ranging between 0.001 to 0.002 inches) is demonstrated to have occurred before the specimen finally ruptured after a total of 187.1 hours at 1350 °F and under a constant load of 36 ksi. However, given that the specimen's elongation was measured to be 55%, and that the recorded specimen elongation was only 3%, it is suspected that the LVDT was not fully engaged or activated during the testing procedure. The accuracy of the time to rupture recorded for specimen S5 (set 128) is not suspected to have been compromised by this lack of LVDT engagement, as the creep bracket fully extends upon a specimen's rupture; the final seconds of the figure 54 plot indicate that the LVDT was successfully engaged upon the specimen's rupture.

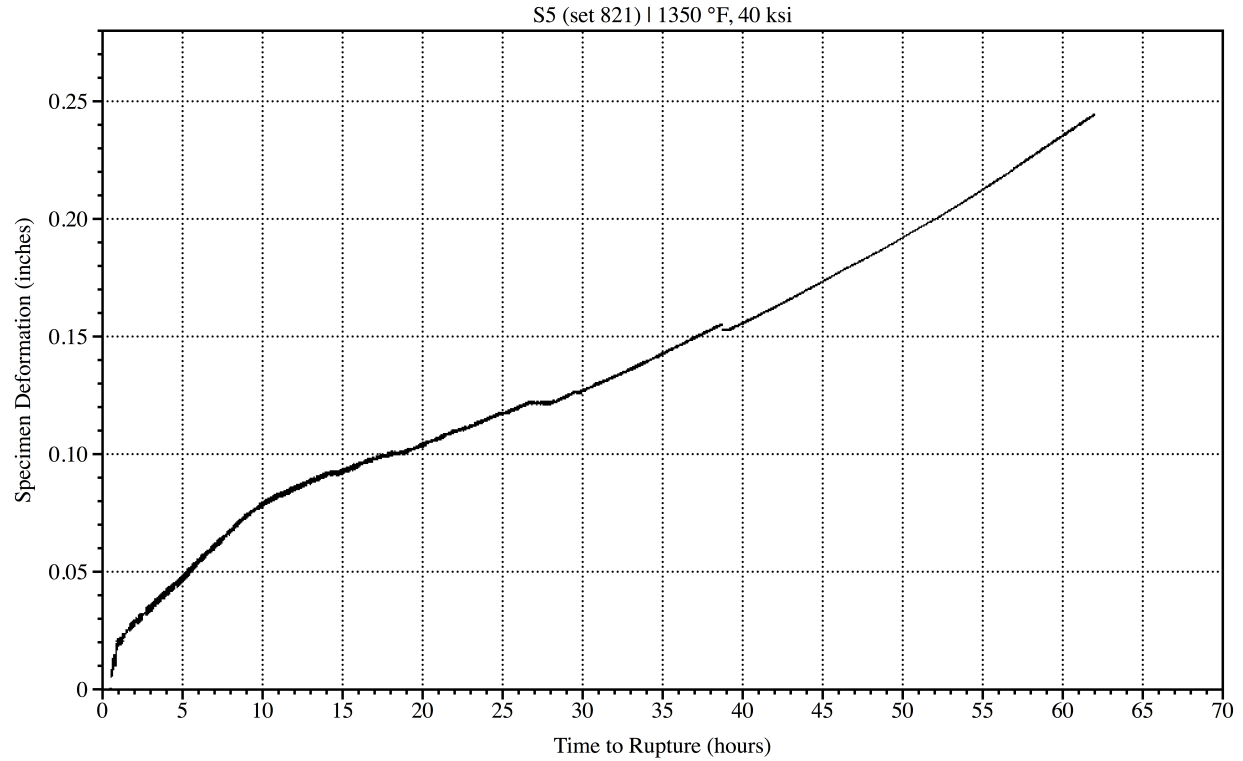
Figure 55. Plot of S5 (set 821) deformation (inches) as a function of time rupture (hours).

Figure 55 demonstrates that specimen S5 (set 821) exhibited all three stages of classically defined creep behavior. Primary creep behavior occurred at the onset of the testing procedure and then transitioned into steady-state, secondary creep behavior after approximately 10 hours of testing; secondary creep behavior was maintained for approximately 17 hours, as the specimen transitioned into tertiary creep behavior after approximately 27 hours of testing. The specimen sustained tertiary creep behavior for approximately 34.3 hours before finally rupturing after a total of 61.3 hours at 1350 °F and under a constant load of 40 ksi.

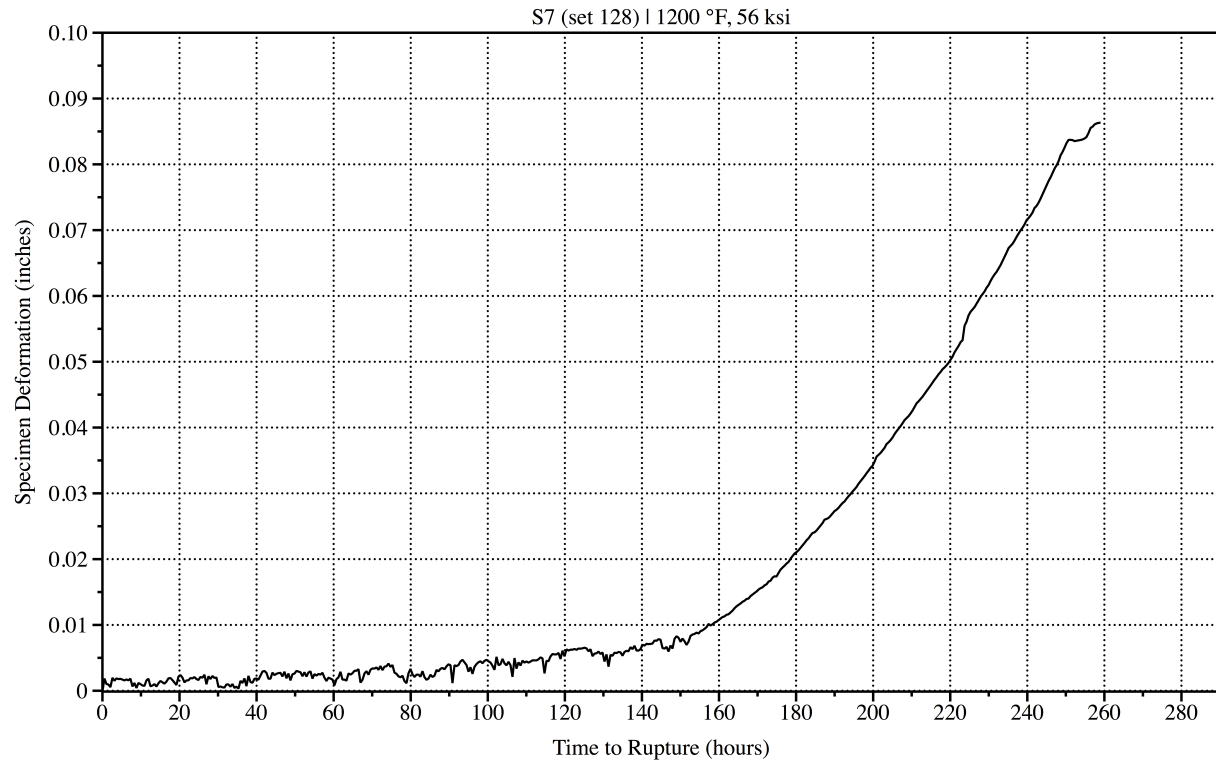
Figure 56. Plot of S7 deformation (inches) as a function of time rupture (hours).

Figure 56 demonstrates that specimen S7 did not exhibit any primary creep behavior at the onset of the testing procedure; instead, it initially demonstrated secondary creep behavior and then transitioned into tertiary creep behavior after approximately 85 hours of testing. The specimen sustained tertiary creep behavior for approximately 174 hours before finally rupturing after a total of 259 hours at 1200 °F and under a constant load of 56 ksi.

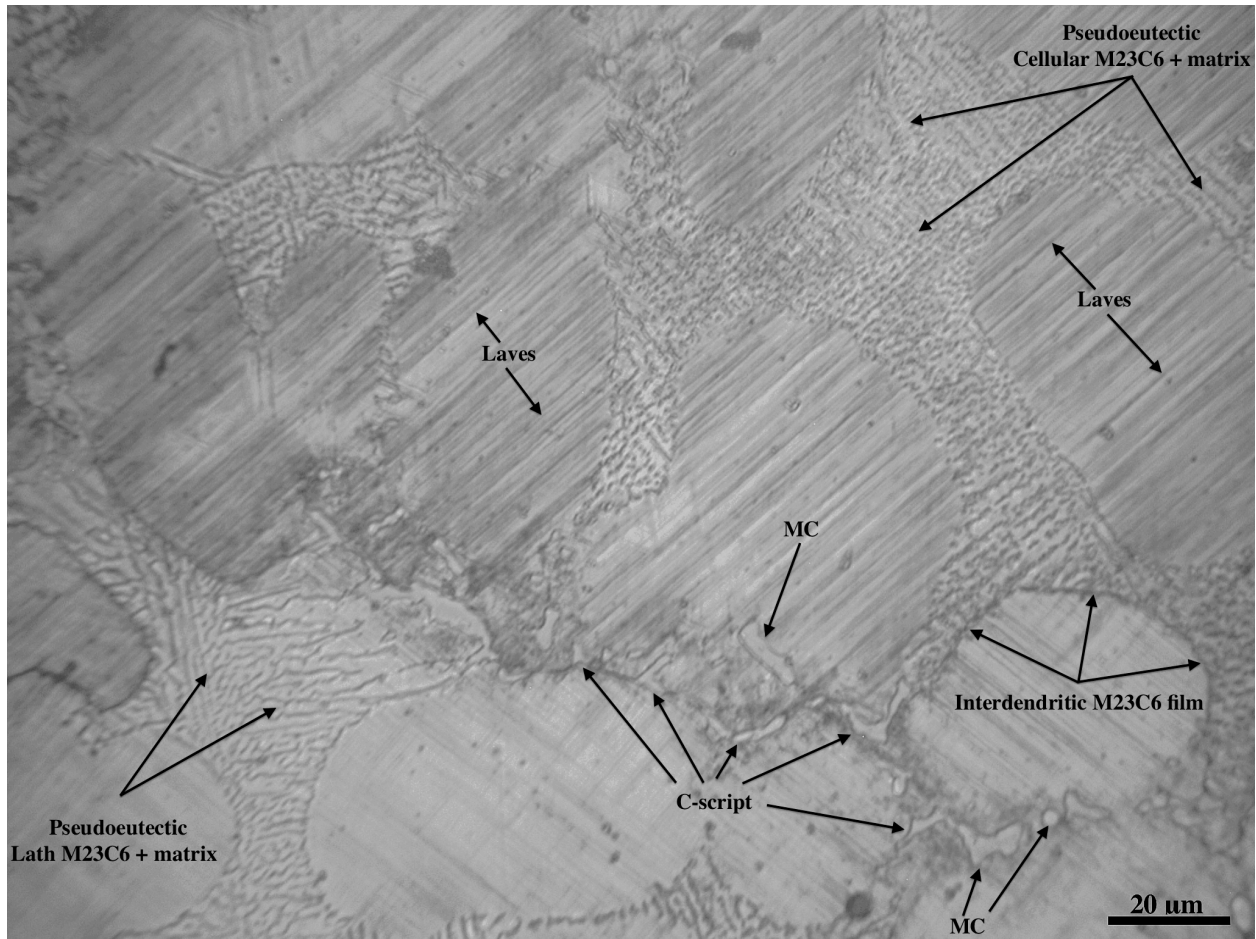
Figure 97. Etched microstructure of specimen 10 (as-received); original magnification: 1000X. Microconstituents identified for metallographic reference purposes.

locational features are consistent with what has been documented of $M_{23}C_6$ carbides in Co-base superalloys [2]; this phase is labeled as $M_{23}C_6$ in figures 97 and 101.

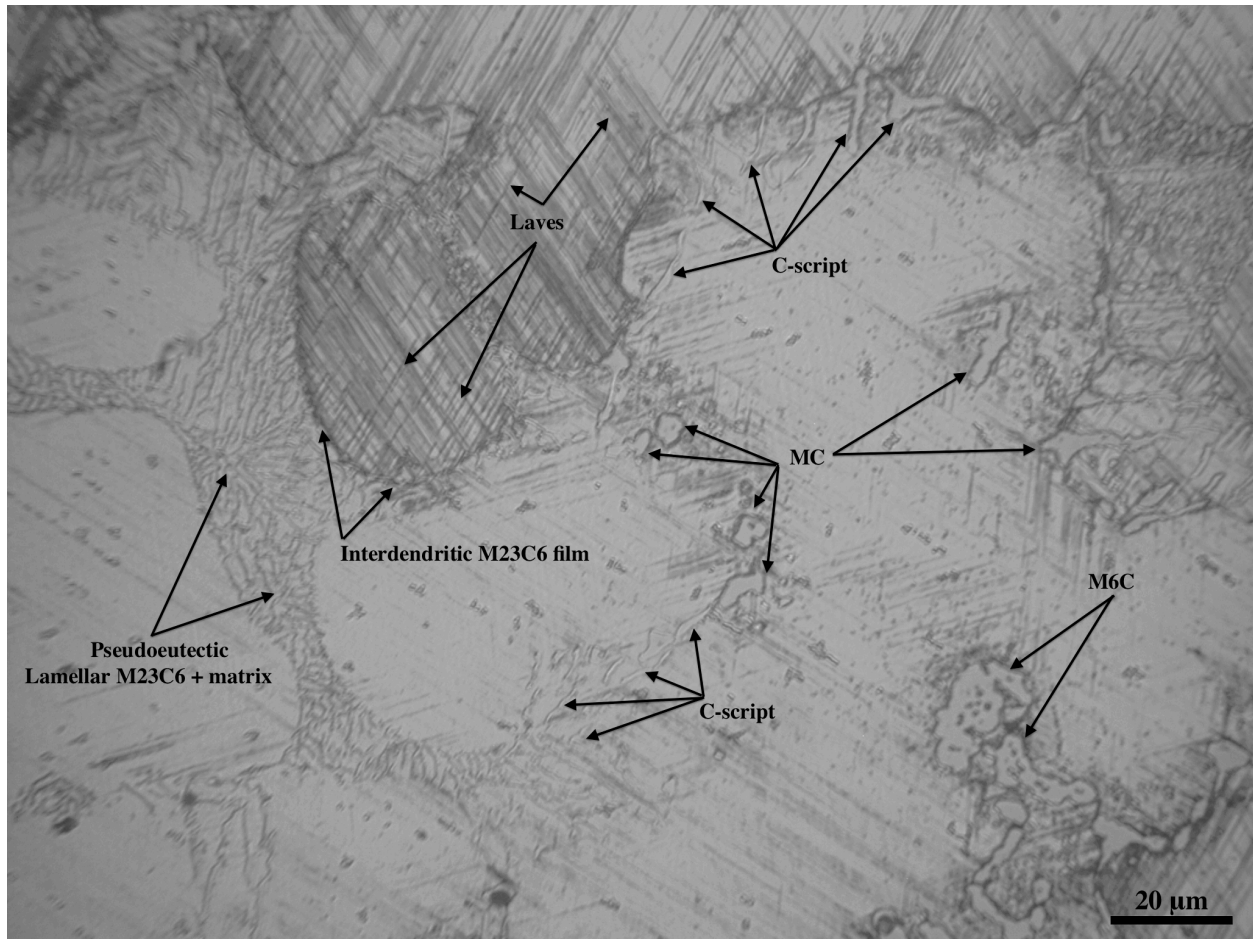
Figure 101. Etched microstructure of specimen 11 (as-received); original magnification: 1000X.
Microconstituents identified for metallographic reference purposes.
