Evaluation of Residual, Post-Service Creep-Rupture Properties of S-816 Turbine Buckets

EVALUATION OF RESIDUAL, POST-SERVICE CREEP-RUPTURE
PROPERTIES OF S-816 TURBINE BUCKETS

THESIS

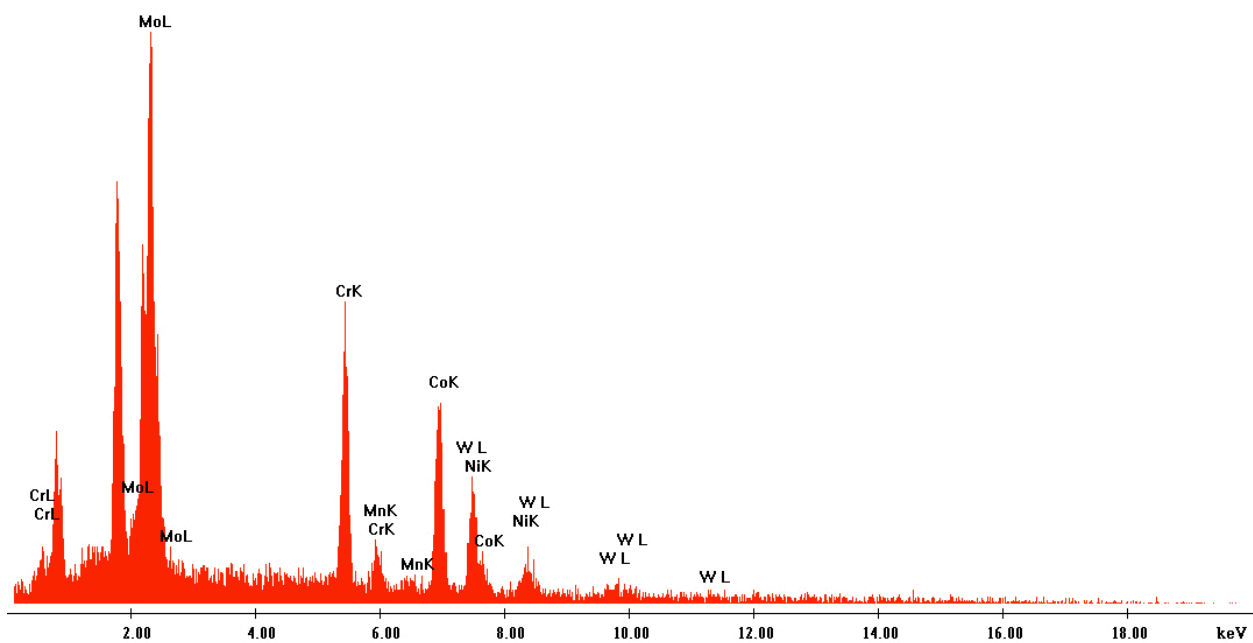
Element	Wt. (%) Location 10
Manganese	0.68
Chromium	15.32
Nickel	9.76
Molybdenum	46.17
Tungsten	11.04
Niobium	-
Iron	-
Cobalt	17.03

Figure 226. Elemental spectrum collected during EDS analysis of location 10 in figure 204.

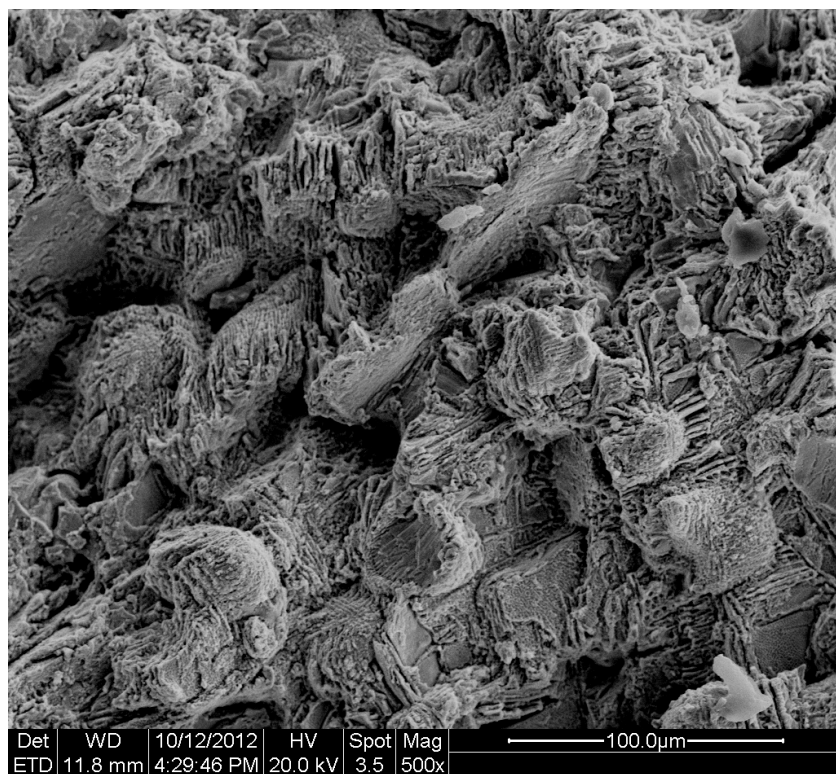
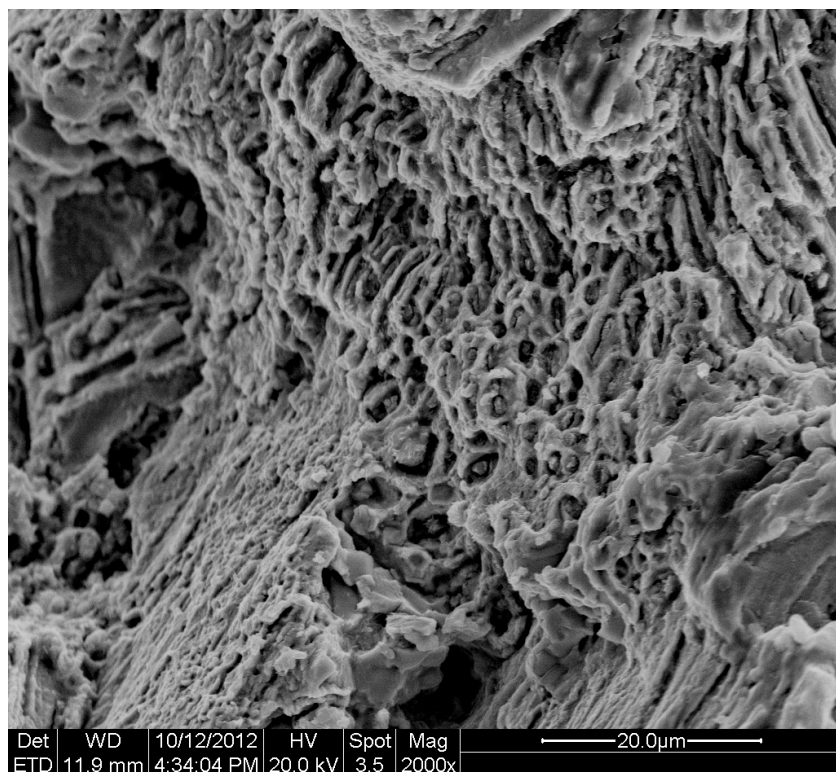
Figure 251. SE image of rupture surface of specimen S7; magnification: 500X.

Figure 253. SE image of rupture surface of specimen S7; magnification: 2000X.

Figures 250-253 demonstrate that specimen S7 fractured along interfacial regions (such as interdendritic and carbide-matrix interfaces), as the rupture surface of the specimen consists mainly of deep, cavernous arrays; this observation is consistent with the results of the metallographic analysis of specimen S7. The rupture surface features of specimen S7 are reflective of the various morphologies exhibited by the five different carbides and carbide arrays that were observed metallographically.

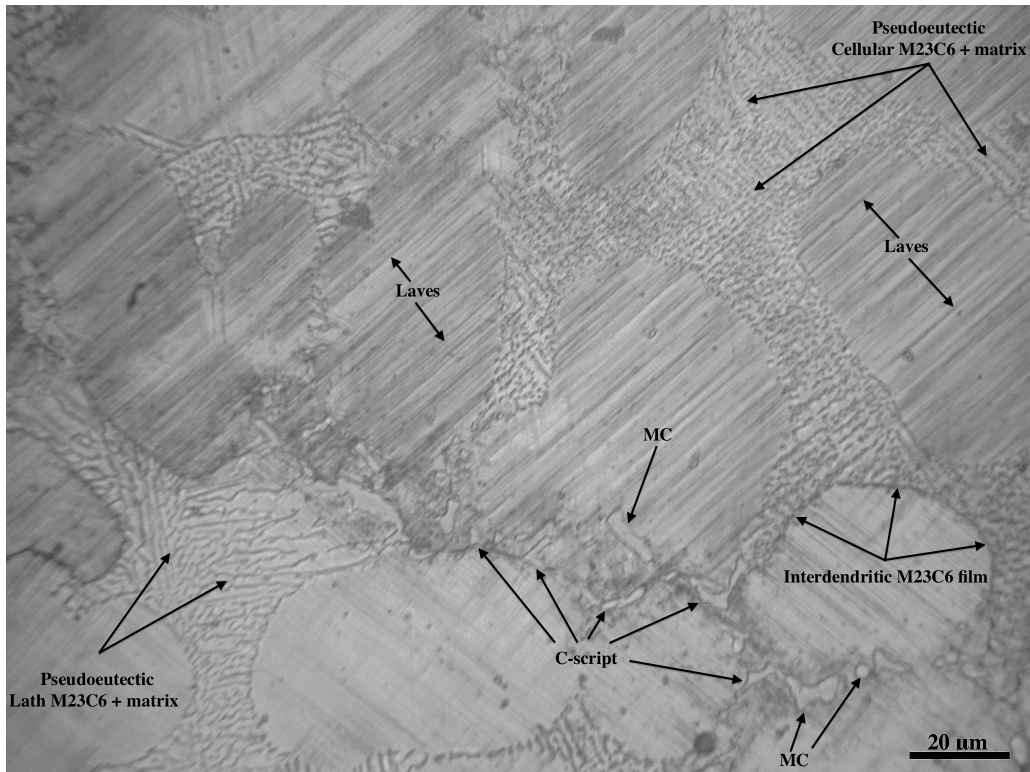
Figure 97. Etched microstructure of specimen 10 (as-received); original magnification: 1000X.
Microconstituents identified for metallographic reference purposes.

locational features are consistent with what has been documented of $M_{23}C_6$ carbides in Co-base superalloys [2]; this phase is labeled as $M_{23}C_6$ in figures 97 and 101.
