Evaluation of Nondestructive Technologies to Assess Presence and Extent of Delamination of Hot Mix Asphalt Airfield Pavements

Manuel Celaya

University of Texas at El Paso, mcelaya@utep.edu

Department of Civil Engineering

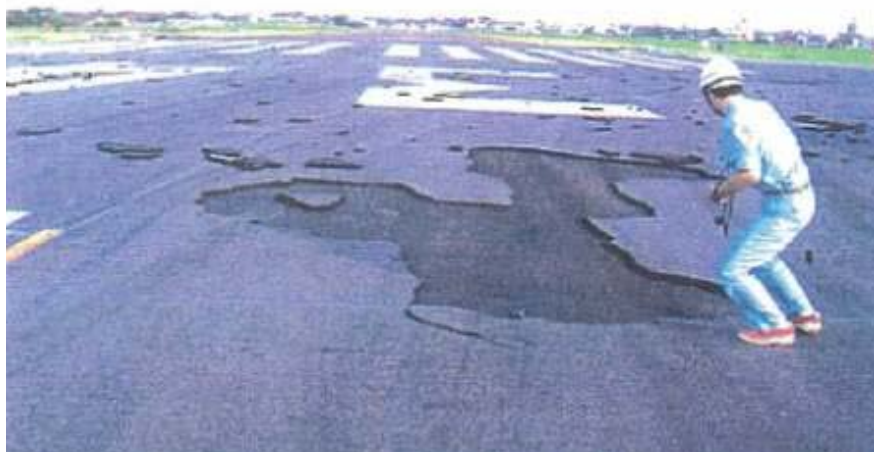
Figure 1.1 – Slippage Failure due to Loss of Bond at Nagoya Airport (from Tsubokawa et al., 2007)

Delamination or debonding problems are particularly more severe on airfield pavements, due to higher traffic loads applied by aircrafts. Especially, the situation is more critical on runways at the high-speed taxiway exits, where airplanes brake and turn (Bognacki et al., 2007), or on areas under large horizontal load of aircraft at takeoff, creating slippage due to inadequate bonding between the top layer and the layer below. In severe cases, it can lead to runway closures (Tsubokawa et al., 2007). As an example, Figure 1.1 shows a case of asphalt delamination that occurred due to loss of bond between the surface and binder courses for a runway constructed only one year before the incident. In this case, the thickness of the surface course that suffered delamination was 2 in., the slippage area was 12 ft wide and 25 ft long, and the runway had to be closed for repairs.

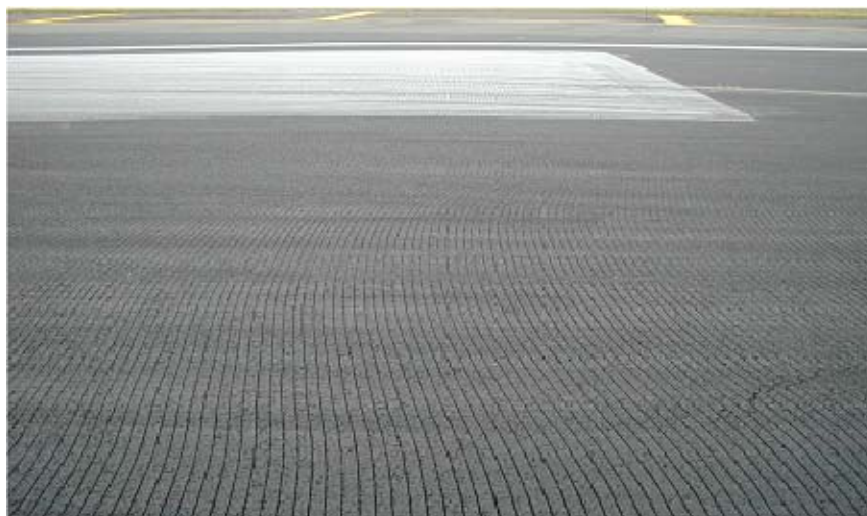
Figure 1.2 – Slippage at High-Speed Taxiway (“Curved” Grooves Indicate Slippage, Bognacki et al., 2007)

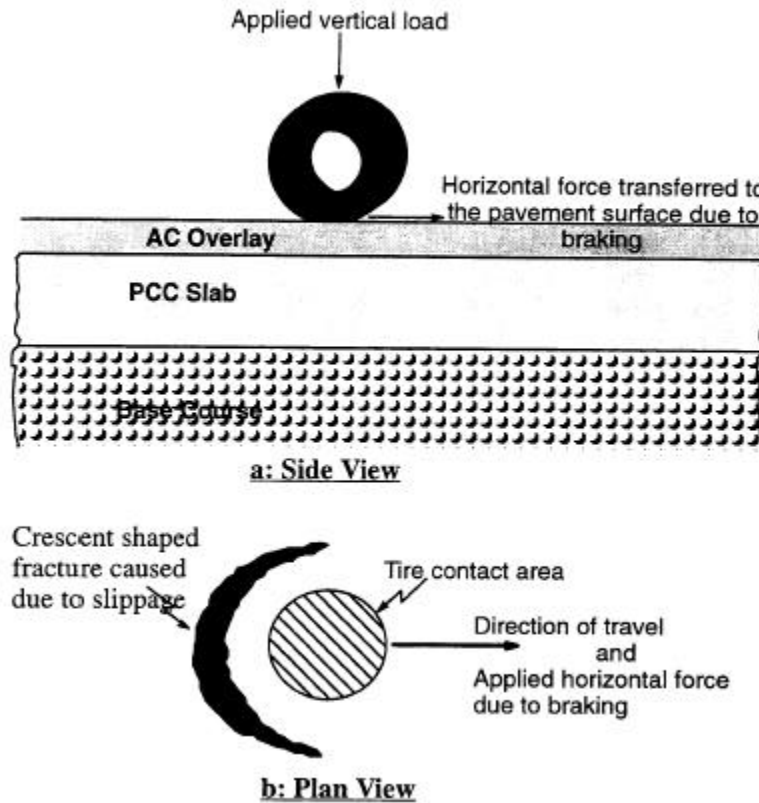
Figure 1.3 – Typical Slippage Failure (from Kulkarni, 2004)

Some other studies have found that the cause of airport delamination can be attributed to intersection of multiple-traffic paths on runways and large shear forces caused by pivoting wheels (Carroll and Dempsey, 2007). Delamination problems in airfield pavements are often preceded by slippage failures that can be detected by the presence of curved grooves on the surface, as illustrated in Figure 1.2, (Bognacki et al., 2007) or half-moon-shaped cracks having two ends pointed away from the direction of traffic, as detailed in Figure 1.3 (Shahin, 2005).

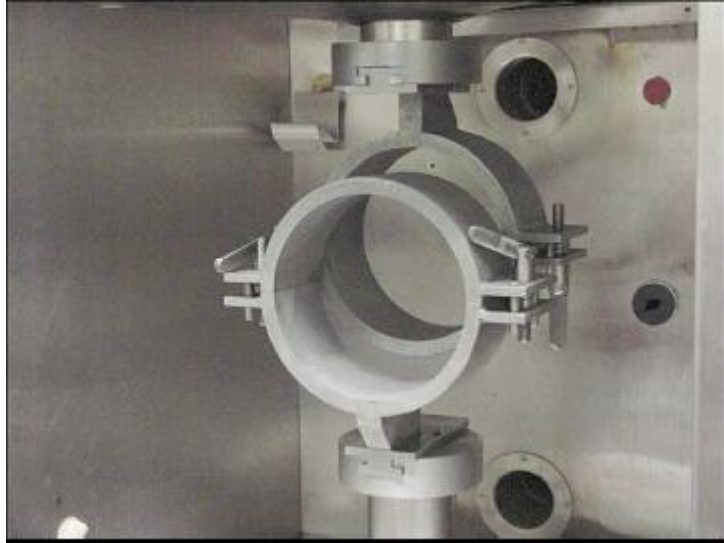
Figure 2.2 – Shearing Setup developed at FDOT (Sholar et al., 2004)

Eedula and Tandon (2006) used a simple shear device similar to ASTRA Shear Box Apparatus for laboratory evaluation of bond strength in recovered cores. The rate of loading, normal pressure, and temperature have been studied and optimized for measuring bond strength. Sholar et al. (2004) investigated the effect of different tack coat application rates, curing time, types of aggregates, rates of shear and moisture on the interfacial bond strength of composite asphalt specimens. A device, shown in Figure 2.2, was developed to test the specimens in shear.

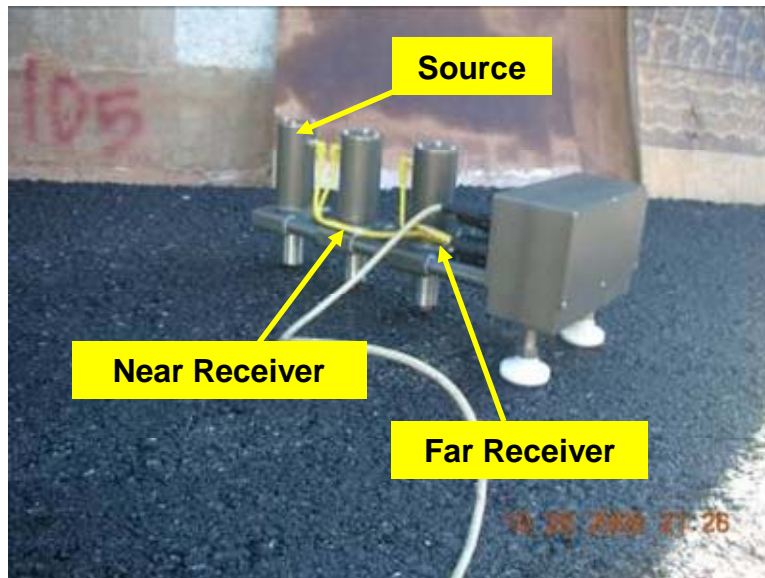
Figure 5.2 – PSPA Detail

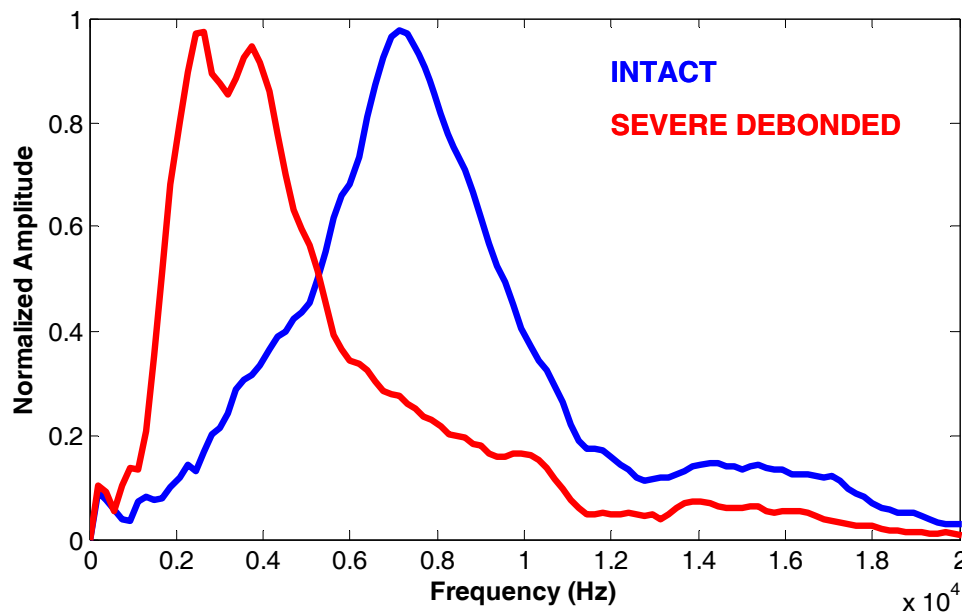
Figure 5.8 – IE Results with PSPA on Controlled Study

The IE method is based on detecting the resonance frequency of the standing wave reflecting from the bottom and the top of a pavement layer. The IE results are illustrated in Figure 5.8 for intact and severely debonded locations. The normalized amplitude of the frequency response on the PSPA receiver closer to the source was used. To obtain the frequency response, a Fast Fourier Transform (FFT) algorithm was applied to the time records from PSPA. For the case of the intact location, only a peak around 6800 Hz dominates the frequency spectrum. For the case of severe debonding, there is a shift to a lower frequency because a flexural (drum like) mode dominates the frequency response of the incident wave on the asphalt.

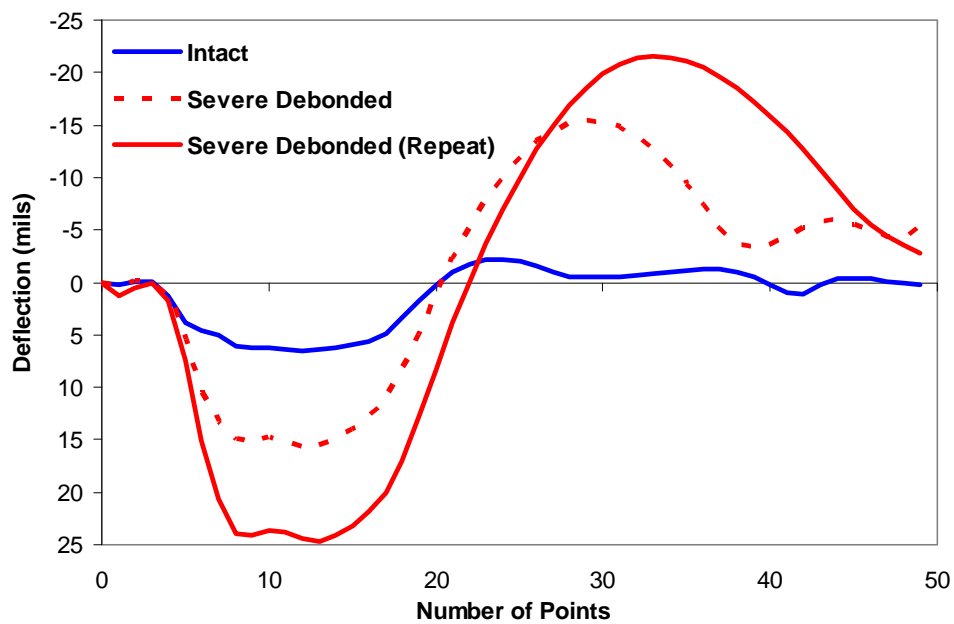
Figure 5.20 – Deflection Examples from LWD on Controlled Study

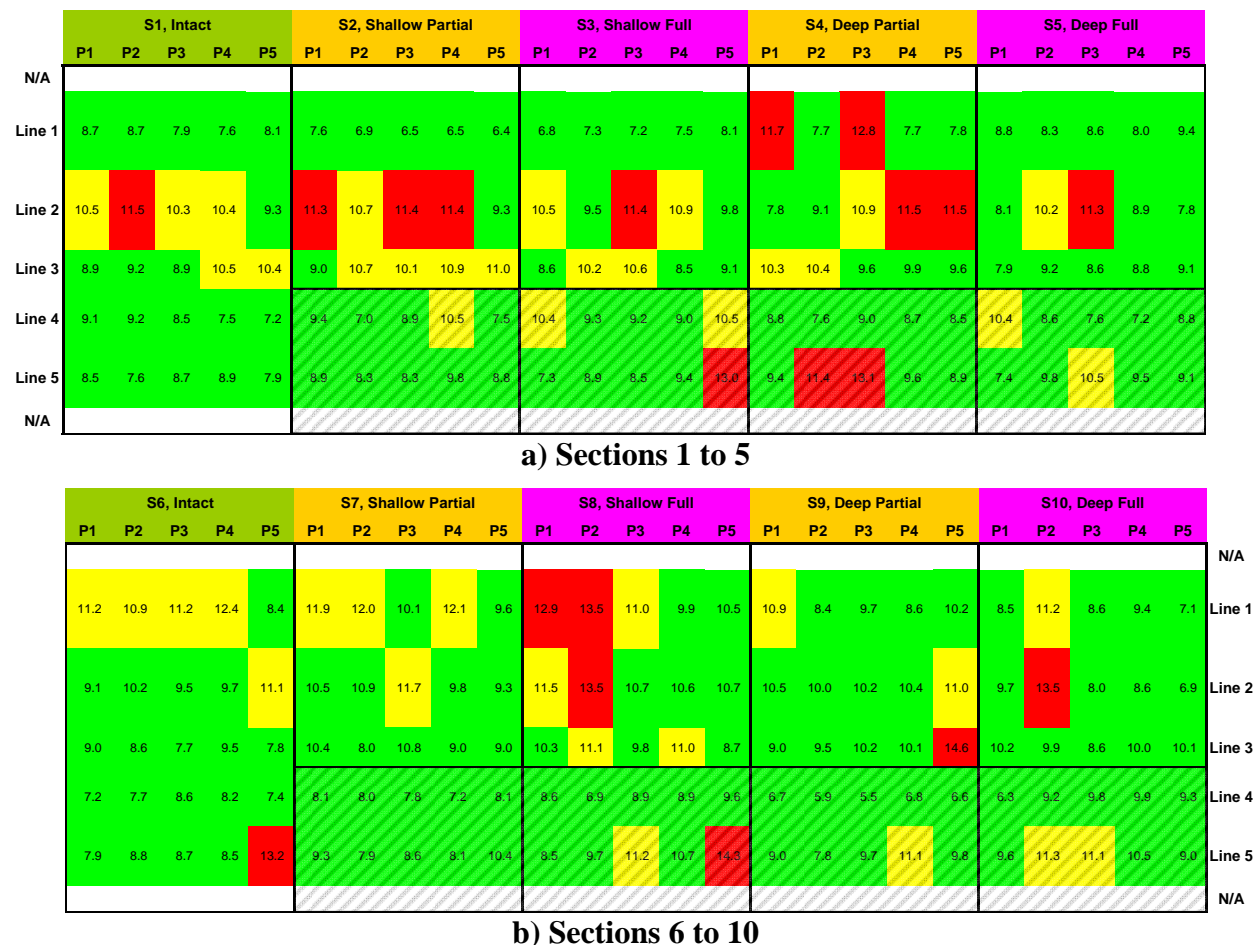
Figure 5.21 – Statistical Analysis of LWD Deflections on Controlled Study

The average deflections for the ten sections are shown in Figure 5.21. The LWD did not provide any indication of debonding for almost all debonded area, since higher deflections did not correspond to delaminated areas. However, a number of intact areas yielded higher deflections. Based on this study, it seems that the LWD may not be suitable for detecting debonding.

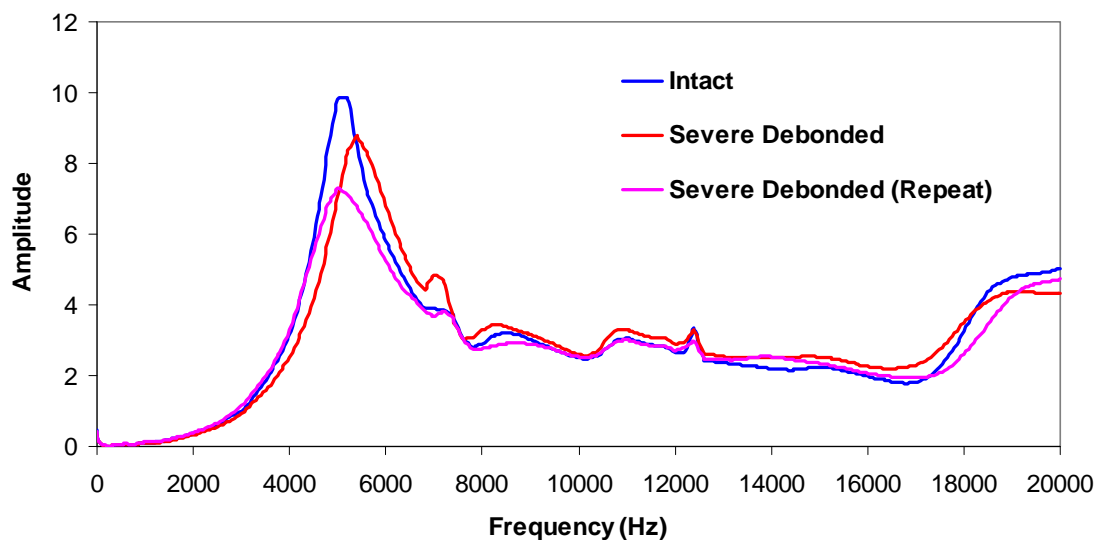
Figure 5.30 – High Frequency Sweep Examples on Controlled Study

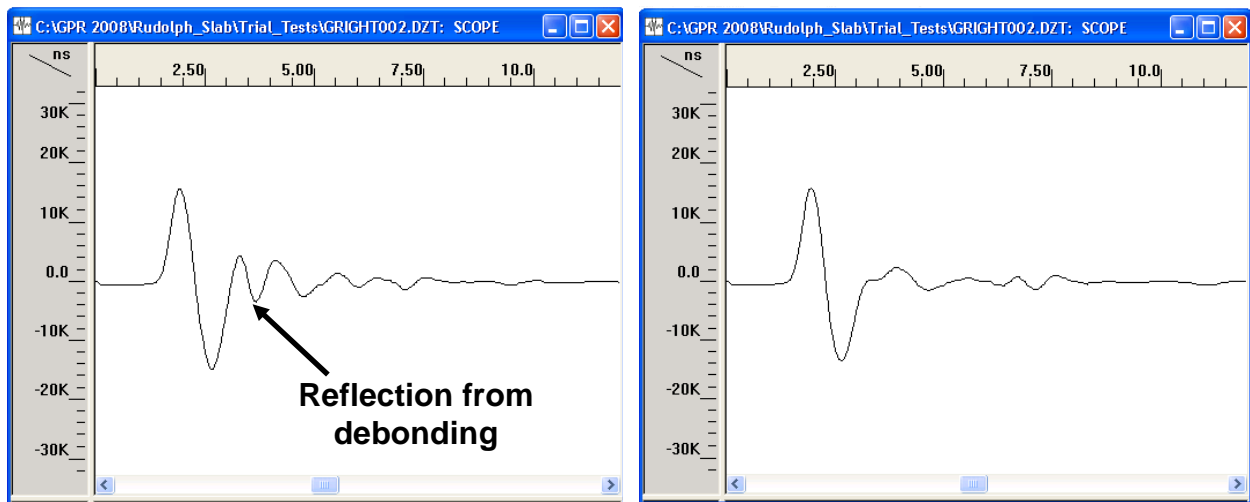
Figure 5.39 – O-scopes for Intact and Severe Debonded Locations with Ground-coupled

debonded locations are shown in Figure 5.39. The reflections from the severely debonded area can be more easily observed in this case because of the higher amplitude apparent on the O-scan. Complete post-processed linescans for all 5 lines are shown on Figure 5.40. The approximate asphalt interfaces of different layers are shown in Figure 5.40a. The following three analyses were performed to obtain these linescans:

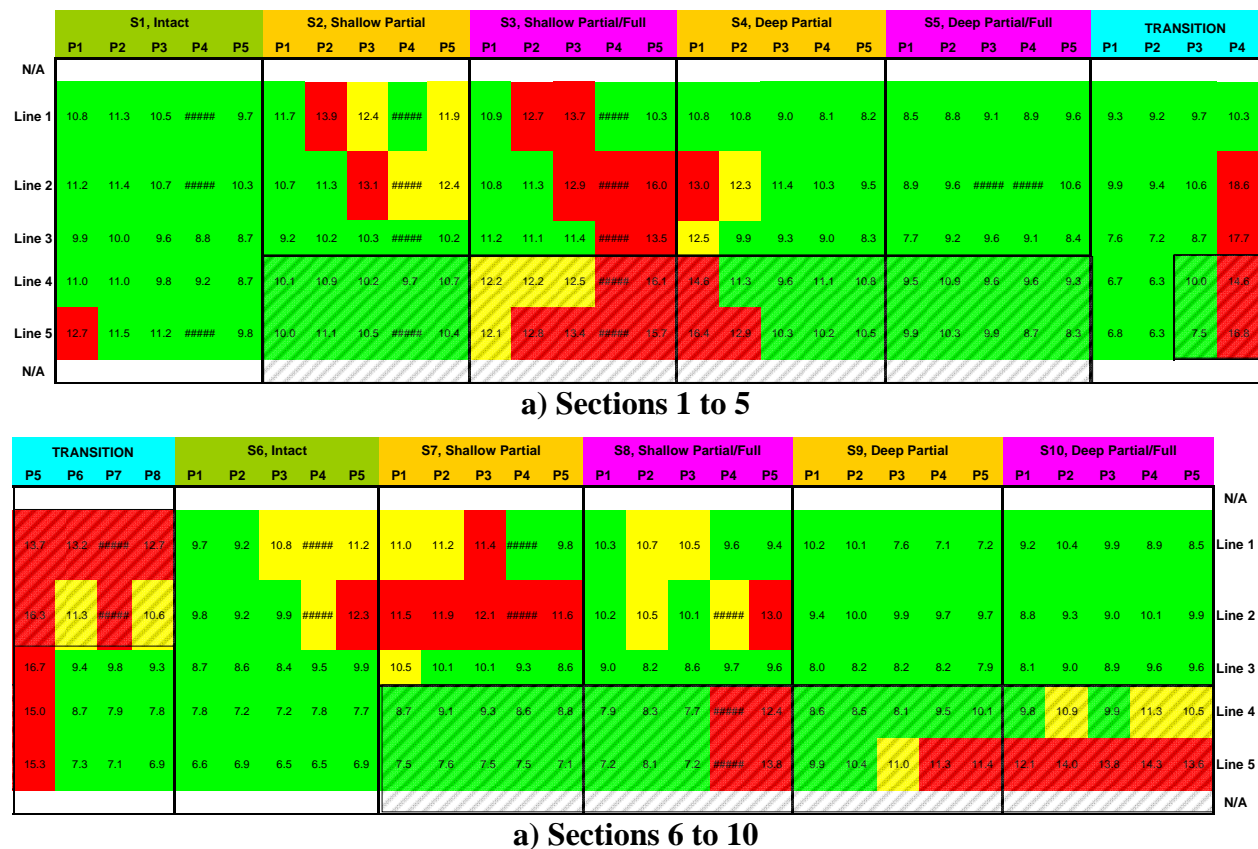
Figure 6.12 – Contour Maps of FWD Deflection in Hot Weather based on Revised Statistical Criteria

The outcomes from the hot weather testing (Figure 6.12) are rather different. The resolving power of the method in detecting debonding is diminished for most debonded sections, while the debonding in Sections 9 and 10 is now apparent. The false positive results (exhibiting the sign of debonding on an intact point) in the intact sections are less severe, but they now show up in Sections 2, 3, 7 and 8.

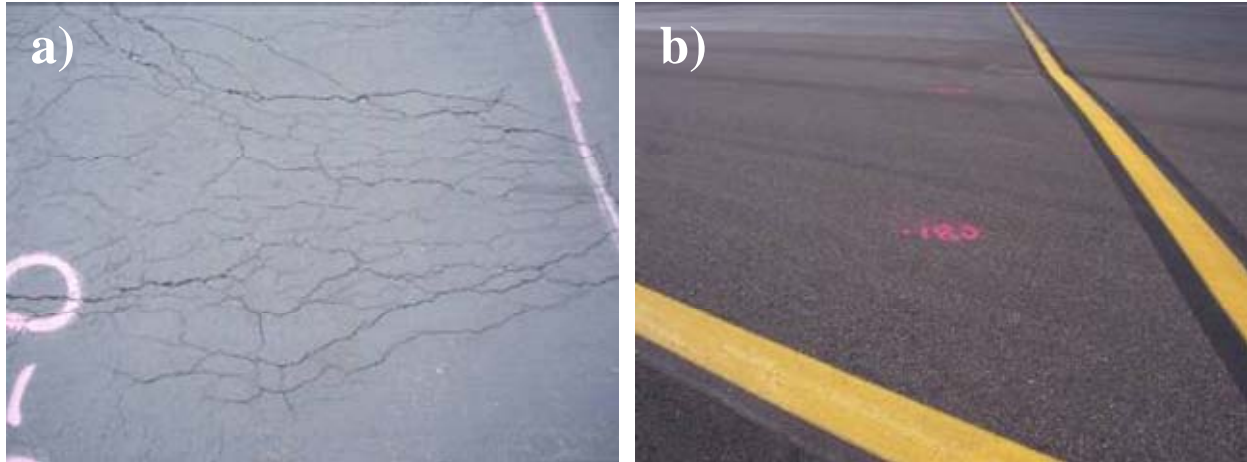
Figure 7.5 – Damaged and Intact Areas on South Ramp Section

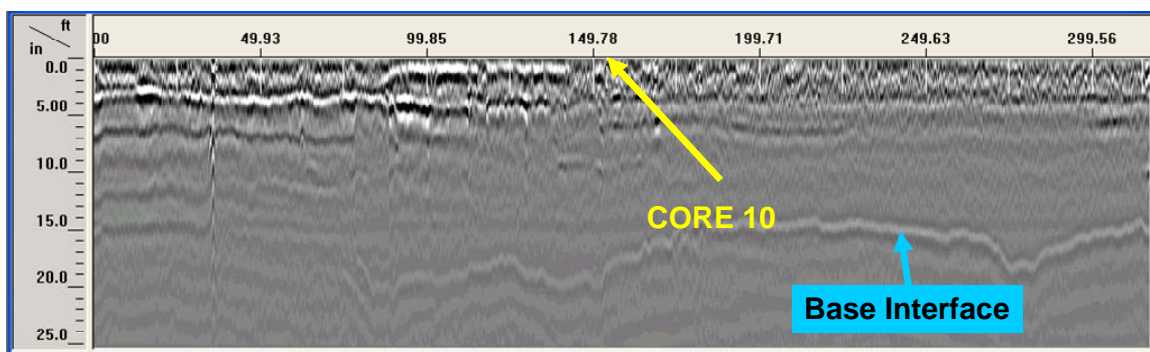
Figure 7.9 – Post-processed GPR Linescans of Line 1 on Section C6

Core #	Location	GPR	PSPA	IR	FWD Deflection	Condition/Comments
C10	L1 @160 ft from start	Intact	Damaged	Damaged	Intact	Stripping between top and middle layer

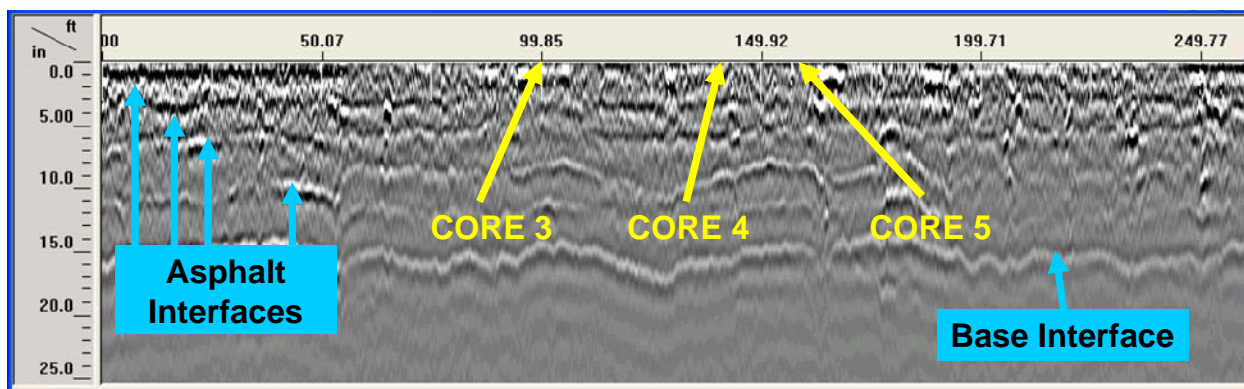
Figure 7.12 – Post-processed GPR Linescans of Line 1 on South Ramp Section

The results from all methods at this section are shown in Figures 7.12 and 7.13, and in Appendix F. The PSPA indicates less of a problem at this section than the IR and FWD, especially along Line 1. For that reason, three of the four validation cores were obtained along Line 1 as shown in Figure 7.14. The conditions of these cores with the interpretations of the NDT devices are summarized in Table 7.3. PSPA and FWD detected Core 3 as intact, where IR showed marginal condition. Cores 4 and 5 were categorized as damaged with both IR and FWD and PSPA showed intact condition. For the case of GPR, a strong reflection close to the surface was evident for Core 6.

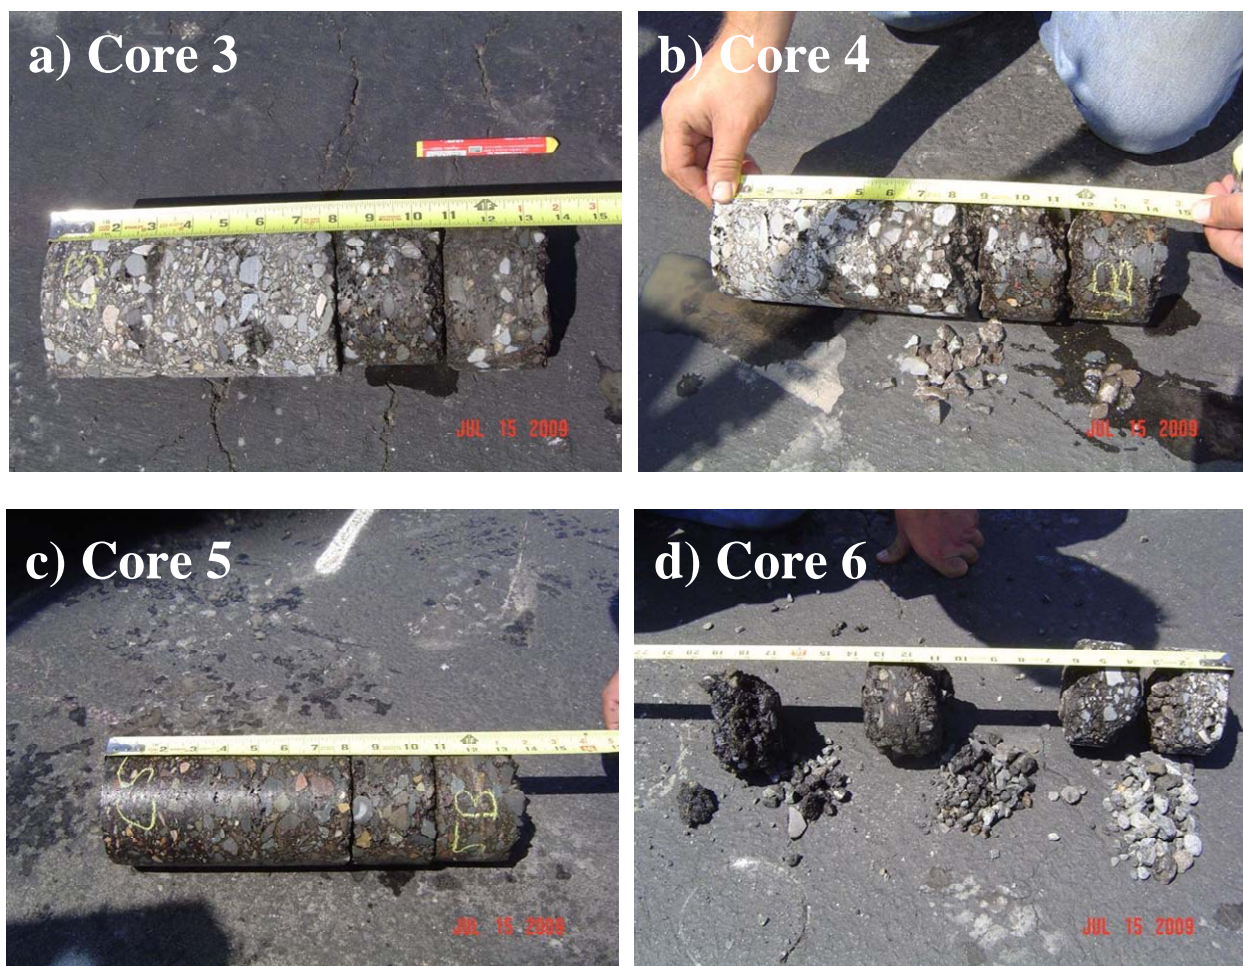
Figure 7.14 – Cores Retrieved from South Ramp Section

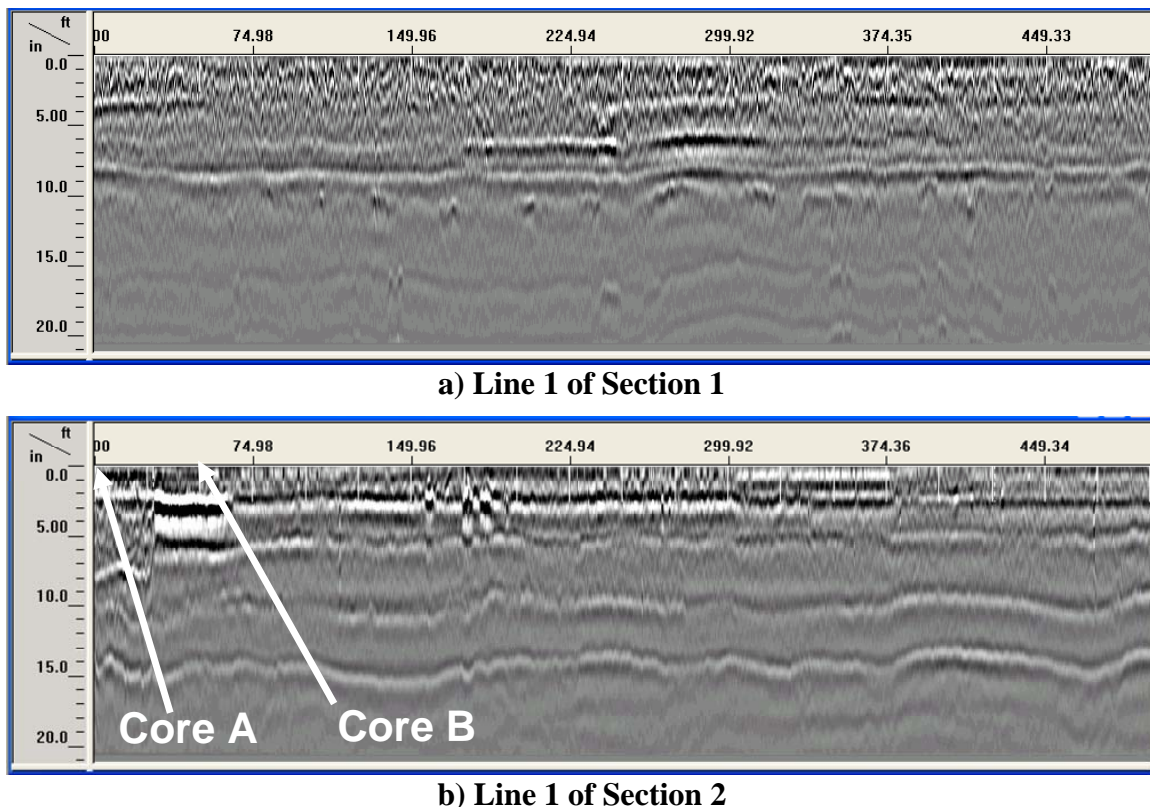
Figure 7.15 – Post-processed GPR Linescans on Line 1 of Sections 1 and 2 of E4

There are some similarities and differences in the damaged areas identified by different methods. PSPA dispersion curves showed stronger reduction in modulus for points along Lines 2 and 3 from Section 1 and less significant reduction for points of Section 2 (see Appendix F).

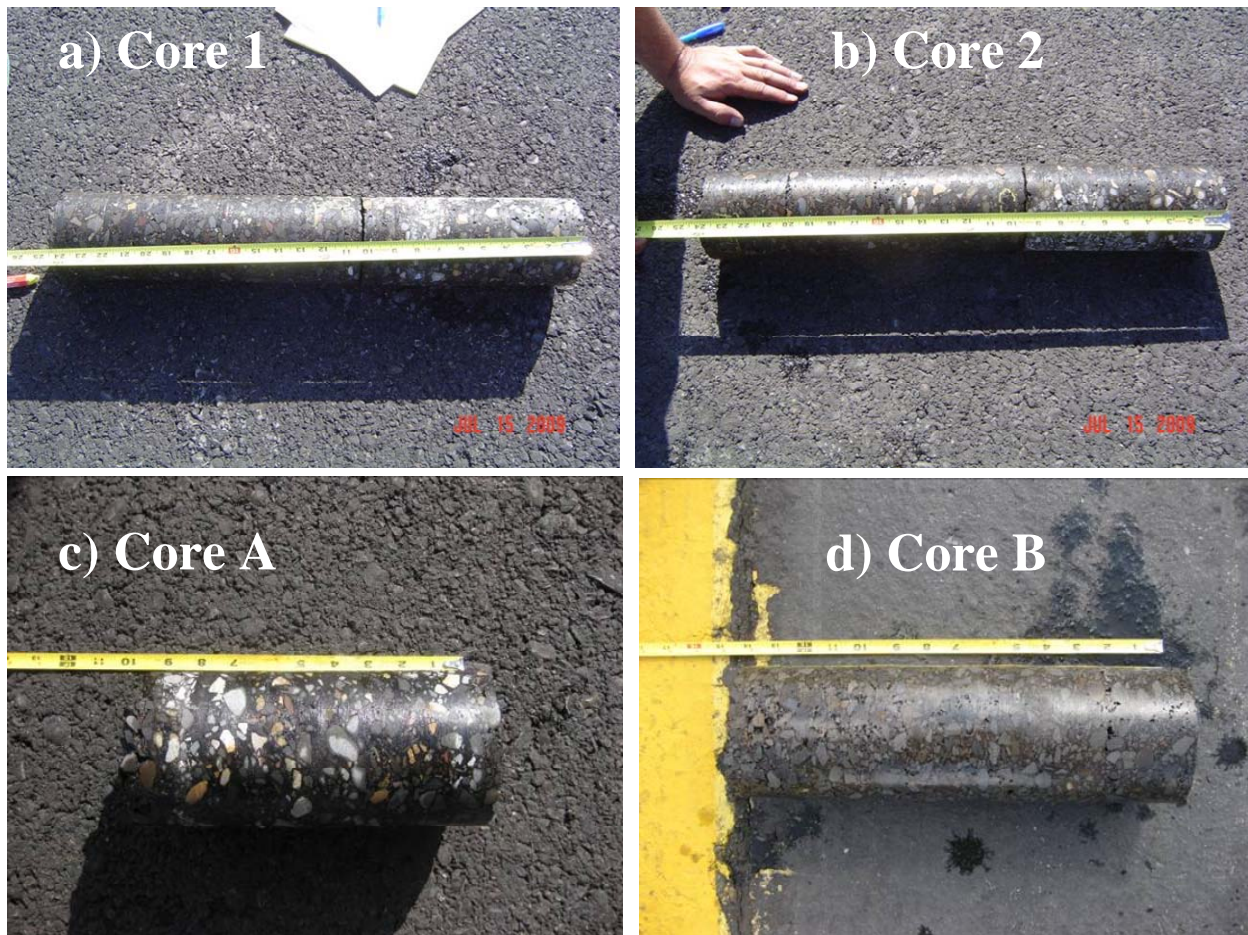
Figure 7.20 – Cores Retrieved from Sections 1 and 2 of E4

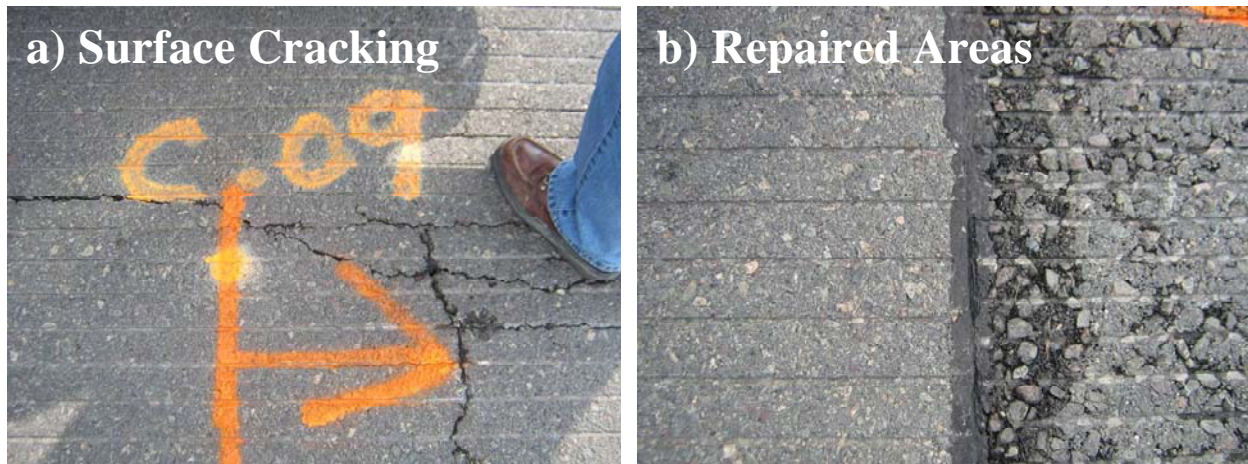
Figure 7.23 – Surface Cracking and Areas with Different Surface Pavement on Section 1

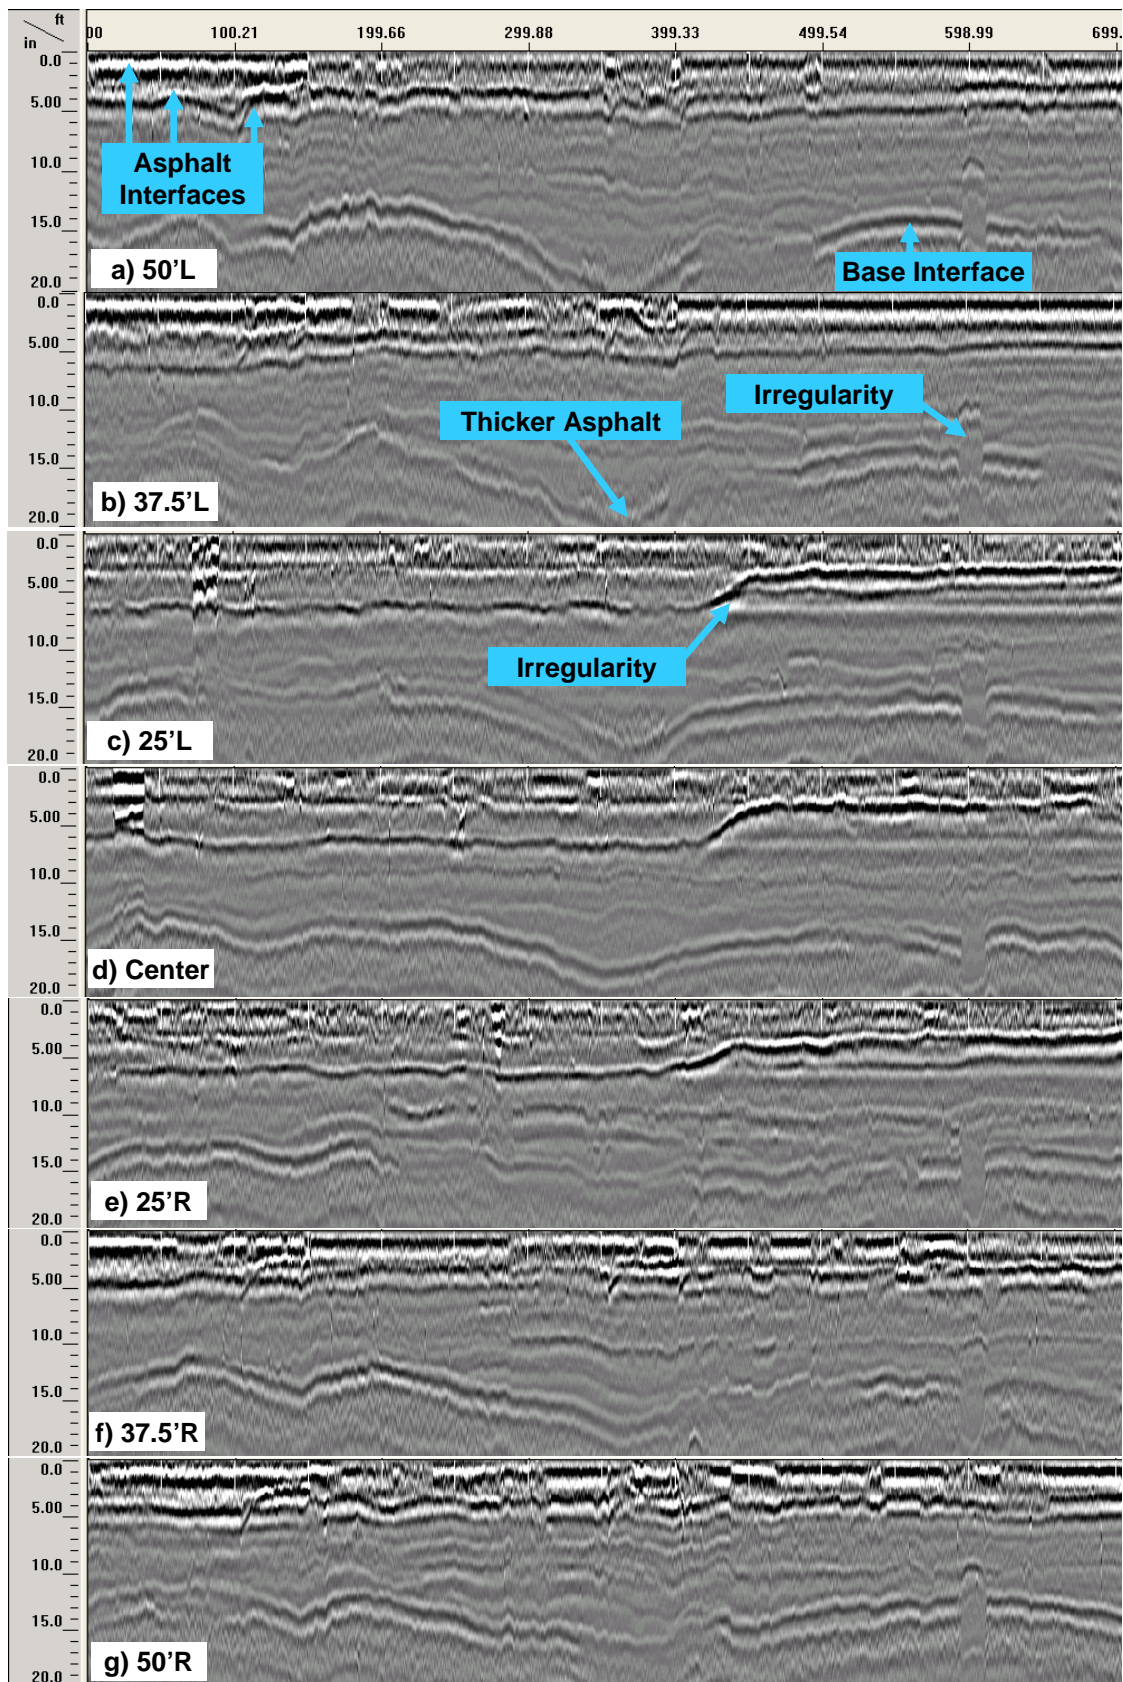
Figure 7.26 – Post-processed GPR Linescans on Section 1

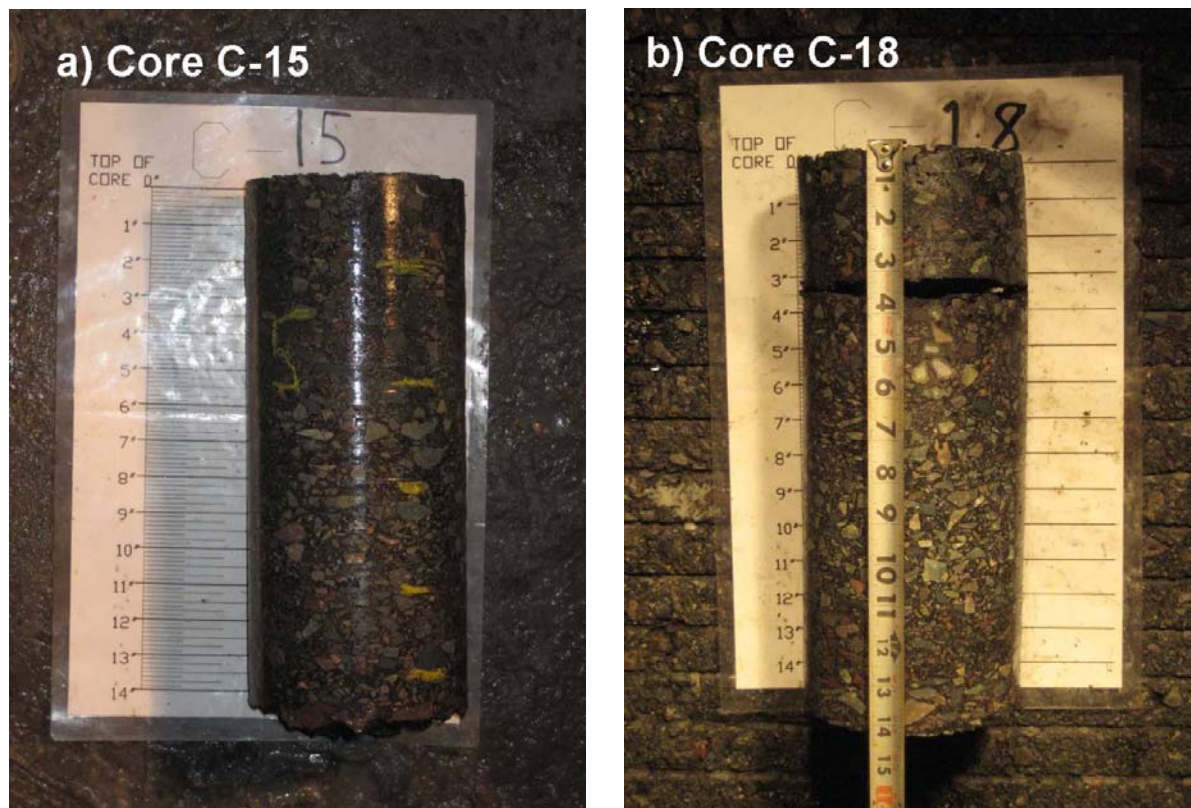
Figure 7.29 – Cores Retrieved from Section 1

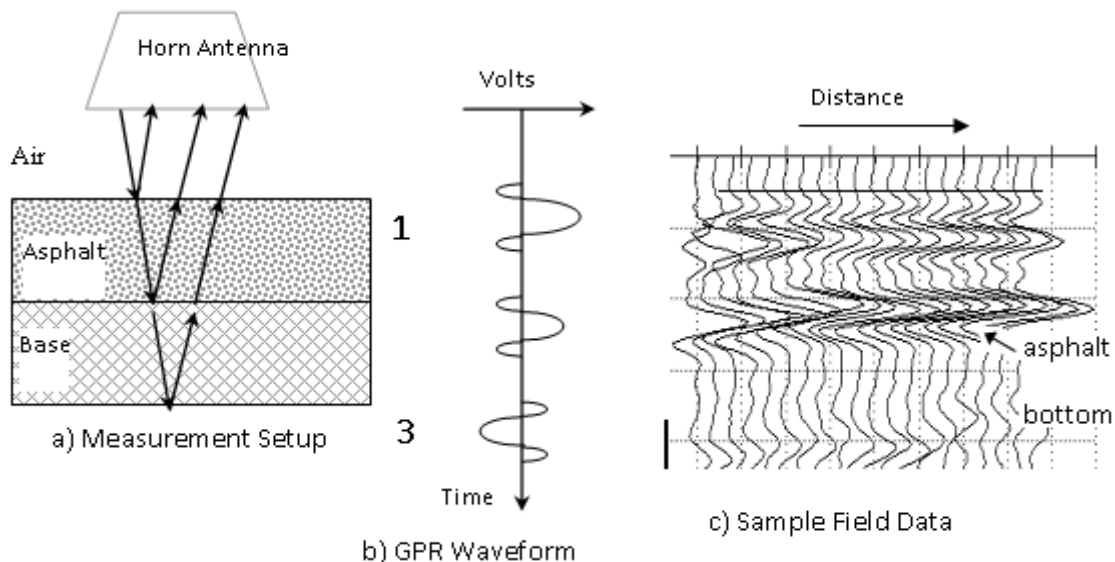
Figure A.2 – Principle of GPR for Pavement Layer Thickness Evaluation

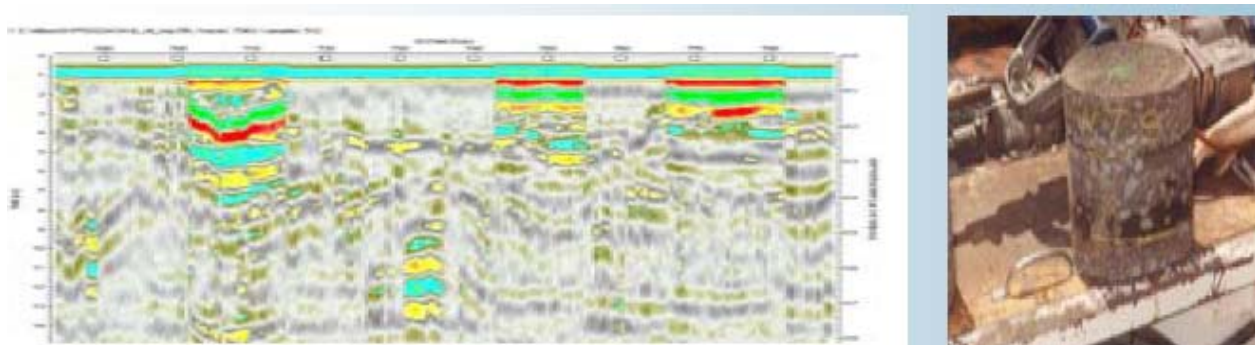
Figure A.5 – Radar Profile and Core Retrieved Showing Asphalt Delamination (GBG Australia)

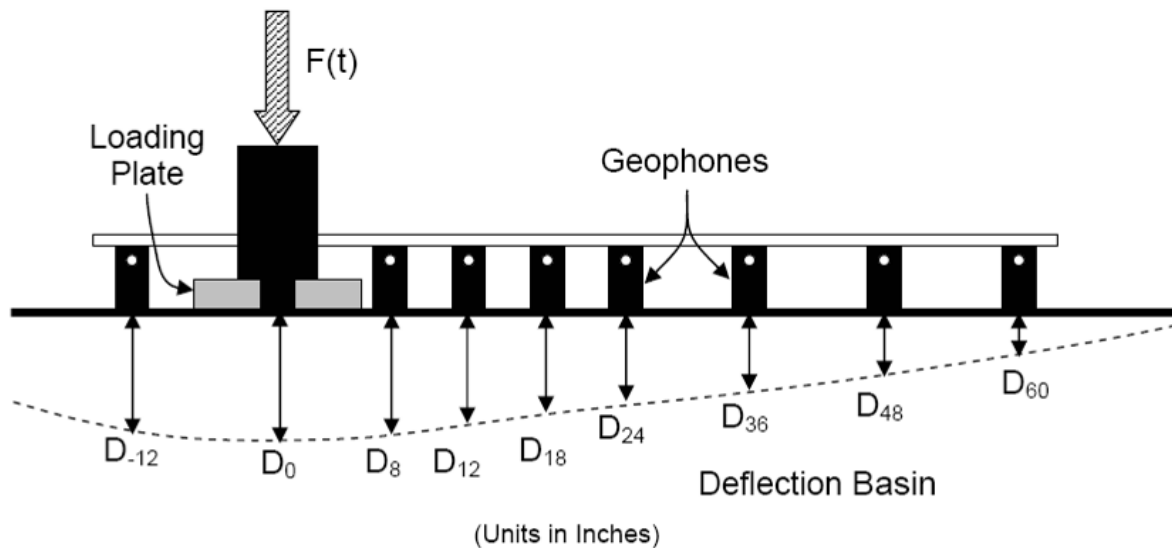
Figure A.7 – Typical Deflection Basin Measured From FWD

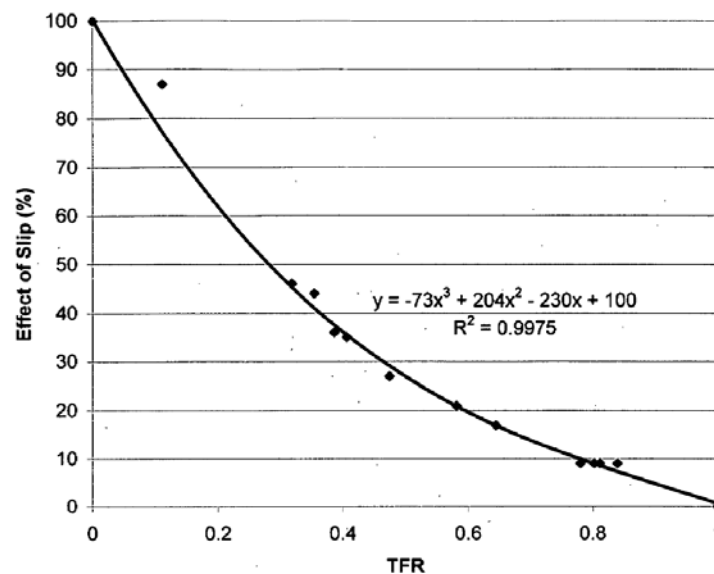
Figure A.8 – Effect of Slip/TFR Correlation (Gomba, 2004)

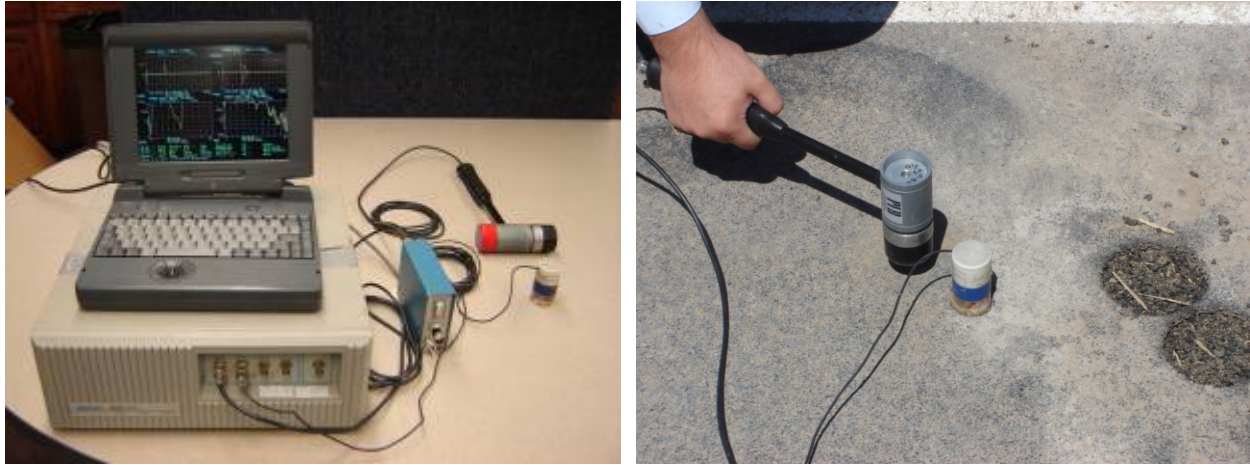
Figure A.10 – Impulse Hammer Test Setup

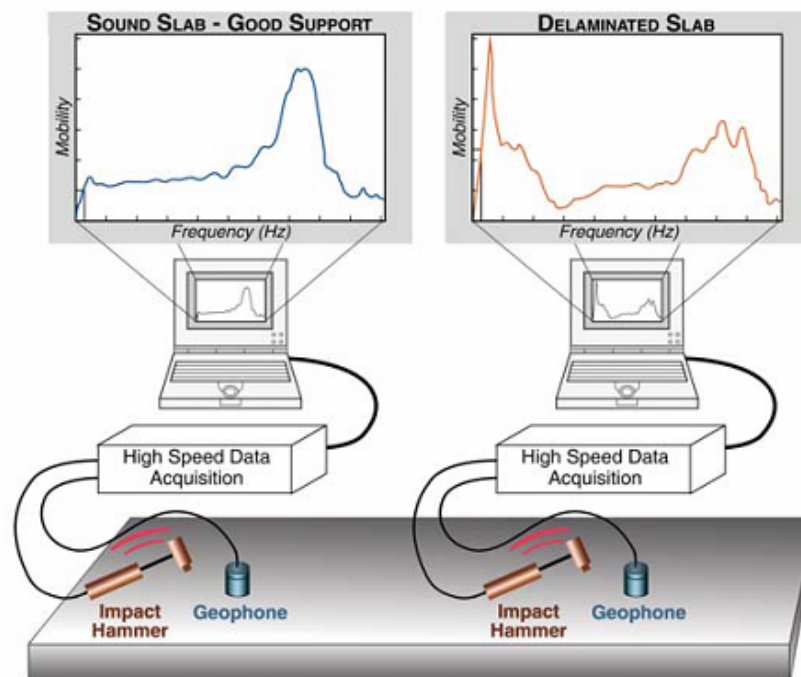
Figure A.11 – Example of IRH Signals for Intact and Delaminated Slabs (CTL, www.ctlgroup.com)

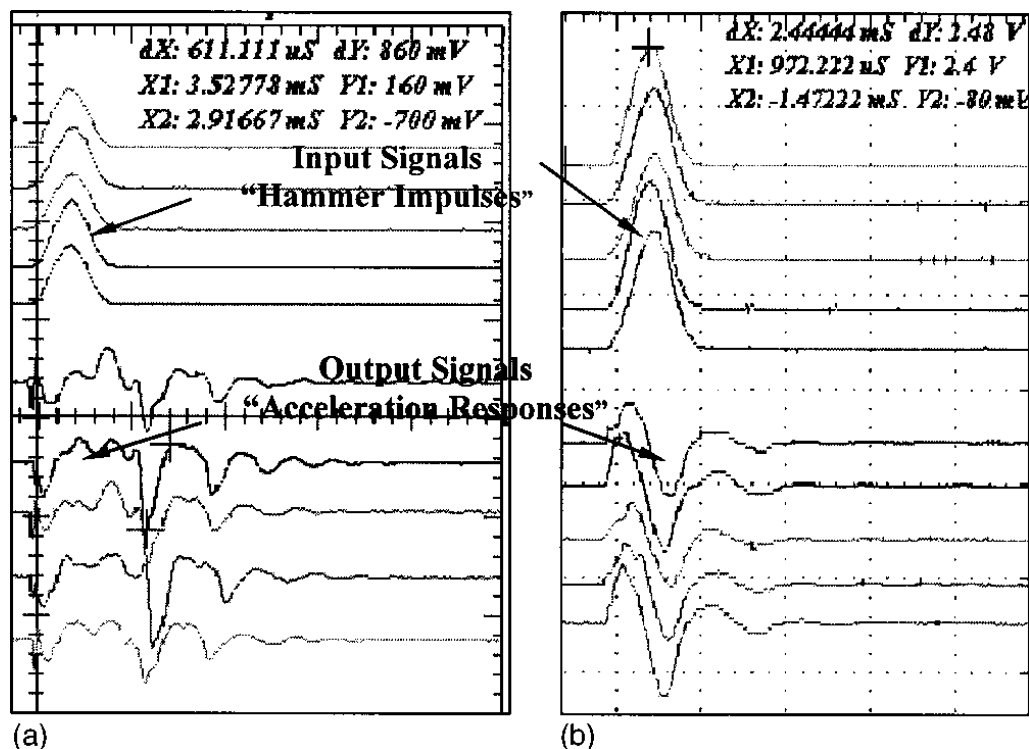
Figure A.12 – Time Histories of Input and Output Signals for Debonded (a) and Bonded (b) Surfacing (Kruncheva et al., 2004)

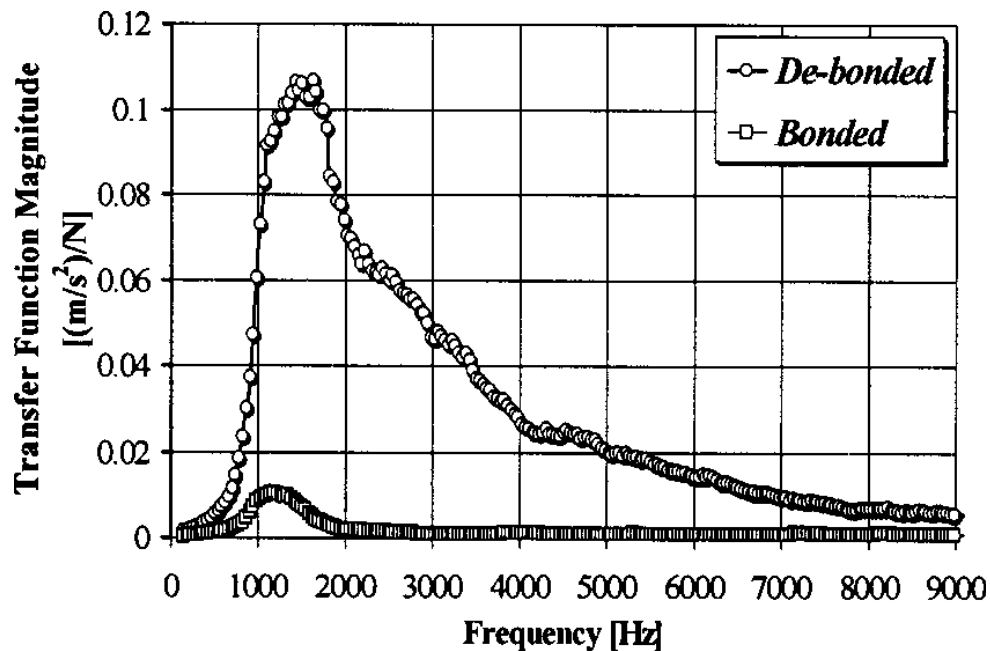
Figure A.13 – Magnitude of TFE versus Frequency for Bonded and Debonded Surfacing
(Kruncheva et al., 2004)

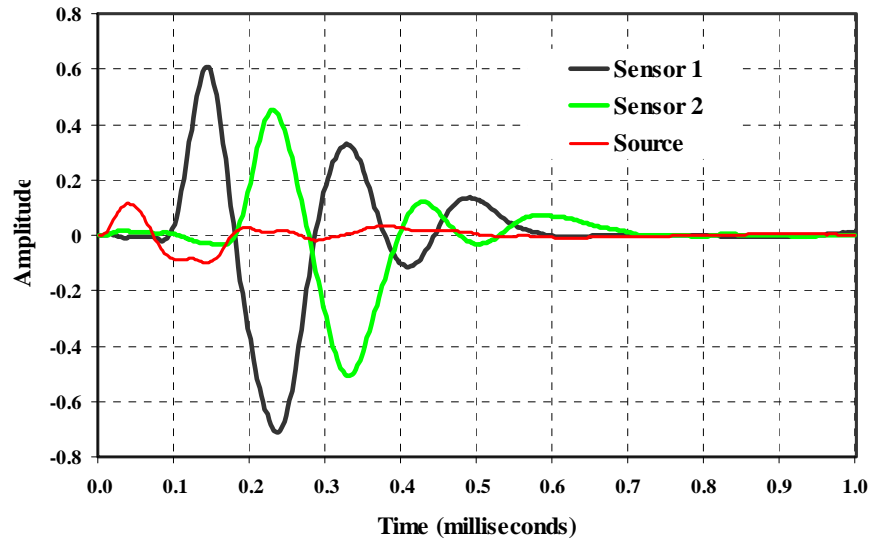
Figure A.24 – Typical Records from PSPA

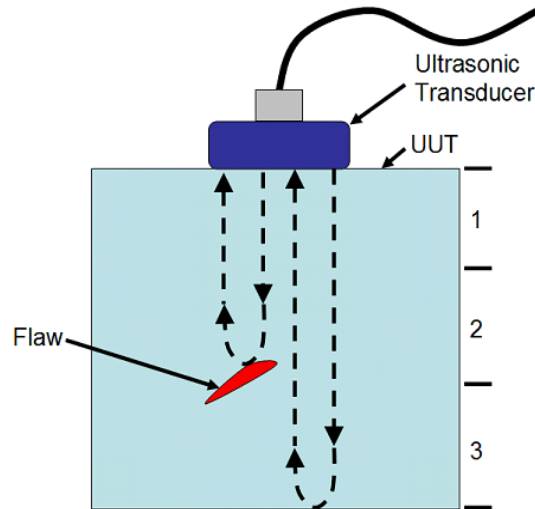
Figure A.25 – Delamination Detection by Ultrasonic Echo Method

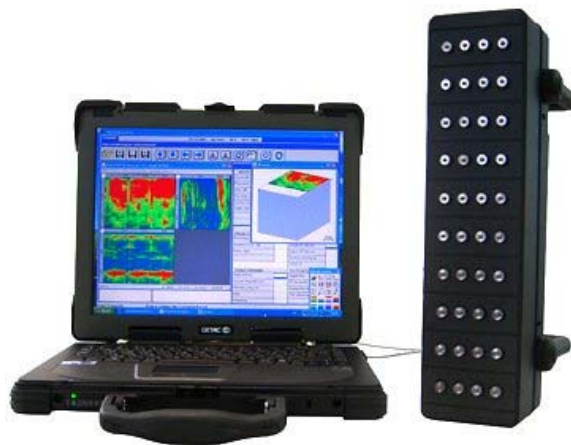
Figure A.26 – A1040 POLYGON Ultrasonic Device
