Evaluation of Nondestructive Technologies to Assess Presence and Extent of Delamination of Hot Mix Asphalt Airfield Pavements

Manuel Celaya

University of Texas at El Paso, mcelaya@utep.edu

Department of Civil Engineering

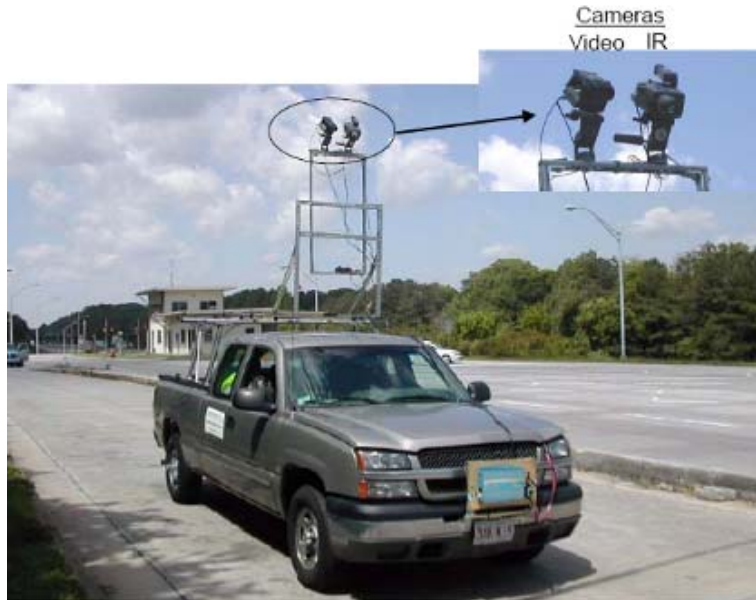
Figure A.28 – Infrared Survey Vehicle

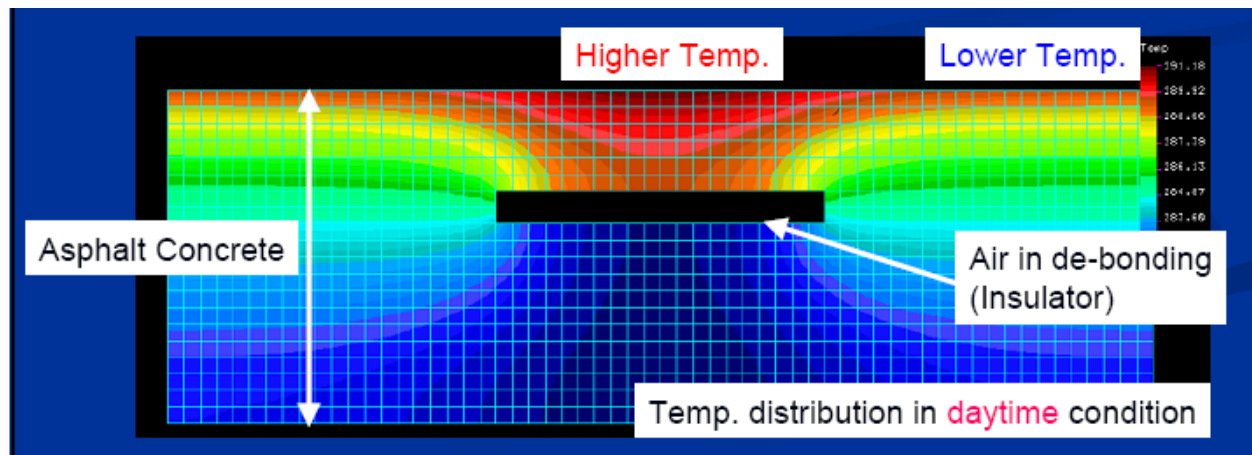
Figure A.29 – Example Image of Thermal Analysis (Daytime Condition) (from Tsubokawa et al., 2007)

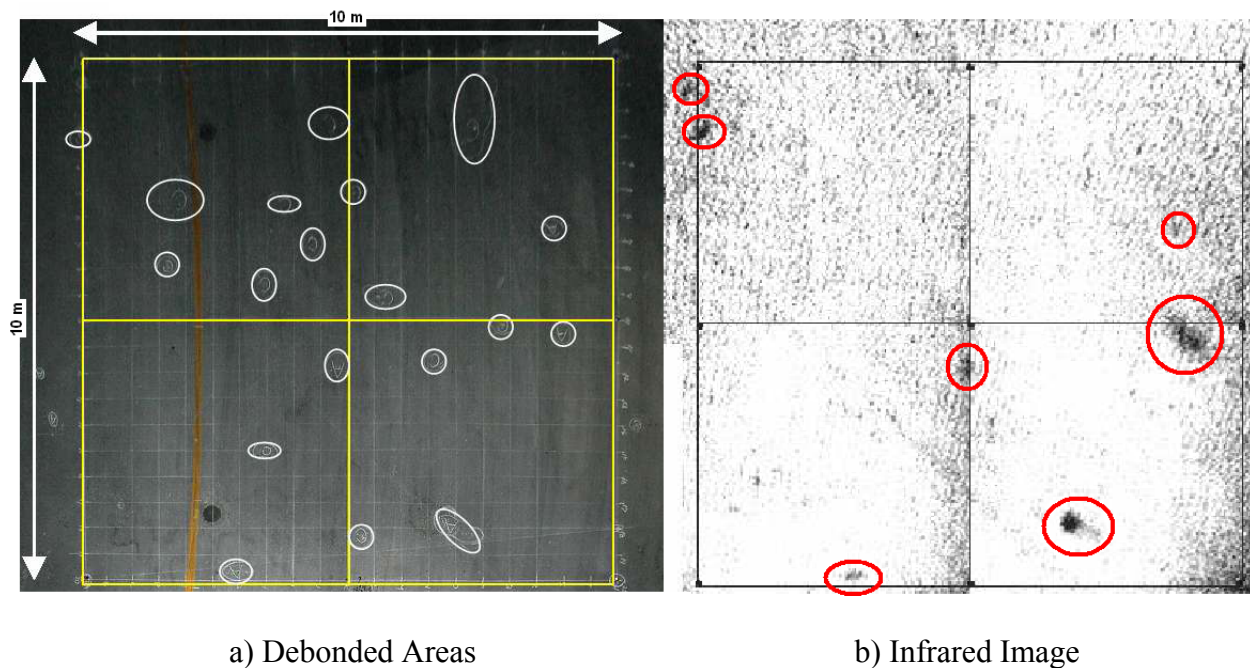
Figure A.31 – Low-temperature Areas Generally Match the Debonded Areas Found by IE.
(Tsubokawa et al., 2007)

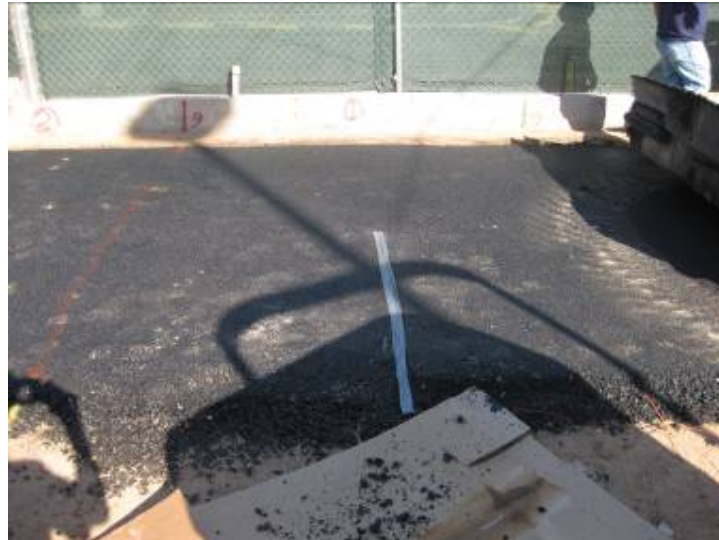
Figure C.7 – Installation of Thermocouple on Asphalt Base
