LOW IMPACT DEVELOPMENT (LID) STRUCTURES FOR GROUNDWATER MANAGEMENT AND
WATERSHED PROTECTION IN THE AMRC10 WATERSHED, EL PASO TEXAS

Department of Civil Engineering

THESIS

December 2010

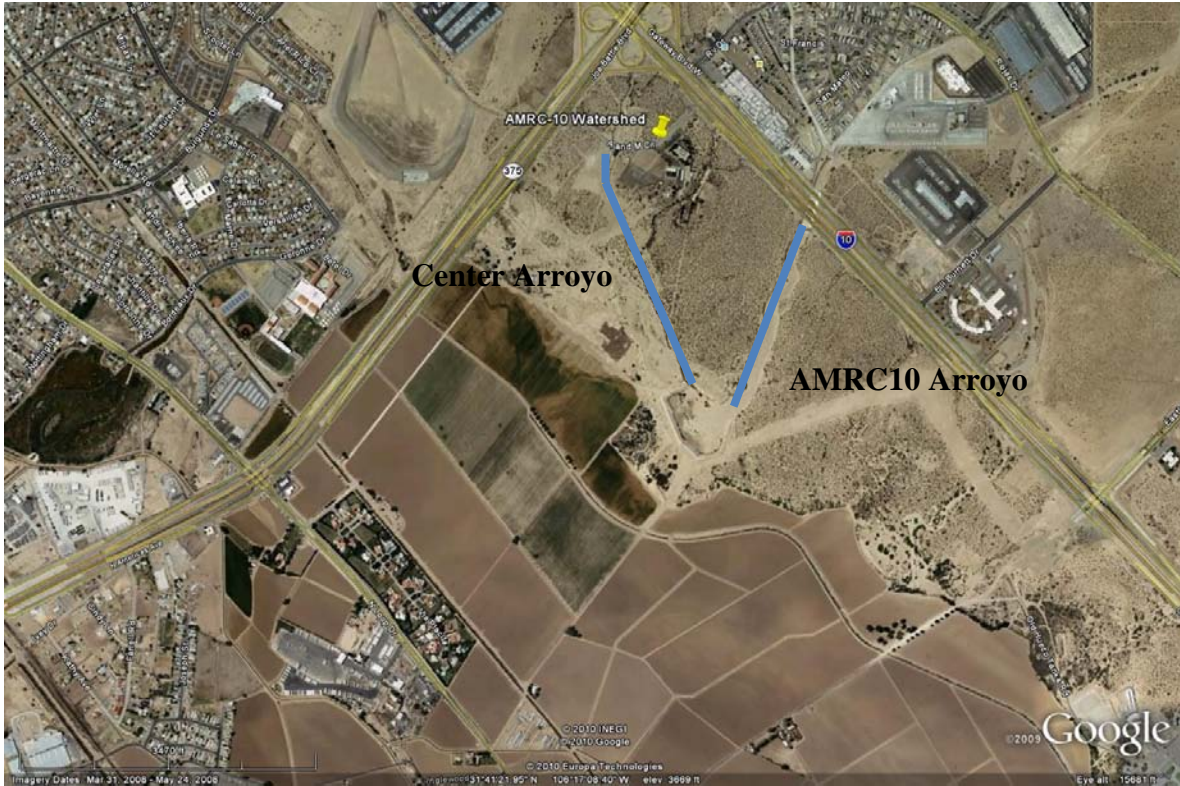
Fig. 5: Location of Center and AMRC10 Arroyos

The arroyos conveying the runoff are designed unlined and with very shallow slopes and wide channels to keep flows shallow. Slotted check dams are included along the arroyos to increase storage, slow flows and reduce erosion. The performance of these channels and check dams were tested extensively in HEC-HMS and in scale models. Stabilization of the side slopes of these channels is achieved by the use of native desert climate trees such as Desert Willow and Mesquite, which provide significant shade and flower very nicely in the spring. Another potential for slope stabilization is the use of cellular confinement mats that drastically increase soil shear strength and allow for intricate deep root structures in the plants used for landscaping. Further testing of the local soil shear strength would be needed to determine the expected reliability of slope stability. For purposes of design, the angle of repose and typical shear strength of dense compacted sand was used. This allowed for assessment of the effects of flows for various storms in the designed unlined channels. The location of the channels is shown in Fig. 5.

Center channel width is 40 ft. It holds 14 check dams evenly spaced along its length. The slope of the channel is 0.01 ft/ft . The channel is 2958 ft long. AMRC10 channel width is 70 ft. It holds 27 check dams evenly spaced along its length. The slope of the channel is 0.024 ft/ft . The channel is 2742 ft long. The existing physical conditions were maintained as much as possible in the design so as to preserve natural slope and flow direction. This will prevent erosion from flow direction changes caused by development. It is a necessary feature of unlined channel design (Temple, D.M., et al, 2003).

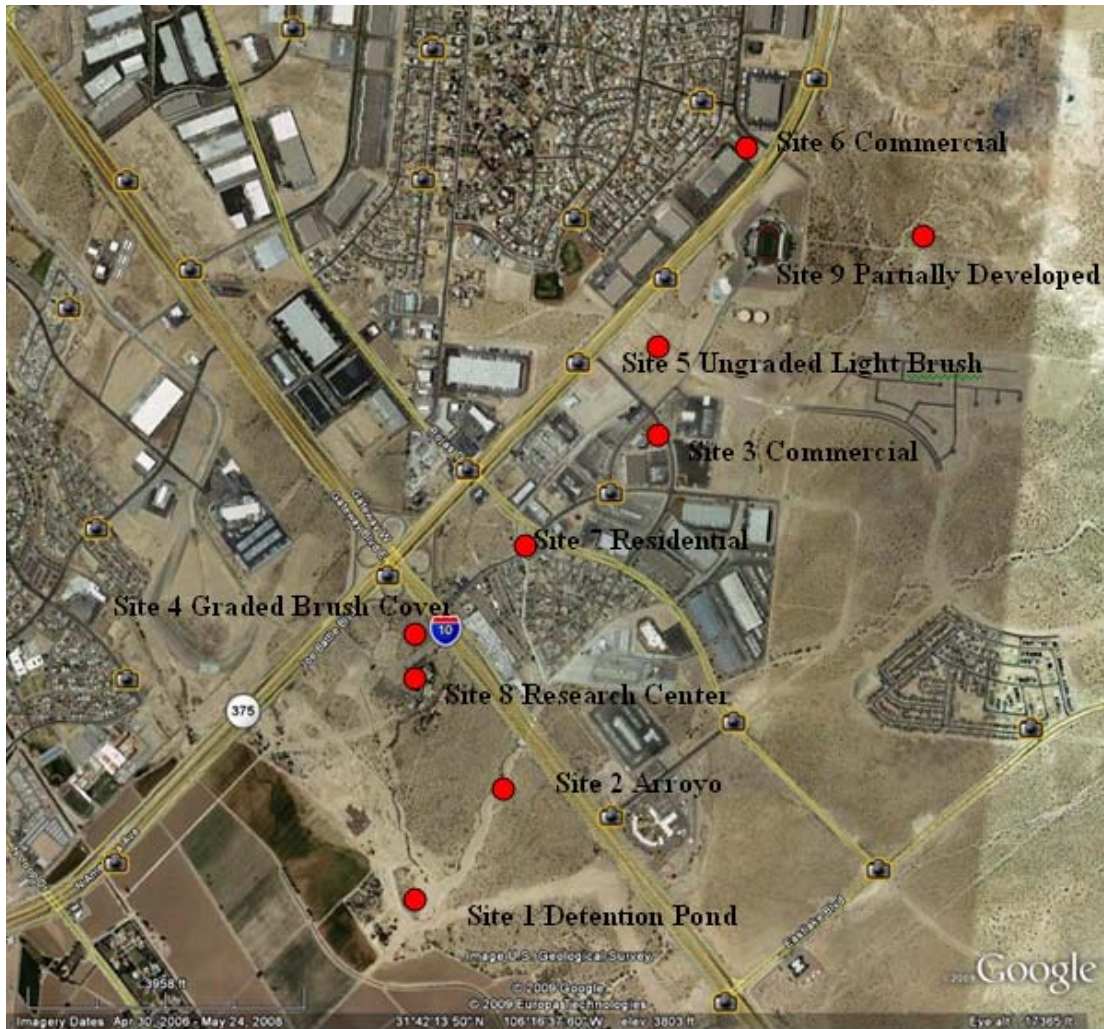
Fig. 11: Test site map

Nine sites within the AMRC-10 watershed were used to run Constant Head Dual Ring Infiltration Tests and to collect soil samples for conducting Constant Head Permeability Tests in the lab and Sieve Tests. Detailed tables and figures on the results of these tests are included in the appendix section. Fig. 11 shows the locations of each of the test sites.

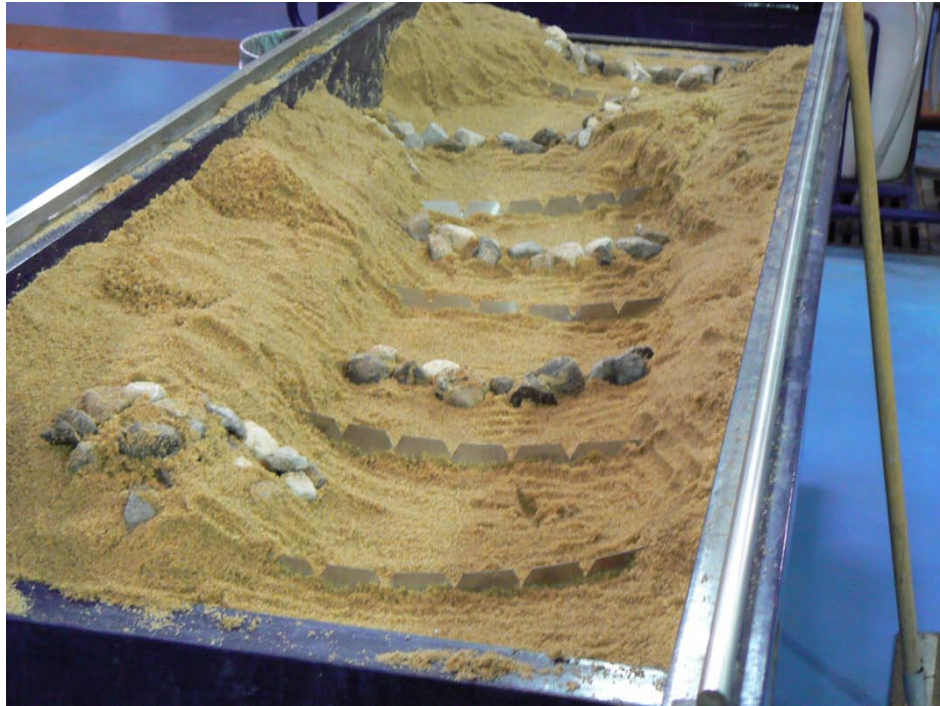
Fig. 12: Scale Model of Center Channel for Testing

In the scale simulation test a river flow simulation machine was used to construct a scale model of a stretch of the Center Channel to assess the effects of real flowing water as would result from storm runoff on the strength, integrity and performance of the design. The model channel was constructed in sand as a 1:40 scale stretch with similarly scaled runoff detention structures. The check dams were constructed of sheet aluminum cut to exactly simulate the designed check dams at a 1:40 scale. Also tested were check dams constructed of what would be large boulders cemented into the channel bed, at scale. The concept is that such an approach with natural building materials would be much more aesthetically pleasing and preferable from a developer and buyer point of view. It was desired to see how such structures would perform under the same loading as the aluminum scale check dam models.

The machine holding the constructed scale model channel and check dams is shown in Fig. 12. Fig. 13 is a close-up of the check dam structures within the model. In Fig. 12 one can see clearly the scale height and open flow spaces of the boulder check dam and the scale height and slotted openings in the standard check dam.

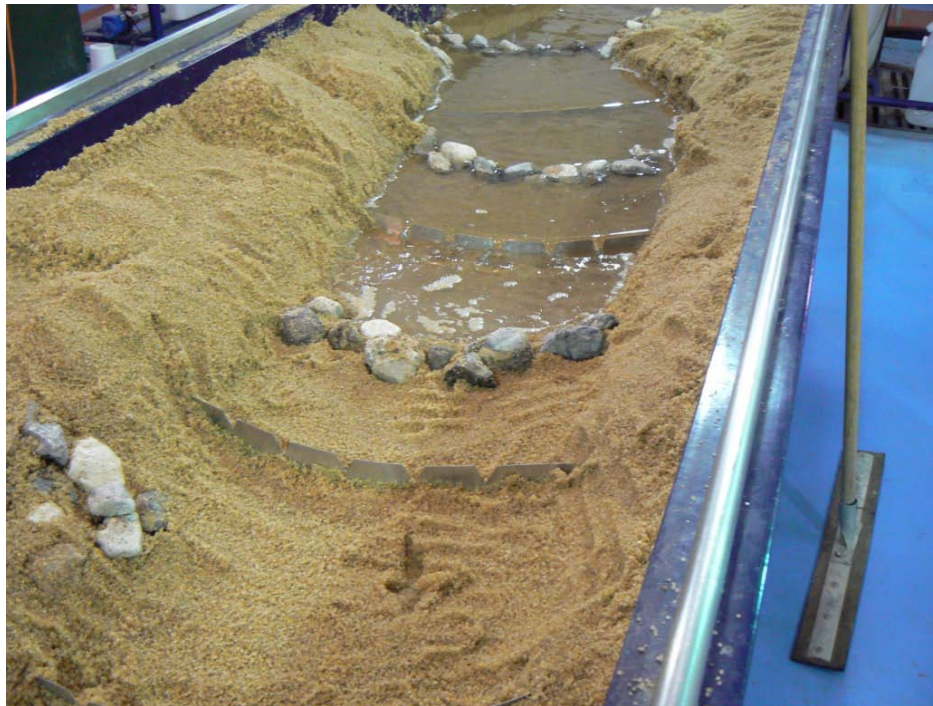
Fig. 14: Scale Model Check Dam Performance 10 Year

Fig. 14 and Fig. 15 show water flowing through the model channel to a depth concurrent with computer modeled 10 year storm. You can see clearly the retention and flow velocity reduction

caused by the check dams. It can also be seen in Fig. 15 that the flow is directed more toward the center of the channel by the curvature of the check dams. During the test it was seen that the slots in the check dams will create significant erosion just beneath them and that this was be guarded against. Gabions placed just beneath the slots are suggested. In the bolder check dams it was seen that flow in between the gaps will cause significant erosion as well. It will be necessary to cement them in place with adequate footing and to place gabions directly beneath the boulders to prevent erosion there. Flowing dye through the system showed localized flow speed increases through the slots, between the boulders and in flow over the check dams. This localized increased flow speed is what caused increased erosion around the check dams and cannot easily be mitigated outside of reinforcing against the potential erosion.

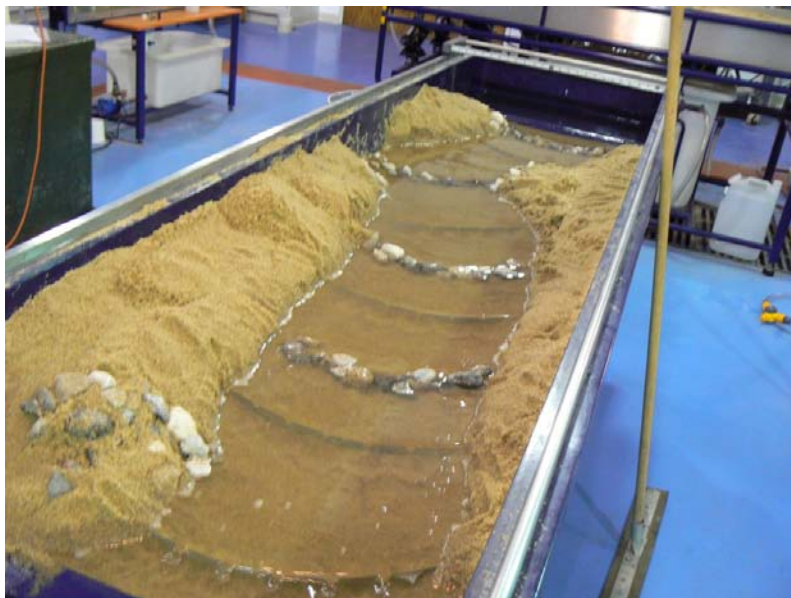
Fig. 16: Scale Model 10 Year Steady Flow

Fig. 16 shows the system at full flow during 10 year depth simulation. Little significant erosion was observed except for within the boulder check dams and just below the standard check dams. It can be reasonably surmised that the system will hold up well to this size of a storm.

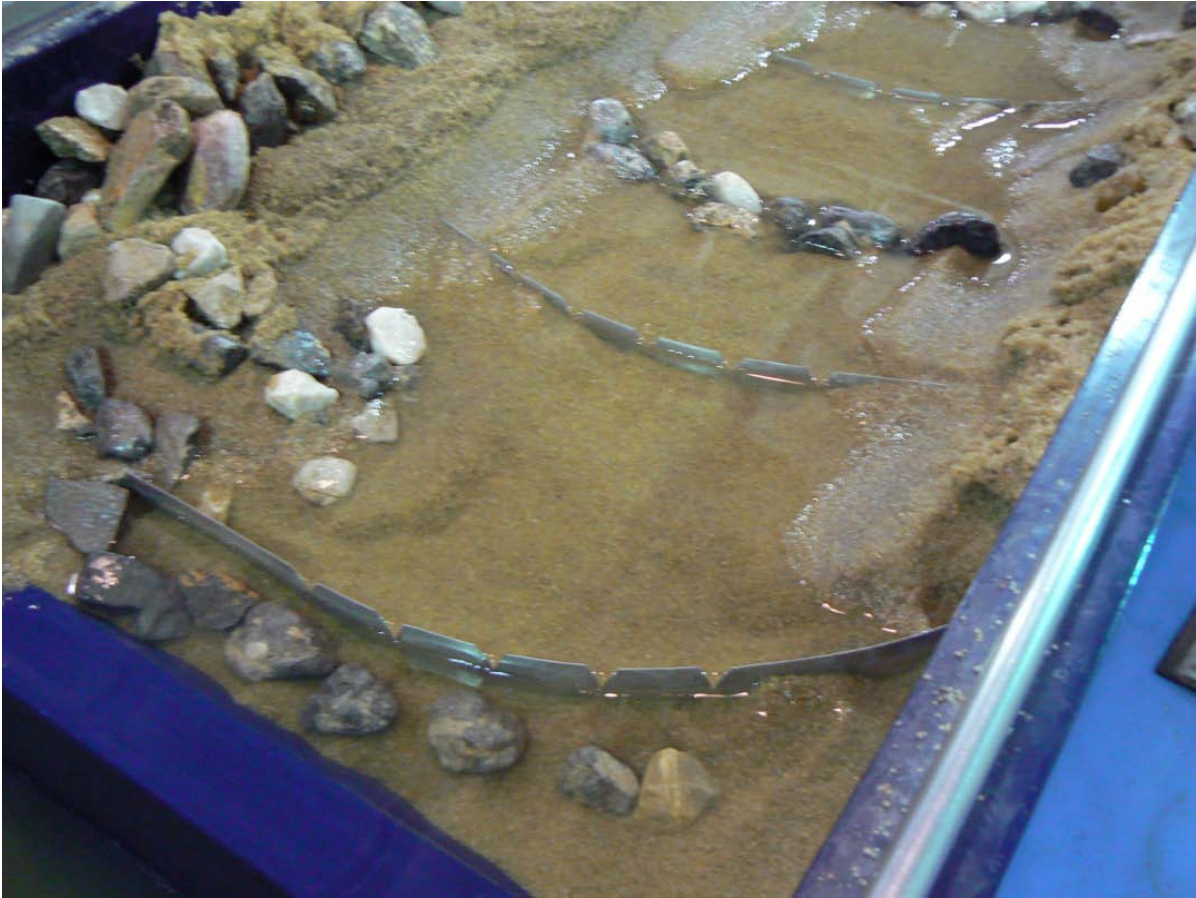
Fig. 18: Scale Model After 100 Year

Fig. 18 shows the aftermath of 100 year flow simulation. In particular, what is shown in the figure is the most damaged portion of the model. During a 100 year storm significant erosion was seen along all channel sides and below each check dam, especially the final dam. It was demonstrated that each dam significantly backed up flows behind it, decreasing flow speeds for the checks behind it and decreasing the erosion they experienced. As the final check, the last

Slope degradation was also witnessed at higher flows. As the sand used in the machine is relatively comparable to the sand that will be available on site it becomes apparent that some form of slope stabilization will be needed if it is intended that such large scale erosion and destruction in the system is to be avoided. Fortunately, the design is specified such that a different, stronger soil composition is to be used on the side slopes and other reinforcement methods are to be applied as well.

The overall results of the scale model test have to do with the expected maintenance of the channels. As one would expect needed maintenance increases with the size of the storm. Since most upkeep will revolve around managing sedimentation and looking at the damaged caused in the testing one can make the assumption that the typical annual storm will require little to no maintenance. However the larger storms will cause a small degree of damage or sediment deposition. For 100 year storms or higher it can be expected that some slope reconstruction may be necessary. As it is impossible to prevent all cases of erosion, even under very low flows, some sediment management will be needed on an annual basis, but this value can be expected to be fairly low and perhaps even negligible.

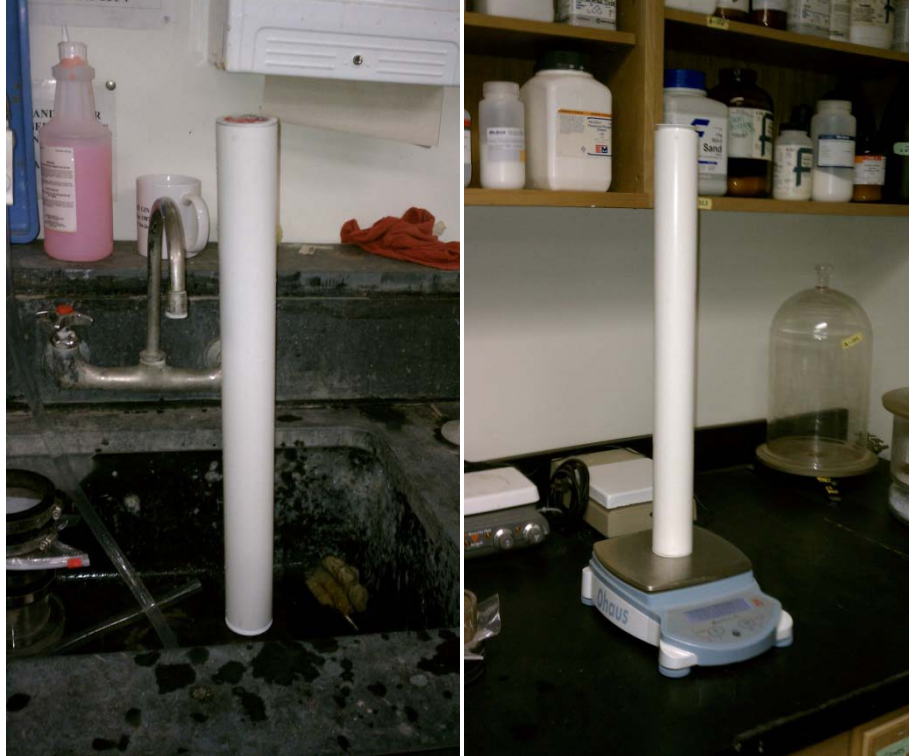
Fig. 19: Specific Yield Test

By the specific yield test it was determined that the specific yield for the soil at site 2 is 18%. It should be considered that the specific yield for different grain sizes in the event of soil engineering or placement in different locations will see some fluctuation and further calculations should be made in these cases. Fig. 19 shows the test during draining and weighing.
