A Tool to Improve and Preserve Flexible Pavement at Intersections

THESIS

Department of Civil Engineering
THE UNIVERSITY OF TEXAS AT EL PASO

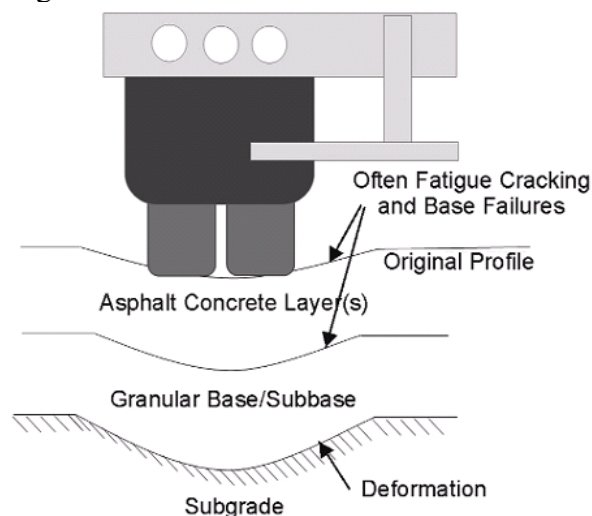
Figure 2.1: Structural Rutting on Asphalt Pavements (Federation of Canadian Municipalities and Canadian National Research Council, 2003).

A cross sectional diagram of structural rutting is shown in Figure 2.1. Structural rutting can be visually identified rather easily. Two main characteristics distinguish structural rutting from other modes of rutting. Structural ruts are wide and do not have humps on their sides as compared with instability rutting described later.

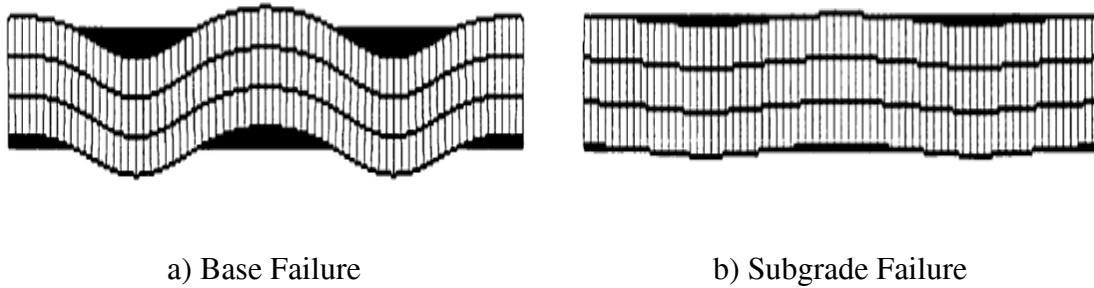
Figure 2.2: Surface Deformation Due to Base and Subgrade Failure. (Fang, 2001)

The surface deformation is dependent on which of the layers is failing to support the load. The visual characteristics will be different when the subgrade is failing as compared to the base. Figure 2.2 illustrates and compares the difference between the surface deformation profiles due to base and subgrade failures. When the base is failing, a small hump will be visible at the surface in the middle of the two wheel paths, while the deformation due to subgrade failure will have no humps at all with a wider wheel path depression (Fang, 2001).

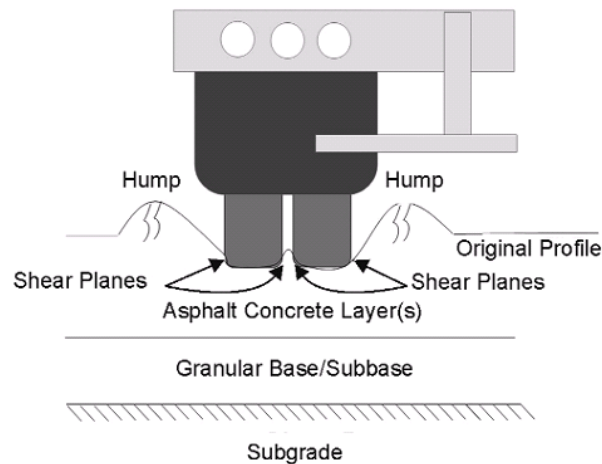
Figure 2.3: Instability or Plastic Flow on Asphalt Pavements (Federation of Canadian Municipalities and Canadian National Research Council 2003).

Instability rutting or plastic flow is the type of rutting that is due to inadequate HMA mix design rather than the structural design. Epps (1990) reported that the shear deformation, rather than densification, is the primary rutting mechanism in HMA surface mixtures when the supporting layers are reasonably stiff. This kind of rutting is visually recognized by the humps formed on the sides of the rut as shown in Figure 2.3.

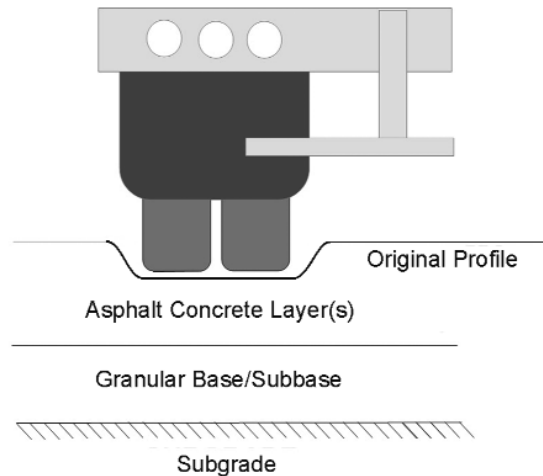
Figure 2.4: Wear Rutting on Asphalt Pavements (Federation of Canadian Municipalities and Canadian National Research Council 2003).

Wear rutting is the consolidation in the wheel paths of the HMA layer due to insufficient compaction effort which is usually reflected in not achieving the target density. Consequently additional compaction to the asphalt layer is generated by vehicle loading without any base/subbase yielding or the formation of HMA humps as seen in Figure 2.4. According to CDOT (2009) the following list of factors contributes to this type of rutting:

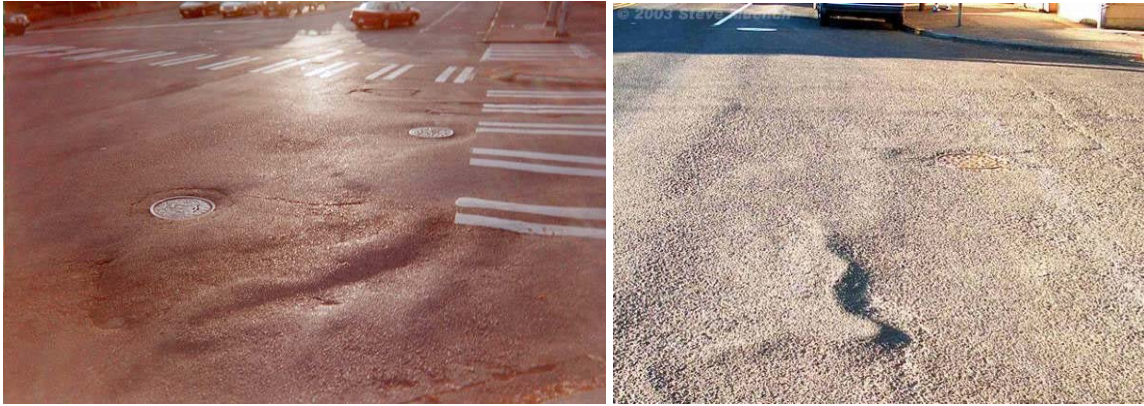
Figure 2.5: Shoving on Asphalt Pavements.

Shoving of an asphalt concrete pavement is defined as the longitudinal surface displacement of the HMA. Shoving is usually caused by an unstable asphalt layer that is not strong enough to resist horizontal stresses. Acceleration and deceleration of vehicles represent a continuous load in the same direction that generally causes shoving as shown in Figure 2.5. Excess binder in the mix, mistakes in the gradation, and erroneous temperature during compaction are parameters that cause a weak asphalt mixture. These potential problems along with poor bonding between the HMA and the underlying layer decrease the resistance to horizontal stresses leading to shoving. Shoving can be easily identified by distortion of pavement markings, and vertical displacements (dips and bumps). In many cases shoving is manifested

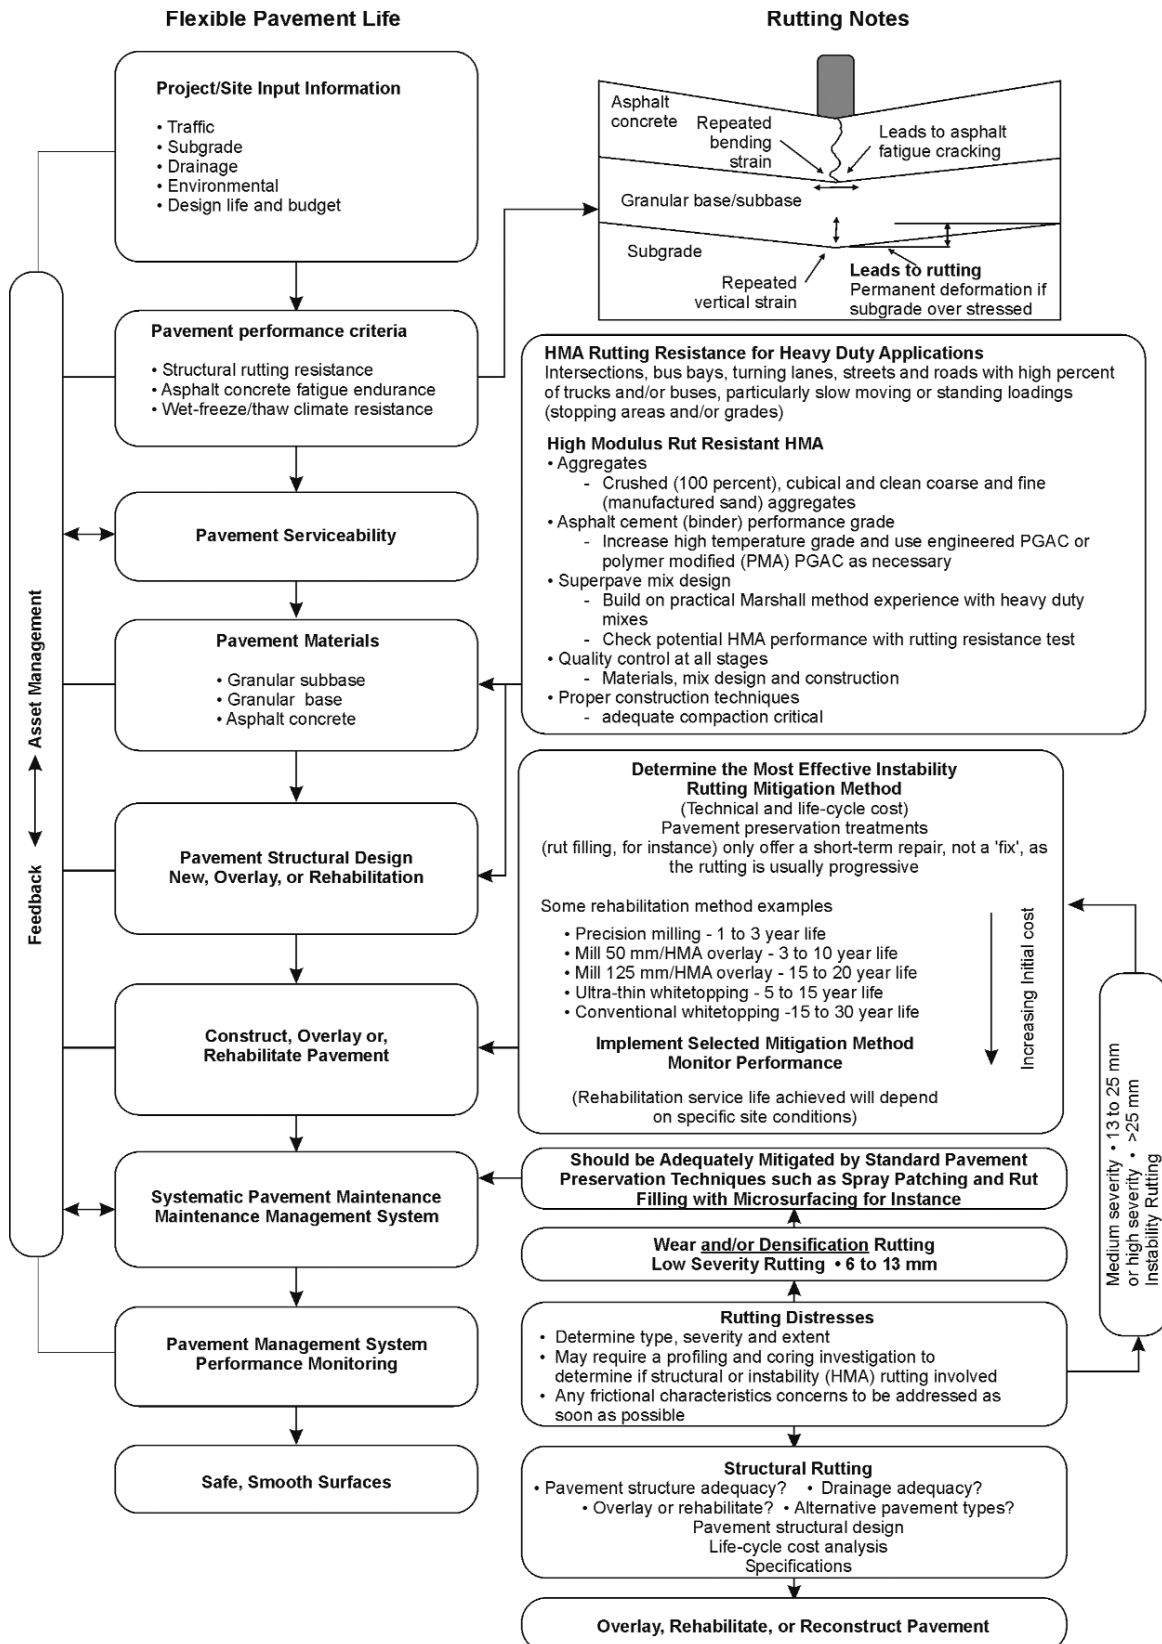
Figure 2.7: Flowchart of Activities for Mitigating Intersection Rutting.

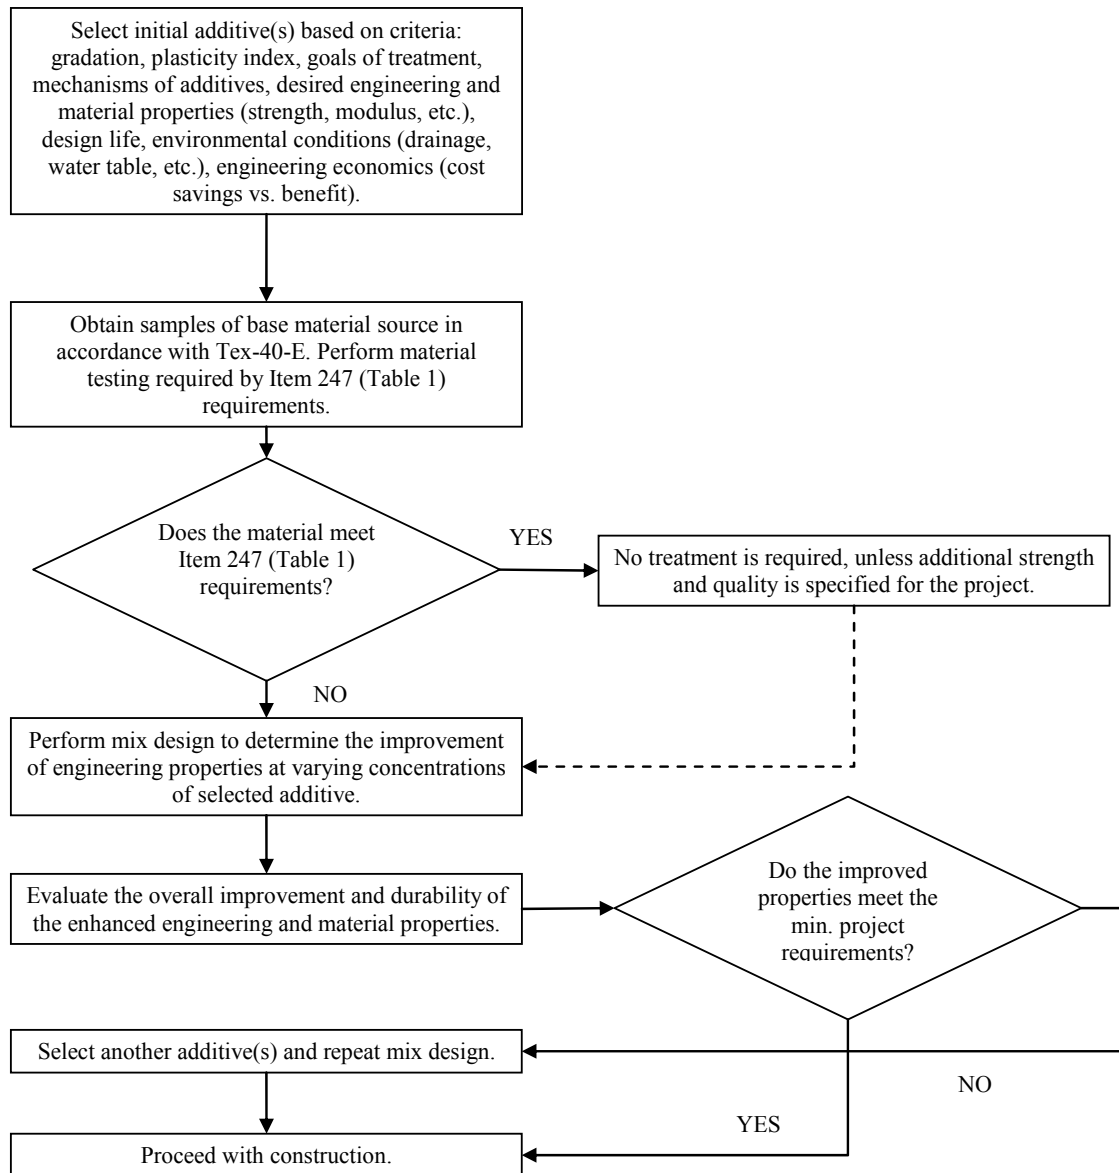
Figure 2.8: TxDOT Flowchart for Base Treatment (TxDOT, 2005a).

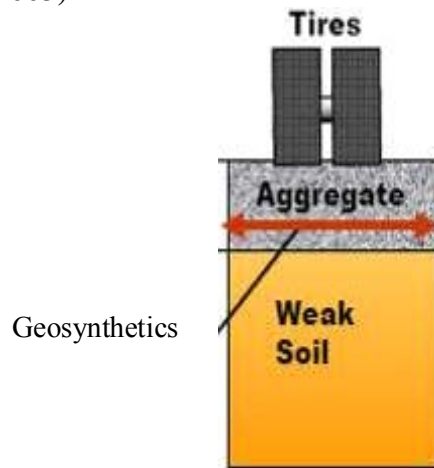
Figure 2.9: Improving Pavement by Using Geosynthetics (from Hopkins et al., 2005).

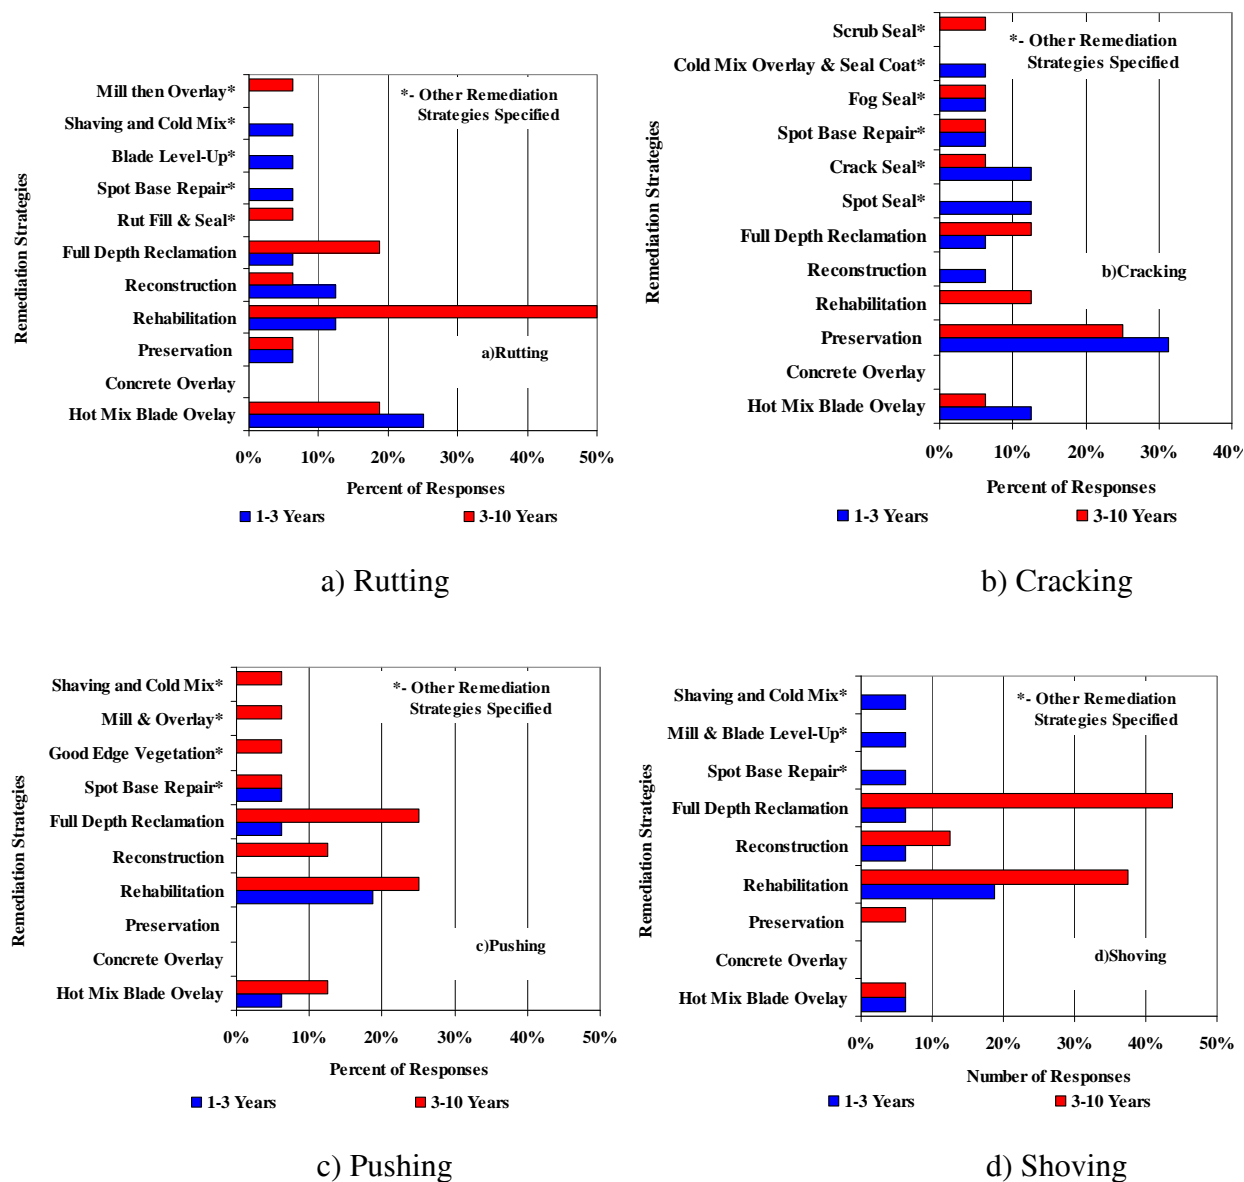
Figure 3.8: Typical Performance Period for Selected Remediation Strategies.

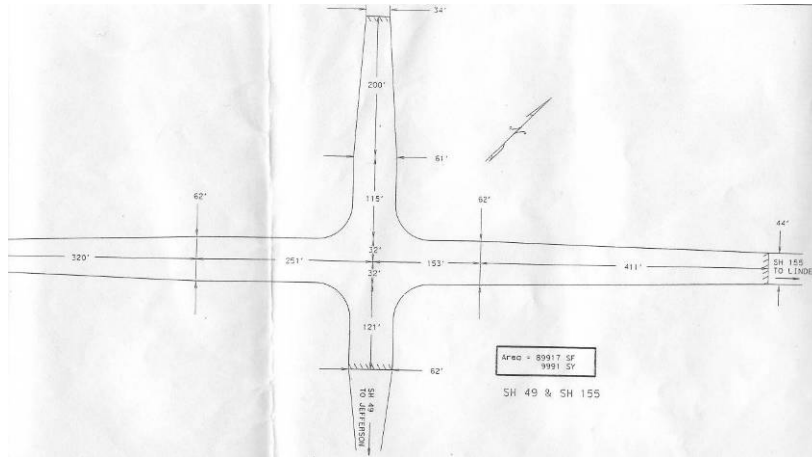
Figure 4.3: Geometry Design of SH 155 and SH 49 Intersection

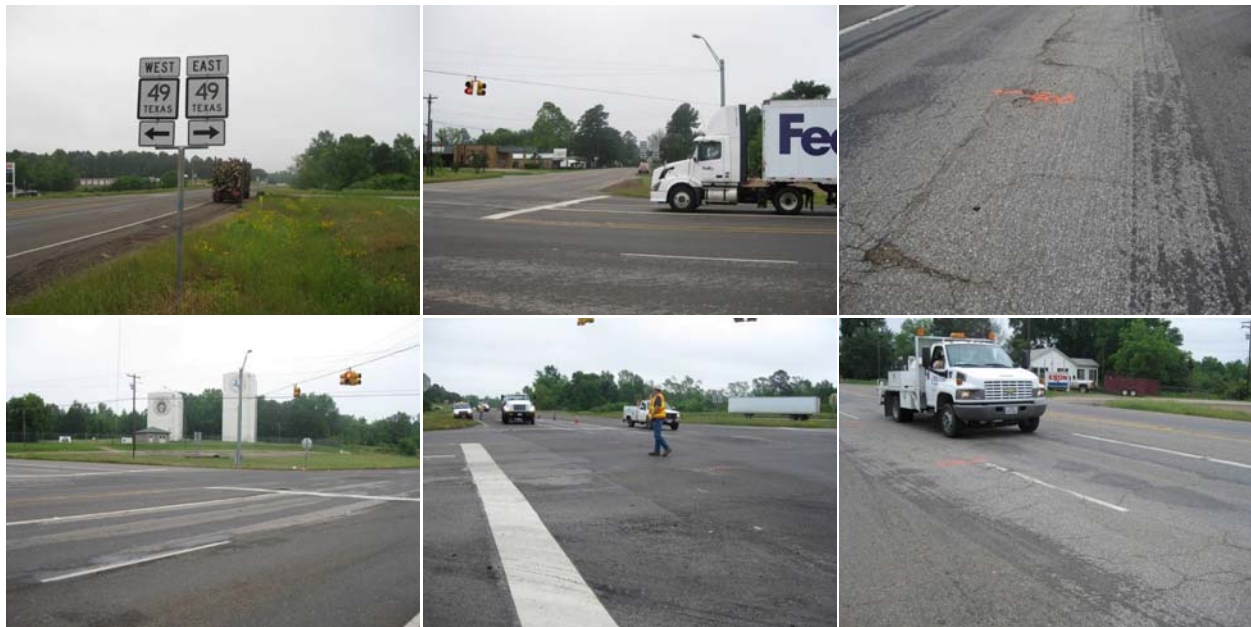
Figure 4.4: Views of the Conditions of SH 155 and SH 49 Intersection.

The investigation concentrated on the intersection portion of the roadway. With the assistance from the District personnel, 500 ft sections of the road on either side of the intersections were closed off to traffic. A thorough inspection was carried out on all legs of the intersection. The primary distress observed were rutting of the surface layer. The intersection, at the southbound approach on SH 155 was rutting. No humps could be seen on the sides of the ruts, so it can be assumed that it might not be a mix problem, but maybe structural rutting. Figure 4.4 shows different views of the intersections along SH 155 with visible distresses. Loss of aggregate was evident on the rutted areas as well as some bleeding and flushing between wheel paths.

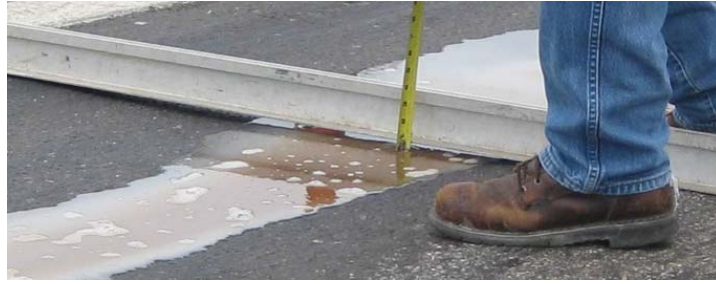
Figure 4.5: Rut Depth Measurement on SH 155.

As shown in Figure 4.5, the maximum rut depth was 0.5 in. on SH 155. This distress can be classified as Moderate Severity Structural Rutting. Another typical intersection distress observed was fatigue cracking with low to high levels of severity, increasing in severity as one approached the intersection. Other distresses included transversal and block cracking specially after crossing the intersection.

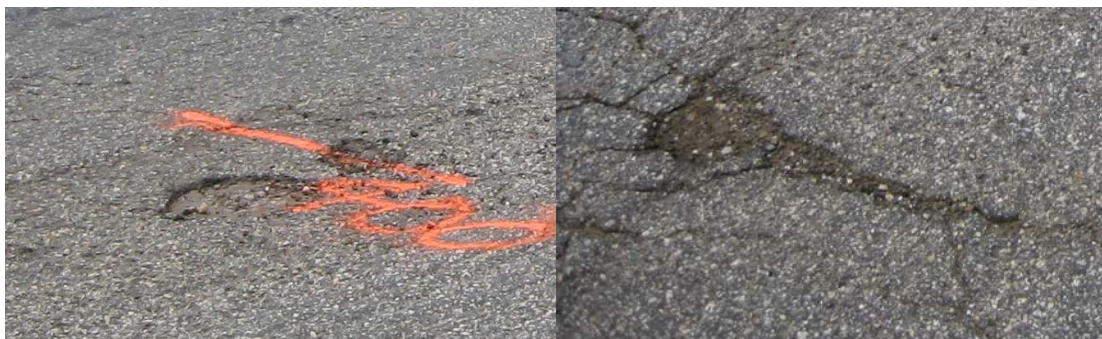
Figure 4.6: Cracking Resulting in Potholes on SH49.

The SH 49 inspection started 500 ft west of the intersection and extended 500 ft east of the intersection. The first 300 ft consisted of a different asphalt mix than the mix closer to the intersection. On the west side, close to the intersection on the eastbound SH 49, a section of approximately 42 yards in length had been milled so no rut profile could be taken at this point. Based on the cores, several lifts were added with time to this intersection. Cores were not extracted from the milled section. It is suspected that the section was heavily rutted and the maintenance crew had overlaid that portion. In addition, transversal cracking could be seen all the way along the 500 ft approach while severe block cracking was seen at the intersection. In some area, the severe block cracking contributed to generation of secondary distresses as depicted in Figure 4.6.

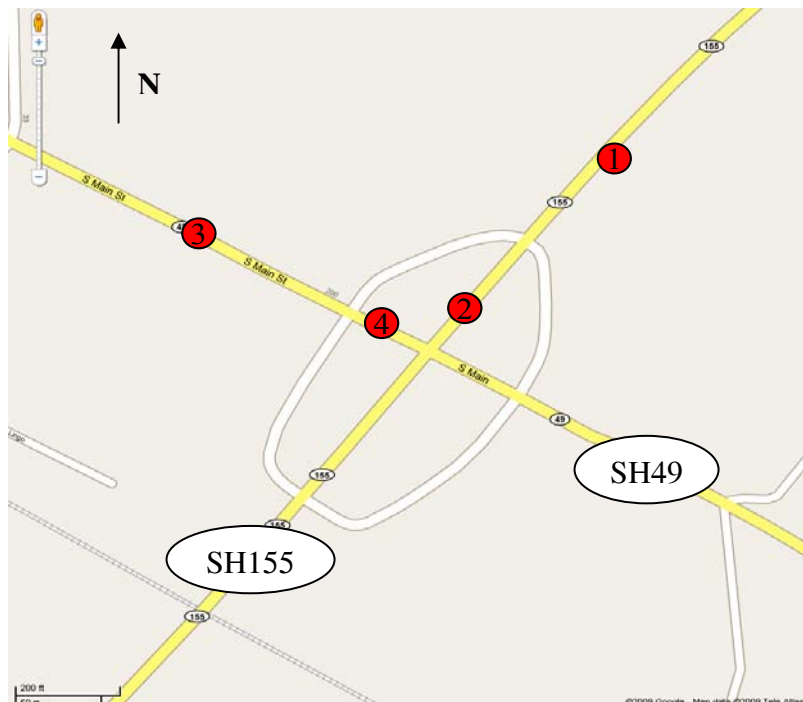
Figure 4.7: Location of the Core Extractions.

For coring purposes, four strategic locations were selected, 2 locations per road, with one location 500 ft away from the intersection, and the other location within 100 ft away from the intersection, all in the approaching lanes. Three cores were extracted from each location, one per wheel-path and one in the middle of the wheel-paths, making it a total of 12 core extractions as marked in Figure 4.7.

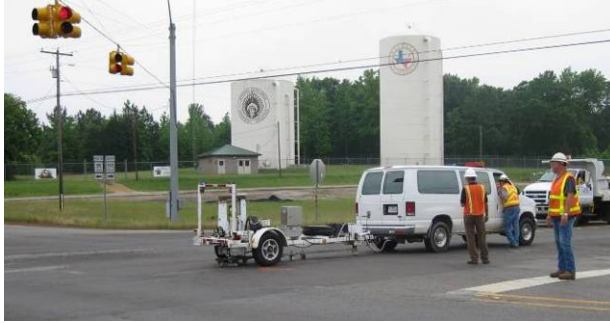
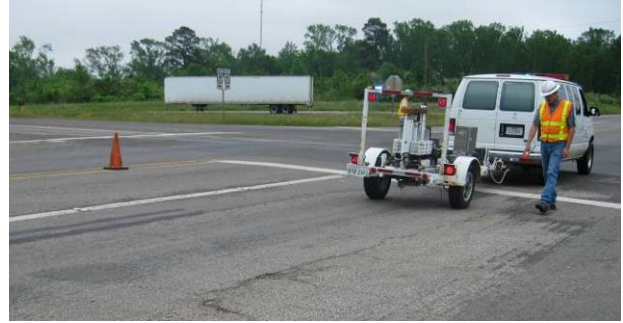
a) SH155

b) SH49

Deflection data was collected using a Falling Weight Deflectometer (FWD). Both roads intersecting were evaluated using this method. Fwd data along SH 155 were collected 500 ft north of the intersection to 500 ft past the intersection. Data was collected at 25 ft intervals except in the vicinity of the intersection where data was collected more densely (see Figure 4.8a). The same was performed for SH 49, starting 500 ft west of the intersection (see Figure 4.8b). An air-launched Ground Penetrating Radar (GPR) was also used along these two roads.

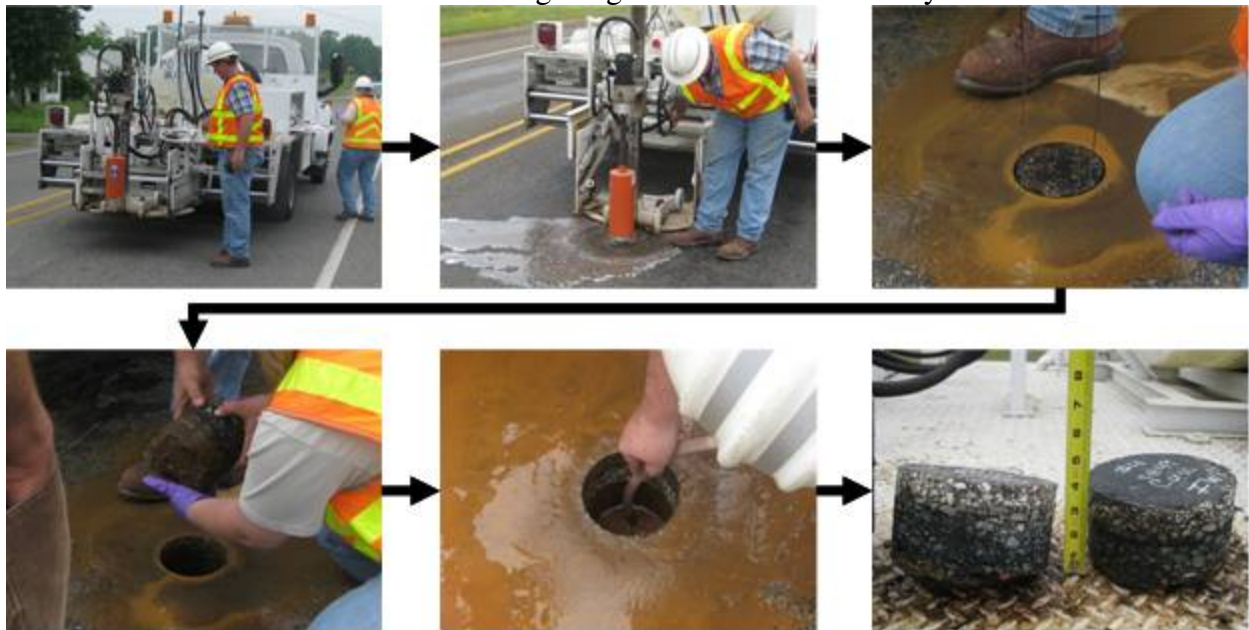
Figure 4.9: Coring Process Images.

Figure 4.9 shows the coring process and a sample of the cores that were extracted. Dimensions and weight of every core were measured, and the V-meter test was performed on each sample to calculate the modulus of the asphalt layer from different locations. The asphalt content of each core was determined using an ignition oven. Sieve analysis was carried out on

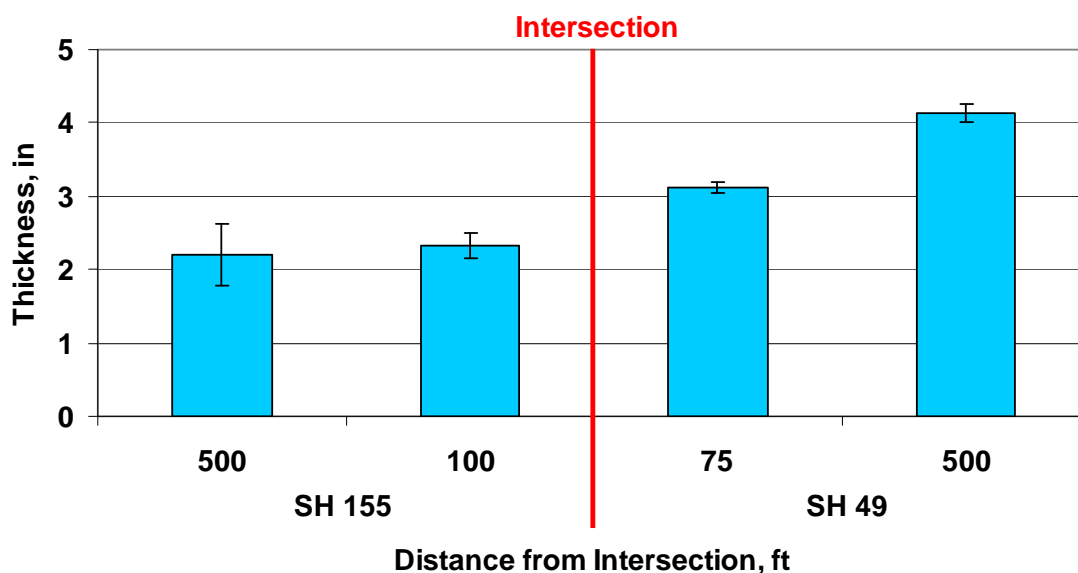
Figure 4.11: Core Average Thicknesses as Approaching the Intersection.

The average thickness of each set of cores is plotted in relation with the distance from the intersection in Figure 4.10. The error bar indicates low variability in the thickness of 3 set of cores, except for the first set of cores extracted 500 ft north from the intersection on SH 155. A decrease in thickness as approaching the intersection is evident along SH 49, while on SH 155 the asphalt layer thickness seems to remain constant. The surface layers of the two sets of cores from SH 49 were different. Severe stripping was observed in the cores away from the intersection along SH 155 that might have prompted maintenance.

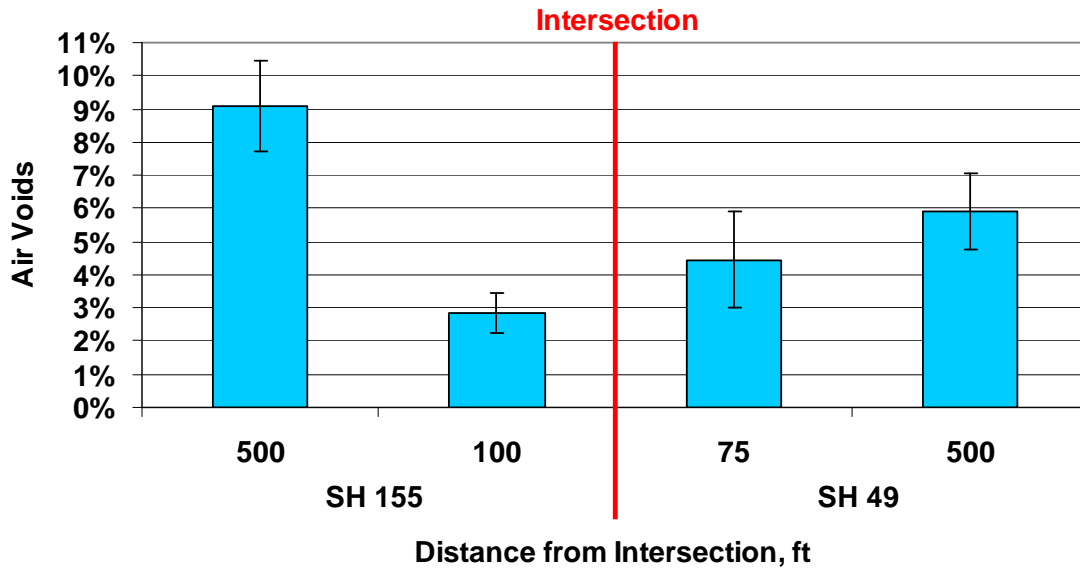
Figure 4.12: Core Average Air Voids as Approaching the Intersection.

Figure 4.12 illustrate the decrease in air voids as approaching the intersection, which might be a result of the over densification of the surface layer produced by the slow moving loads while approaching the intersection. The high values of air voids 500 ft away from the intersection on SH 155 are because of the stripping of the materials.

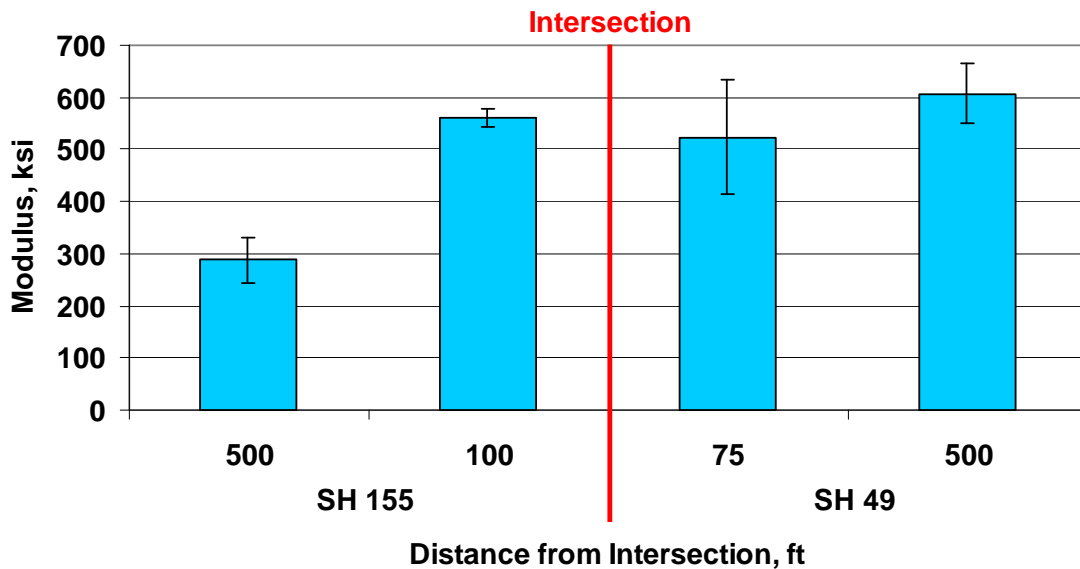
Figure 4.13: Core Average Design Modulus as Approaching the Intersection.

The modulus trends as approaching the intersection are the opposite of the air voids for both roads as seen on Figure 4.13. The modulus was measured on every core using the V-meter, since the SH155 outer wheel path core at 500 ft away was damaged it affected the modulus readings from the V-meter and thereby the trend.

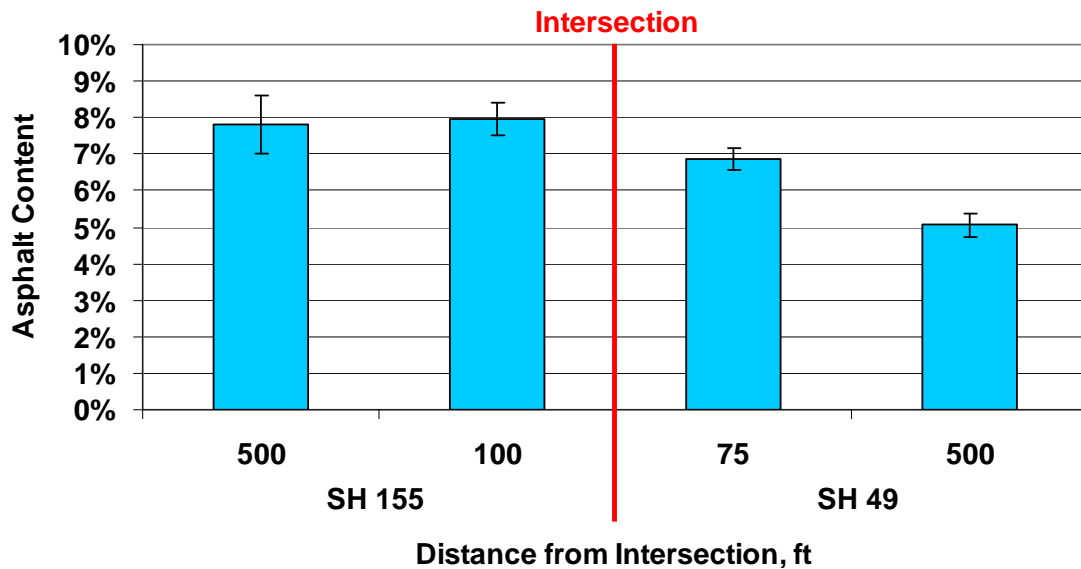
Figure 4.14: Core Asphalt Contents.

The variations in the asphalt contents of the cores are shown in Figure 4.14. Higher asphalt content close to the intersection may be a sign of aggregate loss caused either by aggregate segregation, and/or the high stresses under the breaking and turning of vehicles.

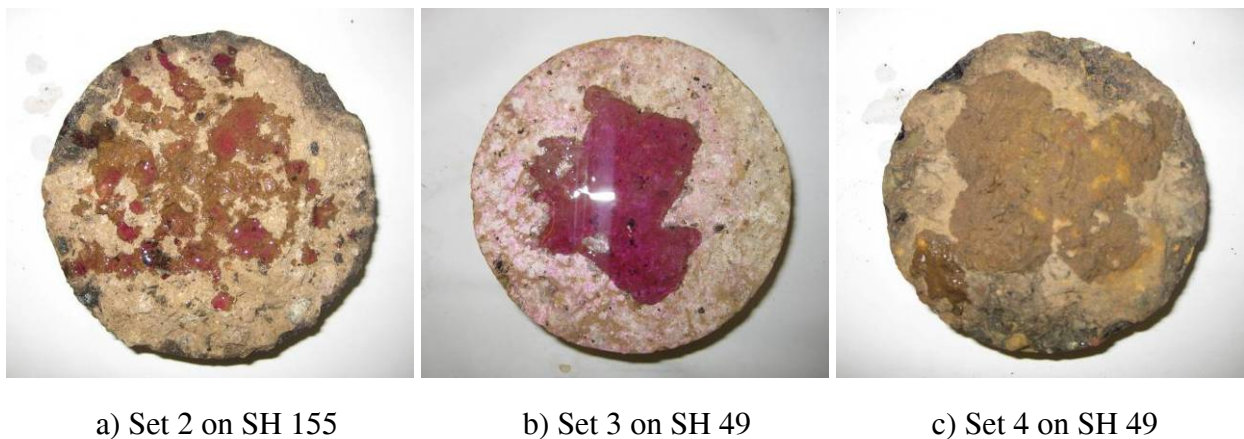
Figure 4.15: Phenolphthalein Test for Lime on Base Material

In order to verify the lime stabilization of the bases, Phenolphthalein was used. The reaction occurred just on the second and third sets of cores as seen on Figure 4.15, but no reaction occurred on the first or fourth set of cores. A complete base core could only be extracted from the third location. Higher lime content was perceived for the third location.

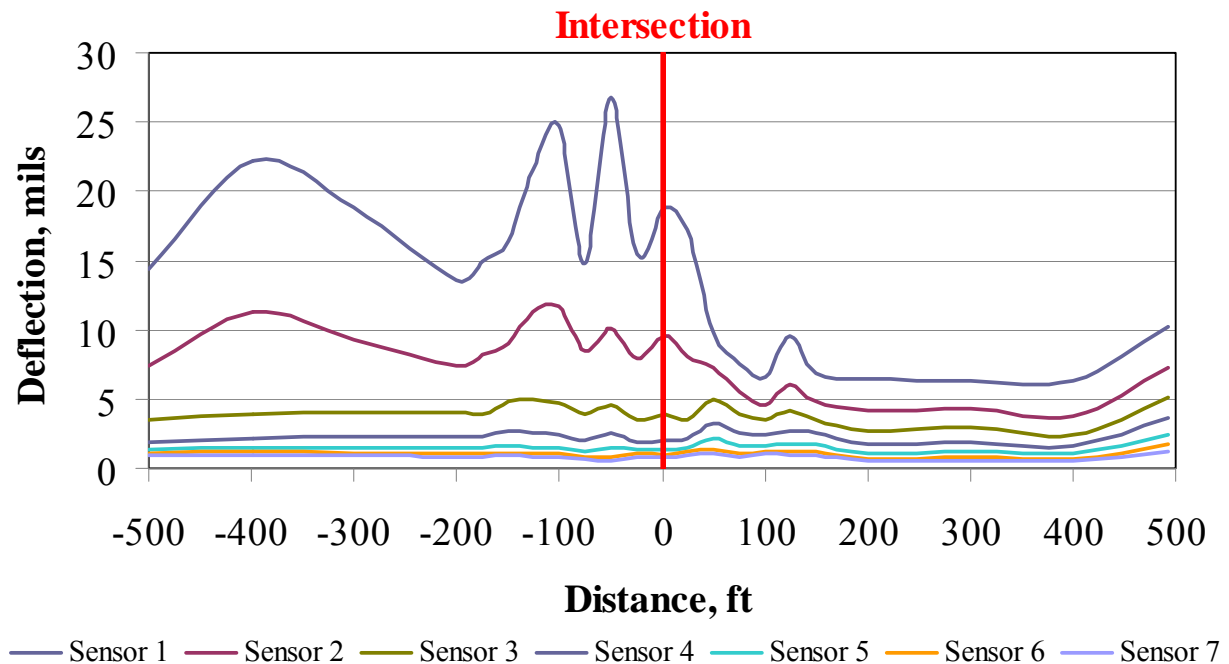
Figure 4.16: FWD Deflection Results on Southbound SH 155.

Figure 4.16 illustrates the deflection results obtained from the FWD along the SH 155 section. Deflection values from the first two sensors are greater close to the approach of the intersection, indicating lower stiffness of this section of the road. After passing the intersection deflection values decreased dramatically and remained fairly constant. The third and fourth sensors also detected a slight increase in deflection for a 150 ft section before the intersection, providing a clue that the source of the problem might come from the base layer. Last 3 sensors did not detect a significant deflection, thereby can be assumed that the source of the problem does not go deeper than the base layer.

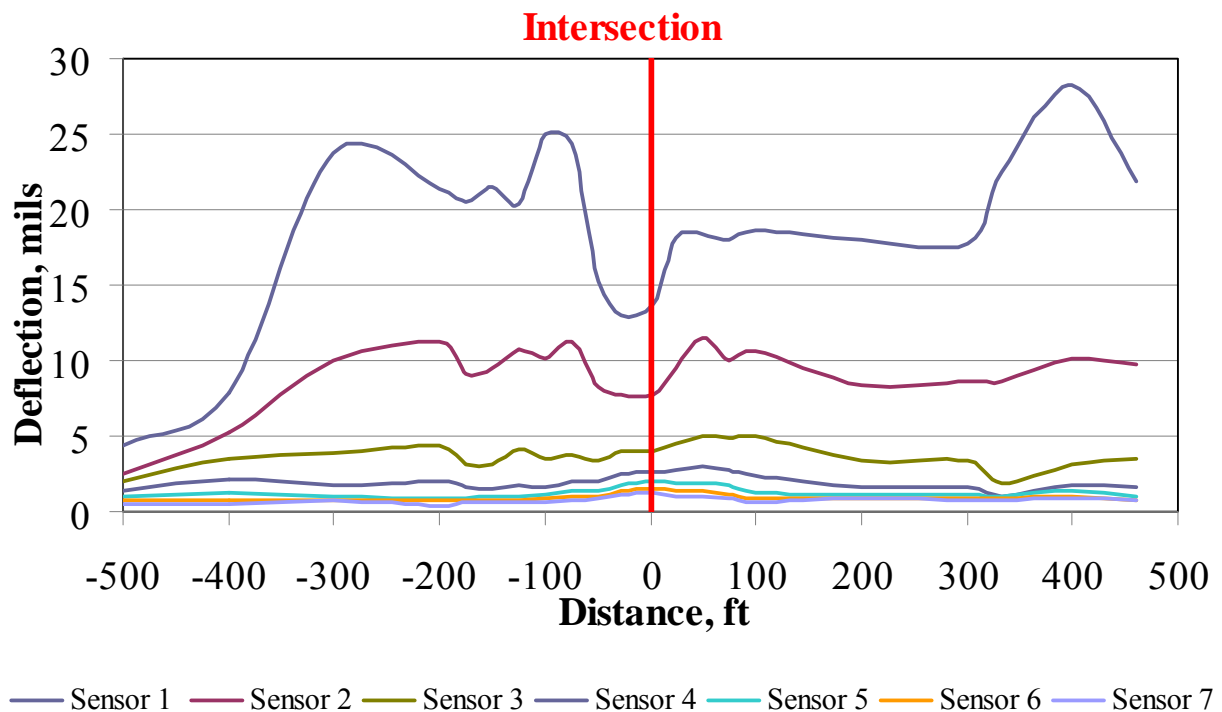
Figure 4.17: FWD Deflection Results on Eastbound SH 49.

increase again to a constant value for the next 250 ft, only a high point is seen 400 ft after the intersection. The structure is more susceptible to deflection along the 300 ft section before reaching the intersection. The third and fourth sensors also detected an increase in deflection as approaching the intersection and slight variations in deflection through the last 200 ft before the intersection. The higher deflection levels detected by the third and fourth sensors as approaching the intersection are consistent with the lack of stabilization on the fourth coring location (100 ft before the intersection). Although the soil tested from core location 4 (100 ft from intersection) did not showed evidence of lime, contrary to location 3 (500 ft from intersection), no permanent deformation could be seen at this place. The last three sensors did not detect a significant deflection; thereby one can assume that the source of the problem might be no deeper than the base.

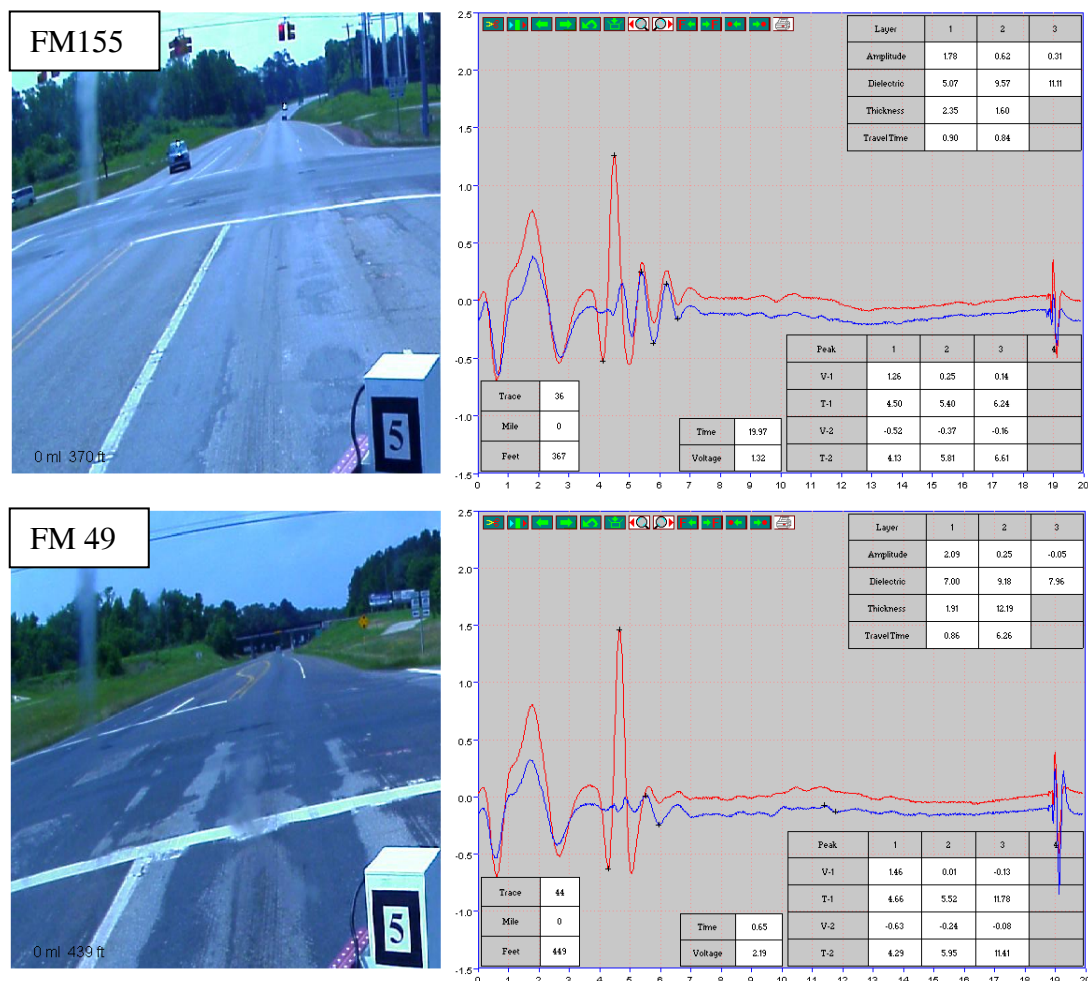
Figure 4.18- Sample of the GPR Data Close to the Intersection of FM155 and FM49.

The PAVECHECK software (Liu and Scullion, 2008), developed to merge the FWD and GPR data together with digital video images of surface condition was used. Figure 4.18 is a sample of the data collected on SH 155 and SH 49 as approaching the intersection.

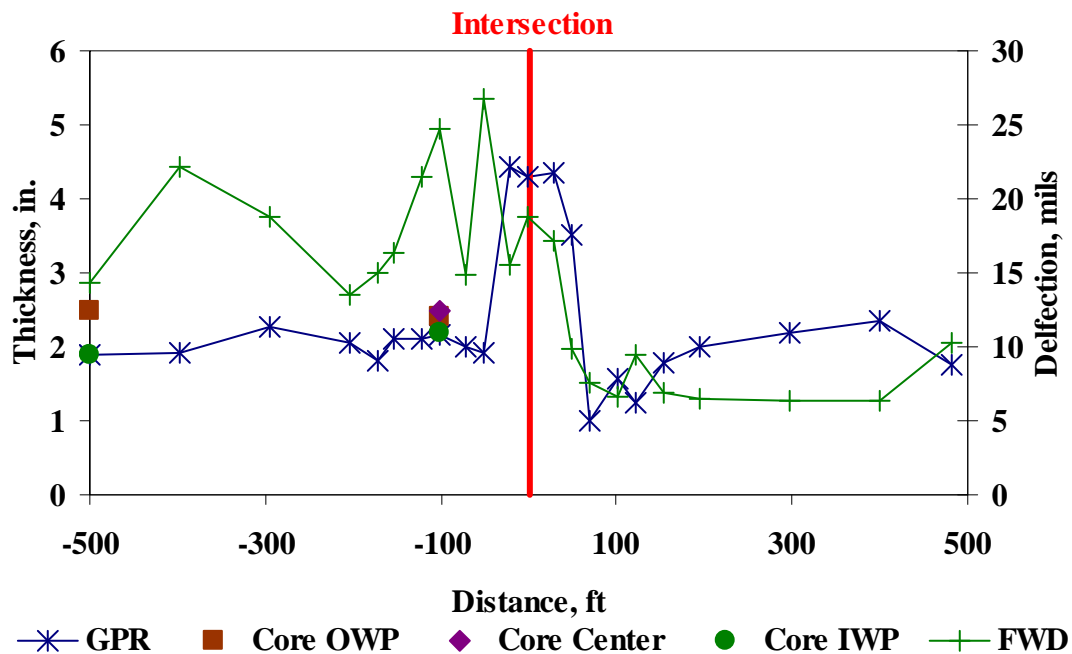
Figure 4.19: GPR, FWD and Cores on SH 155.

in. after crossing SH 49 and slowly increasing its way back to a little over 2 in. along the acceleration section.. The constant GPR measured thickness before and after the intersection may be an indicator that the asphalt layer may not be the source of rutting.

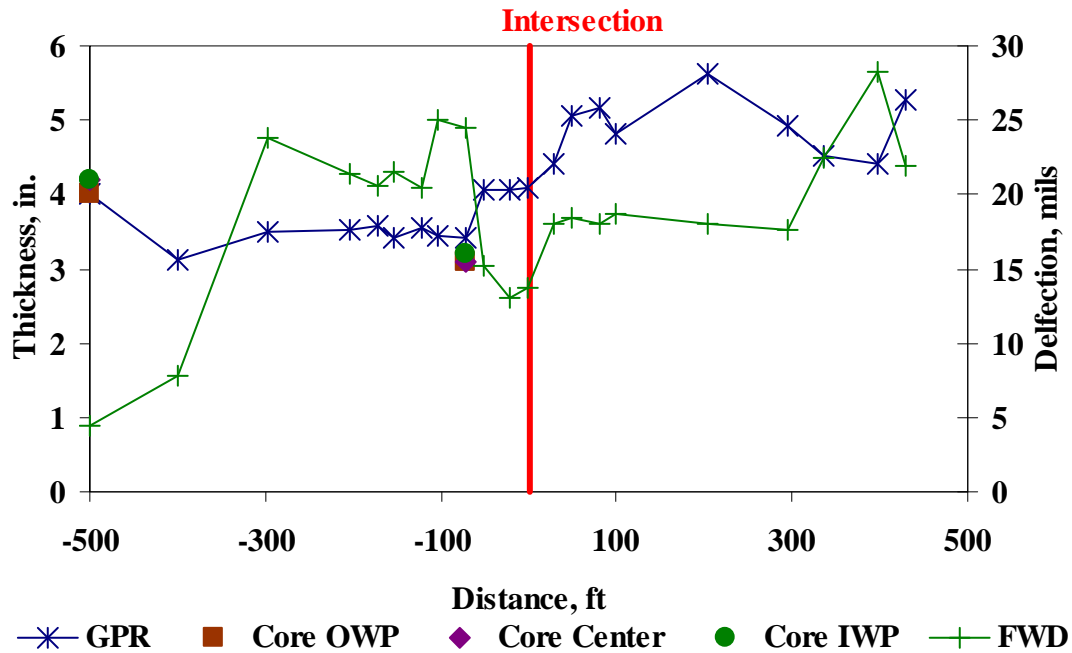
Figure 4.19: GPR, FWD and Cores on SH 49.

A relationship between thickness and deflection is appreciable. The first half section of SH 49 which is thinner provides higher deflections, while past the intersection that trend reverses. No rutting appeared on the first half of the road, most likely the severe block cracking is the reason for the high deflection values.

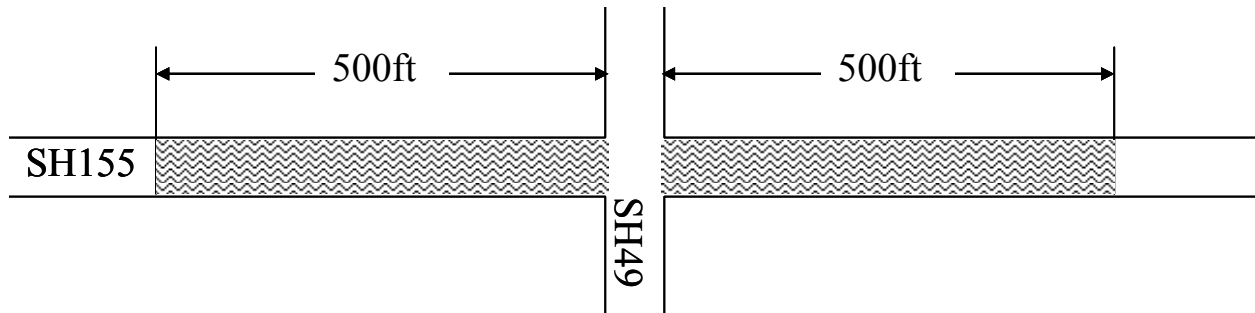
Figure 5.3: Schematic of the Recommended Area for Repair on SH 155.

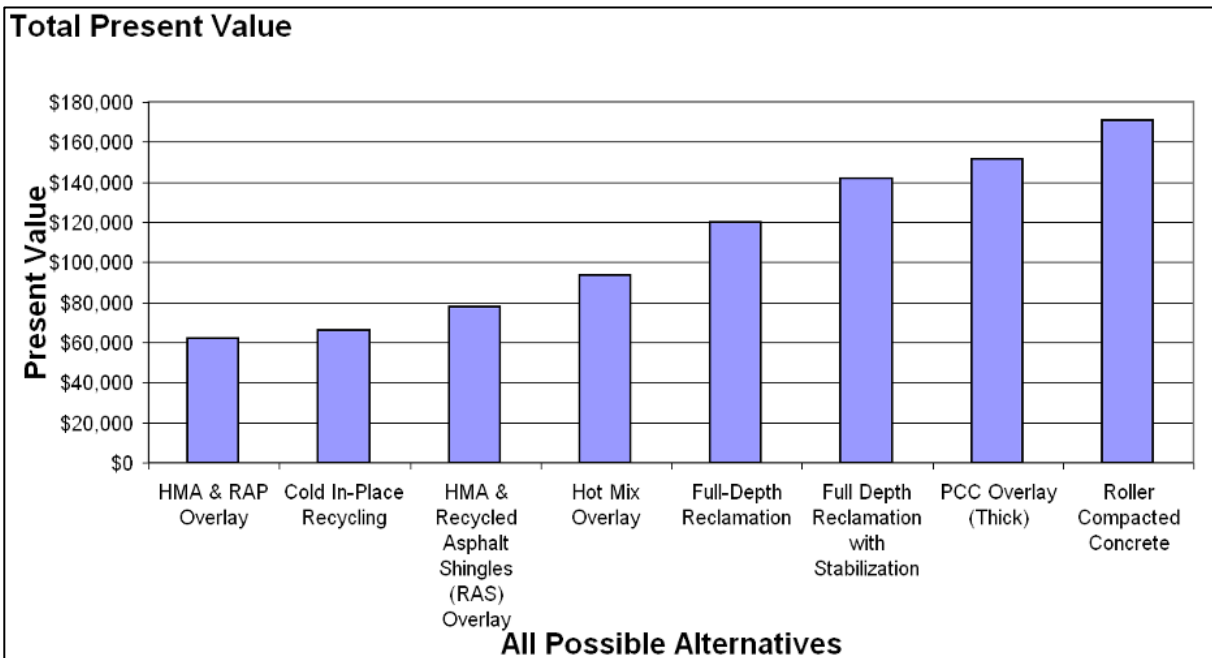
Figure 5.8: All Alternative Present Value Comparison Graph.

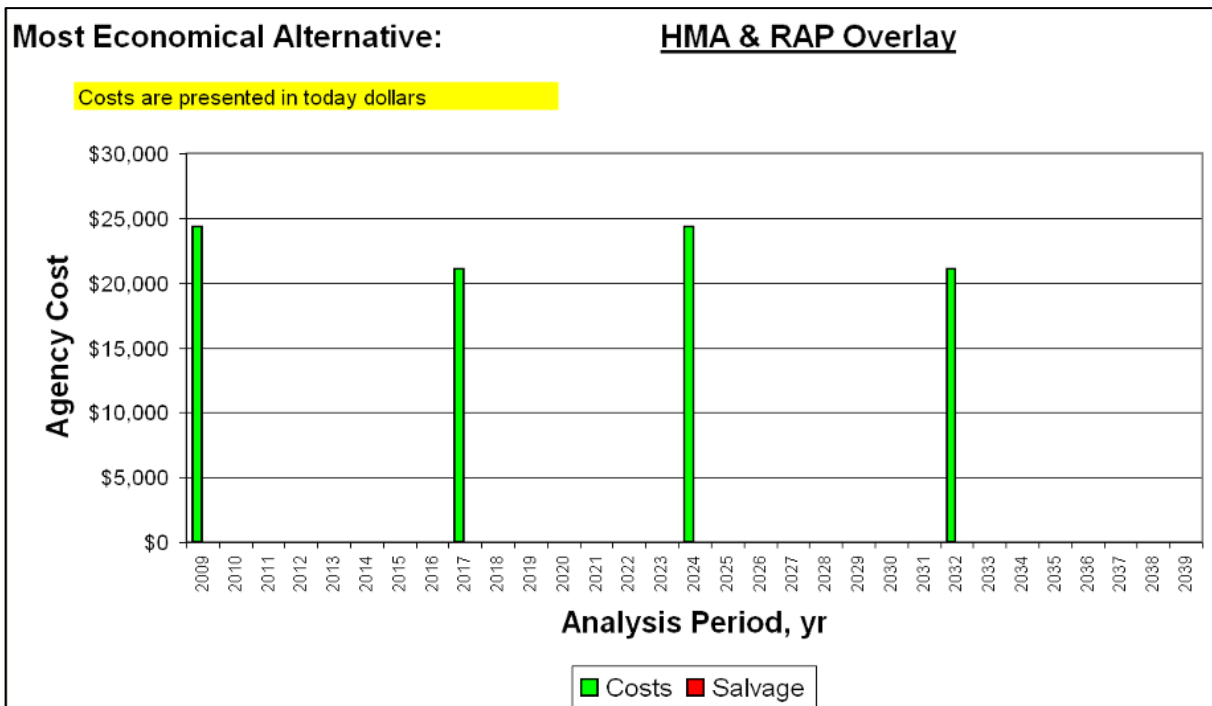
Figure 5.9: LCCA Plot for the Most Economical Alternative.
