A Tool to Improve and Preserve Flexible Pavement at Intersections

THESIS

Department of Civil Engineering
THE UNIVERSITY OF TEXAS AT EL PASO

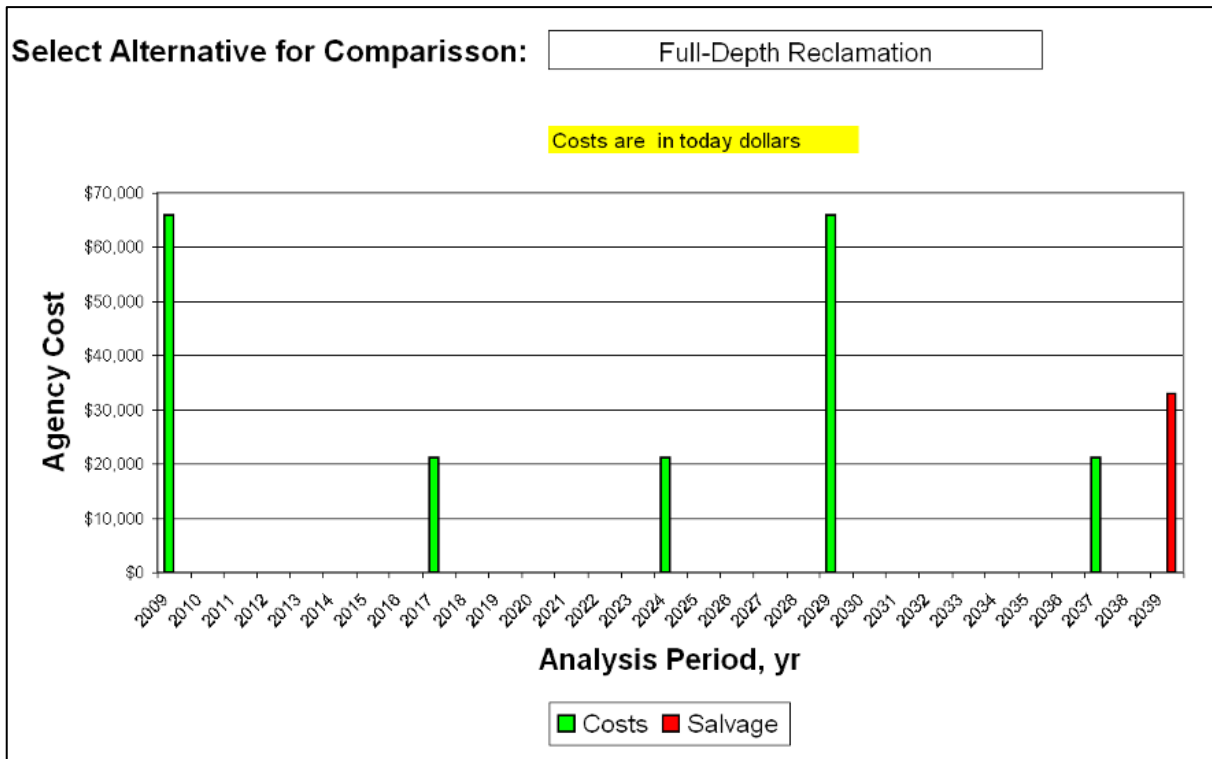
Figure 5.10: LCCA Plot for Full Depth Reclamation.
