Material Behavior of Window 7 Carrier Panel Tiles and Thermal Pane Fragments Recovered from the Space Shuttle Columbia

MATERIAL BEHAVIOR OF WINDOW 7 CARRIER PANEL TILES AND
THERMAL PANE FRAGMENTS RECOVERED FROM THE SPACE
SHUTTLE COLUMBIA

DISSERTATION

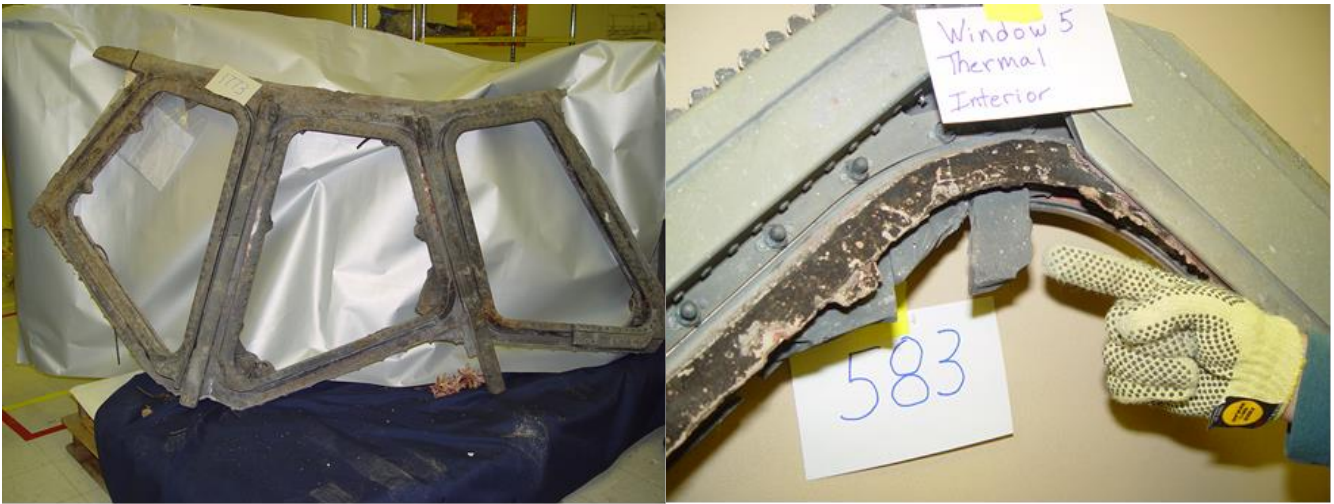
several thermal window panes [24] [19] [18]. All window panes contained this opaque layer and a few examples are shown in Figure 2.7 as a dull coating on the glass. Electron microscope imaging showed an adhered char layer on a Window 8 pane illustrated in Figure 2.8. The layer contained a variety of chemical compositions with an abundant aluminum weight percentage as a result of aluminum alloy oxidation. The alloys closest to the window frames were 2000 series aluminum alloys including 2219 and 7075 alloys [19]. Other elements detected were iron, copper, and oxygen. A sample was obtained from Window 7 where another distinct layer was present after the aluminum-rich layer. This high titanium region was directly applied to the glass and was made up of a Ti/Al mixture. Globules of silicon were also present with other metallic particles. The globules may have been silica droplets that make up the thermal protection system materials. The layered cross-section of the major elements detected is shown in Figure 2.9. Calcium was also found in large amounts but the origin of this element could not be determined. TEM analysis accompanied with EDS was used to confirm the three different phases seen on Window 8. A cross-sectional area is given in Figure 2.9 where the three variances in layered deposits are shown [2]. The three different layers were only present on orbiter Windows 7 and 8 at the exterior. The first inner layer on Figure 2.9 contained titanium dioxide (TiO_2) rutile form grains whereas the following outer layer was an aluminosilicate phase. The last porous layer was consistent with a 2000 series Al alloy composition. These layers were deposited from materials close to the window components. The titanium source may have been a result of orbital structural members which are made up of a Ti-6Al-4V alloy. A mechanism was suggested as the reason for the formation of the three depositions by a process of titanium combustion and plasma sprayed coating behavior [24].

Figure 2.7 Windows 4-6 frames with remaining thermal pane glass. Window 5 opaque thermal pane glass is also shown [19].

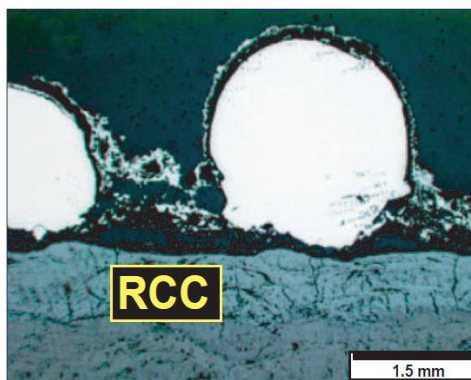
As mentioned before the CAIB analyzed several recovered debris. The right wing and left wing debris showed that the left wing experienced high heat and aerodynamic forces while the right wing suffered from aerodynamic forces only. Several changes in the shuttle program were suggested in the CAIB report after the accident. The RCC panel of the left wing was the first component of the orbiter to fail. Tiles obtained from the lower left wing contained evidence of slumping or heat damage with erosion [1]. Deposits were also discovered on RCC debris where layered slag deposits were present in metallic and non-metallic forms. Other spherical deposits were also found and made up of an Inconel 718 alloy. This type of alloy could be found in the wing leading edge attachment fittings. There was also a difference in deposits found on the left and right wings. The deposits on the left wing were rough had evidence of insulation material. Figure 2.11 shows an example of a deposit found on the left wing on the RCC panel with Inconel 718 particles. This proves that extreme heating for long times occurred. No aluminum was detected on the slag layers. Other locations with deposits were thin and contained primarily aluminum and aluminum oxides mixed with A-286, Inconel, and Cerachrome (insulation material) [1]. The layers containing these deposits were not uniform. This assortment of metals indicates simultaneous melting and re-depositing of the components surrounding the wing. All results determined that the original breach occurred at the RCC panel 8 on the left wing.

Figure 2.11 Spheroid deposits of Inconel 718 found on the surface of the RCC panel of the left wing [1].

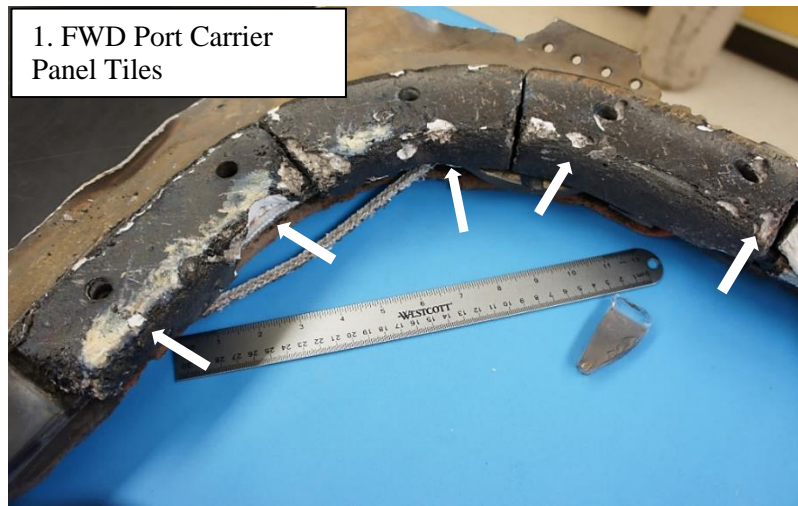
Next, the individual carrier panels were examined with additional photographic documentation. The state of the first carrier panel tiles when placed on the window are shown in Figure 4.3. When comparing to original carrier panels (Figure 2.4), the surfaces of the tiles in this panel contained areas that exposed the inner silica fibers of the tiles. Several areas are pointed out in Figure 4.3 where the exposed areas are mostly located in the inner lip regions of the tiles. Several distinct areas are also shown in Figure 4.4a where several yellow and blue discolorations are present along the inner edge of the tile. The rest of the carrier panel contains surface scratches and brown discolorations as shown in Figure 4.4b. Evidence of slumping is also present along the holes used for threading in the direction shown. When looking at the inner sides of the tiles on Figure 4.4c, the black coating contains a glassy coat that is only found in the inner lip areas of the tiles. The inner areas or lip regions of the tiles all contained a porous surface with many pits. The black coating seems to be worn away and directionality can be determined to be occurring in the direction shown in Figure 4.4d. When looking at the yellow and blue discolorations, there are several splat-like metallic deposits shown in Figure 4.5a and b. These metallic features were only present in the forward port tiles.

Figure 4.3 The forward port carrier panel tiles on Window 7. White arrows show areas with exposed silica material.

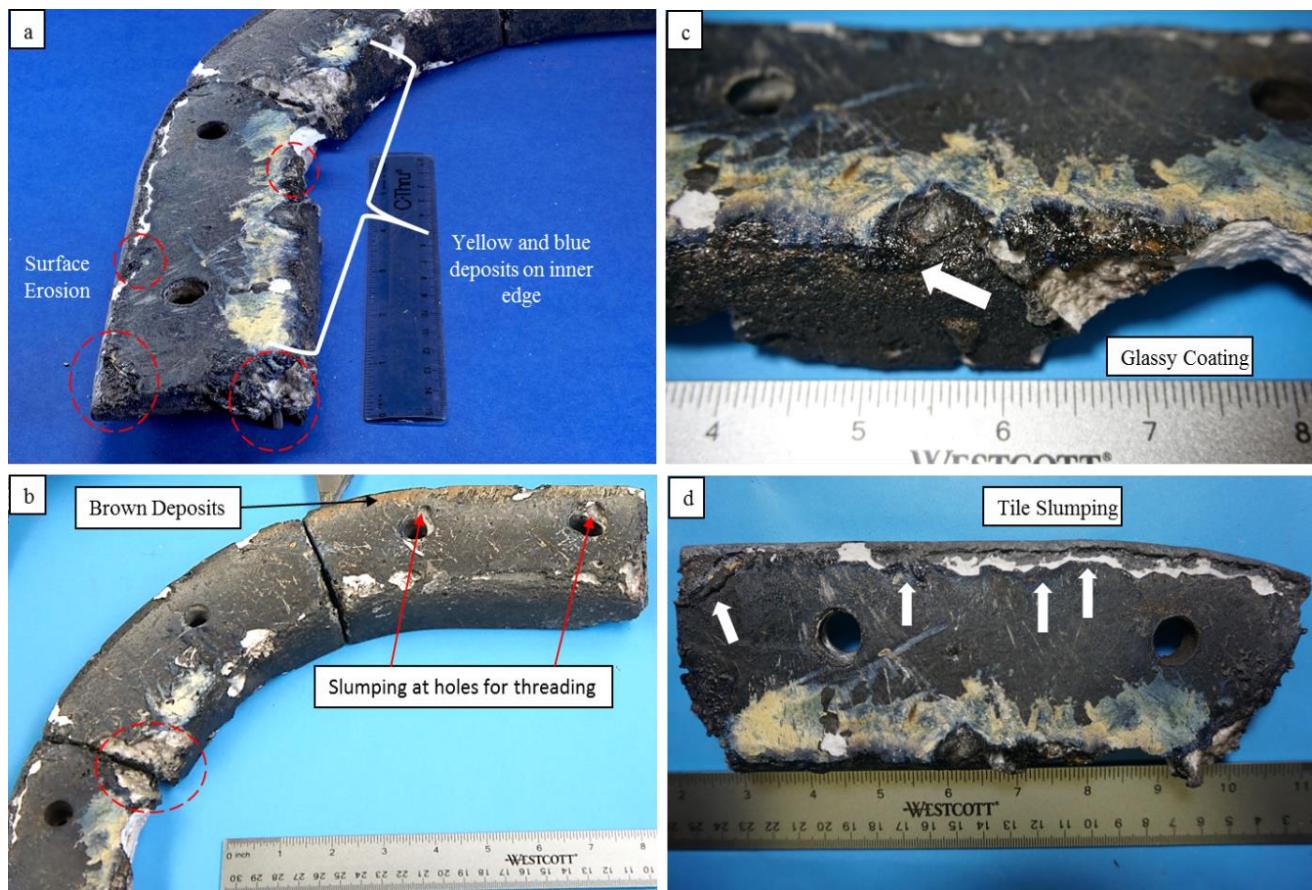
Figure 4.4 Several unique surface features seen on the FWD port carrier panel tile: (a) points out the deposits present and evidence of erosion, (b) shows the rest of the carrier panel tiles with similar features, and (d) shows tile slumping occurring from aft to forward.

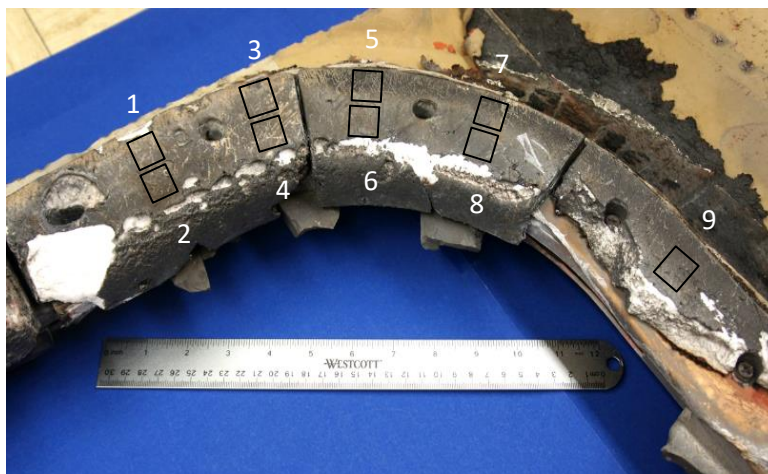
The remaining window frame from the fuselage in general contained an average of 25wt% aluminum, 17wt% copper, and 41wt% silicon. XRF measurements were obtained on the forward starboard carrier panel tile in the areas shown in Figure 4.9. The results in Table 4.1 show several elements were detected on the tile surfaces. The elements with the highest weight percentage detected were aluminum, silicon, iron, and titanium. Remarkably, the compositions of titanium were larger when comparing to the

percentages of aluminum. The largest weight percentage of titanium was 39.89wt% occurring in location 8. Other minor elements present at the tile surfaces include manganese, nickel, phosphorous, zinc, and zirconium.

Figure 4.9 Locations for XRF measurements of the forward starboard carrier panel tiles.

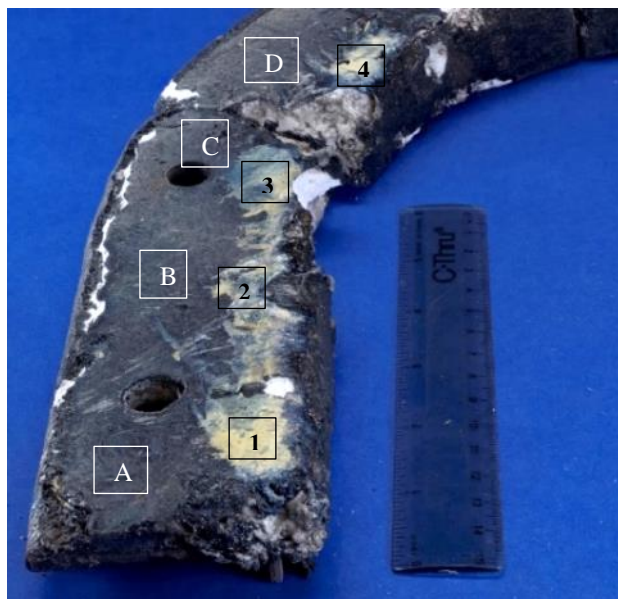
The next carrier panel tile also contained similar elemental compositions in the locations displayed in Figure 4.10. The areas measured include areas A-D to represent the outer areas of the tiles, while the sides close to the edges contained the colored deposits with areas 1-4. The XRF results of these areas are

shown in Table 4.2. Areas A-D contained consistent compositions of aluminum, silicon, and a range of 12-15wt% of titanium. Areas at the yellow and blue discolorations contained the largest weight percentages of titanium. The results are shown in areas 1-4 where locations 1 and 3 contained a presence of approximately 44 wt% titanium. Locations 2 and 4 had 30 and 35 wt% titanium. The primary elements detected were similar to the forward starboard tiles. A variation of silicon was observed to occur in areas where the yellow and blue deposits were present. The amount of silicon decreases at locations 1-4, while the silicon amounts are constant in areas A-D. The rest of the carrier panel shown in Figure 4.11 contained equivalent elemental compositions. The locations of the measurements are marked and the main elements present are shown. The primary elements of aluminum, silicon, and titanium had similar concentrations when compared to the previous carrier panel. The carrier panel tile in all areas had much lower concentrations of titanium than those pertaining to the yellow and blue deposits. Therefore, the deposits contained the highest relative amount of titanium compared to any other measured areas. The XRF results have proven that the areas to be sectioned will take place where significant unique deposits are found such as titanium and the degradation of tiles.

Figure 4.10 Forward port side detached tiles and corresponding XRF results on areas A-D and 1-4.

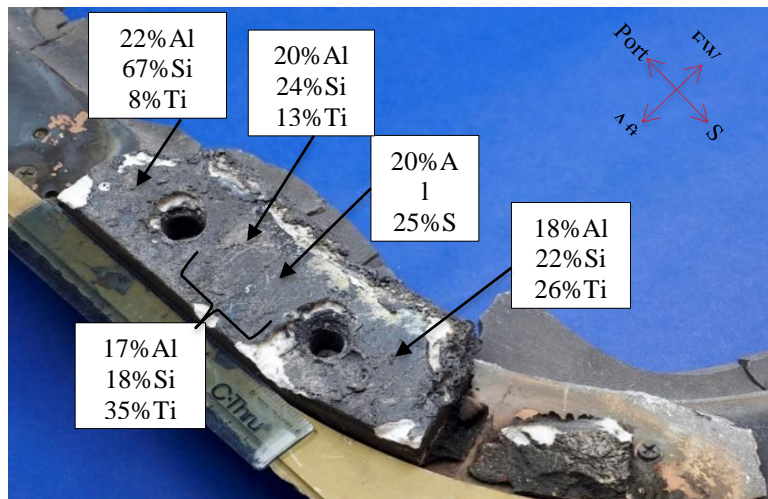
The attached aft tile just aft of the window frame also indicated the same primary elements, except with lower amounts of titanium ranging from 8-26 wt%. The locations of the XRF readings are shown in Figure 4.12 along with the major elements compositions. The yellow and blue deposits were also located on the aft tile near the inner edge, however they were unable to be analyzed by XRF since the deposits are in close proximity to the tile edge. The areas showed a continuous presence of titanium with the largest

amount being 35 wt% appearing at the outer edge of the tile as shown. The amount of titanium appears to increase from the forward to the port side of the tile. Additional examination of the deposits will provide a more accurate elemental analysis due to the severe degradation present.

Figure 4.12 Aft tile with selected elemental analysis results of several locations with primary elemental species.

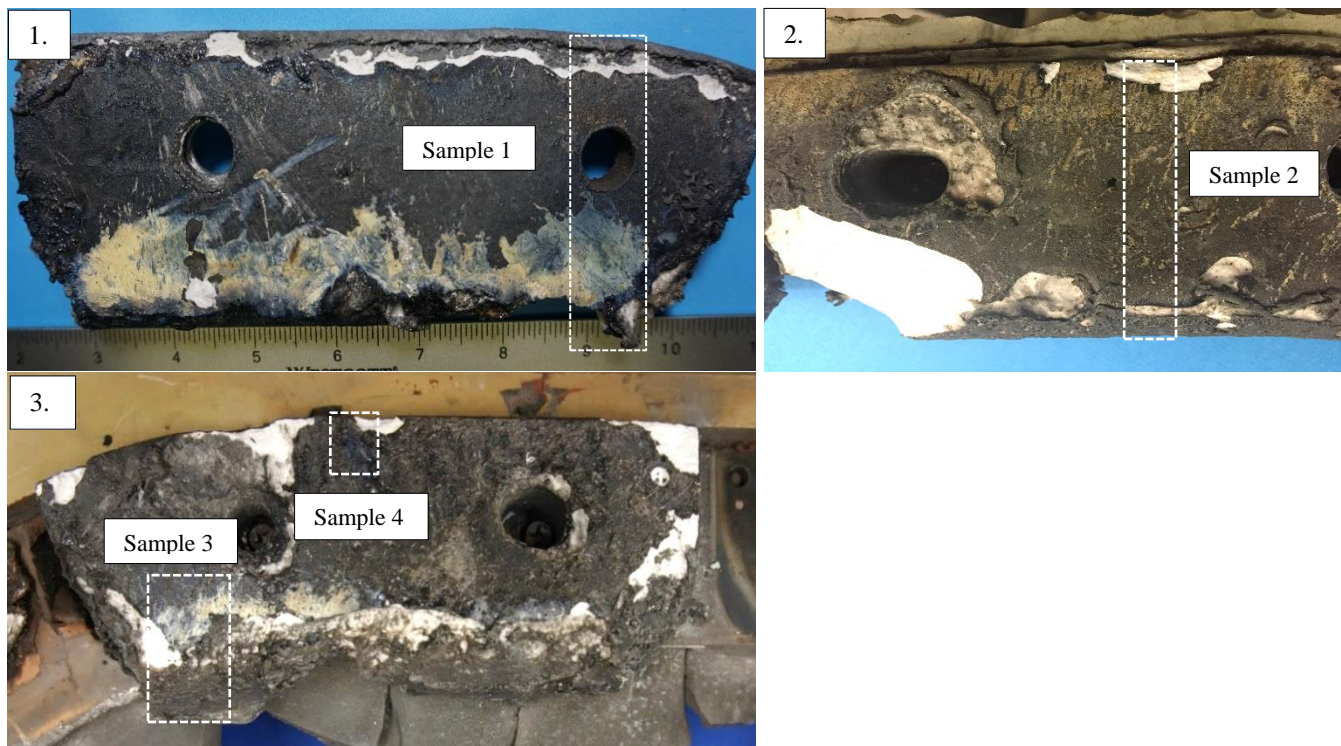
Several areas were selected as a result of the preliminary non-destructive evaluation outcomes. Samples were chosen from all carrier panel tiles located on Window 7. The areas are shown in Figure 4.15 with carrier panels 1-3. Areas of interest were samples 1-4. Sample 1 was obtained to characterize the colored deposits with metallic splats. This area was also obtained to confirm surface XRF measurements and to verify the amounts of titanium present. The following sectioned area is located on the forward starboard tile as sample 2. The area was to study any deposition formation and examine the inner sides of the tiles as XRF could not measure small edges. This area also contained a large percentage of titanium. The aft tile was also selected since the tile is nearest to the two payload bay bulkhead latch rollers, and the specific areas gathered are shown in Figure 4.15. The yellow and blue discolorations that make up sample 3, were necessary to determine if they contain similar chemical signature as those seen on the forward port side carrier panel. Sample 4 also chosen as it contained metallic deposits and to investigate traces of the surrounding materials are present. All samples were essential as they embodied all directions of Window 7 and facilitated investigating plasma flow directionality from re-entry.

Figure 4.15 Selected areas for experiment with sectioning guides for each carrier panel tile. Sample 1 corresponds to the forward port side, sample 2 is from the forward starboard side, and samples 3 and 4 are located in the aft tile.

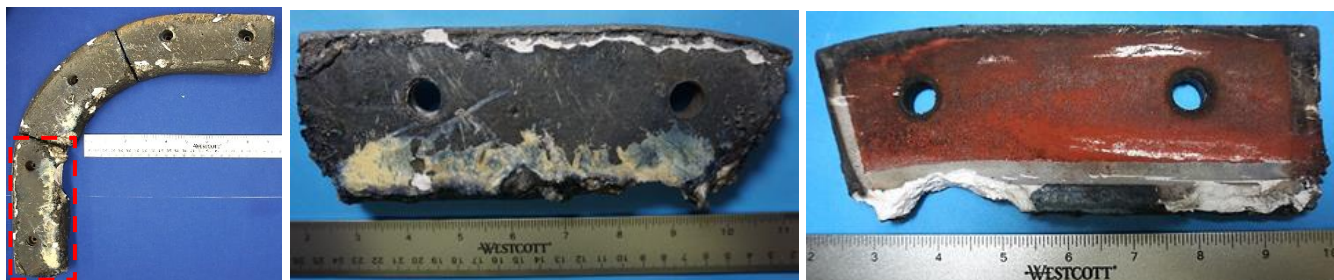
Given that the forward port side carrier panel contained the most evidence for depositions as demonstrated in Figures 4.5 and 4.10, the tile was removed from the frame. This was in particular due to the carrier panel being attached to Window 7 and to determine the most favorable way of sectioning areas within the carrier panel. The tile was removed by using a heavy-duty razor blade and a hacksaw blade to detach. Figure 5.2 shows the tile after its removal and the underside of the tile contained several areas of burned Nomex felt pad.

Figure 5.2 Forward port side carrier panel tile with legend after removal and underside of tile (right).

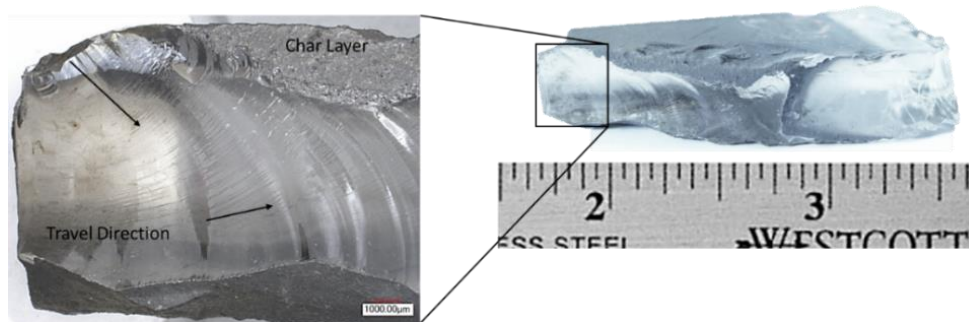
Figure 5.8 Digital image obtained from the side view showing travel direction of Wallner lines [41].

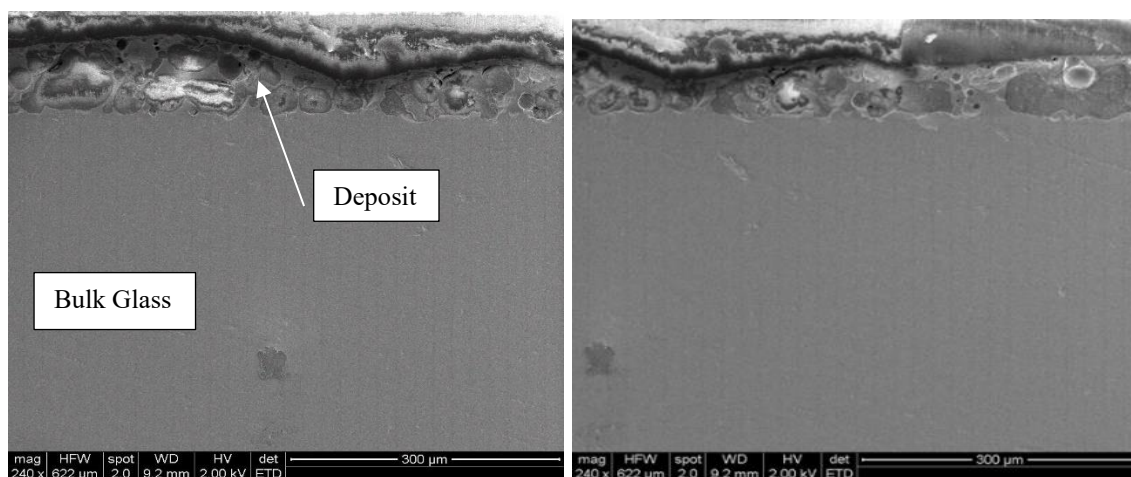
were observed using an FEI Quanta 400 field emission SEM. A deposit layer as indicated by the white arrow was concentrated in one location of the glass and contained porosity. Next, the removed charred particles were observed with a Hitachi S-4800 Field Emission SEM shown in Figure 5.10 and all particles were irregularly shaped with various particle sizes. The EDS spot spectra of several particles identified similar elements and the most prominent peaks are titanium oxide, silicon, and aluminum. Other constituents were also recognized and the results are comparable to the metallic elements obtained from Olivas et al., 2010. The same procedure was used when studying the Window 7 thermal pane glass fragments.

Figure 5.9 SEM images of the cross-section of the test glass sample from Window 8 with evidence of a deposit layer.

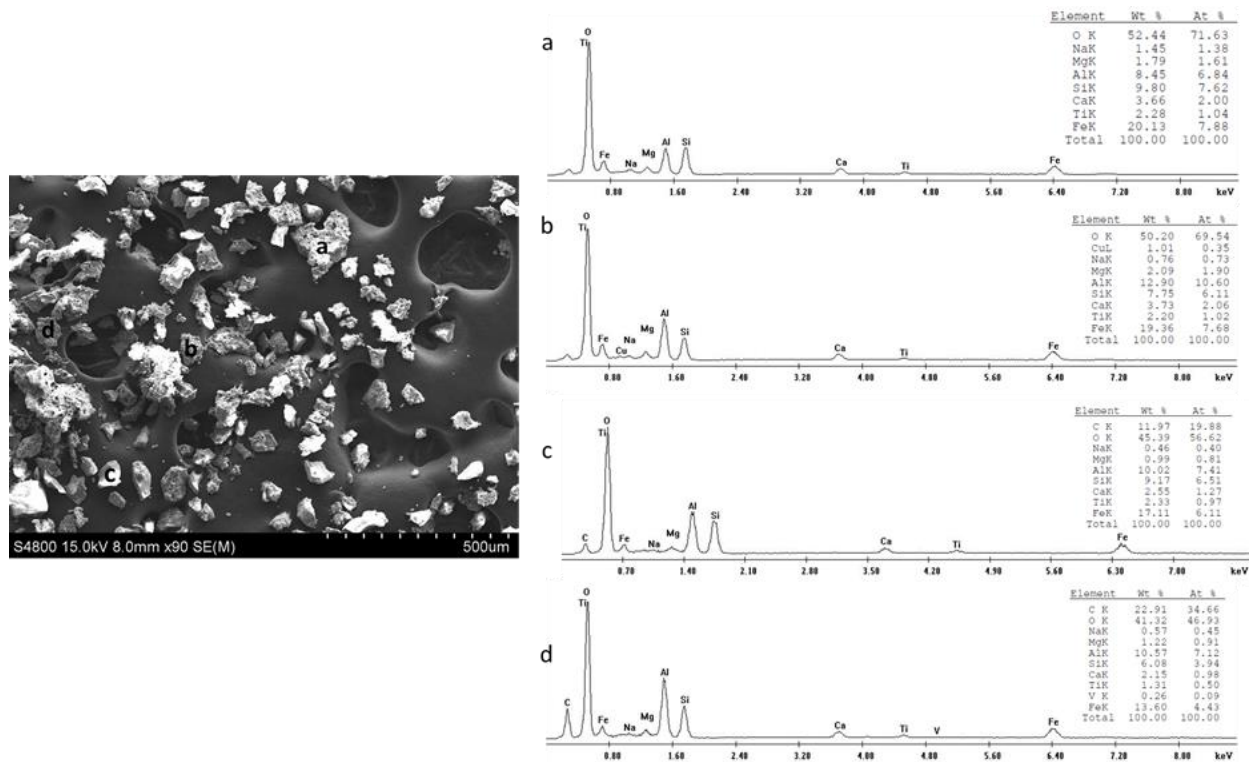
Figure 5.10 SEM image of the removed charred particles from the Window 8 test sample and several EDS spot spectras a through d of several particles.

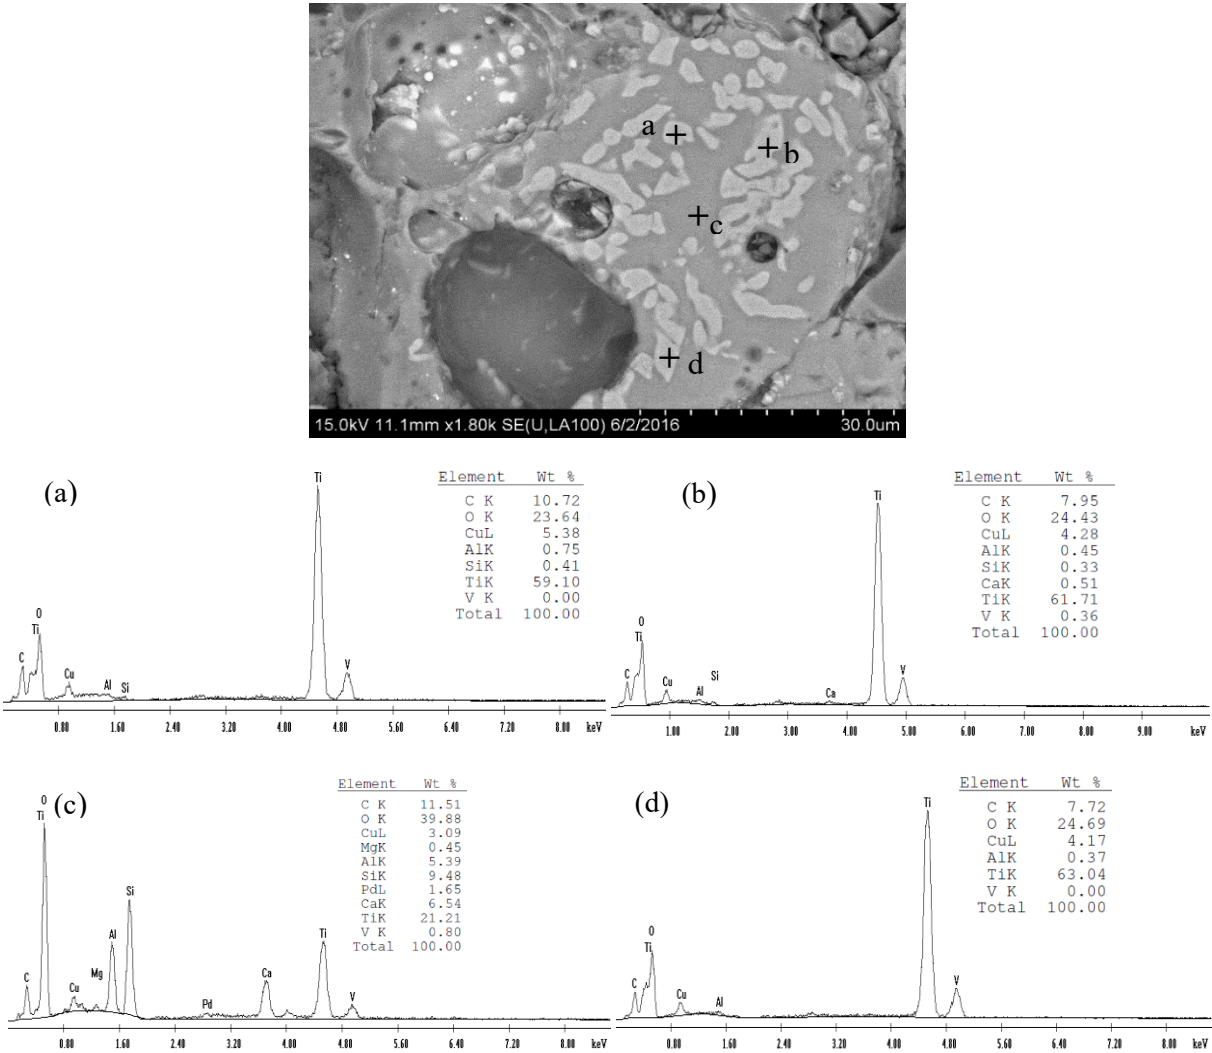
EDS spot measurements were obtained to determine the chemical composition of these formed phases. Figure 5.12 shows four EDS spot readings for determining their chemical compositions. Spots a, b, and d were located within the light gray phase that contained between 59 to 63wt% of Ti. However, when analyzing the darker gray phase, it was a titanium oxide mixture with minor amounts of silicon, aluminum, calcium, and copper. When mapping the entire cross-section, the elements detected are also shown to be concentrated in certain areas. This is shown in Figure 5.13 along with the spectra. It is clear that the light gray phase contains a mixture of titanium, oxygen, and vanadium. However, the concentration of titanium is higher. The dark gray phase contains titanium oxide, silicon, and calcium. Two areas are shown not to be an oxide but aluminum particles as illustrated by the yellow color. Sodium was also present on the cross-section as well as copper. The carbon present was located in areas where

pores or cavities were present. These compositions present are comparable to the obtained particles from the Window 8 glass samples.

Figure 5.12 SEM micrograph of a deposit with EDS measurements of the light gray phase (a,b,d) and the dark phase (c).

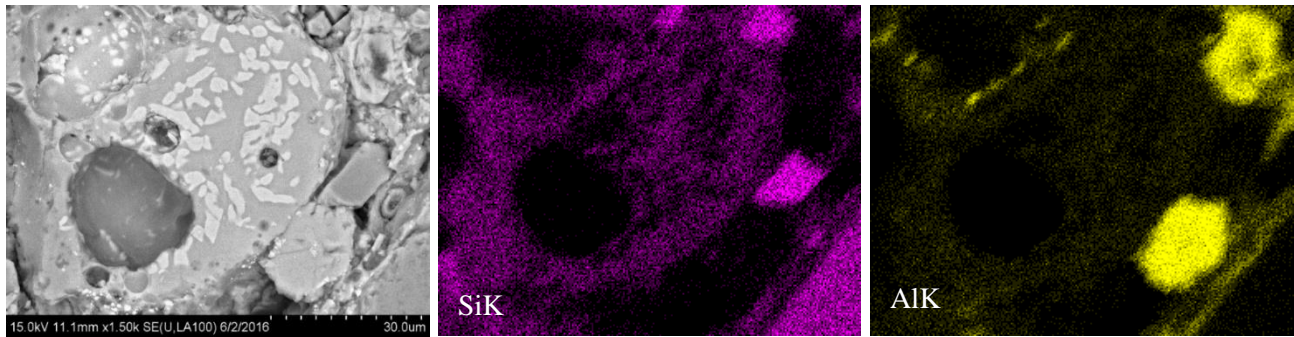
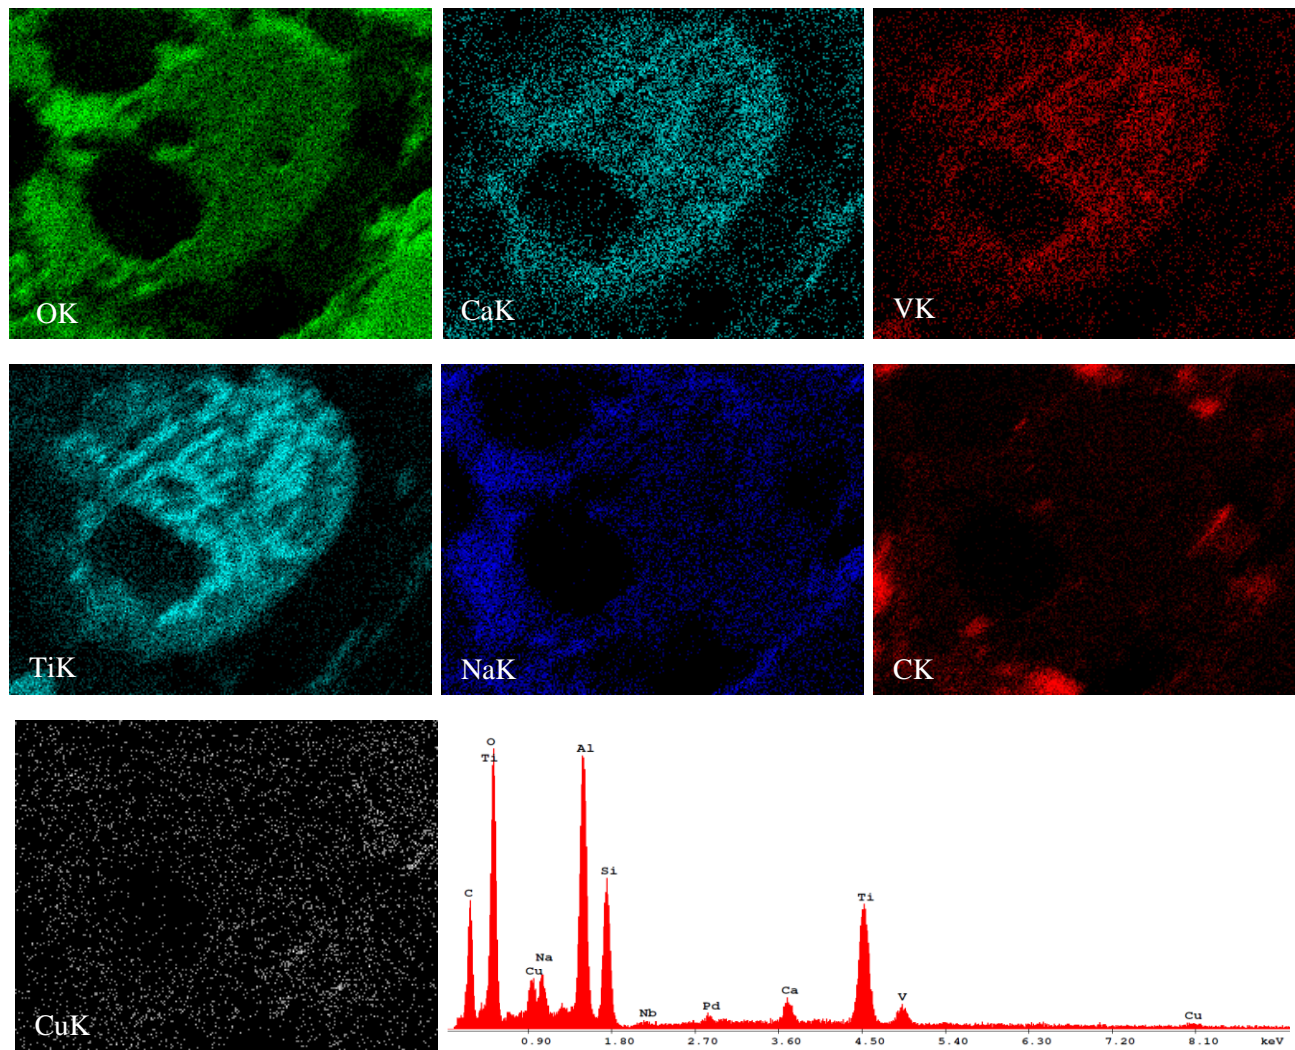
Figure 5.13 X-ray map and corresponding spectra of the deposit.

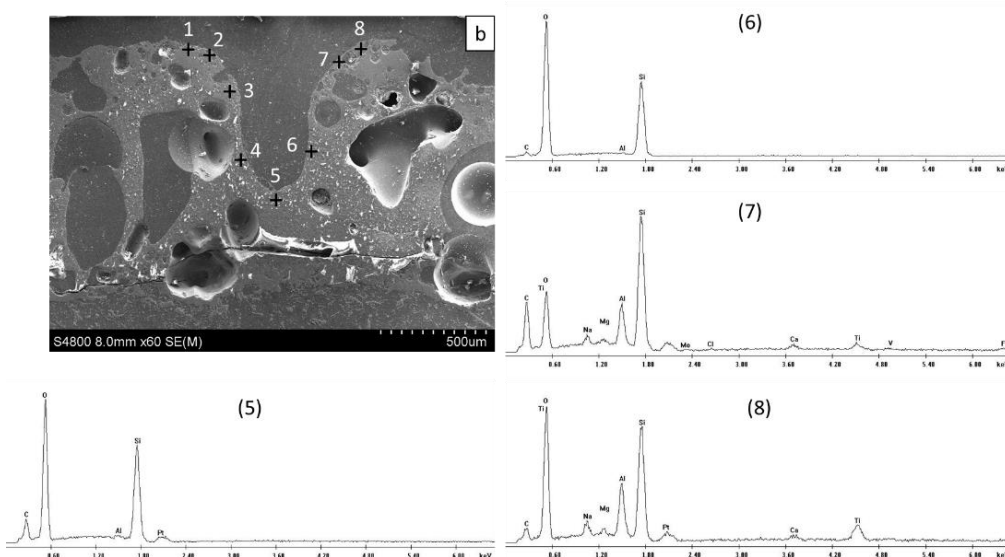
The TPS coating contained degradation given that the upper surface appeared to be highly disordered. An example of the damaged surface is shown in Figure 5.15 and Figure 5.16 along with EDS spot readings along the edges of a deep “valley” in the coating. Most of the locations also contained similar peaks of oxygen, silicon, aluminum, and traces of carbon. Readings closest to the concave area (2-6), all exhibited similar EDS peaks. The upper surfaces in spots 1, 7, and 8 contained other unique constituents such as titanium oxide (TiO) and smaller intensity peaks of sodium, magnesium, and calcium. Elemental titanium was also found in these three areas from 1.82wt% to 5.75wt% including traces of iron and vanadium.

Figure 5.16 Completed EDS results for the remaining spots 5 through 6.

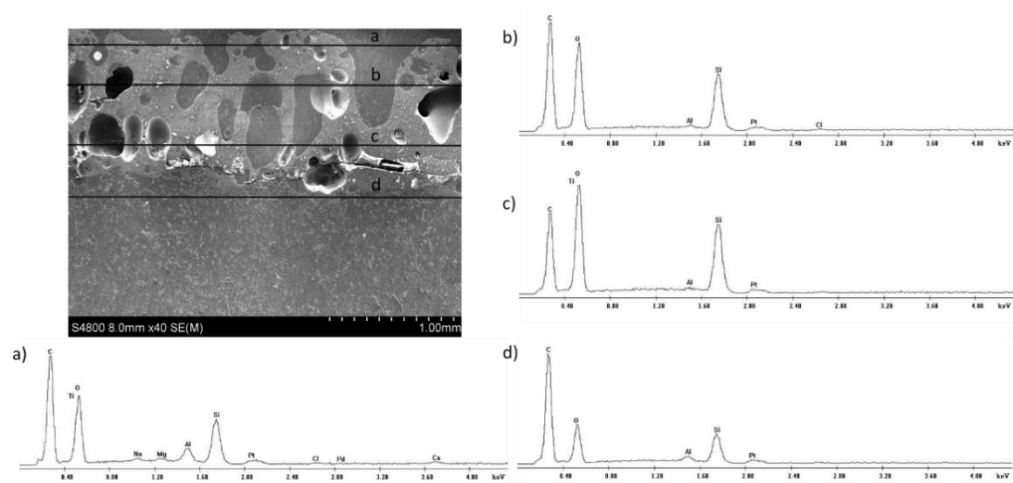
Changes in the compositional results were inspected by analyzing EDS line readings along four lines through the cross-section as shown in Figure 5.17. Line a represents the top edge of the TPS coating and lines b through c signify lower regions of the cross-section. The characteristic peaks detected on line a are similar to other spot readings taken at the top edge of the coating which correspond to carbon, titanium oxide, silicon, aluminum, magnesium, and platinum. On line b however, the titanium oxide is not present as well as magnesium. Just above the interface between the coating and the inner silica

material, the titanium oxide (TiO) was identified. The EDS line results of the silica correspond to the results obtained in Figure 5.14d. Another area showed a large presence of hollow cavities and porosity present on the TPS coating as seen in Figure 5.18. Several EDS readings were completed and were comparable to the previous spot measurements of the light gray and dark gray areas. The EDS analysis indicated peaks corresponding to titanium oxide (TiO) that were predominately concentrated on the upper surface of the TPS coating. Both spots in Figure 5.18 contained the same elements detected including elemental titanium and vanadium.

Figure 5.17 EDS results along lines shown in a through d to determine the change in compositional results throughout the coating.

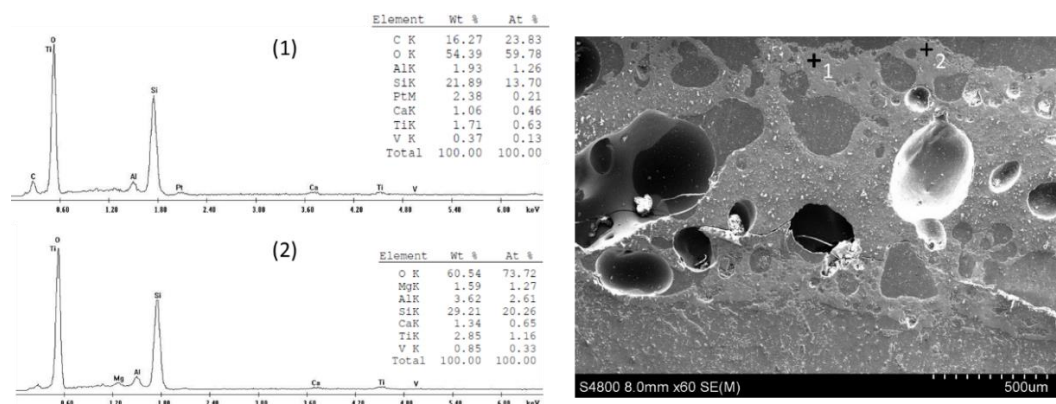
Figure 5.18 Additional spot readings with elemental percentages on the upper surface taken at another location of the TPS coating.

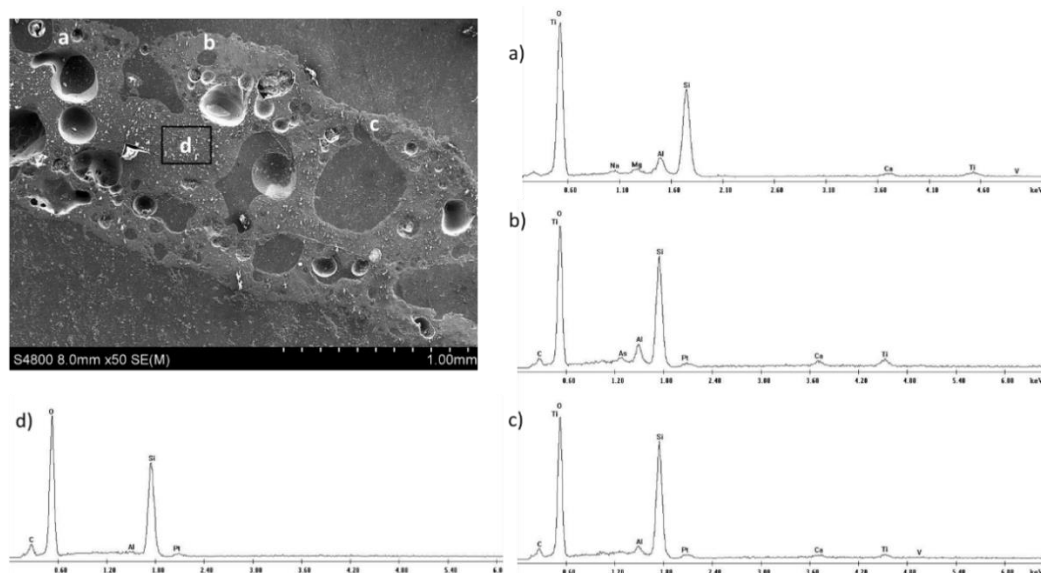
Examining the coating close to the distinctive lip of the carrier panel tile in Figure 5.19, showed hollow black pores and cavities. The spots analyzed on the upper surface (a-c) were consistent in the characteristic EDS peaks of titanium oxide and silicon. Area d on the coating consisted of mostly oxygen and silicon peaks. When comparing the EDS results of the upper surfaces of the Window 8 specimen to the surface XRF results of the carrier panel tiles from Window 7, the main elements of aluminum, silicon, and titanium were present.

Figure 5.19. Microscopic image of the TPS coating near the carrier panel lip along with EDS spectrums of spots a-c and area d.

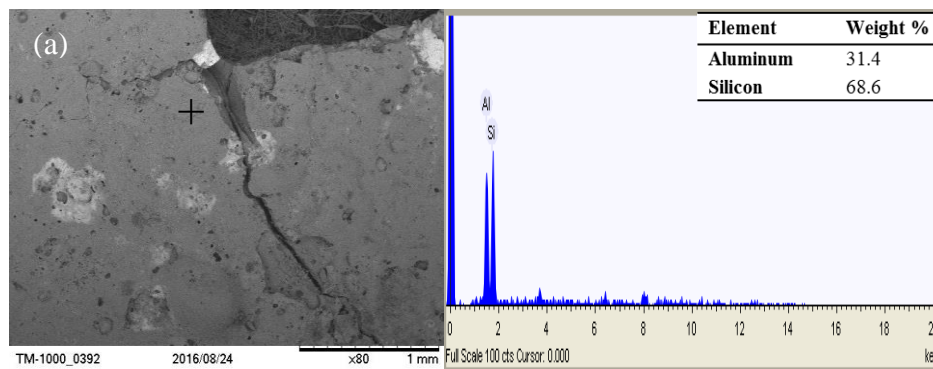
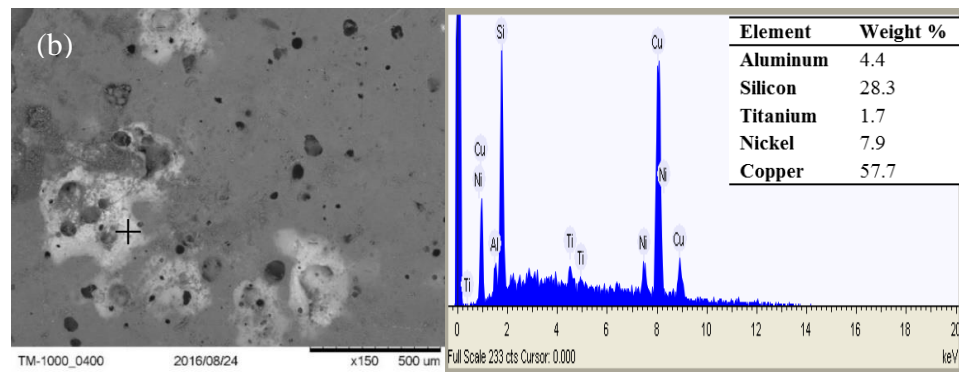
Two areas were chosen to reveal elemental compositions and verify the results obtained by XRF. Figure 6.5a shows an EDS spot reading of a dark area with no apparent deposition. The results show that the surface contains Si and Al only. However, an area with a white deposit is shown on Figure 6.5b to contain major elements of Si and Cu. Minor elements consisted of Al, Ti, and Ni. Additional EDS spot measurements are presented in Figure 6.6 where a dark spot number 1 is shown to contain TiO_2 , Al_2O_3 , and SiO_2 major concentrations. Spot 2 on Figure 6.6a was measured on the white deposits were shown to be abundant in Al, O, and Si. The white deposits also contained copper and iron as shown.

Figure 6.5 Two EDS spot measurements of a dark gray area in (a) and a white deposit in (b).

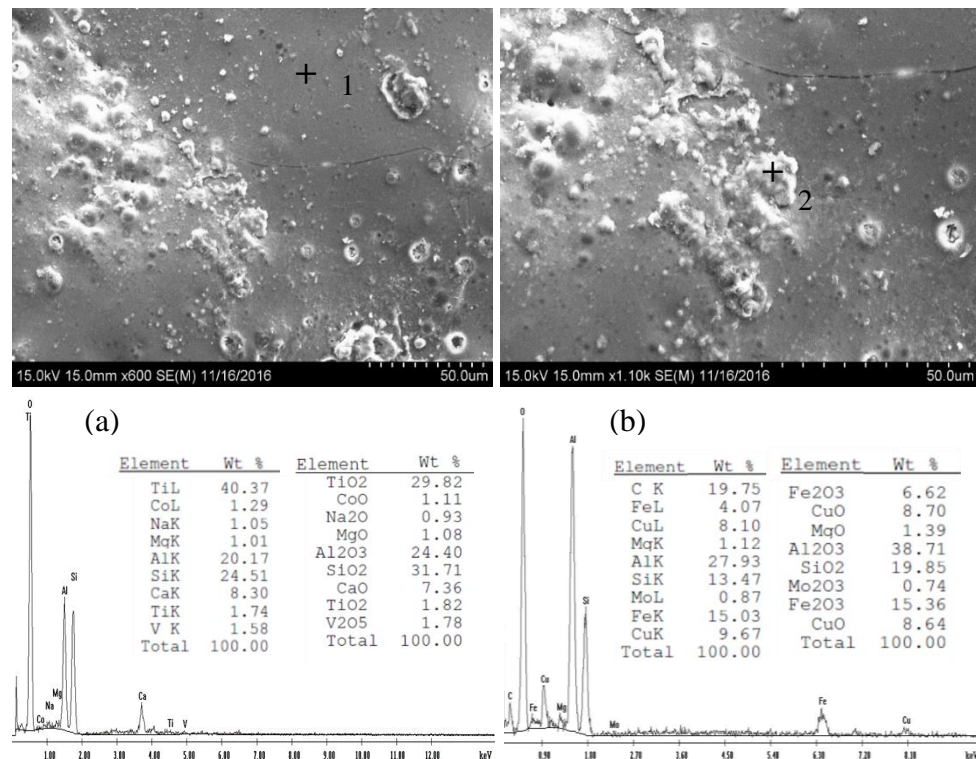
Figure 6.6 EDS measurements of (a) spot 1 and (b) spot 2 with individual element compositions and oxide compositions.

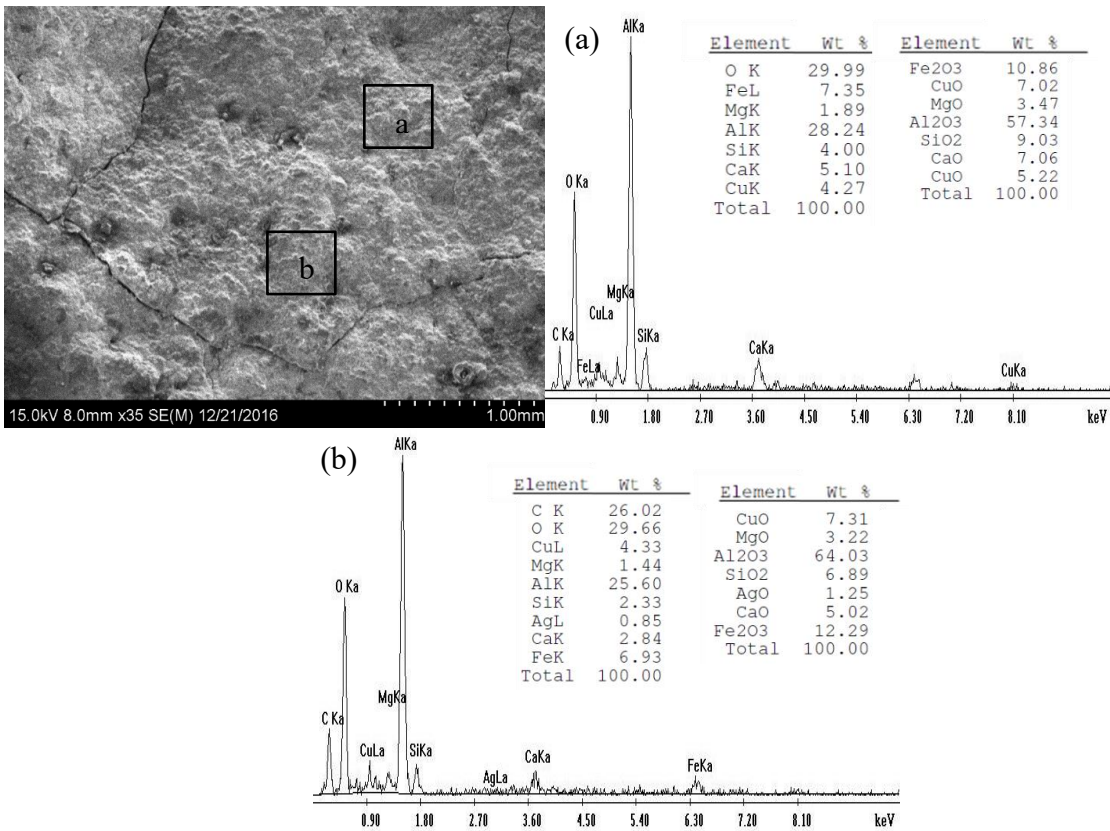
The next sample that was studied was sample 1.1B which was originally attached to sample 1.1A. The surface is presented in Figure 6.7, which was highly irregular. The surface is no longer flat and had several cracks that branched out as shown in the figure. The surface also may have contained deposits as the surface had a rough and jagged texture. When analyzing the surface through EDS, the largest weight percentage of an element detected was aluminum. This is shown on the image in Figure 6.8 that contains the EDS results within areas a and b. Both areas analyzed also contained major elements of oxygen. Other

Figure 6.8 Two areas analyzed at (a) and (b) with EDS data showing similar compositional results.

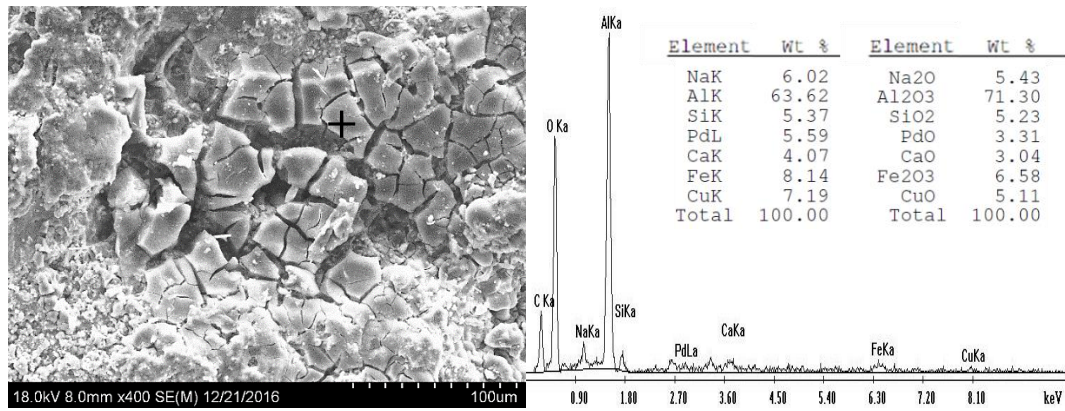
features observed on the surface of the sample, in which small areas of the coating appeared to be individually fragmented and found to be aluminum oxides (Figure 6.9). The EDS results of one of these cracked pieces were consistent with major element aluminum with 63.62 wt%.

Figure 6.9 The micrograph shows an area on the surface of 1.1B with aluminum oxide fragments analyzed through EDS.

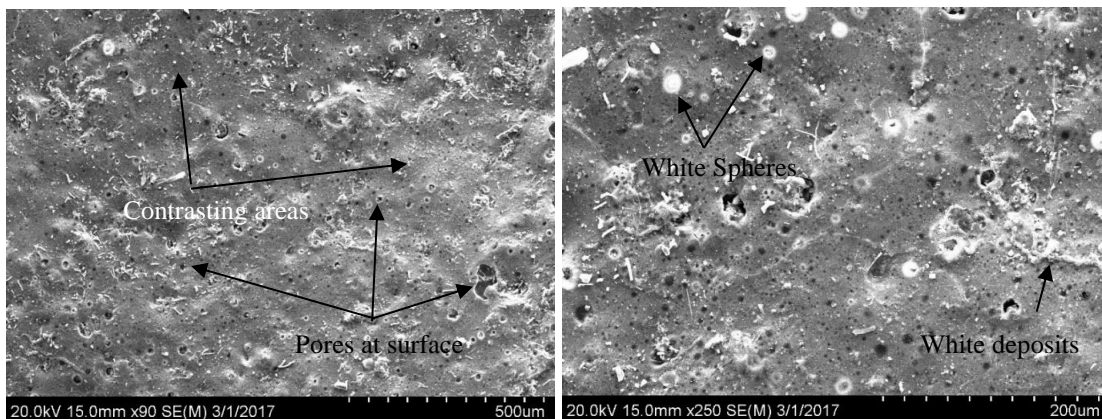
Moreover, the next sample that was examined was sample 1.2 that did not have such a rough texture compared to the previous specimens. Figure 6.10 shows the as-received surface that was generally flat with some changes in contrast and several indentations or pores at the surface. There were also several white spherical spots observed as well as small areas of white deposits. These features are demonstrated by the black arrows. EDS analysis was also performed on the surface of this sample as it did not contain a thick and irregular surface. Figure 6.11a shows a boxed area at a bright contrast with the major compositions of 42.62 wt% O and 21.84%Ti. The following minor elements included 11.90 wt% C, 7.48 wt% Si, and 4.36 wt% Al. Gold was detected as the sample was sputter coated with an Au/Pd target and often times, it is detected with EDS. When obtaining oxides calculated through the EDS software, the major oxides were TiO_2 , SiO_2 , and Al_2O_3 .

Figure 6.10 Surface of as-is condition of sample 1.2 with several features pointed out.

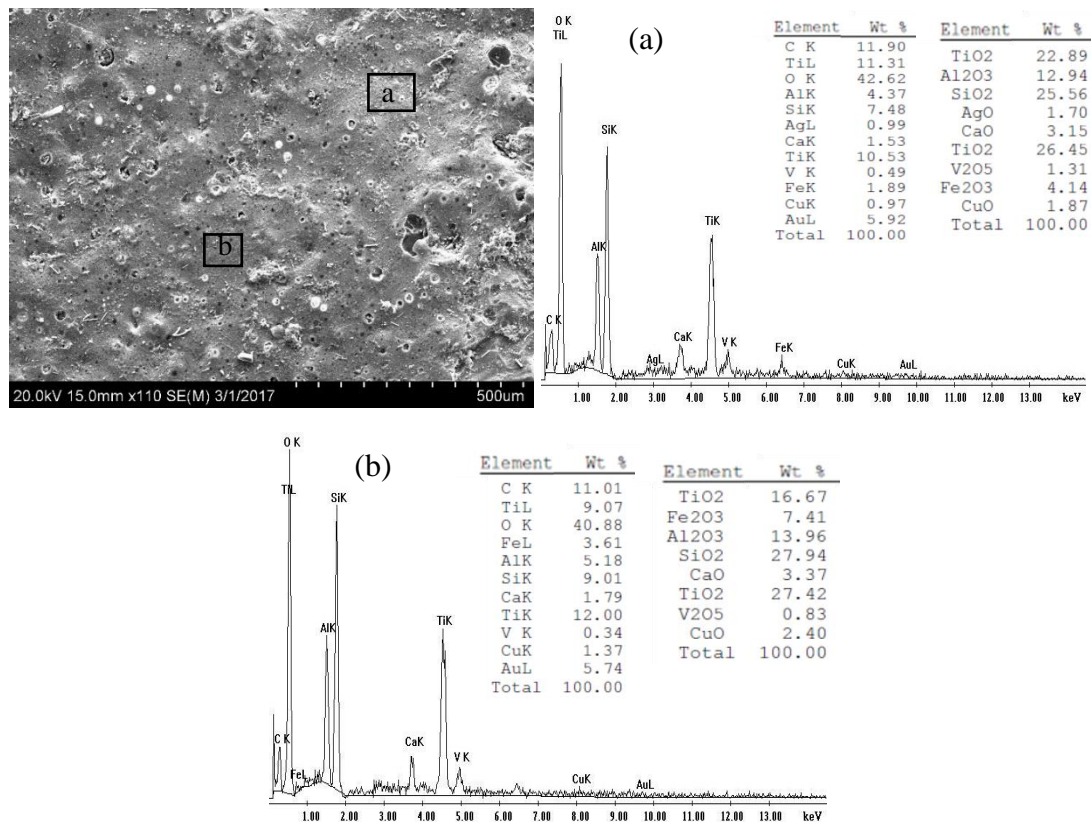
Figure 6.11 EDS area measurements of darker area (a) and a lighter area (b) with compositional results for sample 1.2.

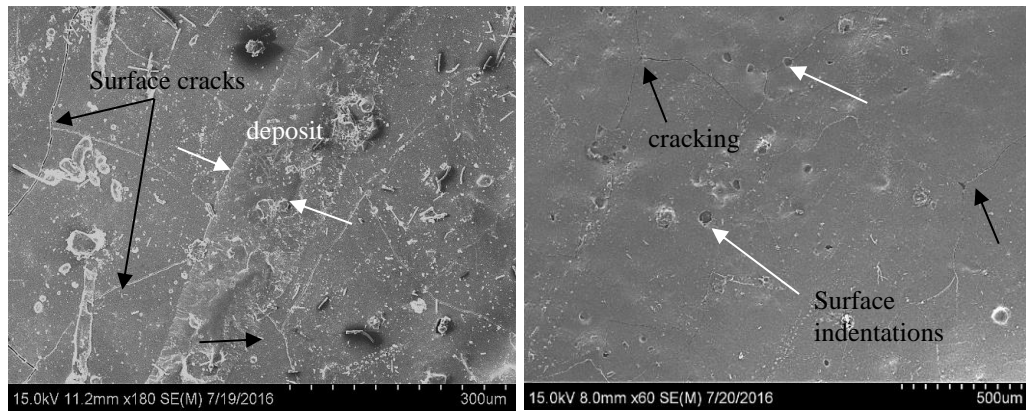
Moreover, Sample 1.3 was the TPS piece that contained the brightest yellow and blue deposits. These areas were analyzed to determine the composition of these deposits. The appearance of the as-received surface is shown in Figure 6.12. Similarly, to the other TPS samples, surface cracks were present on most of the coating. A deposit was observed on the surface as shown in the figure which may be representative of the metallic splats seen in Figure 4.5. Several small surface indentations were also recorded which are located by the white arrows. EDS results obtained from the metallic splat on Figure 6.13 reveal that it is enriched in aluminum (25.67 wt%), oxygen (32.43 wt%), and carbon (36.14 wt%). In contrast, spot b was measured at an area where no deposit was present and it was rich in titanium oxide with 59.11 wt% O and 10.34 wt% Ti. Other elements detected include 13.03wt% Si and 7.31 wt% Al.

Figure 6.12 Surface of sample 1.3 with the characteristics shown.
