Material Behavior of Window 7 Carrier Panel Tiles and Thermal Pane Fragments Recovered from the Space Shuttle Columbia

MATERIAL BEHAVIOR OF WINDOW 7 CARRIER PANEL TILES AND
THERMAL PANE FRAGMENTS RECOVERED FROM THE SPACE
SHUTTLE COLUMBIA

DISSERTATION

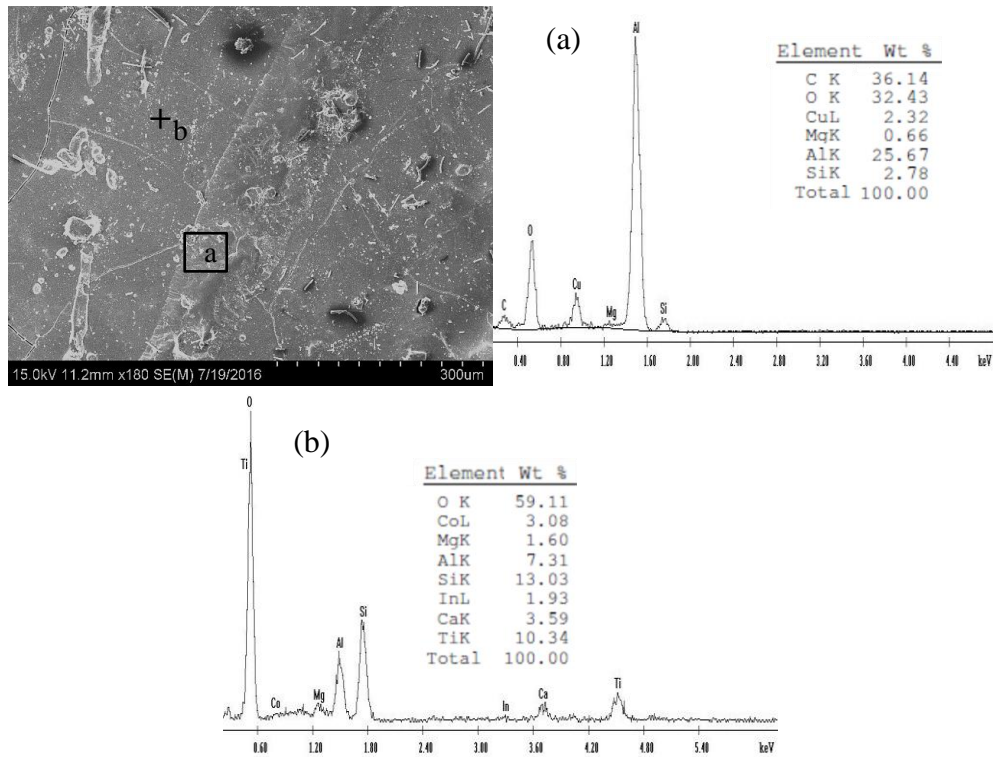
Figure 6.13 Area EDS measurement (a) and spot measurement (b).

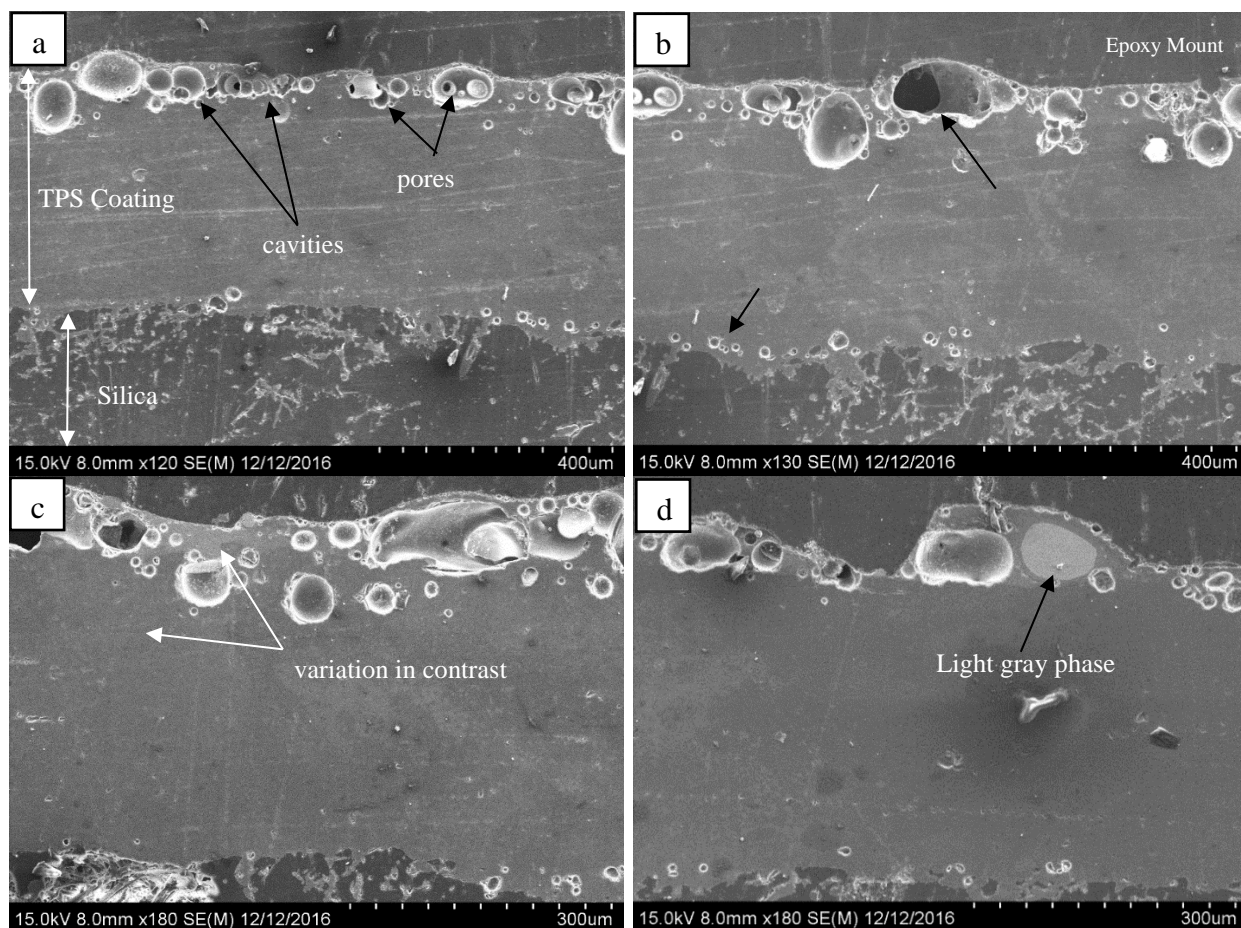
The sample cross-sections were examined to find evidence of deposits that were present in the TPS coating or base material. Images of the first sample 1.1A at the cross-section are shown on Figure 6.14 a-d. The location of the TPS coating is shown directly adhered to the silica base material on Figure 6.14a. Several of the silica fibers were obscured by the hard epoxy mount. Several cavities and pores with a

variety of sizes were predominately present in areas closest to the surface of the TPS. Figure 6.14b shows additional cavities at the surface and the interface between the coating and silica fibers contained small cavities. The cross-section also shows two distinct layers where a difference in contrast can be distinguished. These two areas are pointed out in Figure 6.14c. It was clear that the surface of the coating was irregular and evident on Figure 6.14d. Throughout the sample observation, the coating thickness did not remain constant but irregular. Within the coating, a light gray phase close to the upper edge was present. One edge of the sample is shown on Figure 6.15 and contained severe damage within the coating. The texture of the coating was altered when compared to the upper surfaces (Figure 6.14) with removed areas of the coating (indicated by black arrows).

Figure 6.14 Cross-sections of sample 1.1.A detailing various residual characteristics.

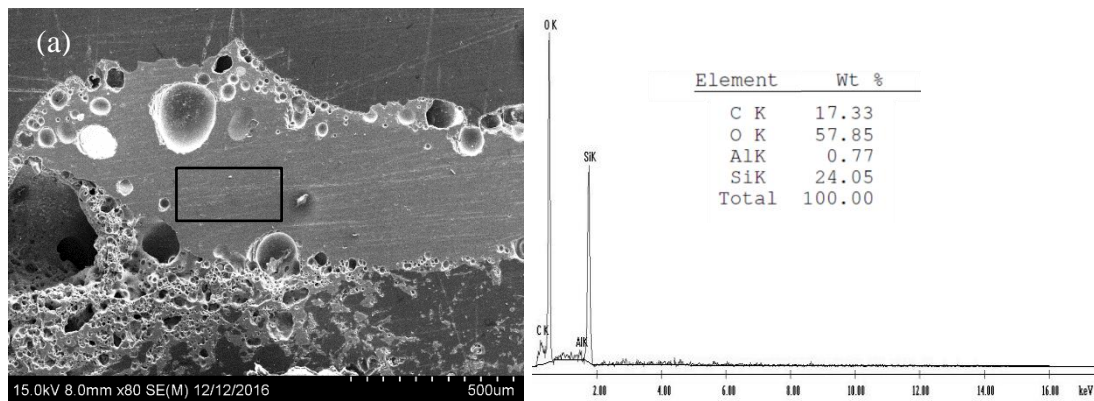
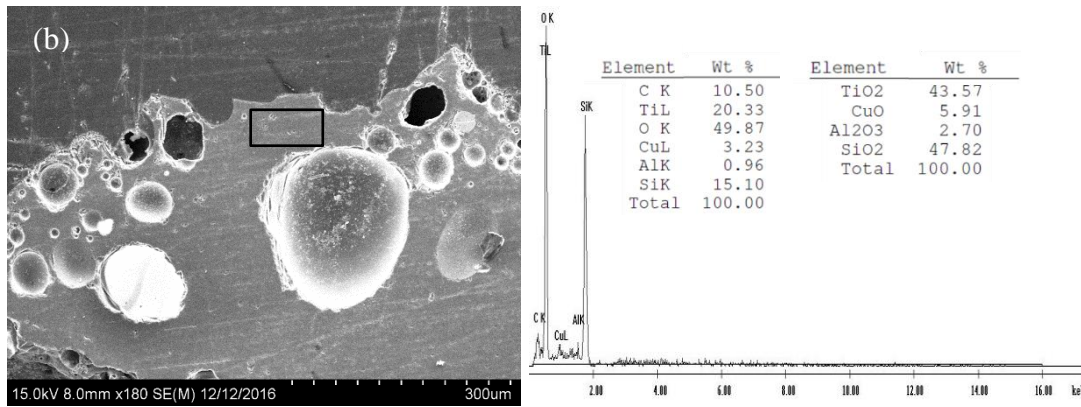
Figure 6.16 Two areas (a) and (b) analyzed through EDS.

Next, EDS analysis was performed to discover if any deposits were embedded in the cross-section. The coating was first analyzed in an area located in Figure 6.16a where area EDS results show that it was rich in Si and O. However, all areas at the top edge of the coating contained additional elements or oxides. This is shown in Figure 6.16b where the results of the top edge consisted of TiO_2 and SiO_2 . Copper was also frequently present as a minor oxide, CuO , and an aluminum oxide Al_2O_3 .

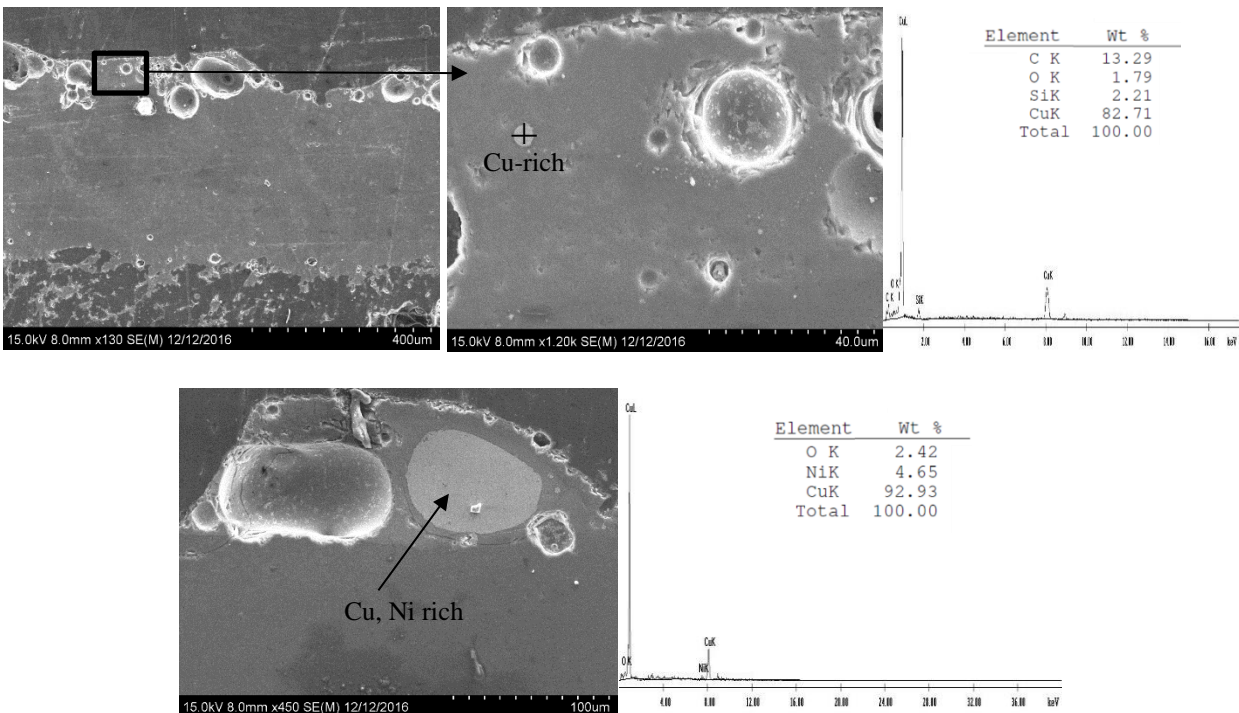
The light gray particles that were present in the coating were analyzed and two particles are shown in Figure 6.17. The first area was located at the upper edge of the coating at a higher magnification, at a light gray phase. Through EDS, the light gray spherical particle was Cu-rich as shown in the spectra. A second larger particle is also shown except it contains an additional minor element of Ni mixed with major element Cu. Several of these particles were observed in the upper areas of the coating.

Figure 6.17 The uppermost area of two cross-sections with spot EDS spectras of two light gray spots.

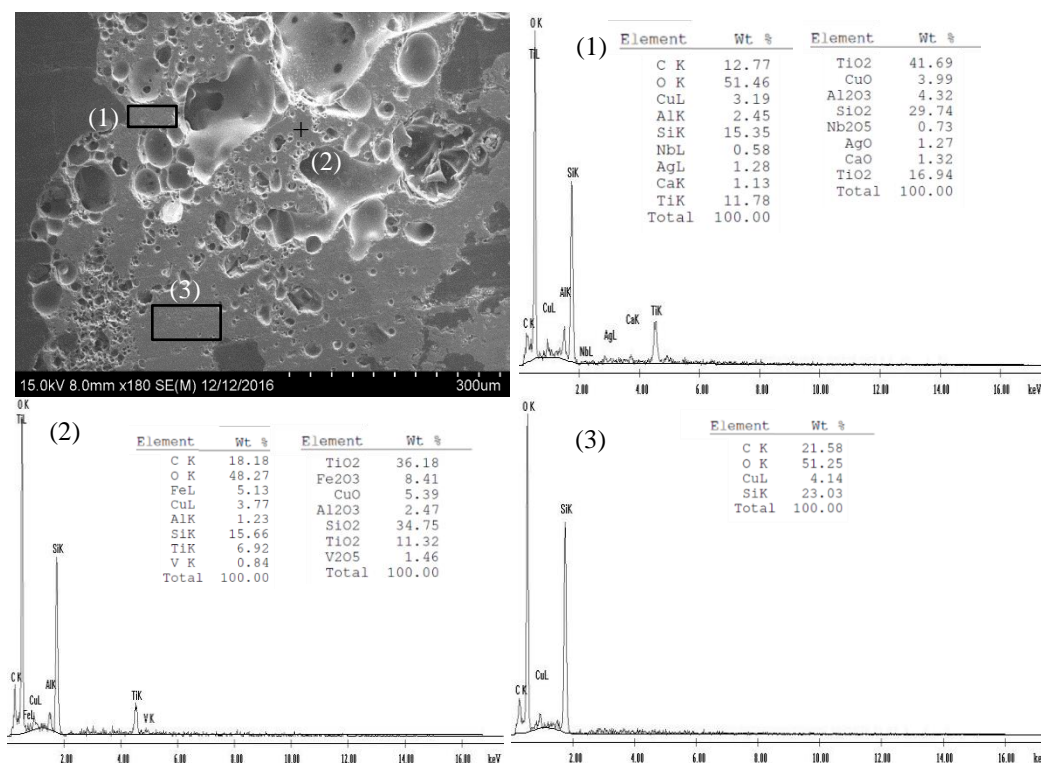
Next, the edge of Sample 1.1A was evaluated since the coating contained the most damage. Two areas and one spot at the coating were studied and shown in Figure 6.18. Area 1 is located close to the edge of the sample and was found to contain O, Si, and Ti. These correspond to SiO₂ and TiO₂ oxides. Other minor elements found were aluminum and copper. Area 3 was located in an area away from the edge of the coating and its spectra shows the same major oxides of SiO₂ and TiO₂. Additional minor oxides of Fe₂O₃, CuO, Al₂O₃, and V₂O₅ were present. Much further from the edge of the coating in spot 2 was rich in O, Si, and C. Copper was a minor element present at this area.

Figure 6.18 Outer edge of the sample with area reading (1), spot reading (2) and an area on (3).

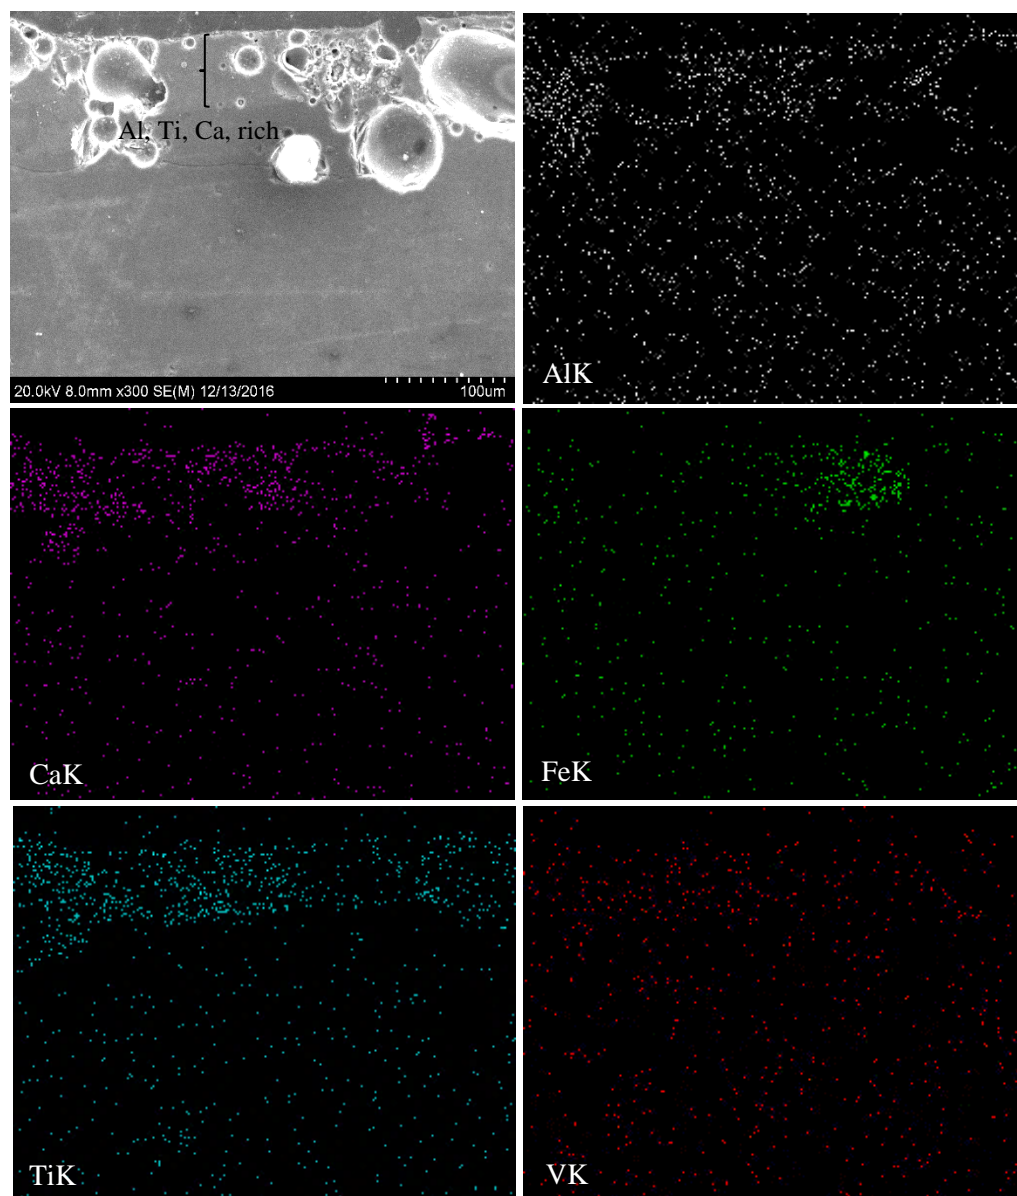
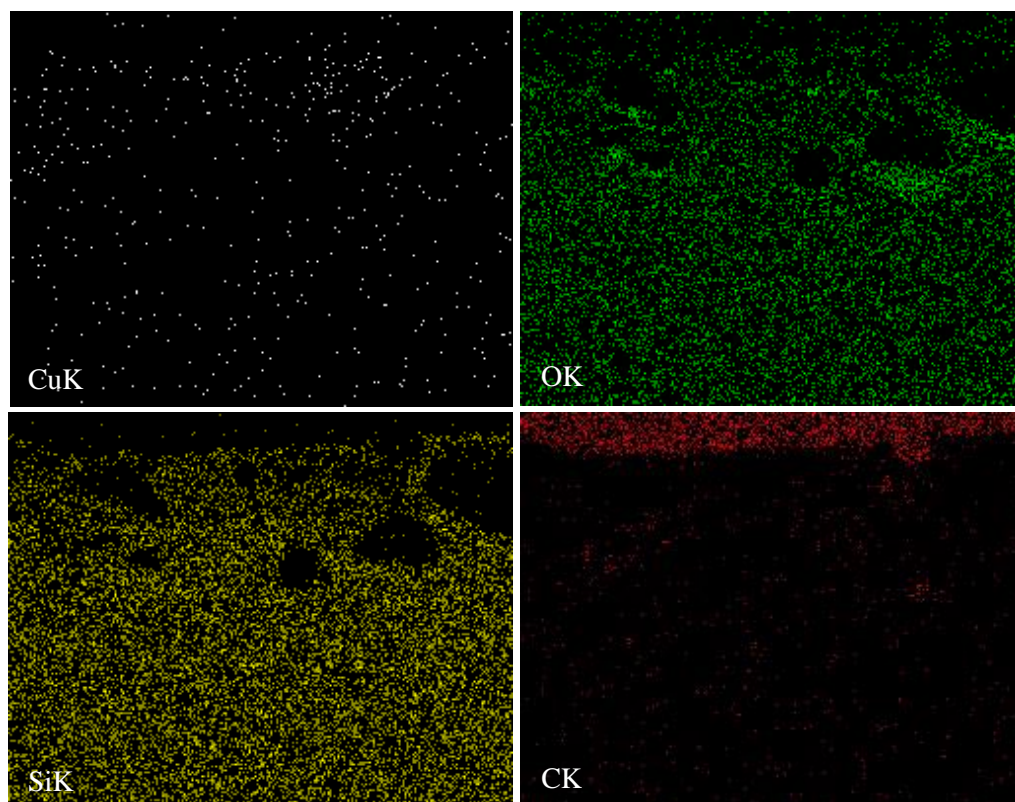
Figure 6. 19 X-ray maps of one cross-section of sample 1.1.A.

Because there were clear indications of the aforementioned constant elements and oxides existing well below the TPS coating, EDS area X-ray elemental maps were generated from an image obtained from SEM. The intensities of the color and distribution are related to the concentration and the distribution of each element detected. The positions of the specific elements of a cross-section of the TPS coating are shown in Figure 6.19. The elements present at the entire surface analyzed are oxygen and silicon. The image measured also contained a lighter contrasted phase and it is clear from the X-ray maps that this area

was rich in Al, Ti, and Ca. Aluminum was concentrated on this lighter phase and dispersed throughout the cross-section. The calcium and titanium were mostly prevalent at the light gray layer. Iron was also present and located in one area near the cavities of the coating. Vanadium and copper were dispersed throughout the cross-section. The location of the carbon detected was due to the plastic mount of the sample and the deep porosity of the coating.

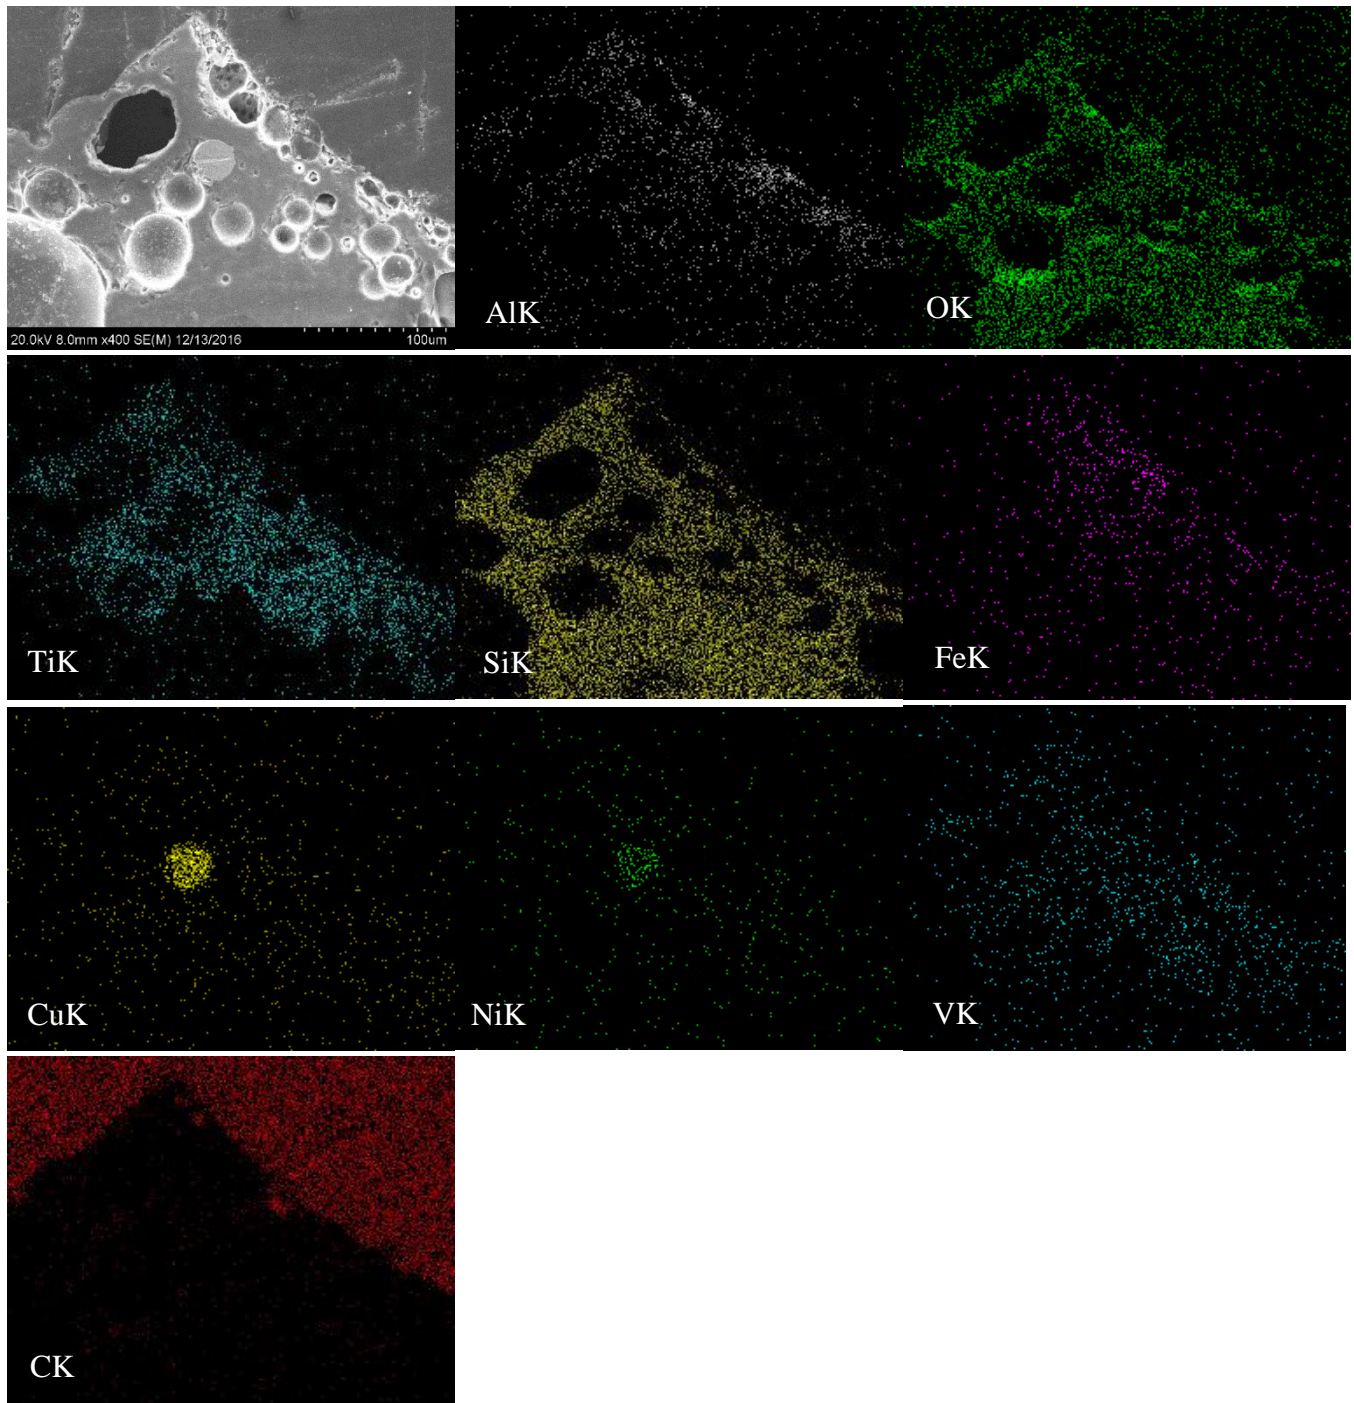
Figure 6.20 X-ray maps of sample 1.1A on the upper edge of the coating.

A second area was also analyzed through X-ray mapping at a location closer to the top edge of the coating. This area previously contained TiO_2 and SiO_2 and developed a light gray spherical phase. The X-ray maps are shown in Figure 6.20 where similar elements were detected and include Al, O, Ti, Si, Fe, Cu, Ni, V, and C. The difference between the area shown in Figure 6.19 was that calcium was the only element not detected. The common elements present throughout the coating were silicon and oxygen. The presence of oxygen shows that there are oxides present on this cross-section. The aluminum detected was concentrated at one edge of the surface and diminished through the coating. Iron contained a similar characteristic and was also shown to be located on the same edge of the coating. The map demonstrates that titanium formed at most of this area of sample 1.1A. Similarly, vanadium formed along where titanium is located. A light gray particle was present on the cross-section where it is confirmed to be comprised of copper and nickel highlighted by their maps.

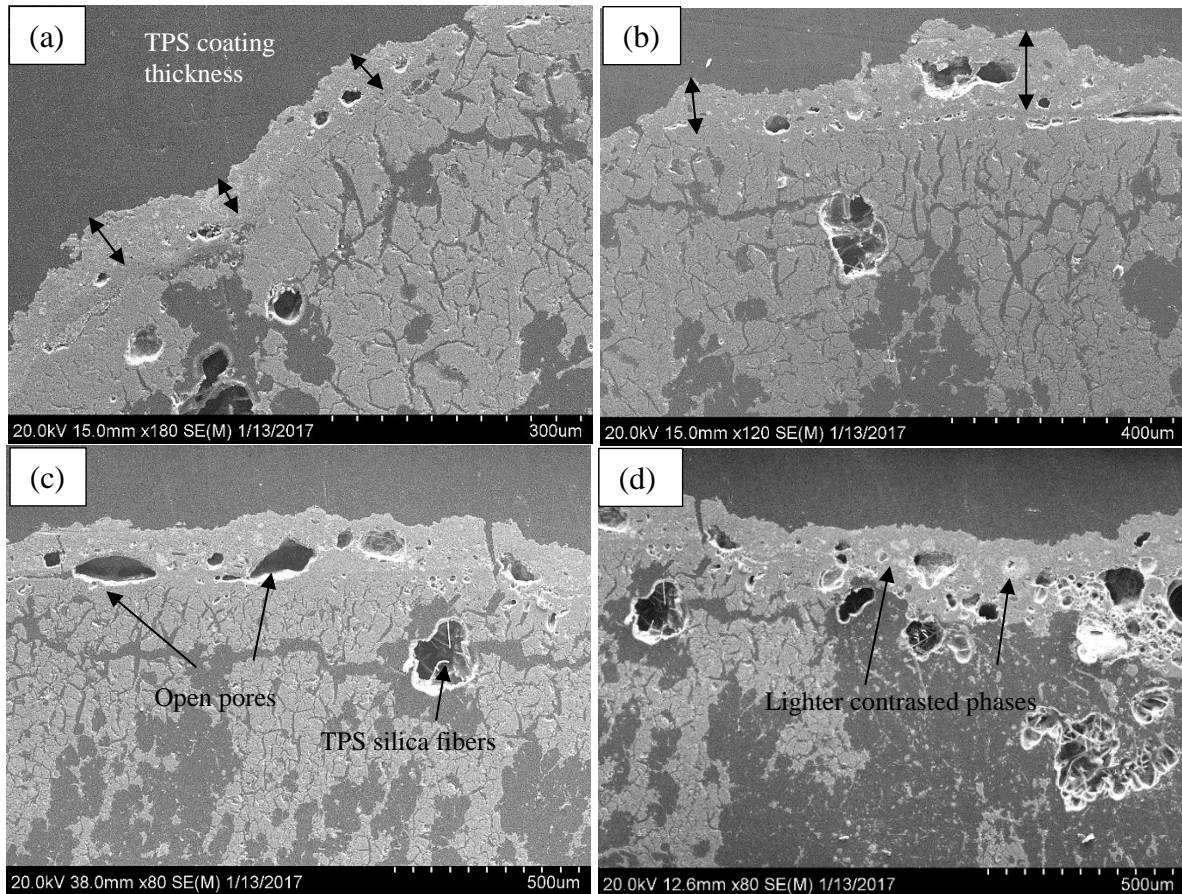
The following sample that was examined at the cross-section was sample 1.1B which was previously attached to sample 1.1A. Four microstructures, a through d, show several areas of the sample in Figure 6.21. The coating of the sample is exhibited by the black arrows in Figure 6.21a and b. The coating of this sample ranges from 50 to 55 μ m and is smaller in width when compared to sample 1.1A.

Also present in the coating are a few open pores within the coating and several areas of the silica fibers were not fully encapsulated by the mounting material. The exposed silica fibers are noticeable in Figure 6.21c and d. Image d also shows open pores and cavities along the interface of the coating and base material. On the coating, several light areas were also distinguished. The micrograph shown in Figure 6.22 shows two areas that were studied with EDS. Area a was located near the surface of the sample, while area b was located well below the interface at the bulk material. The difference in both areas was that near the surface, silicon and oxygen were the largest weight percentages obtained of 24.58 wt% and 52.31 wt%, respectively. This corresponds to having a SiO_2 composition of 56.39 wt%. Whereas, the area below the interface contained 44.13 wt% Al, 22.0 wt% O, and 10.52 wt% Ti.

Figure 6.21 Four microstructures depicting different areas a-d of sample 1.1B.

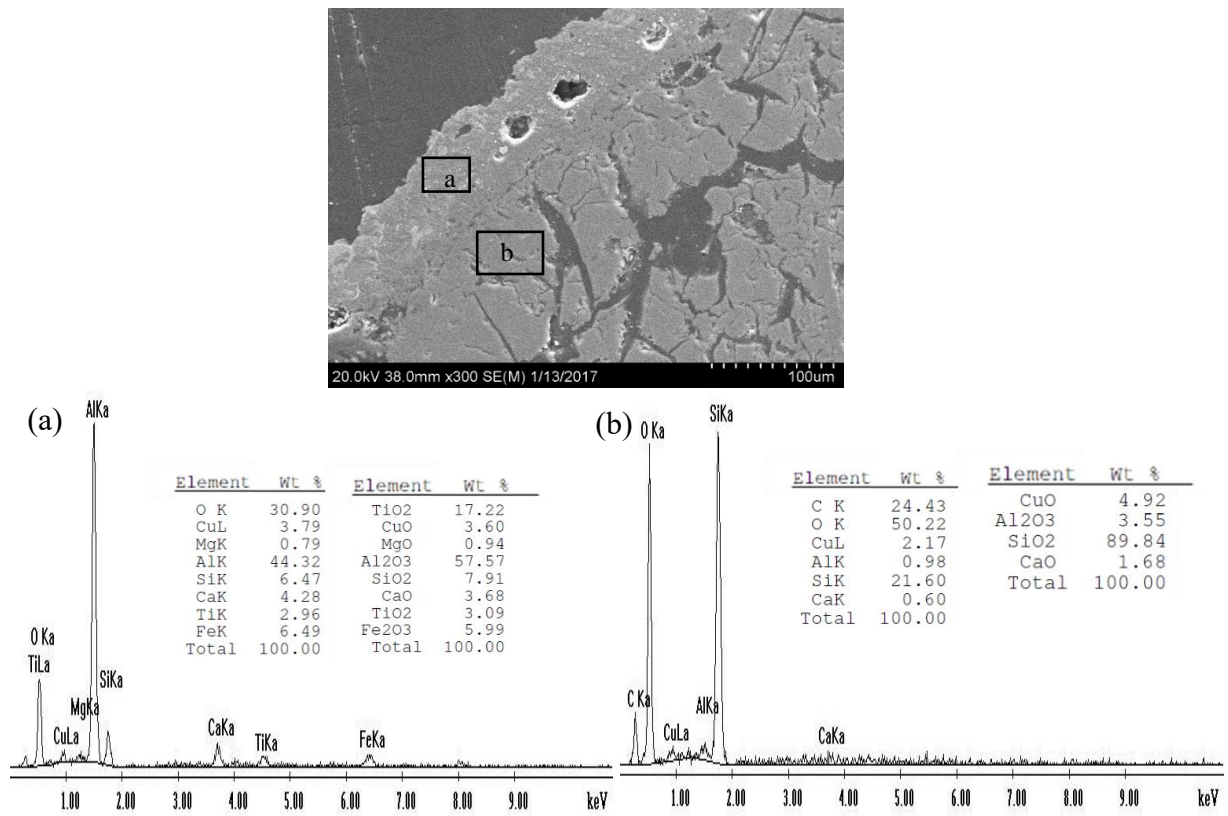
A second area was studied where one side of the sample sloped downwards and the SEM image is presented in Figure 6.23. EDS was performed at the coating and base material where the coating at this location contained 44.32wt%Al whereas at the base material contained mostly silicon and oxygen. It is evident that different locations on this sample contain dissimilar formed deposits. In order to better determine the location of the phases present, X-ray maps were generated for a cross-section shown in Figure 6.24. The elemental maps show that the light gray phases are concentrated with aluminum, iron titanium, and copper. Oxygen and silicon appear to make up most of the sample analyzed. Calcium was only present in the coating of sample 1.1B. The vanadium as shown in red was finely distributed mostly within the coating.

Figure 6.23 A second micrograph showing the difference in elements detected of the coating (a) and the base material (b).

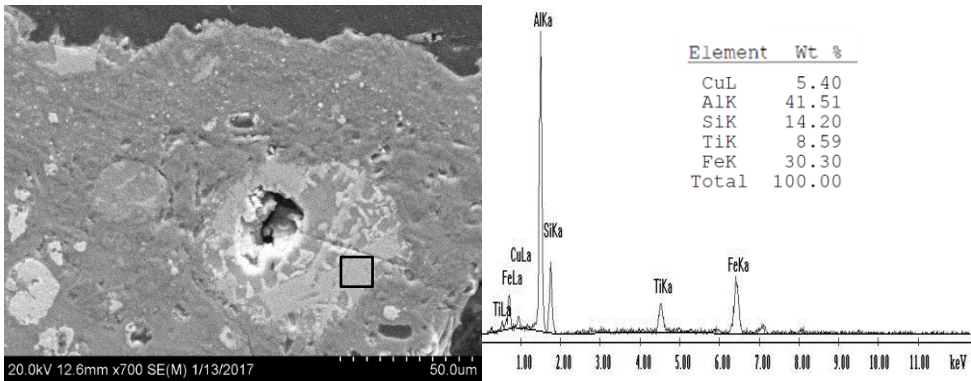
Figure 6.25 A light gray area analyzed with the EDS composition shown.

Because the maps show a mixture of elements within the light gray phases in the coating, an SEM image was obtained at one of these phase locations. Figure 6.25 demonstrates the morphology of the phase that seems to contain a darker gray and light gray contrast. Smaller specks of light gray particles can also be identified. When analyzing a spot through EDS, the phase was consistent with the elemental maps with 41.51 wt% Al, 30.30 wt% Fe, and 14.20 wt% Si. No oxygen was found in these areas, which show that it is a metallic phase mixture. Another microstructure shows that the light gray phase mixture was also

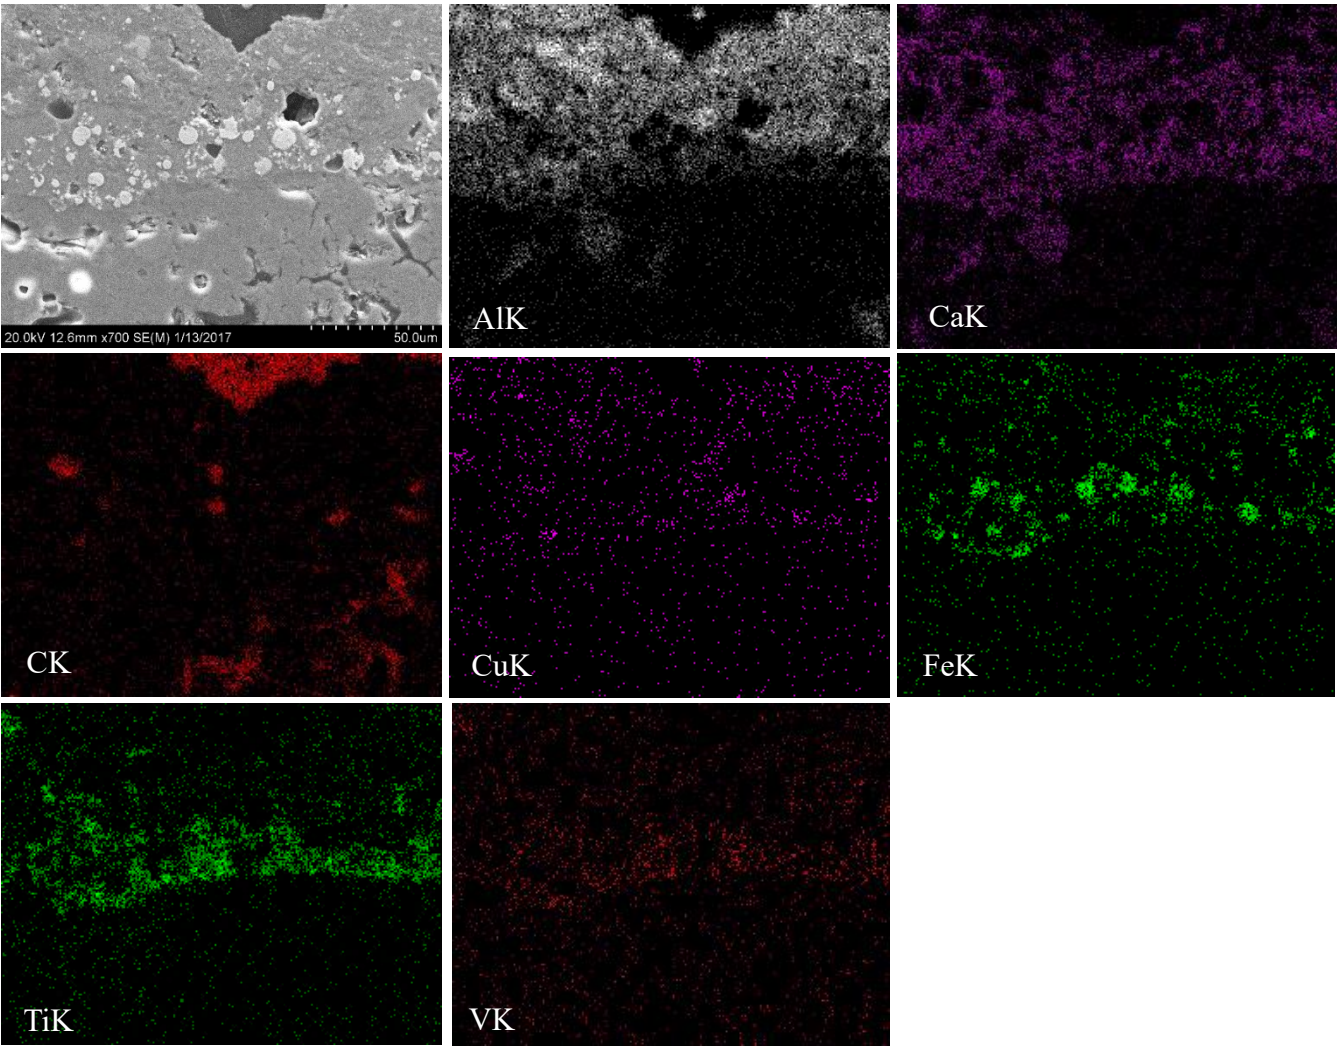
Figure 6.26 X-ray map distribution of sample 1.1B with a phase mixture at the interface.

located near the interface between the coating and bulk material. The micrograph in Figure 6.26 shows these Al, Si, Ti, Fe, and Cu phases also exist at the interface as illustrated by the X-ray maps.

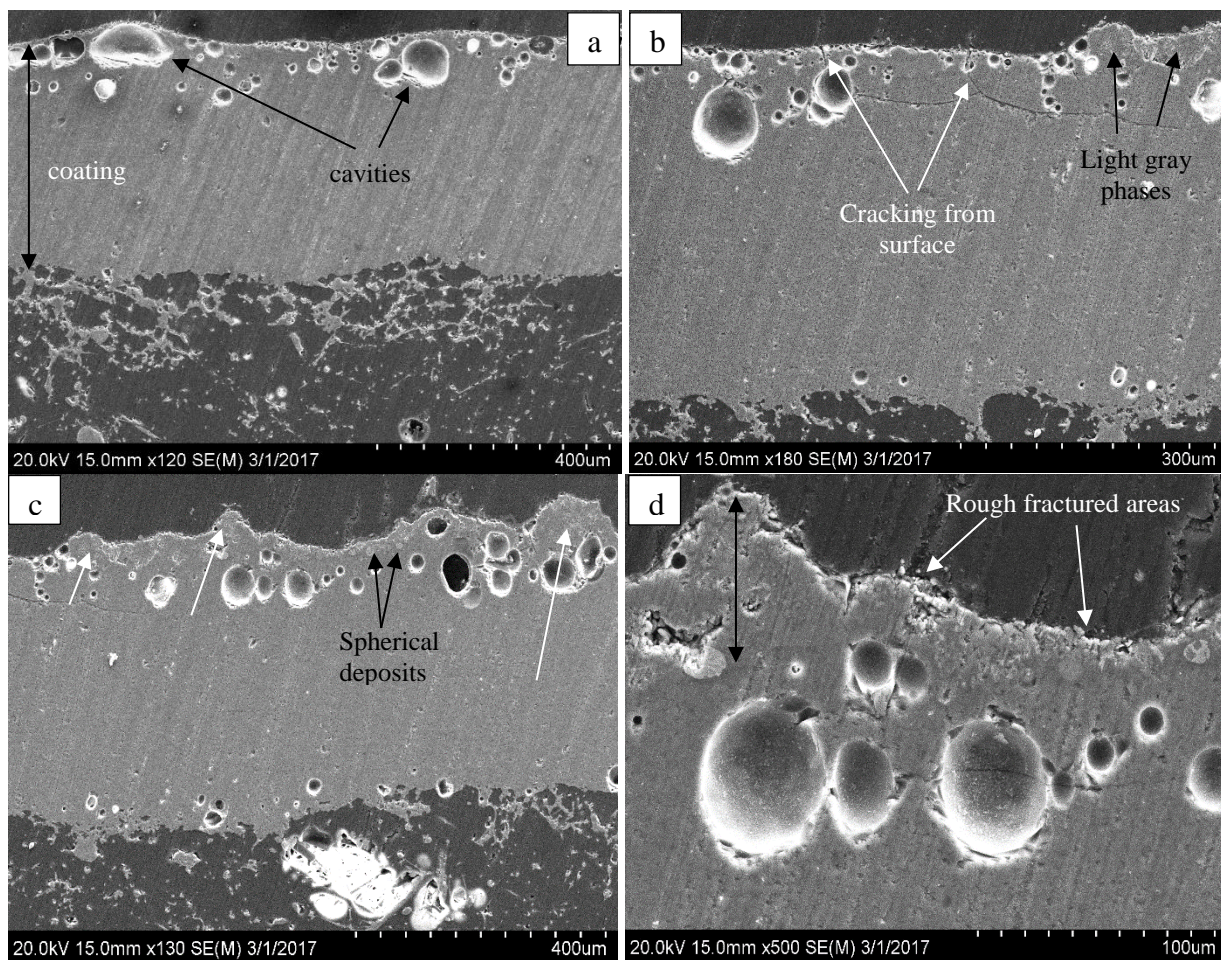
Figure 6.27 Cross-sections a-d of sample 1.2.

Sample 1.2 was then evaluated to determine the existence of deposits as the surface did not contain a thick coating. However, similar elements were detected. Figure 6.27 shows the microstructures of the sample with several characteristics pointed out. On Figure 6.27a, cavities are present near the surface of the TPS and the thickness of the coating remains constant. Figure 6.27b shows cracks emanating from the surface that branch through the coating. Some light gray phases can be discerned especially on Figure 6.27c and d. Several spherical phases were developed along with fracture areas of the surface. The arrow on image d shows a distinct light layer.

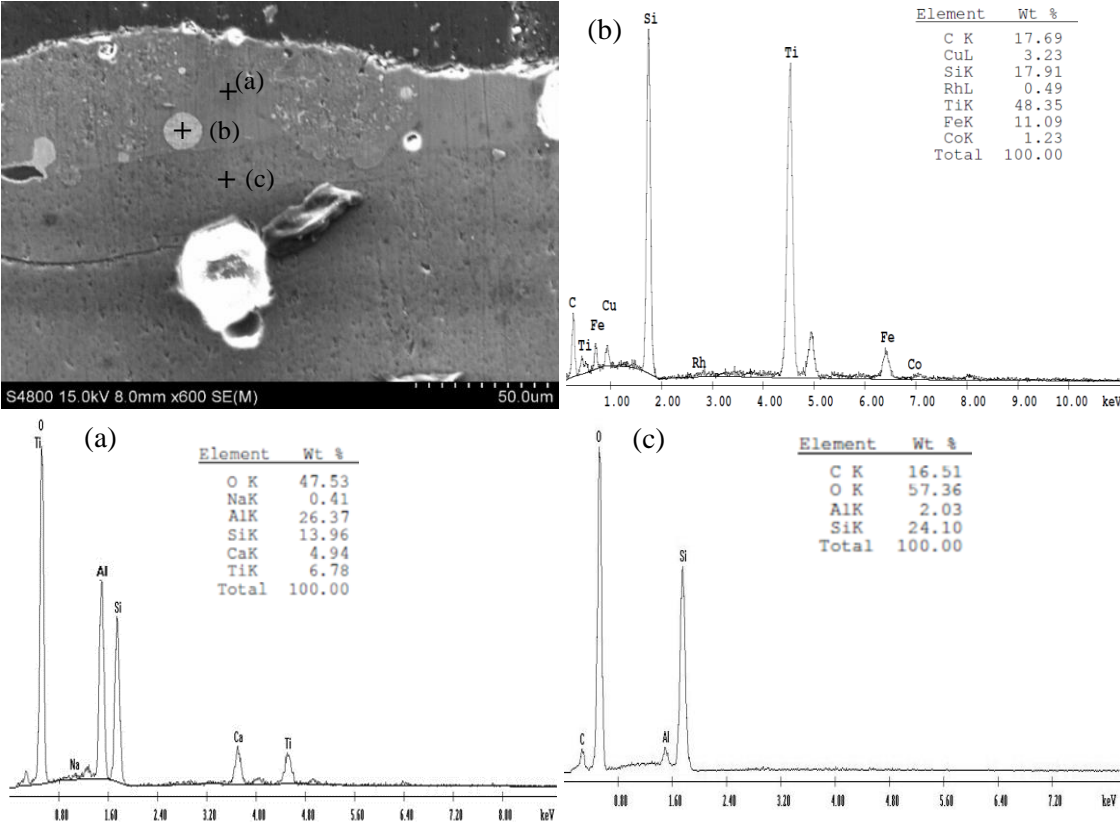
Figure 6.28 Spot EDS measurements of a gray area (a), spherical phase (b), and a darker area on (c).

As a result of evidence of light phases, EDS spot measurements were obtained near the coating of the sample. Figure 6.28 shows three spot evaluations to represent a location of a gray layer on spot a, a light gray spherical phase b, and a dark gray area c. Spot a contained prominent peaks of titanium oxide,

aluminum, silicon, calcium, and titanium. Spot b did not contain any oxygen but was a combination of 48.35 wt% Ti, 17.91 wt% Si, 11.09 wt% Fe, and 3.21 wt% Cu. Spot c however, was comprised of 57.36wt% O and 24.10wt%Si. Because the light gray phases were abundant in titanium, X-ray maps were collected on the microstructure shown in Figure 6.29. The light gray dispersed phases are emphasized in the titanium map. Within the titanium phases, other small phases of copper and vanadium were also highlighted on the element map. Oxygen and silicon were also present on the entire cross section, however, an aluminum layer surrounded the Ti and Cu phases. The titanium suggests that it was deposited before the aluminum layer. The calcium map shows it was mostly located in the aluminum layer.

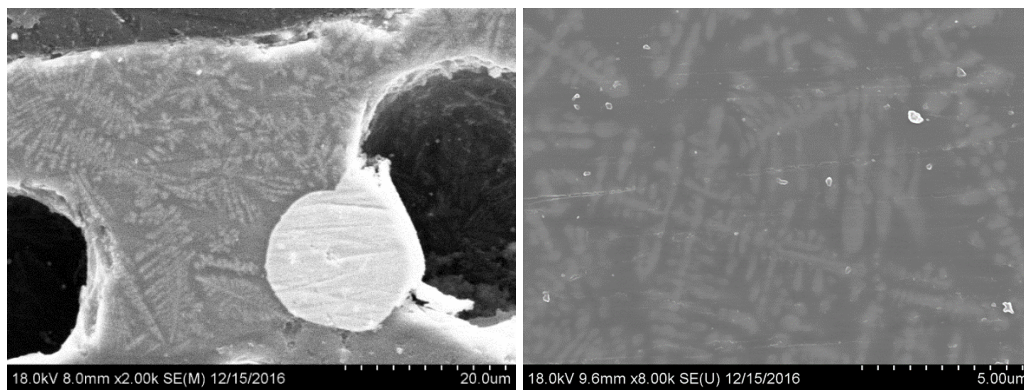
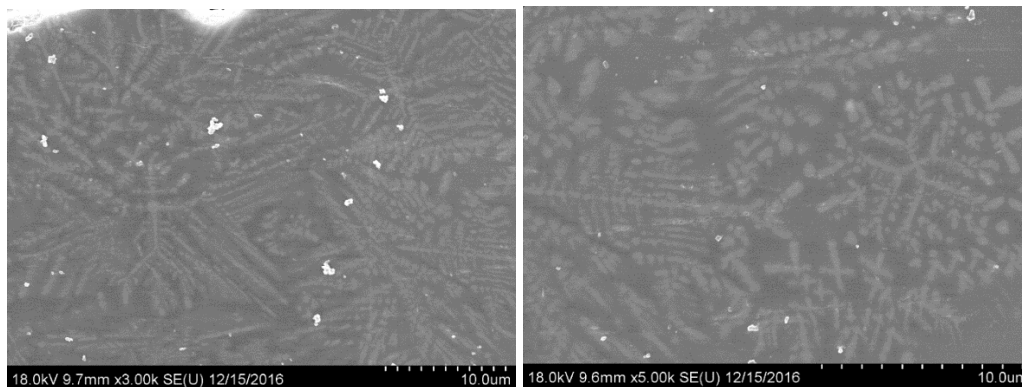
As sample 1.3 contained metallic splats rich in aluminum, the cross-section was evaluated for deposits and microstructural features. Figure 6.30a and b show a light gray deposit layer that was present on the surface of the sample. Several hollow areas and cavities were present near the coating as well as cracks that initiated at the surface. Within the light gray coating, a certain texture was observed along with a bright spherical phase shown on Figure 6.30c. Another area in the sample contained a large deposit formation with a light gray coloring as illustrated on figure 6.30d. At higher magnifications of the deposit revealed the morphology shown on Figure 6.31a through d. Several areas of the deposit contained a dendritic-like structure at higher magnifications. The morphology consisted with tree-like formations, indicative of secondary and tertiary dendritic arms, with branching in certain directions.

Figure 6.31 Four images showing areas of the deposit line near the surface with a dendritic-like structure.

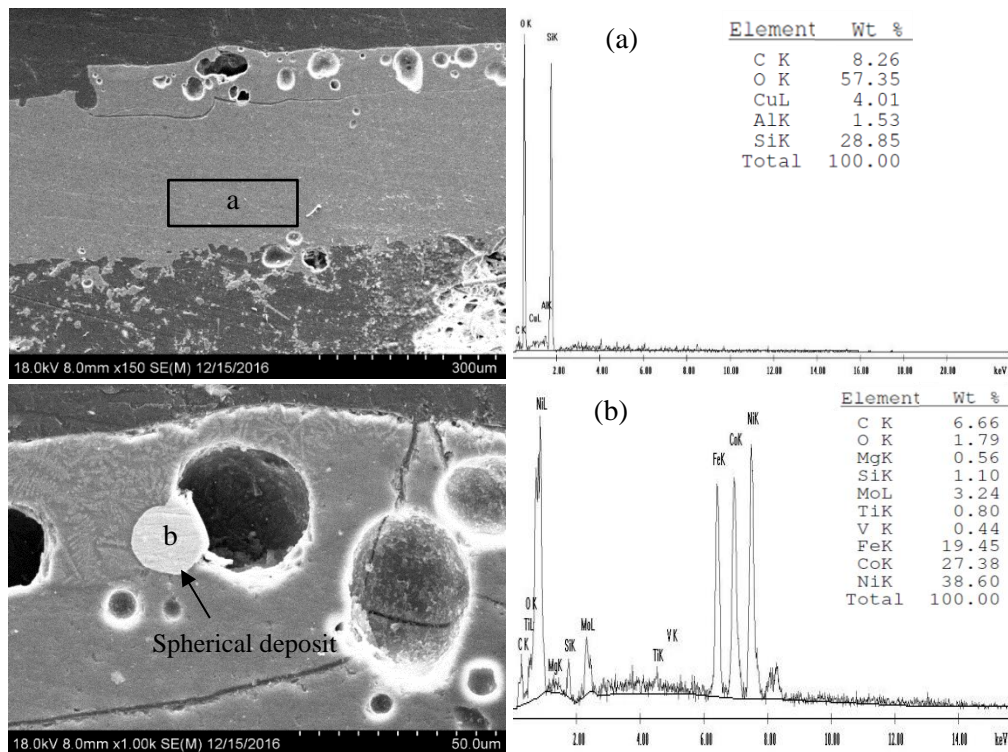
Figure 6.32 EDS area analysis deep within the TPS coating cross-section (a) and a bright deposit (b).

Elemental analysis was next completed and Figure 6.32a shows an area analyzed near the interface of sample 1.3. The main elements detected were 28.85 wt% Si and 57.35 wt% O. The minor elements included 8.26 wt% C, 4.01 wt% Cu, and 1.5 3wt% Al. Conversely, the previously discussed unique features in the microstructure were analyzed and presented in Figure 6.32b. Several major elements were identified and included 38.60 wt% Ni, 27.38 wt% Co, and 19.45 wt% Fe. These compositions were not previously present in the samples studied. After that, the dendritic region was investigated with EDS. Figure 6.33 presents two spot evaluations with a light gray dendrite at spot 1 and a surrounding dark gray phase spot 2. There is a major difference in these two phases in which the light dendrites contained an average of 38.76 wt% Ti and 38.26 wt% O. The minor elements at spot 1 constituted of 6.28 wt% Si, 5 wt% Al, 3.72 wt% Cu, and 2.18 wt% Ca. Spot 2 contained less titanium (16.86 wt%) and 35.13 wt% O. The minor elements were similar with compositions of 9.16 wt% Cu, 9.14 wt% Si, 4.09 wt% Ca, 3.50 wt% Fe, and 9.45 wt% Au.

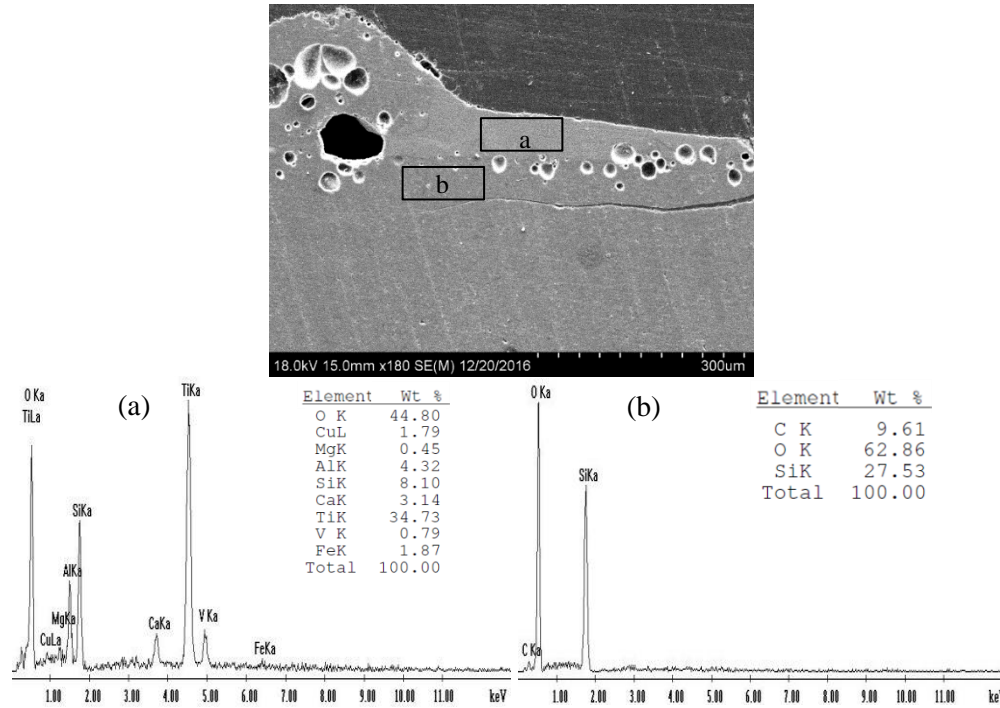
Figure 6. 34 EDS area assessment of the deposit (a) and below the deposit (b).

The deposited layer near the largely formed deposit was also inspected to determine where the composition changes. Figure 6.34 distinguishes the light gray deposit on a and a darker area following the interface on b. The dark area does not have most of the elements identified on the top layer. Area a contained 44.80 wt% O, 34.73 wt% Ti, 8.10 wt% Si, 4.32 wt% Al, and 3.14 wt% Ca. The only compositions present on area b were 62.86 wt% O, 27.53 wt% Si, and 9.61 wt% C. To determine what phases deposited first, a set of individual X-ray maps were performed to highlight the phase distribution. In the set of element maps shown in Figure 6.35, the light gray deposit shows high aluminum, calcium, titanium, oxygen, and vanadium. In this area after all, is richest in titanium as shown. The dendritic area was analyzed next to reveal the phases at the dendrite grains. Figure 6.36 shows a micrograph used to develop individual maps where the black arrows show the extension of the dendrites. The microstructure changes after this area. The majority of the dendritic area contained titanium, silicon, oxygen, and

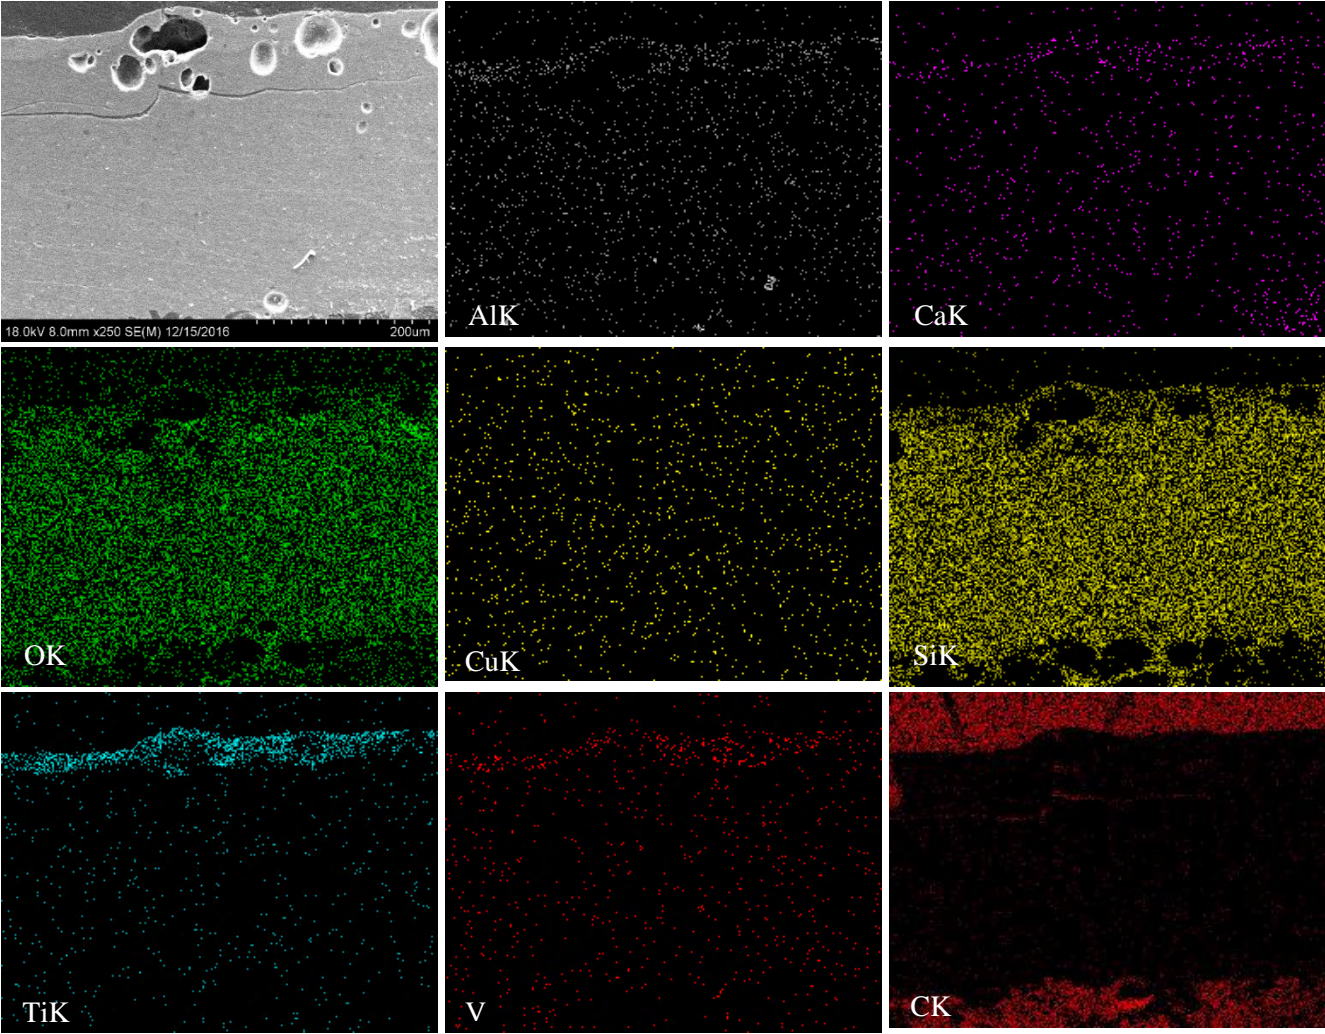
Figure 6.35 X-ray maps of an overall cross-section of sample 1.3.

vanadium. It was observed on the maps that the areas with no dendrites are high in aluminum and calcium. Nickel was a minor element and dispersed through the microstructure.
