Material Behavior of Window 7 Carrier Panel Tiles and Thermal Pane Fragments Recovered from the Space Shuttle Columbia

MATERIAL BEHAVIOR OF WINDOW 7 CARRIER PANEL TILES AND
THERMAL PANE FRAGMENTS RECOVERED FROM THE SPACE
SHUTTLE COLUMBIA

DISSERTATION

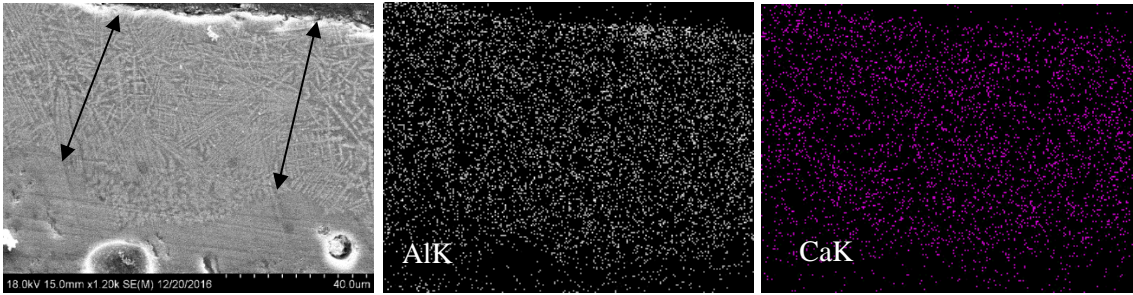
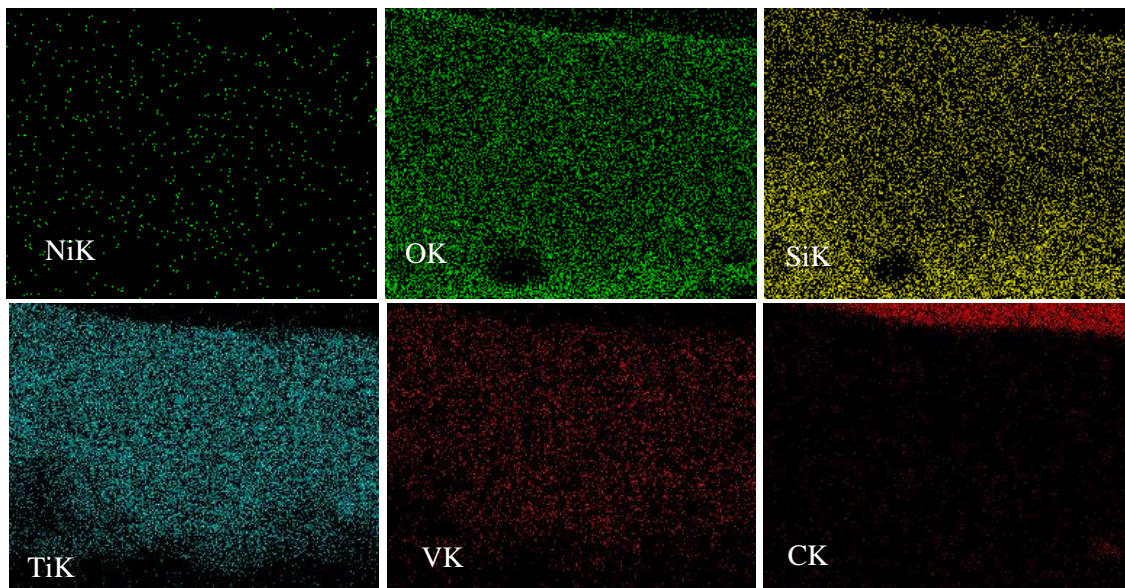
Figure 6.36 X-ray maps of the dendritic area of sample 1.3.

The deposited layer near the largely formed deposit was also inspected to determine where the composition changes. Figure 6.34 distinguishes the light gray deposit on a and a darker area following the interface on b. The dark area does not have most of the elements identified on the top layer. Area a contained 44.80 wt% O, 34.73 wt% Ti, 8.10 wt% Si, 4.32 wt% Al, and 3.14 wt% Ca. The only compositions present on area b were 62.86 wt% O, 27.53 wt% Si, and 9.61 wt% C. To determine what phases deposited first, a set of individual X-ray maps were performed to highlight the phase distribution. In the set of element maps shown in Figure 6.35, the light gray deposit shows high aluminum, calcium, titanium, oxygen, and vanadium. In this area after all, is richest in titanium as shown. The dendritic area was analyzed next to reveal the phases at the dendrite grains. Figure 6.36 shows a micrograph used to develop individual maps where the black arrows show the extension of the dendrites. The microstructure changes after this area. The majority of the dendritic area contained titanium, silicon, oxygen, and

vanadium. It was observed on the maps that the areas with no dendrites are high in aluminum and calcium. Nickel was a minor element and dispersed through the microstructure.

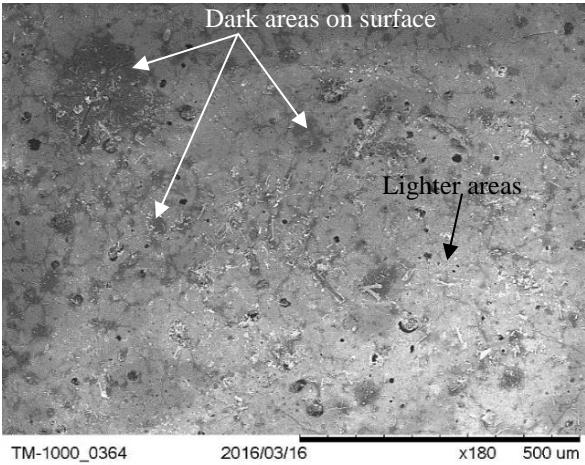
Surface features of sample 2.1.1A were examined and presented in Figure 6.37. The morphology of the surface contained areas where a light deposit was applied. Some dark areas as shown in the image were exposed areas of the black TPS coating. Thinly shaped deposits were present along with indentations, cracks, and pores. When acquiring elemental information on the surface, all locations measured contained

Figure 6.37 Surface SEM of sample 2.1.1A with dark spots and lighter areas.

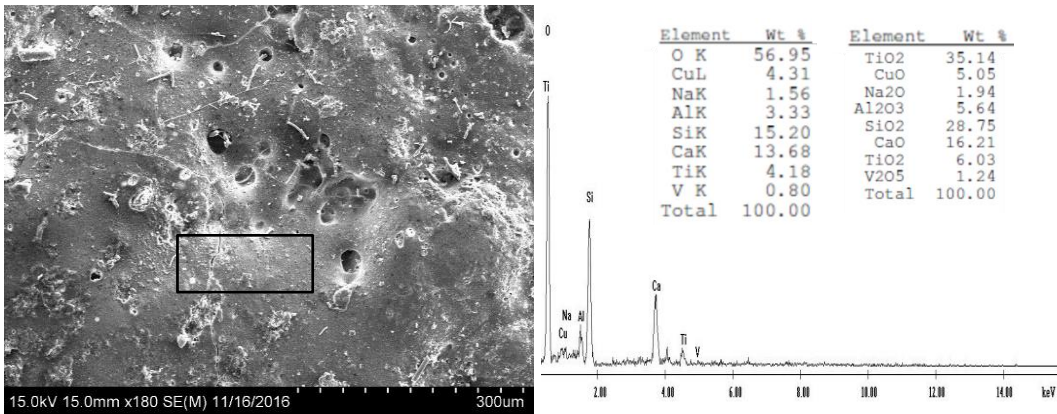
Figure 6.38 Surface SEM analysis and EDS results of sample 2.1.1A.

similar compositions. Figure 6.38 shows the recurring composition of the surface that consists of 56.95 wt% O, 15.20 wt% Si, 13.68 wt% Ca, 4.31 wt% Cu, 4.18 wt% Ti, and 3.33 wt% Al. Other minor elements detected included 1.56 wt% Na and 0.80 wt% V.

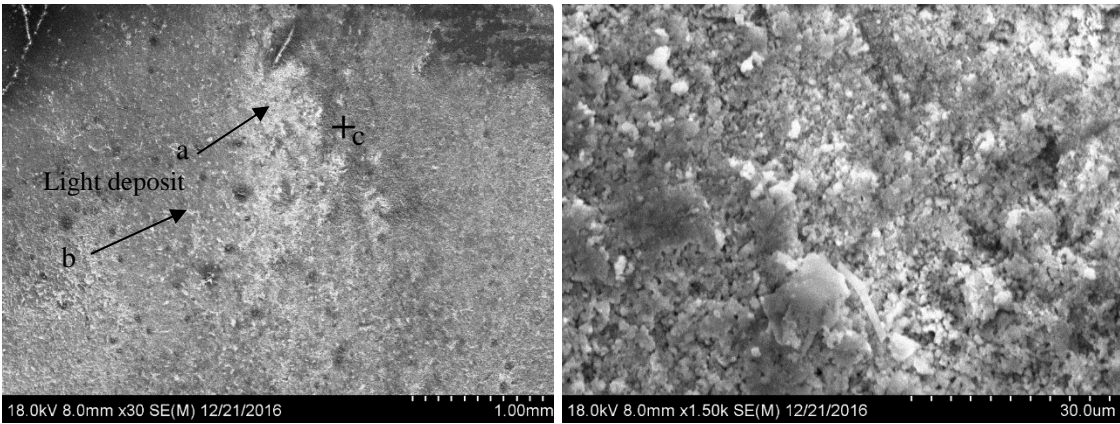
Figure 6.39 Surface of sample 2.1.1B at 30X and 1,500X. Image also shows areas where EDS measurements were obtained.

The next sample analyzed was the sample sectioned perpendicular to the top surface of the TPS. Sample 2.1.1B was originally attached to sample 2.1.1A but it’s vertical edge. The surface of the sample contained visible white discoloration during NDE. Under SEM, a light deposit was recognized and at a higher magnification, the surface appeared to contain grain-like particles (Figure 6.39). The marked areas show the positions of where EDS spot measurements were taken. Figure 6.40 displays the corresponding EDS results of two measurements in the light deposit and an area without the deposit. Spots b and c

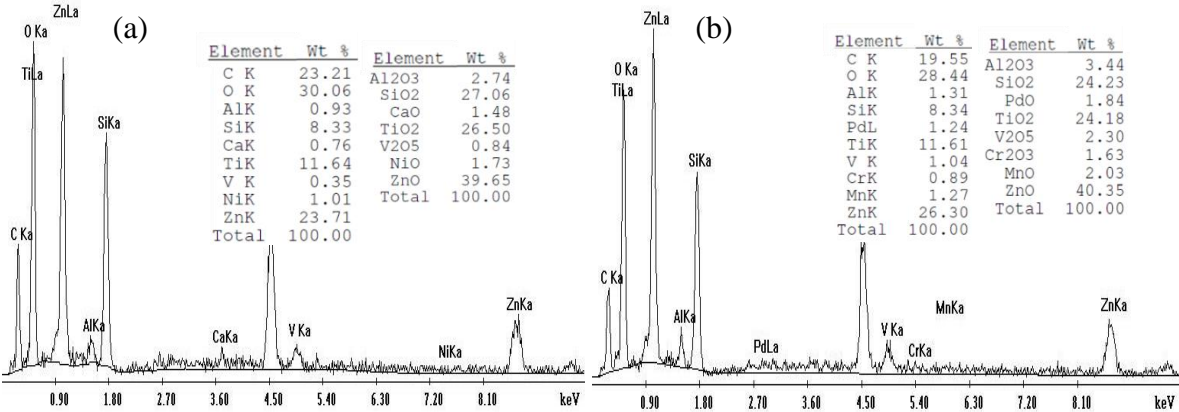
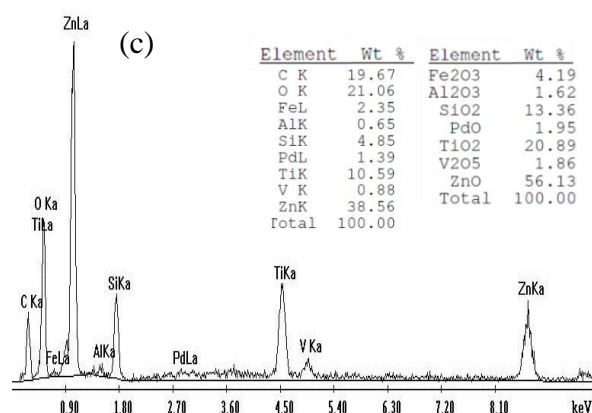
Figure 6.40 Corresponding EDS spot measurements of locations a-c.

confirm that the light deposit contained a high weight percentage of Zn, O, and C. The oxides present were shown to be mostly ZnO, TiO₂, and SiO₂. In this sample dissimilar to all previous sample, the trace elements were Al, Ca, V, Cr, and Ni. Spot c contained a high amount of Zn followed by O, C, and Ti. The amount of Zn was higher than that of spots a and b. The measured oxides also included ZnO, SiO₂, and TiO₂. The source of the Zn would have been the zinc based chromate used to protect the aluminum substructure of the orbiter [2]. Another possible source of Zn would be derived from any 7000 series Al-Zn alloys within the substructure.

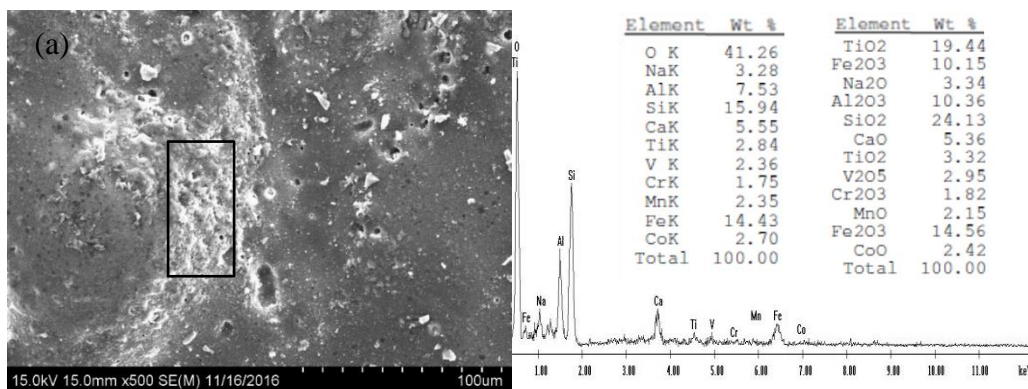
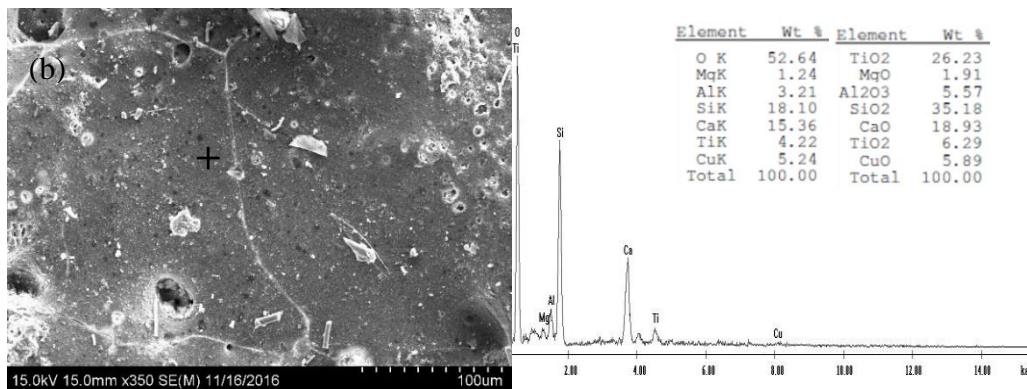
Figure 6.41 EDS results obtained on the white area (a) and dark area (b) of sample 2.1.3.

The adjacent samples 2.1.2 and 2.1.3 contained similar deposits during NDE, as the bright yellow discolorations began to diminish in these locations. The surface of sample 2.1.2 was preserved for XPS surface analysis. The surface morphology of sample 2.1.3 was identical to that of sample 2.1.1A. The surface contained a variety of white deposits and darker areas. Pores that penetrated through the coating were also observed along with small indentations. Surface cracks were also present. The EDS analysis was also comparable in white a light deposit on Figure 6.41a contained major peaks of TiO_2 , Si, Al, and Ca. A darker area with no visible deposit (Figure 6.41b) also consisted of similar compositions except without the trace elements of Fe, Na, V, Cr, Mn, and Co.

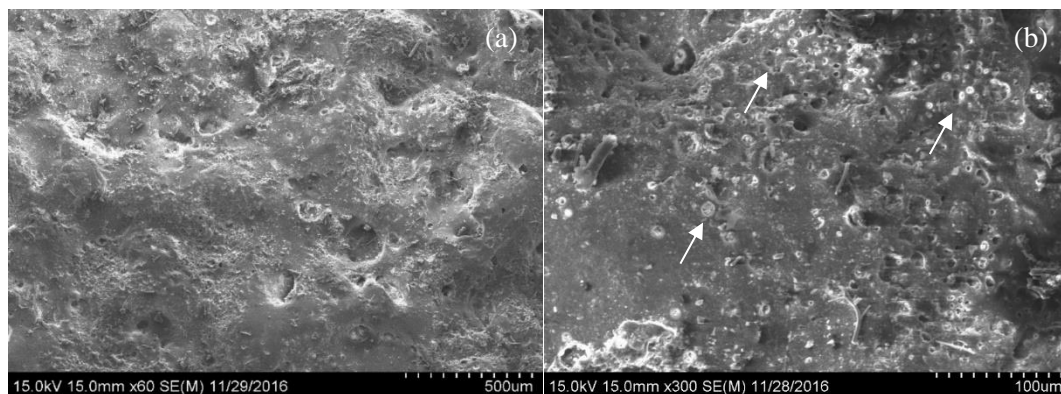
The sample that was close to the inner side of the tiles was sample 2.1.4 and had small metallic deposits with yellow discolorations. The surface was uneven and had an irregular texture when compared to the previous samples. No flat areas were obtained and some difference in contrast was also observed. Figure 6.42 shows the morphology of the overall surface of sample 2.1.4. Image b also demonstrates small white impacts on the surface. Differences in the surface elemental composition results were recorded and displayed on Figure 6.43a and b. The identification of elements in the first area showed that the major amounts were 59.57 wt% O, 18.35 wt% Si, and 16.18 wt% Ca. Al, Mg, and Mn were present in minor amounts. The oxide results show major oxides of SiO_2 and CaO . A second area b contained elevated titanium oxide. The major amounts of Si and Ca were similar to area a. Minor elements were present that include Cu, Al, Fe, V, and Mn.

Figure 6.42 Sample 2.1.4 surface SEM image (a) shows the surface with a rough uneven texture and at a higher magnification, image (b) shows small white impacts on surface.

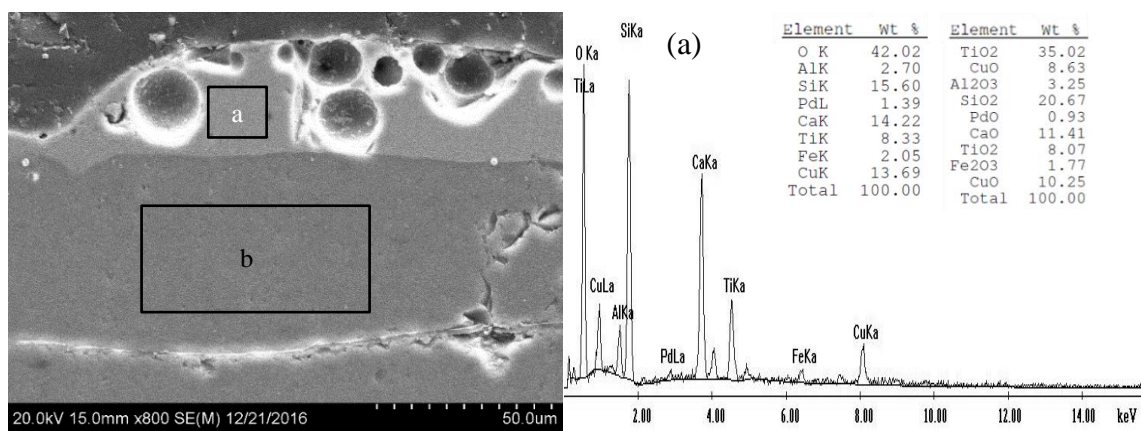
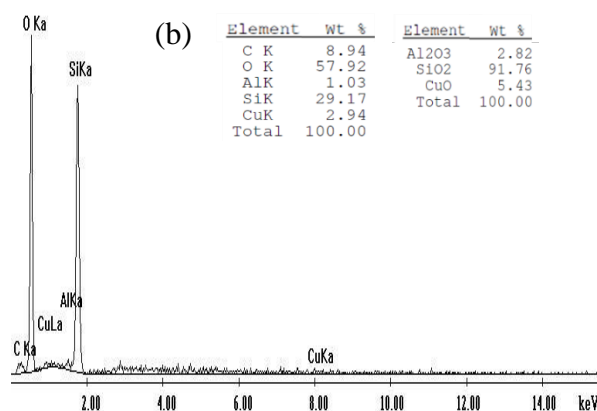
Figure 6.45 EDS results of an area on the light gray layer (a) and darker layer (b).

Elemental composition was collected to determine if the present layer contained identical composition to the layer seen on the previous TPS samples. Figure 6.45 shows the elemental identification of the layer on a and at a location separate from the deposit on b. The deposit contained major characteristic peaks of titanium oxide with 42.02 wt% O and 8.33 wt% Ti. Other major peaks correspond to 15.60 wt% Si, 14.22 wt% Ca, and 13.69 wt% Cu. The second area b shows a change in the composition where it is comprised of 57.92 wt% O and 29.17 wt% Si. The amount of copper decreases to 2.94 wt% and no calcium, iron, and titanium was present. Another area at near the edge of the coating was also analyzed and is presented in Figure 6.46. The measured spot shows similar compositions to Figure 6.45a except for an increase in titanium was present (16.42 wt%). EDS mapping confirms that the layer is a mixture of aluminum, titanium, oxygen, copper, and silicon. The SEM image along with the individual elemental maps are displayed on Figure 6.47. The distribution of aluminum shows that it was also present well below the deposited layer. Although the microstructure contained aluminum maps from the micrograph on Figure 6.45 the maps show no aluminum present on Figure 6.48 since the weight percentage was low. The deposited layer in this area was composed of calcium, copper, oxygen, silicon, and titanium. The elemental compositions of the deposited layer vary when analyzing different areas of the sample.

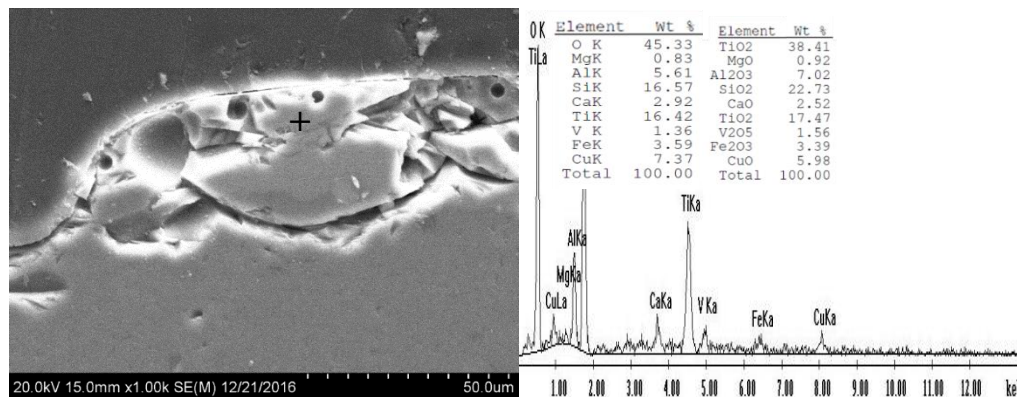
Figure 6.46 Micrograph at 1000X with spot EDS results.

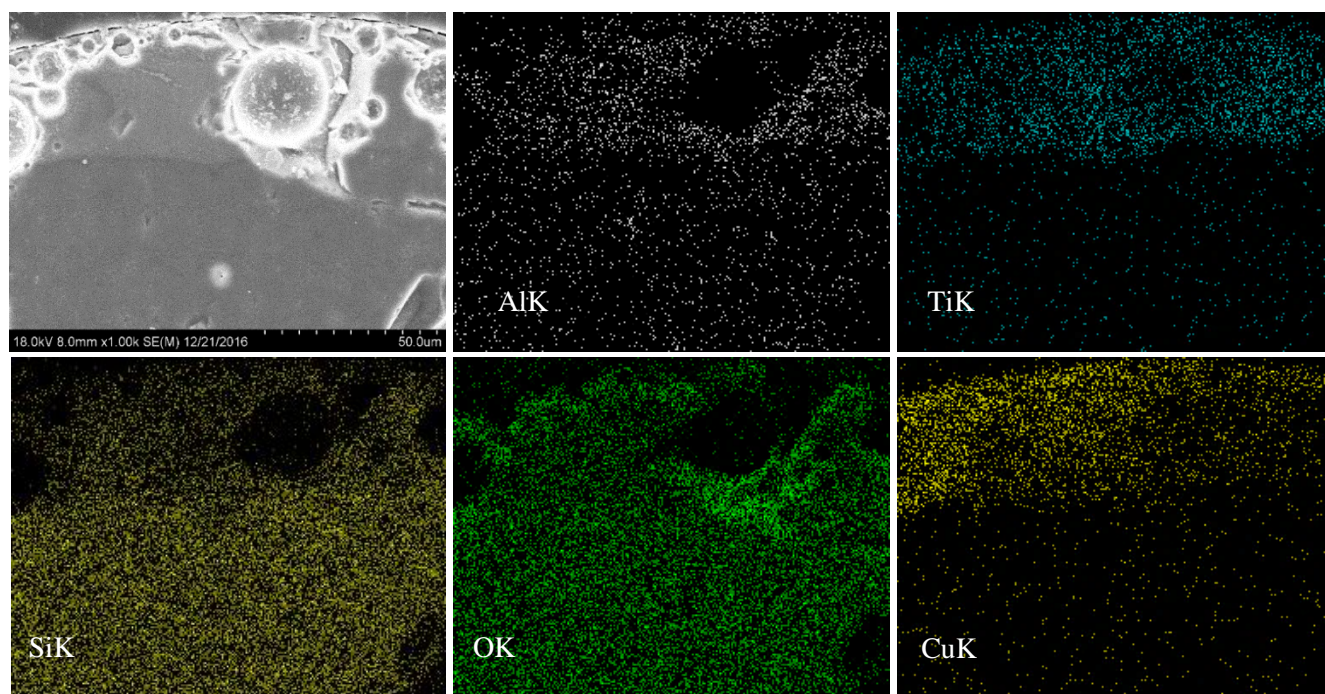
Figure 6. 47 X-ray maps collected from the micrograph shown of sample 2.1.1A.

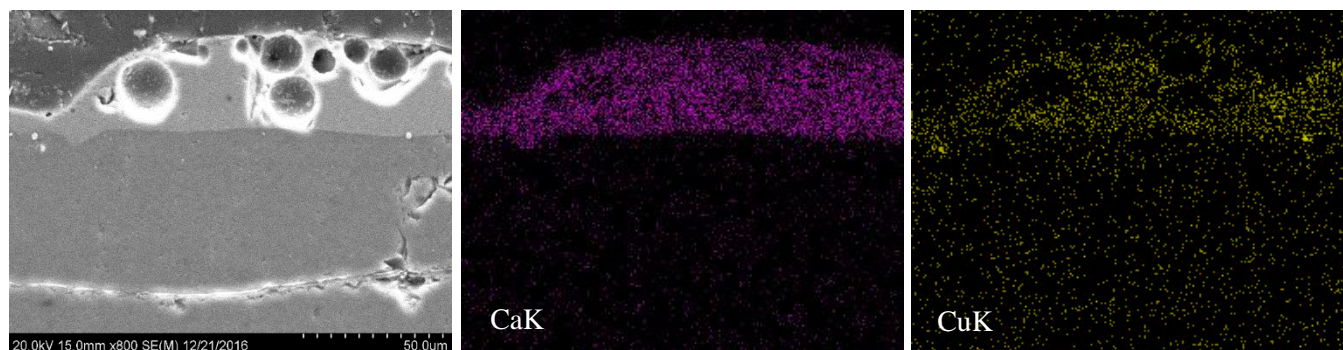
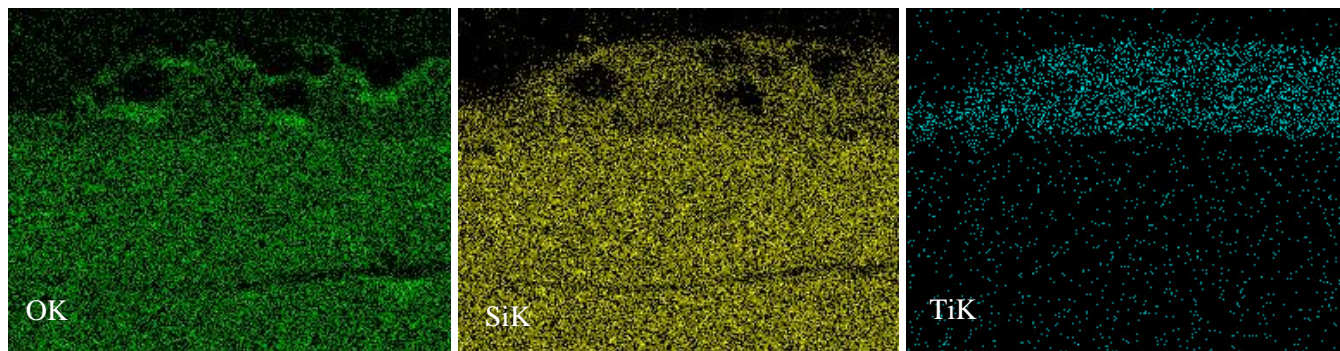
Figure 6. 48 X-ray maps collected from the micrograph shown with the addition of Ca.

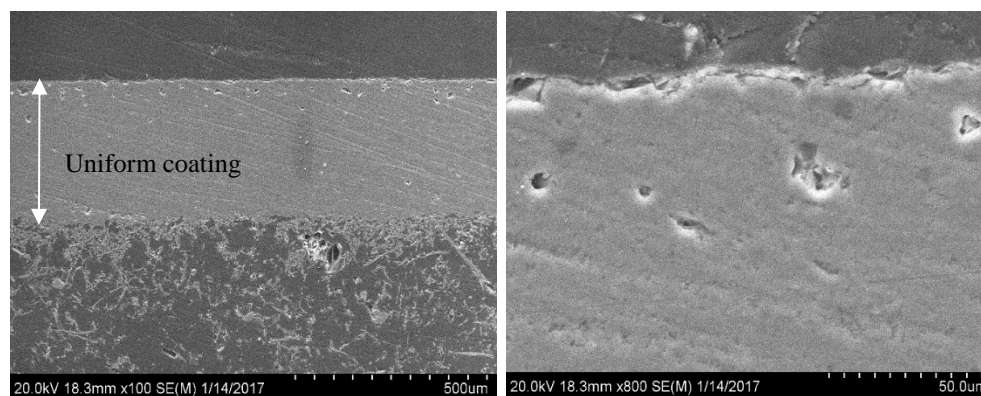
Seeing that the connected sample 2.1.1B involved high amounts of zinc at the surface, the cross-section was also studied. The entire sample was consistent in coating thickness and adhered to the silica fibers as shown in Figure 6.49. Unlike the previous samples, areas near the surface or interface did not contain any pores or cavities. No frequent cracks were present and small indentations were present as a result of polishing. A light deposit layer or white spherical deposits were not observed in this sample. To determine if any deposits were present, an elemental composition was obtained along two large areas on Figure 6.50 a and b. Both areas show identical elements present of Si, O, Cu, and Al. The zinc present at the surface of the sample did not penetrate through the cross-section. When examining the X-ray maps, they show that aluminum was first deposited near the coating-to-silica interface. The evidence is shown in Figure 6.51 along with silicon and oxygen maps. Carbon was present at areas of the mounting material.

Figure 6. 49 Cross-sections of sample 2.1.1B with no surface degradation.

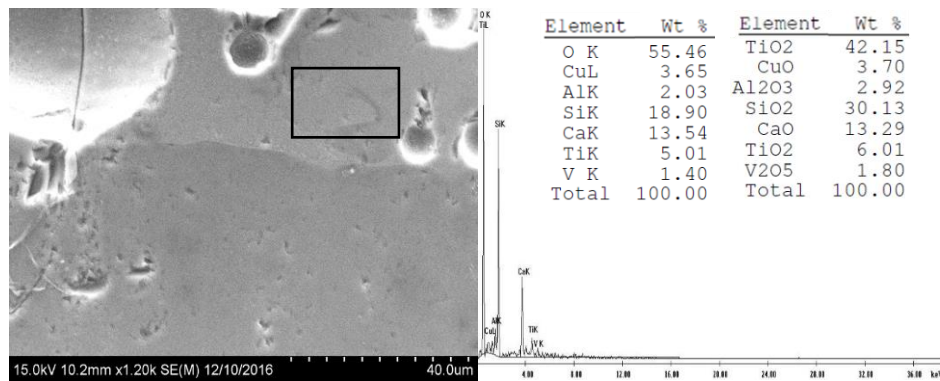
Figure 6.53 The analyzed deposit layer with EDS results.

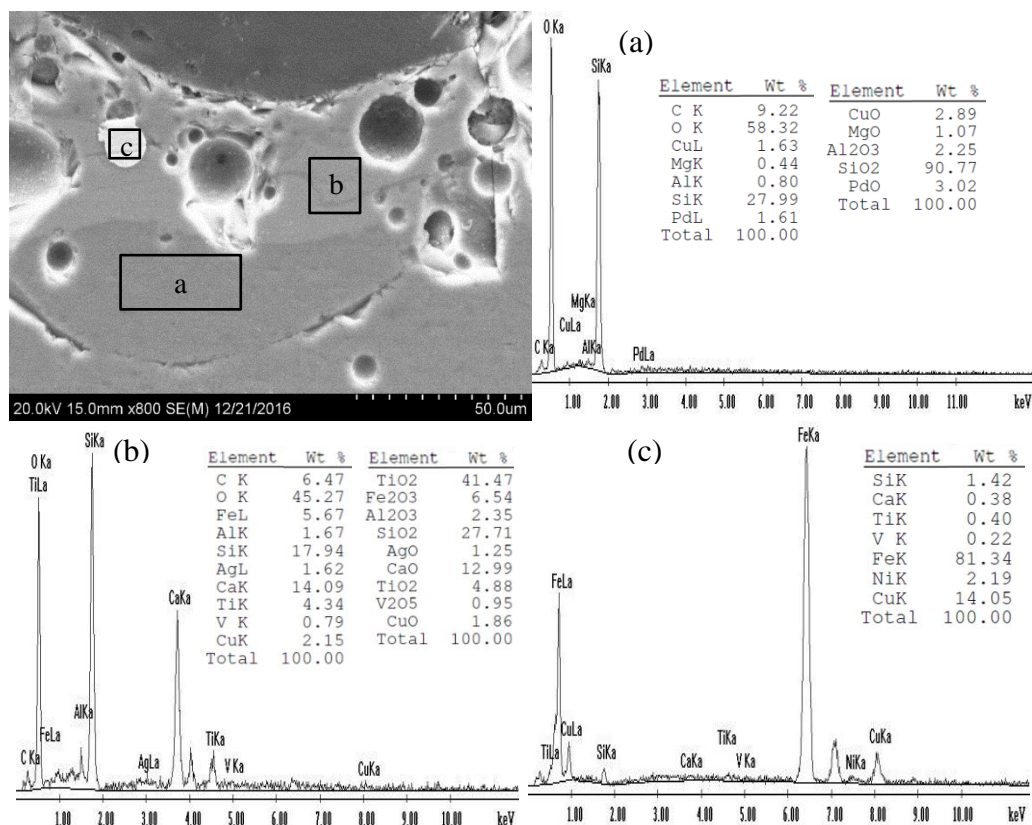
Sample 2.1.4 was further analyzed at the cross-section as variations in surface compositions were present. Figure 6.55a and show how the upper area of the surface was severely affected. Elongated hollow areas were frequently formed (Figure 6.55a) thus causing cracks to propagate through the coating as shown on Figure 6.55b. The surface of the TPS in this sample contained several depressions on the surface. Image c exhibited a deposited layer within the porous area. A white spherical-like phase was also present within the deposited layer as pointed out by the black arrow in Figure 6.55c. EDS results of different locations on the micrograph are given in Figure 6.56. Areas a and b show a compositional change where Ti was present as an oxide on area b at the deposited layer. Ca was also only present on the deposited layer. Area a contained the major oxide of 90.77 wt% SiO_2 . The white spherical phase was a mixture of 81.34 wt% Fe and 14.05 wt% Cu. Several minor elements of Si, Ca, Ti, V, and Ni was also detected.

Figure 6.56 Three areas for EDS measurements at the deposit line (a), below the deposit line (b), and the spherical phase (c).

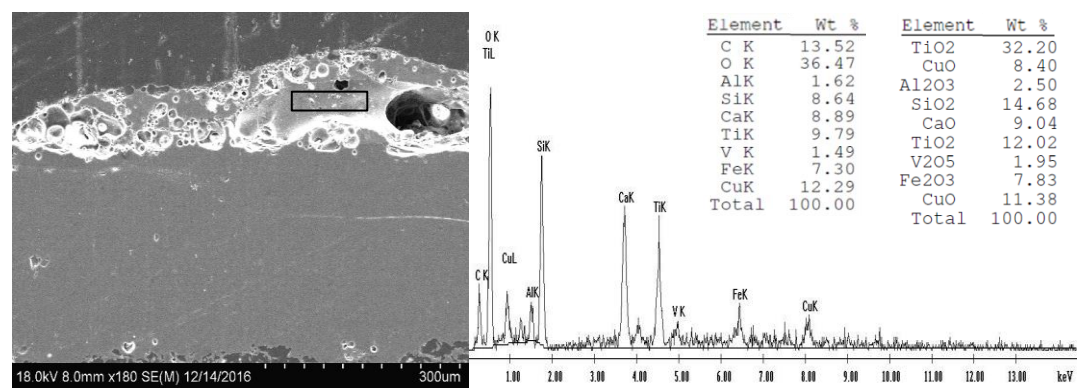
Sample 2.1.4 also contained changes in the composition of the deposited layer and is shown in Figure 6.57. The layer was not as clear as the areas previously analyzed, and spherical cavities masked the entire layer. The corresponding composition of the area analyzed was composed of several elemental species. The layer contained primarily TiO₂, Si, Ca, Ti, and Cu peaks. The minor and trace elements included C, Al, V, and Fe. When compared to the deposited layer in Figure 6.56b, the layer contained higher percentages of Ti and Cu. Figure 6.58 shows additional maps with no Al in the cross-section, but with a greater presence of Fe. The maps also indicated that Ti, Ca, Fe, O, and Si constructed the deposited layer. The Fe present did not appear in white phases as illustrated by the elemental map but was dispersed throughout the deposited layer. In contrast, X-ray maps of the previous microstructure analyzed (Figure 6.55) are given on Figure 6.59. The deposited layer shows that it was formed with Al, Ca, O, Si, and Ti. The Al present was concentrated on the top border of the surface and at the beginning of the deposit

Figure 6.57 Area analyzed at the upper edge of the cross-section near the degradation.

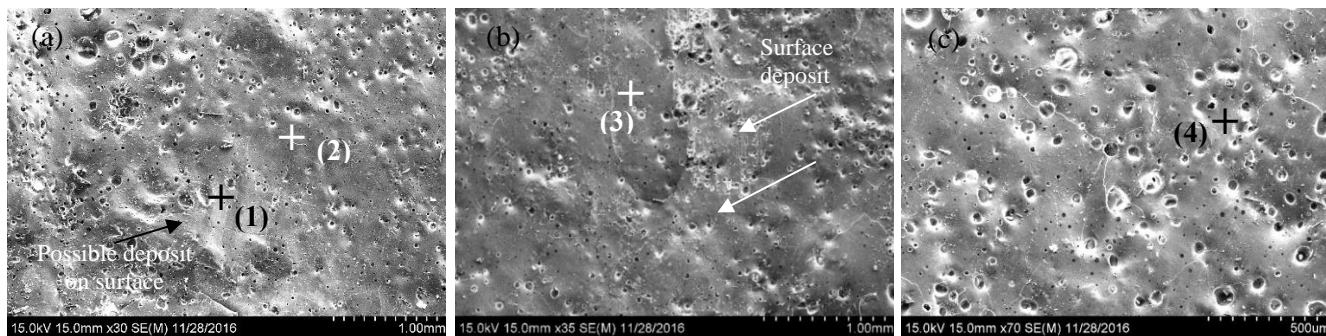
SEM surface analysis results of sample 3.1A and 3.1B are shown in Figure 6.60. Image a represents sample 3.1A which had similar surface features to sample 3.1B. Both samples sustained large amounts of porosity and small impacts to the surface. Bright surface deposits were also observed in both samples (Figure 6.60a and b) and more indications of surface degradation are shown in image c. Elemental compositions of the surfaces of both samples are provided in Figure 6.61. Spots 1 and 2 were measured on sample 3.1A, in which both contained equivalent compositions of Ti, O, Al, Si, Ca, and Mg. Spot 3 and 4 from sample 3.1B show comparable results with primary peaks of Ti, O, Si, and Al. Overall, both samples show identical deposits.

Figure 6.60 Surfaces of (a) sample 3.1A and 3.1B (b and c). EDS readings were measured at spots 1 and 2 for sample 3.1A. Spot 3 and 4 for sample 3.1B.

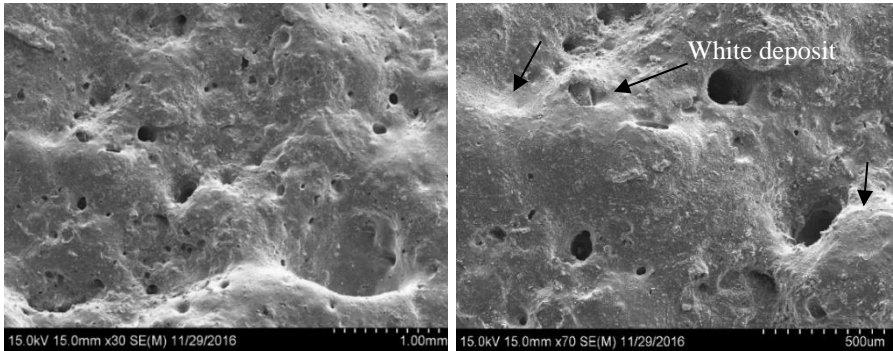
The adjacent sample analyzed was sample 3.2 which was located at the inner side of the carrier panel tile. This sample contained the maximal damage at the coating with visible pores. The damage of the surface is demonstrated on Figure 6.62 with a coarse and irregular surface. Possible anomalous white deposits were observed. In contrast to the previous samples (3.1A and 3.1B), changes in elemental compositions appeared. Aluminum and oxygen were the most prominent elements measured on Figure 6.63a and b. Titanium oxide was still present except aluminum surpassed in weight percentage of area a.

Figure 6.62 Images depicting the uneven surface of sample 3.2

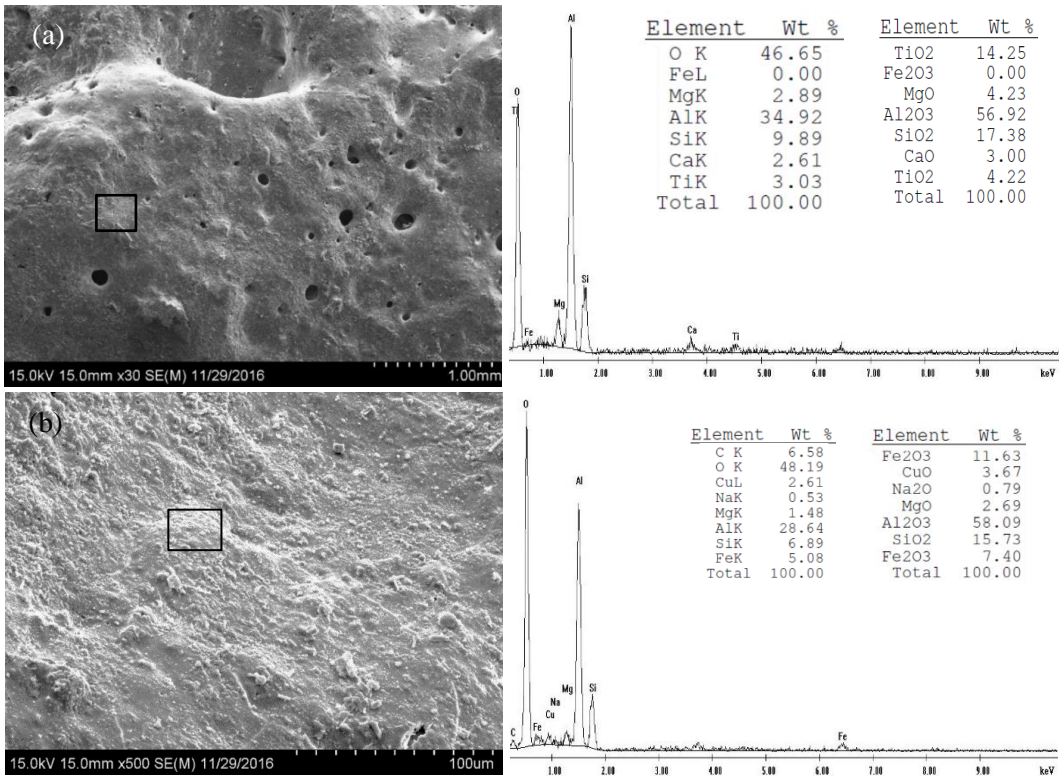
The minor elements included Mg, Si, and Ca. Area b was analyzed at a different location which shows major peaks of Al and O.

Figure 6.63 Area EDS analysis of (a) and (b).

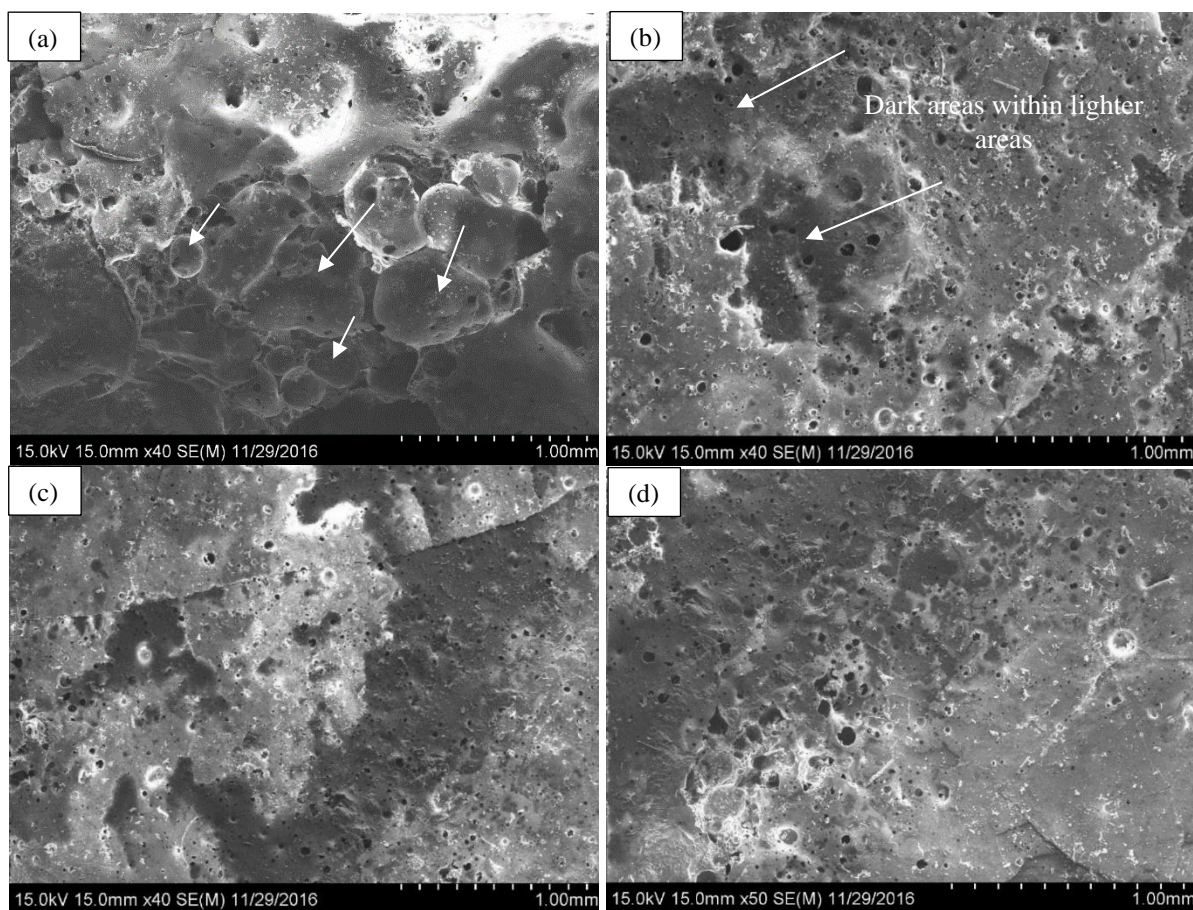
The second set of samples were also retrieved from the aft tile located near the outer surface of the tile to identify the elemental species. Sample 4.1 consisted of two sides of the coating as it was located at the edge of the tile. Figure 6.64a and b demonstrates the damaged surface of sample 4.1. The nature of the coating suggests deterioration as large indentations were present (image a). The coating also contained

dark and light contrasts as demonstrated on Figure 6.64b. The surface of Sample 4.2 (Figure 6.64c and d) also contained similar surface characteristics with dark or light areas. It was assumed that the dark areas are the black TPS coating and the light areas are surface deposits.

Figure 6.64. Sample 4.1 surface images (a) and (b). Sample 4.2 surface (c) and (d) with similar features.

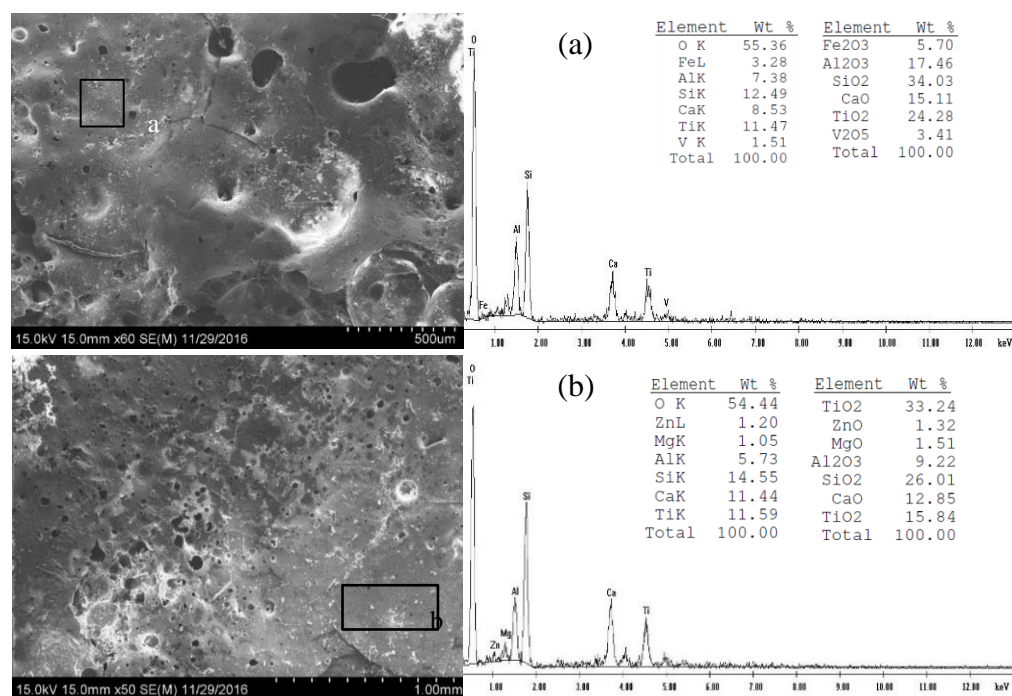
The identification of the surface discolorations present on sample 4.1 and sample 4.2 are shown in Figure 6.65. Most of the surface chemistry of sample 4.1 was consistent with the spectra shown on image a. The major peaks were comprised of 55.36wt% O, 12.49wt% Si, 11.47wt% Ti, 8.53wt% Ca, and 7.38wt% Al with minor elements of V and Fe. Sample 4.2 contained resembling compositions on Figure 6.65b with the exception of Zn and Mg minor elements. When compared to samples 3.1A and 3.1B, all samples contained similar surface deposits and discolorations at the surfaces. Sample 3.2 however, contained aluminum as the primary element deposited.

Figure 6.65 EDS results of area (a) of sample 4.1 and area b of sample 4.2.

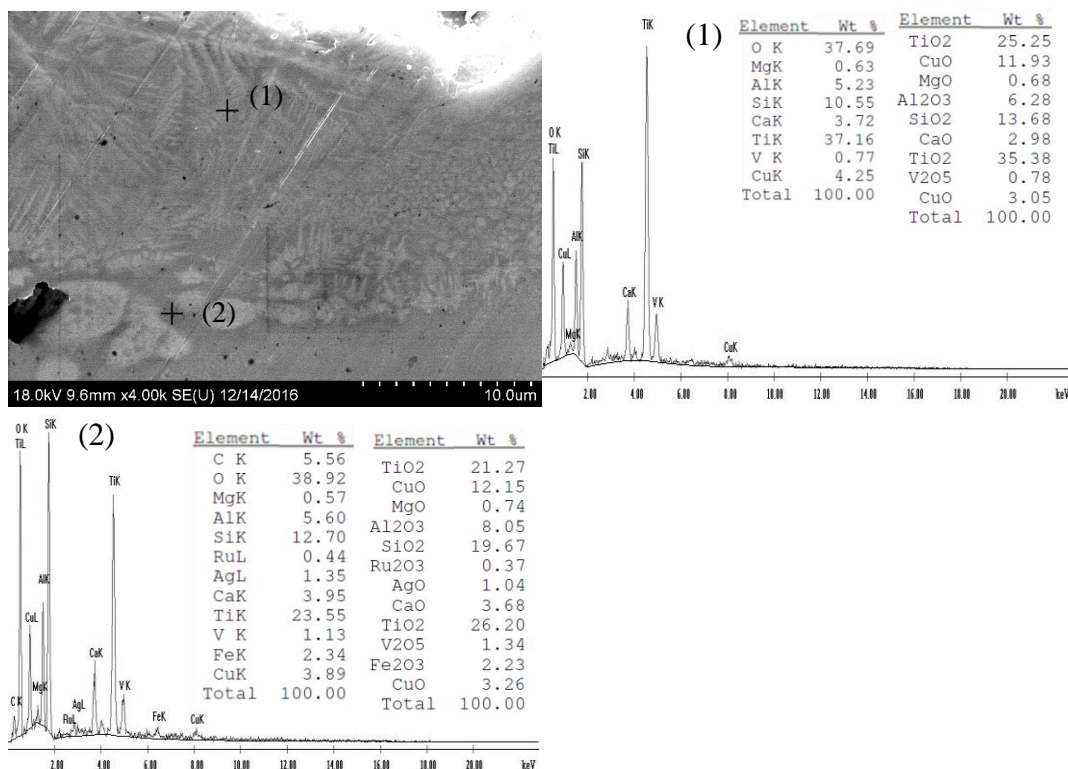
EDS measurements were collected at the light gray needle-like phase (1) and dark gray phase (2) and the results are shown on Figure 6.68. The compositions show that the needle-like phase consists of 37.16 wt% Ti, 37.69 wt% O, 10.55 wt% Si, 5.23 wt% Al, 3.72 wt% Ca, and 4.25 wt% Cu with trace amounts of Mg and V. The dark areas (spot 2) contain less Ti weight percent and detected additional elements. The primary elements were 23.55 wt% Ti, 38.92 wt% O, 12.70 wt% Si, and 5.60 wt% Al, respectively.

Figure 6.68 EDS spot measurements representing a light phase (1) and dark phase (2).

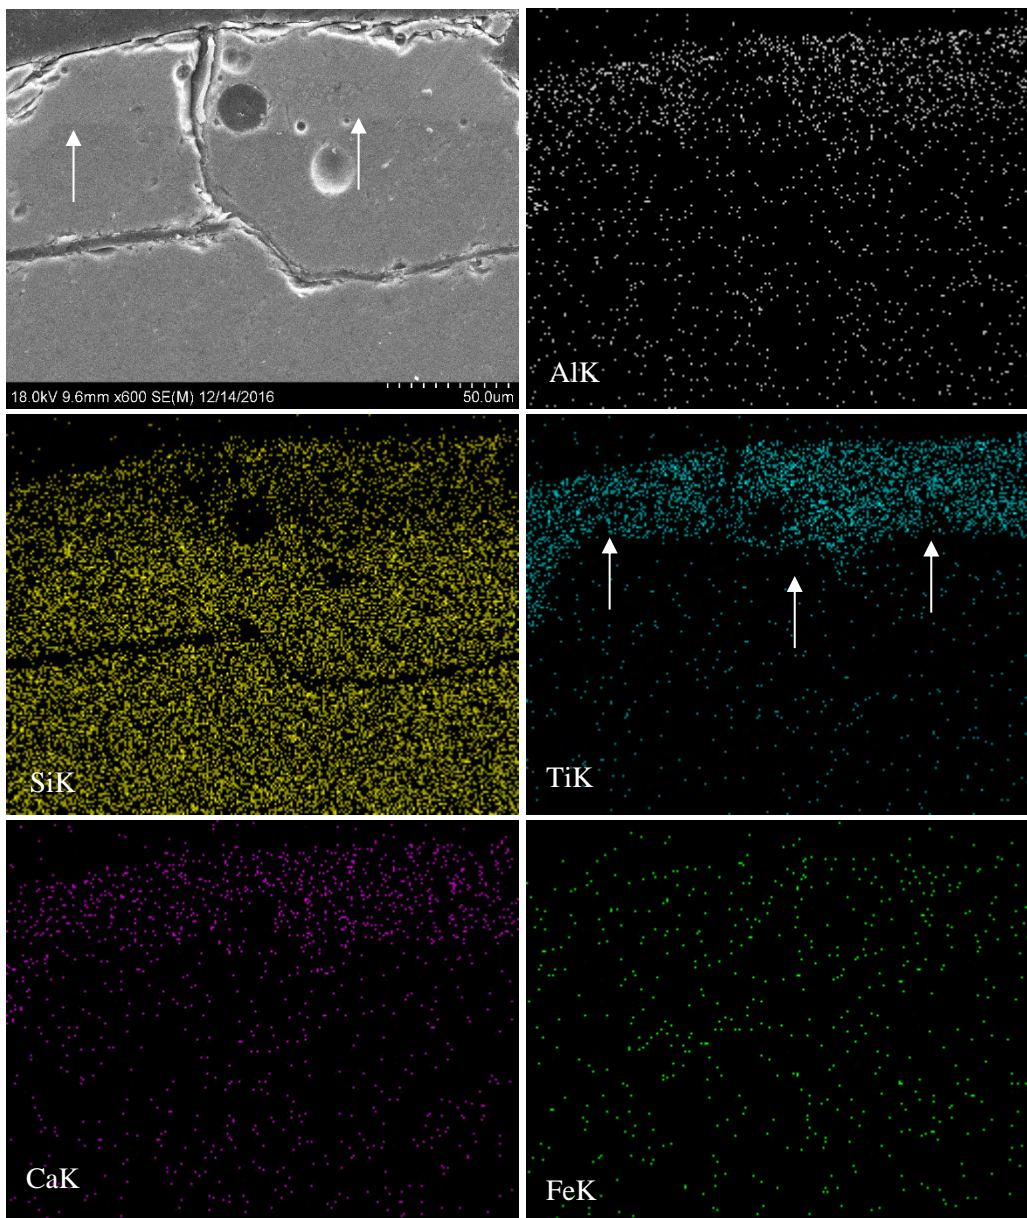
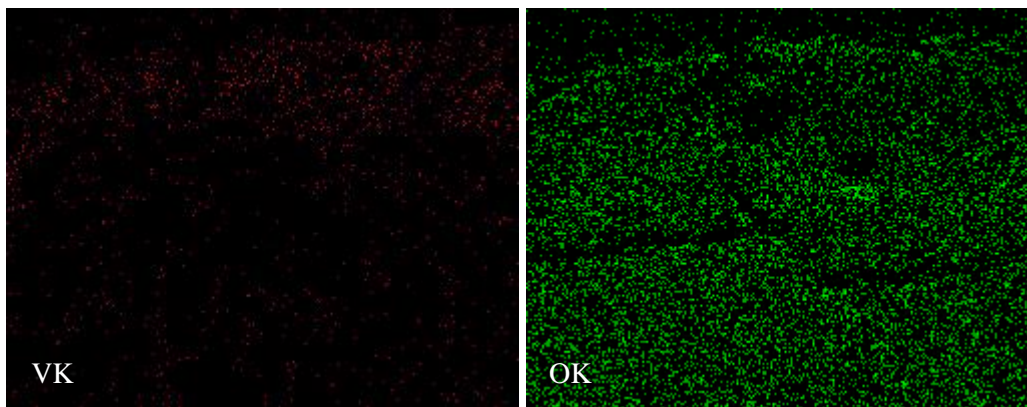
X-ray maps (Figure 6.69) were developed to examine the cross-section from Figure 6.67a with arrows indicating the start of the deposited layer. The maps show that aluminum was deposited but its concentration was higher near the top surface of the sample and decreases through the cross-section. A distinct interface was clear and shows a large concentration of titanium. The beginning of the titanium deposit is illustrated by the white arrows. Vanadium, silicon, oxygen, and calcium also make up the deposited layer. The silicon map shows a decrease in weight percentage. Iron was present as a trace

Figure 6.69 X-ray maps at the cross-section of sample 3.1A sample shown.

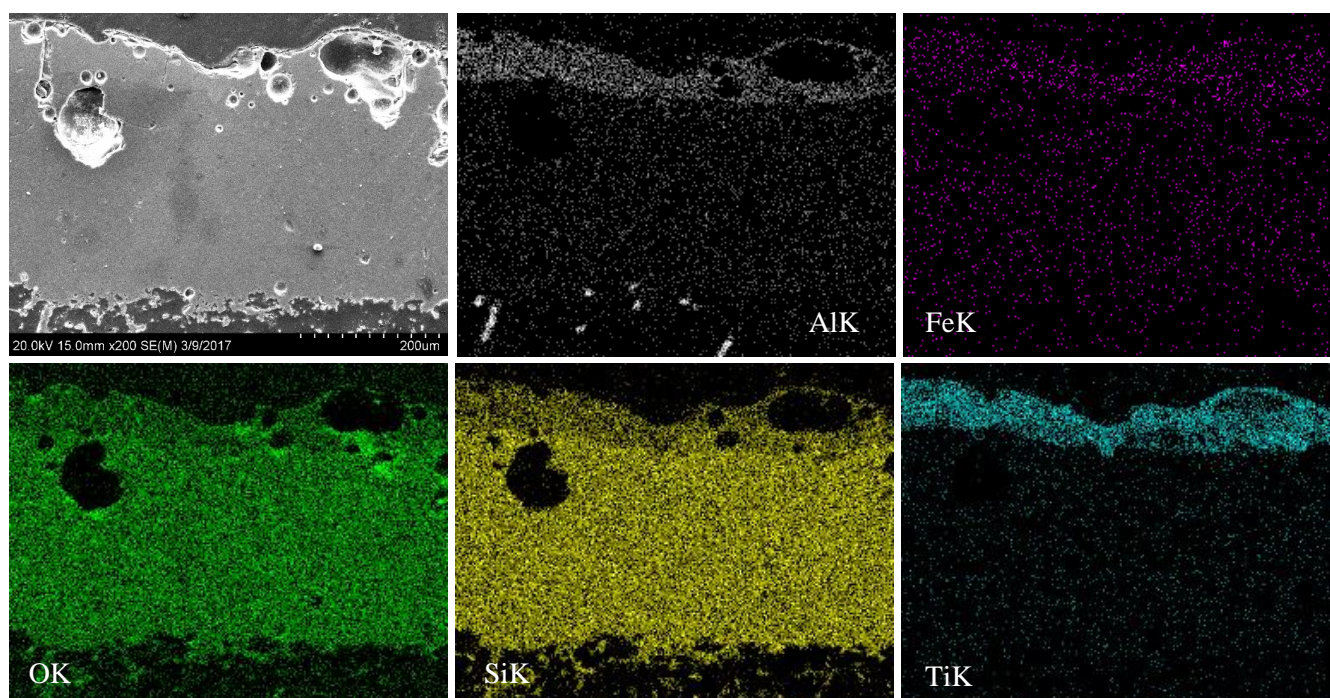
element and lightly scattered through the microstructure. Carbon was still present at the cracks in the coating, cavity, and mounting material. The second map at a lower magnification of 200X revealed areas of aluminum at the tile-to-silica interface as shown in Figure 6.70. Titanium was more pronounced in the coating area than any other element detected and was even present in the cavities. The deposited layer in this area does show a large presence of iron and is also dispersed through the coating. Again, oxygen and silicon also show up in the coating.

Figure 6.70 A cross-section showing the coating and base material with X-ray maps.

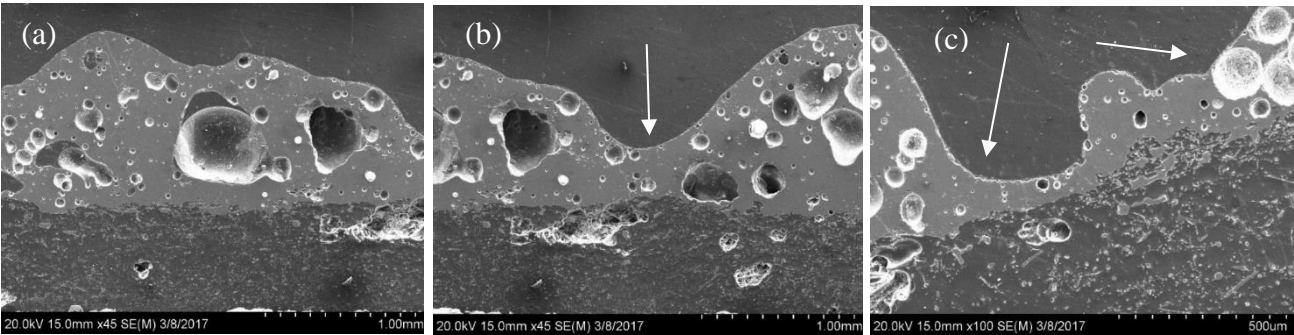
Further examination of sample 3.1.1B revealed missing areas of the coating with varying thicknesses. These features can be seen in Figure 6.71 a-c and the sample contained the greatest damage to the coating out of all samples analyzed. Image c shows that the surface sustained enough heat that diminished the entire thickness of the tiles and almost reached the inner silica. A prominent area of the coating contained differences in EDS composition results. Unlike the previous samples, this sample did

Figure 6.71 The cross-sections of sample 3.1.1B detailing the changes in coating depth.

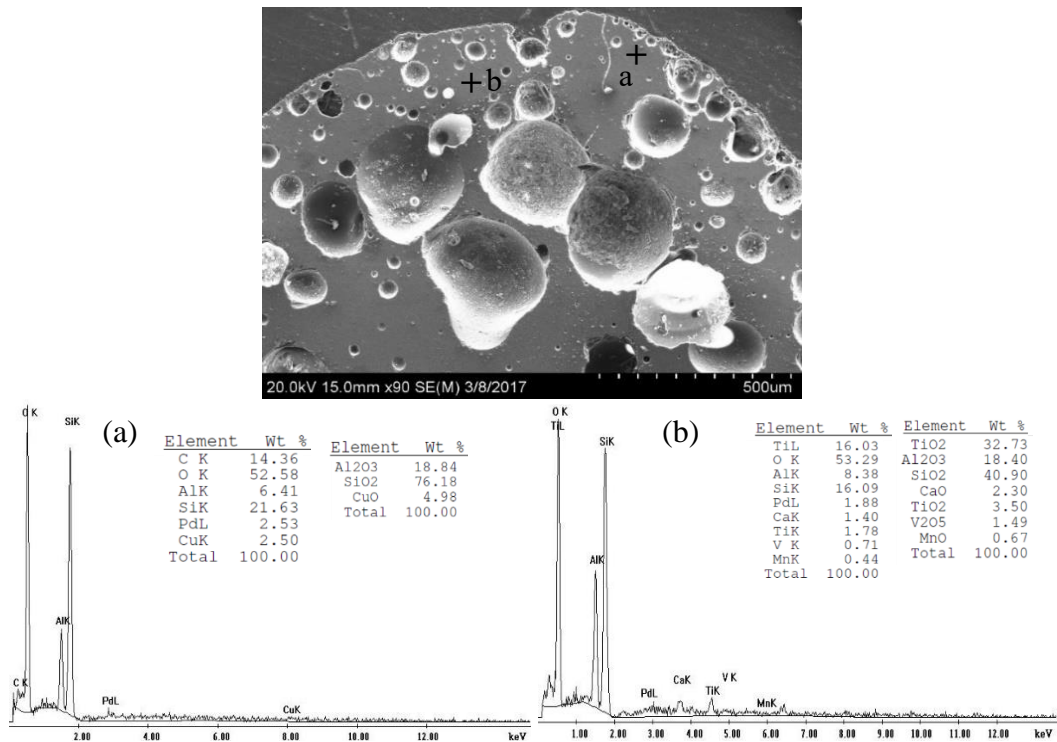
not have a definite deposit layer. As a result of this, EDS analysis was performed in different areas of the cross-section. Spots a and b from Figure 6.72 had similar major elements except for trace elements and Ti. No titanium was found on spot a only on spot b. Additional acquisition of elements present at the two areas analyzed (Figure 6.73 a and b), were found to be rich in Ti. The presence of these elements was surprising as no clear accumulation of a deposited layer was observed.

Figure 6.72 EDS spot measurements at the highest point of the coating.
