Material Behavior of Window 7 Carrier Panel Tiles and Thermal Pane Fragments Recovered from the Space Shuttle Columbia

MATERIAL BEHAVIOR OF WINDOW 7 CARRIER PANEL TILES AND
THERMAL PANE FRAGMENTS RECOVERED FROM THE SPACE
SHUTTLE COLUMBIA

DISSERTATION

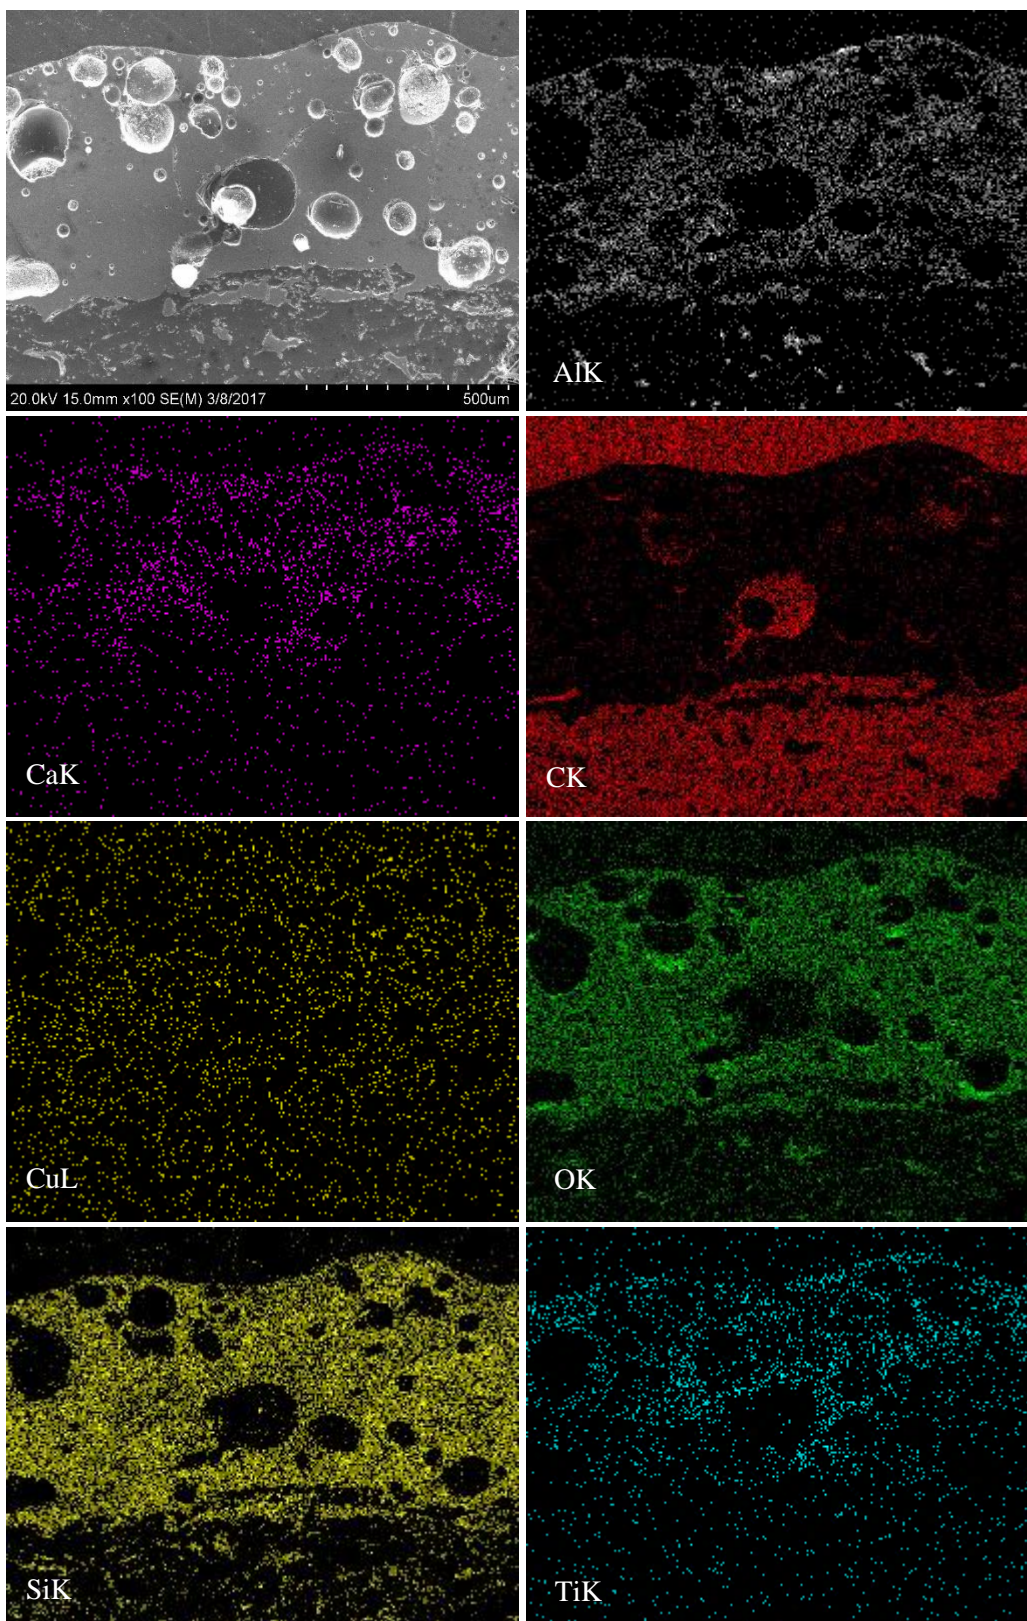
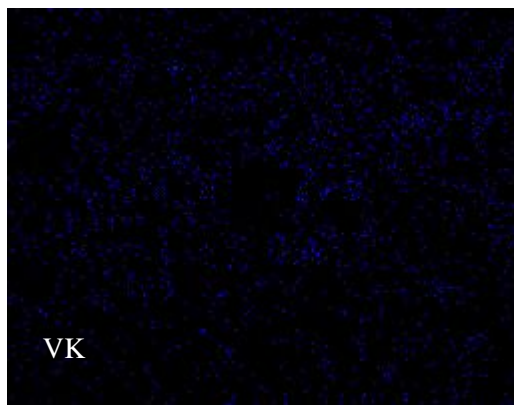
In addition to point analysis, the variations in the composition of the sample are provided in Figure 6.74 and Figure 6.75. Although no evidence of a bright layer was observed, the elemental species previously identified were deposited on the sample. Deposits existed beyond the TPS surface and spanning down to the silica fibers (Figure 6.74) with elements of aluminum, oxygen, silicon, titanium, and vanadium. Aluminum accumulated first as several areas of the silica were highlighted. Bright areas near the top surface of the coating contained aluminum. The coating contained oxygen which was distributed throughout its thickness while elemental titanium, along with calcium, were the last deposits to accumulate. The distribution of vanadium was also concentrated on the TPS coating. No copper deposits were present. A large number of spherical cavities on the coating were surrounded by the deposits and appear to be consistent with carbon and copper. Further analysis of the protruding residual coating was found to contain aluminum, iron, titanium, silicon, and oxygen. The collected maps are shown in Figure 6.75. Small unique areas of aluminum were also present beyond the coating. The cavities on the coating

Figure 6.74 X-ray map of the cross-section of sample 3.1B.

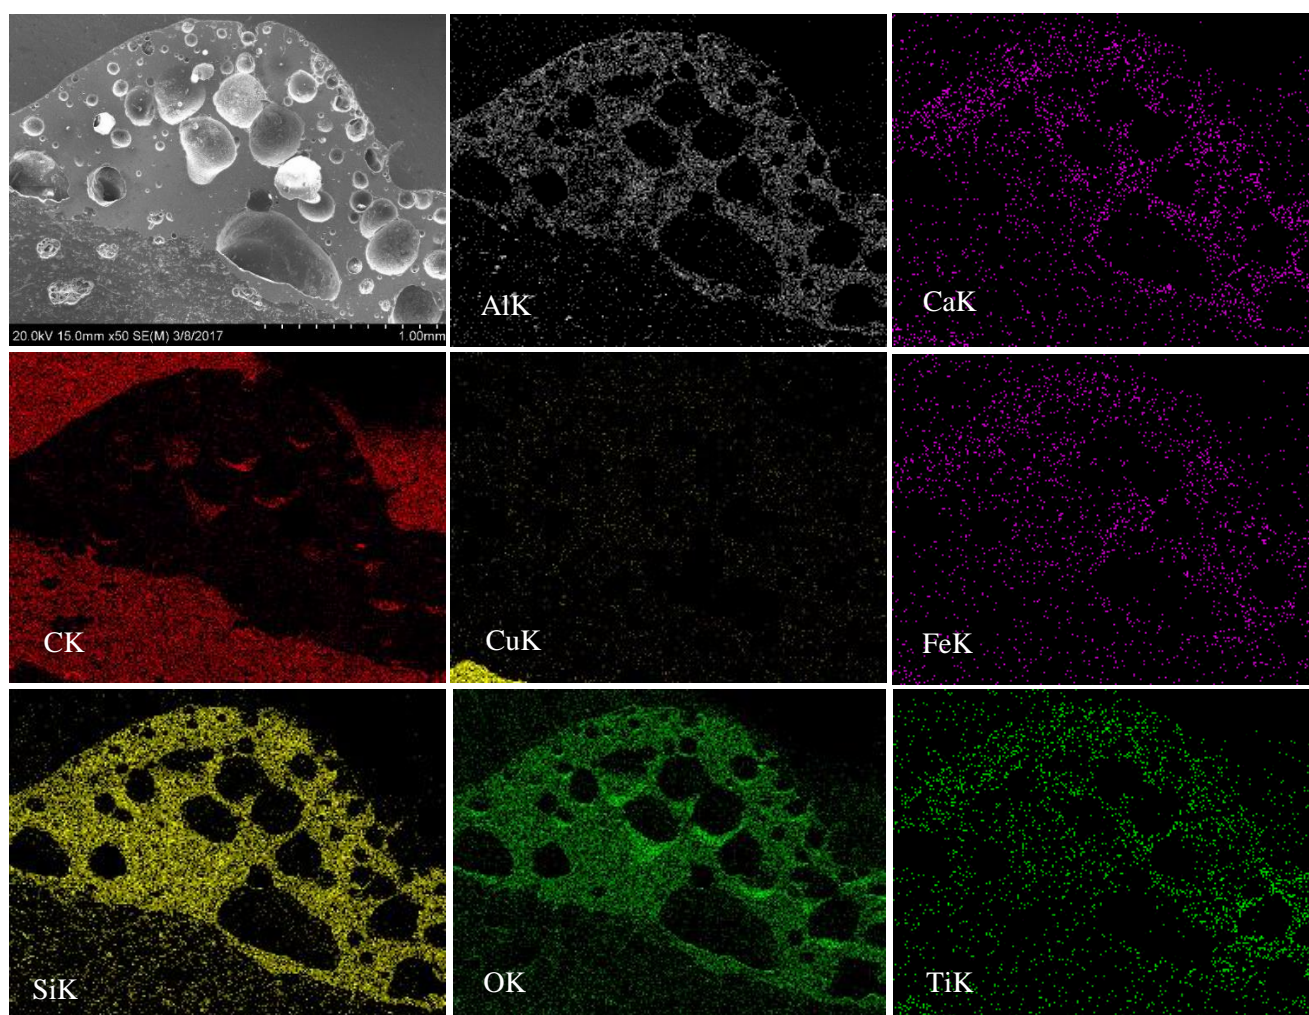
did not contain any of these deposits only carbon. The assortment of these elements was unique as no defined changes in microstructure was observed.

Figure 6.75 Remaining high point of the TPS coating and resultant elemental maps.

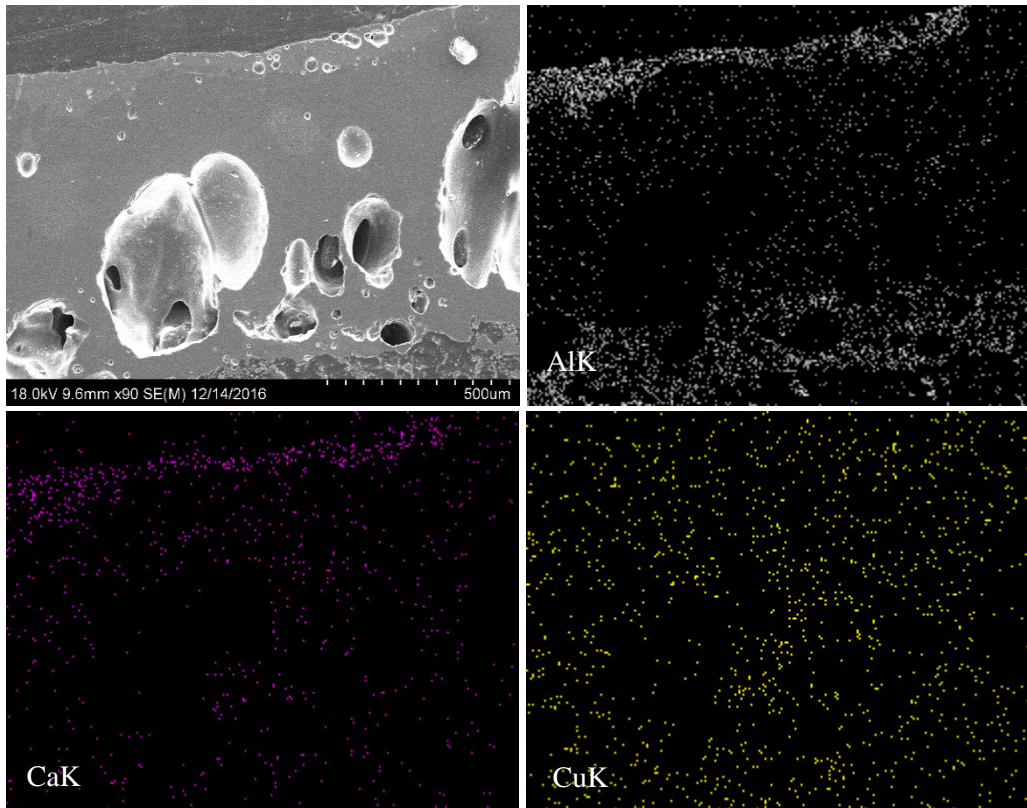
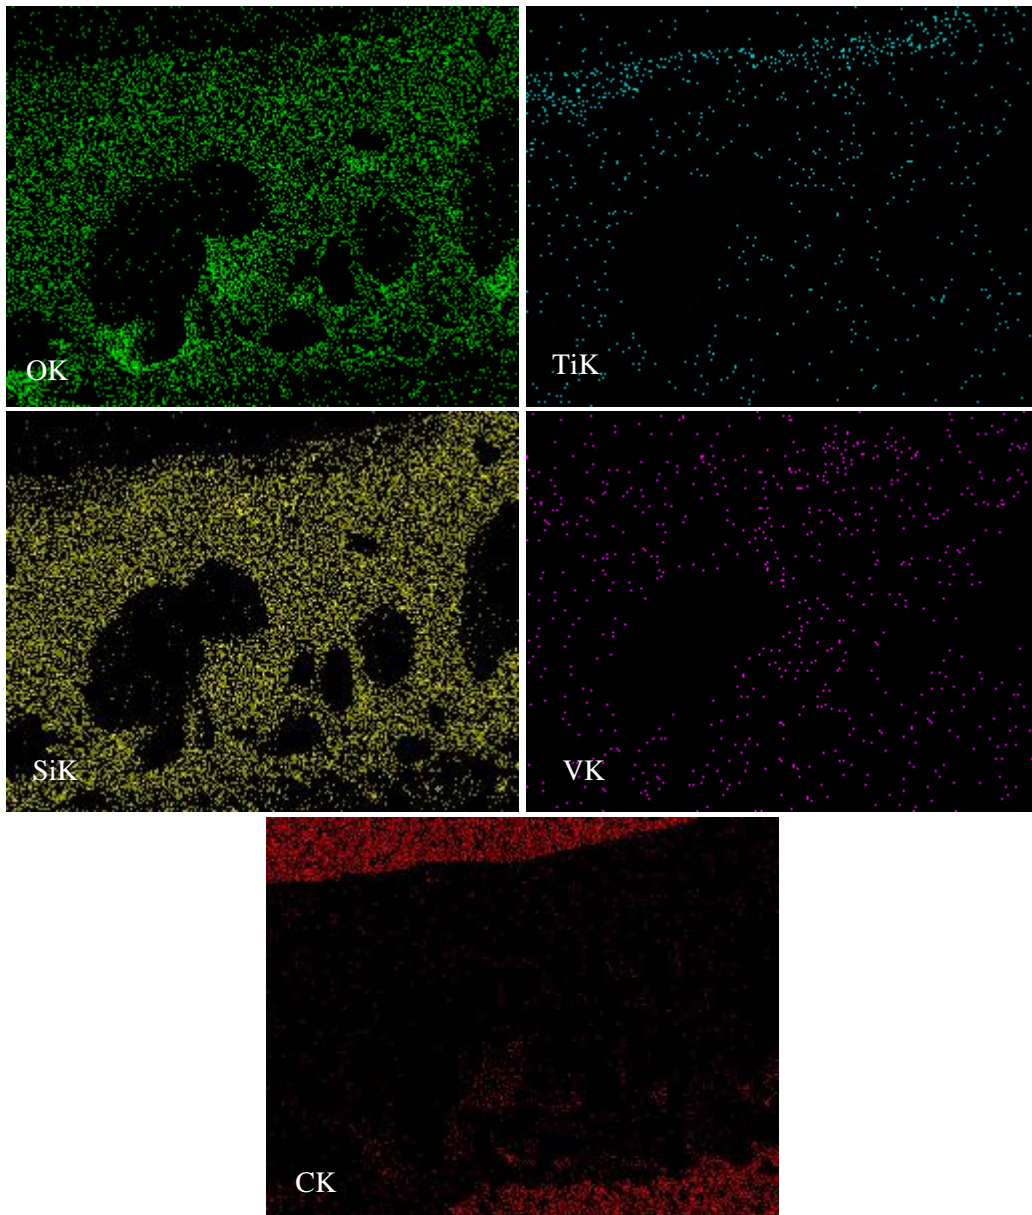
To distinguish how the depositions differed at this sample, individual X-ray maps are provided in Figure 6.78. Aluminum was first deposited as it was concentrated below the coating in addition to a thin deposit at the surface. The thin deposit was confirmed to be a mixture of Ca, Ti, O, and Si. The vanadium

Figure 6.78 X-ray maps of sample 3.2.

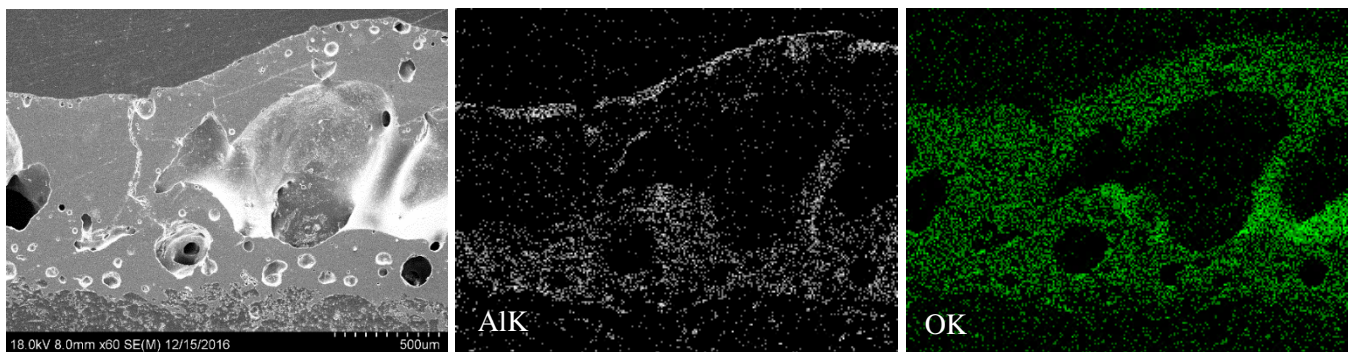
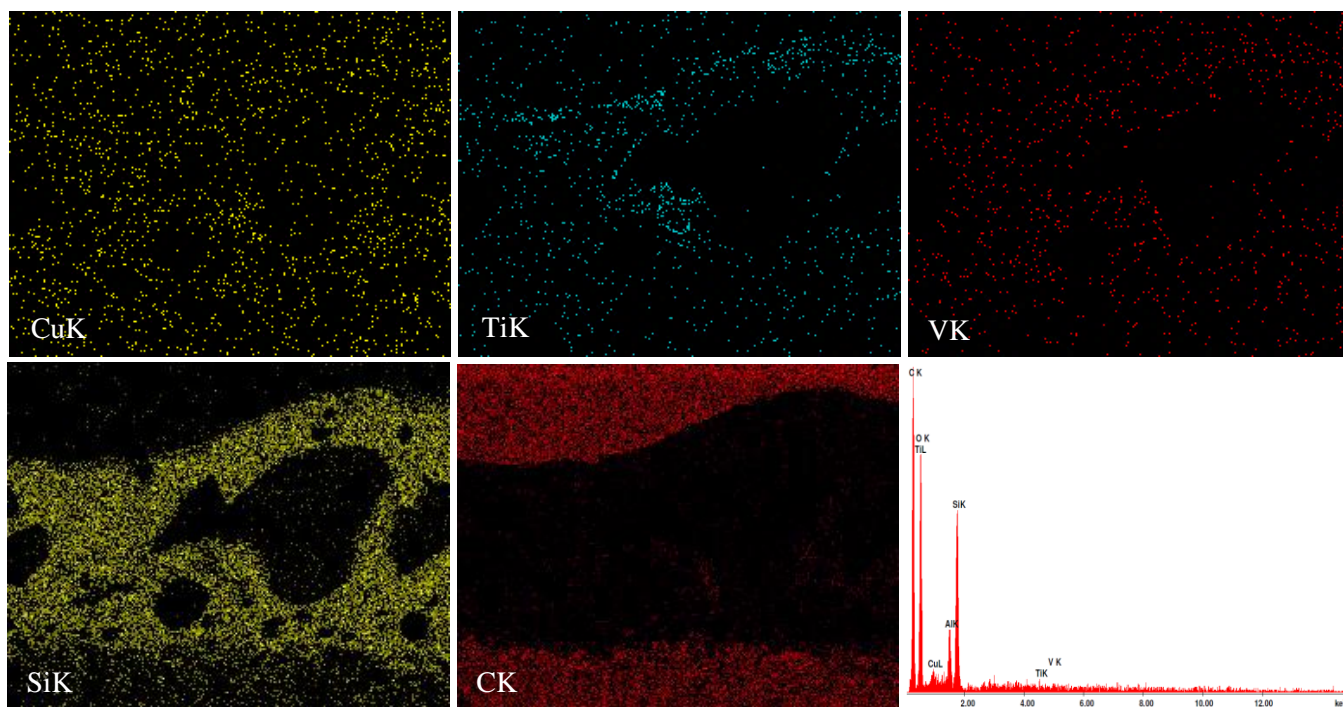
deposit was not as concentrated as the other deposits. Some carbon was found to be located in the cavities. However, the hollow pores located above the silica interface did not show to contain any deposit. The next area that was mapped was the micrograph in Figure 6.79 which had missing areas of the coating. The distribution of aluminum was also located at the interface and top surface of the coating. Minimal evidence of titanium was deposited whereas vanadium was uniquely present in the coating. The brightness of the vanadium map shows that it contained a greater concentration than titanium. Calcium did not settle on the cross-section. Similar to the previous area, copper was distributed throughout the coating. Silicon and oxygen were the primary elements concentrated on the coating. Minimal areas with carbon were concentrated near the coating-to-tile interface.

Figure 6.79 X-ray map of an additional cross-section.

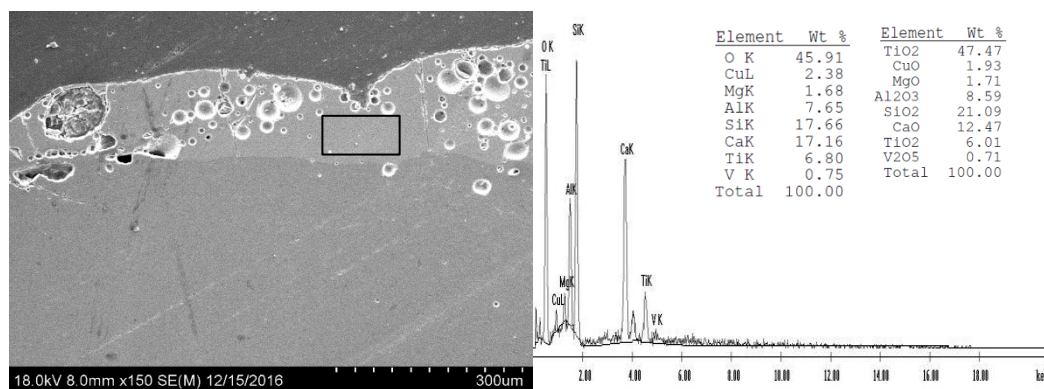
The coating at the horizontal area was not found to contain texture changes. The deposit was adhered and contained spherical cavities. The recurring composition of the deposited layer is shown in Figure 6.82. The primary elements were 45.91wt% O, 17.66wt% Si, 17.16wt% Ca, 6.80wt% Ti, and 7.65wt% Al. The deposit contained less weight percentage of Al than the deposited layer found at the vertical side. Other areas of the deposited layer at the vertical end were analyzed through EDS mapping.

Figure 6.82 Area EDS results of the coating at the horizontal location.

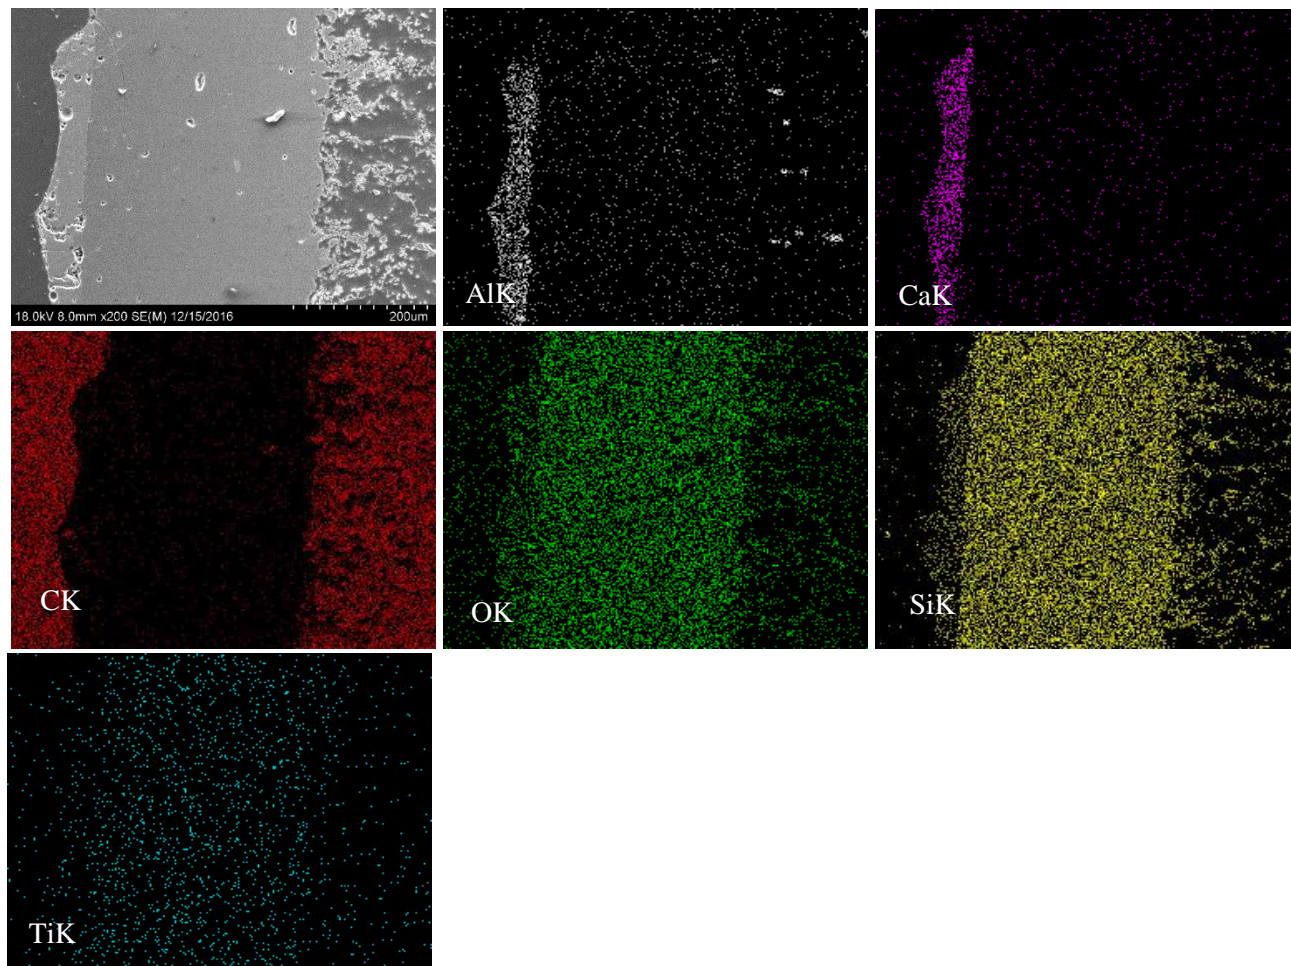
The X-ray maps of a fully-adhered light gray deposit layer at the vertical side are provided in Figure 6.83. The maps show that the layer was a mixture of Al, Ca, O, and Si. Remarkably, the relative concentration of titanium occurs beyond the deposited layer. Titanium was mostly deposited on the coating width. Aluminum also appeared at areas near the silica fibers. This is also true for the maps obtained from the micrograph on Figure 6.84.

Figure 6.83 X-ray maps of the vertical side of sample 4.1.

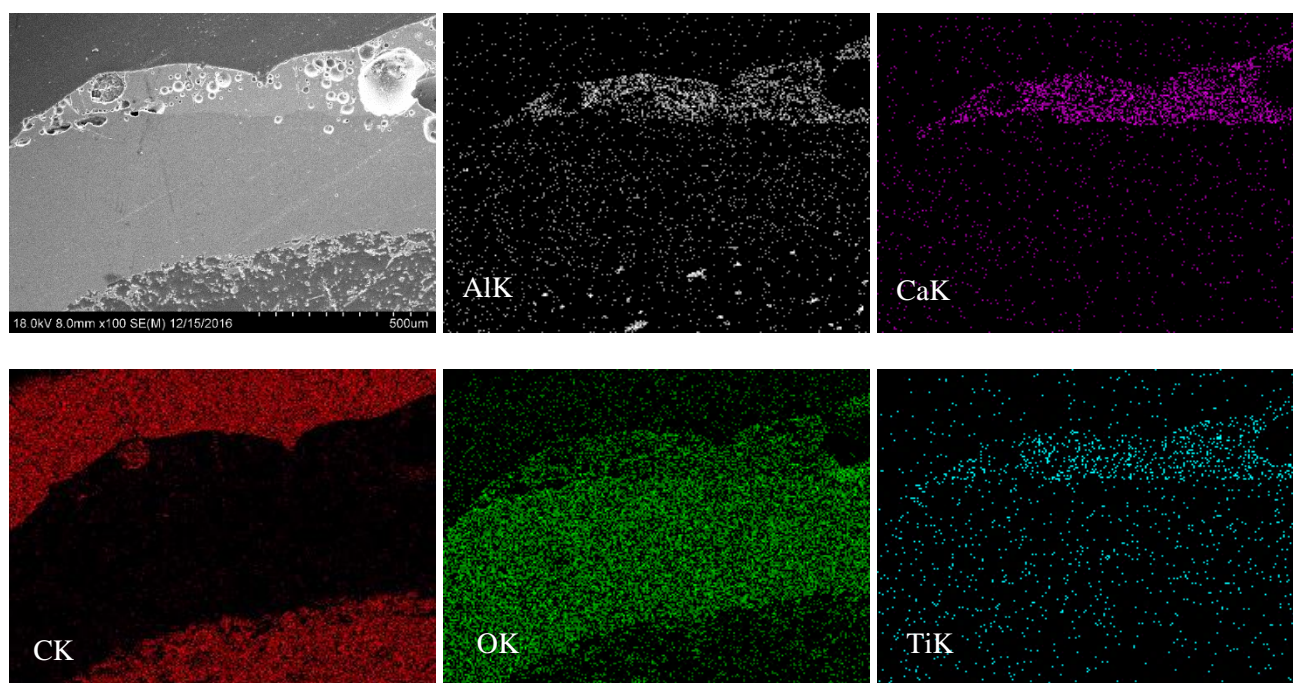
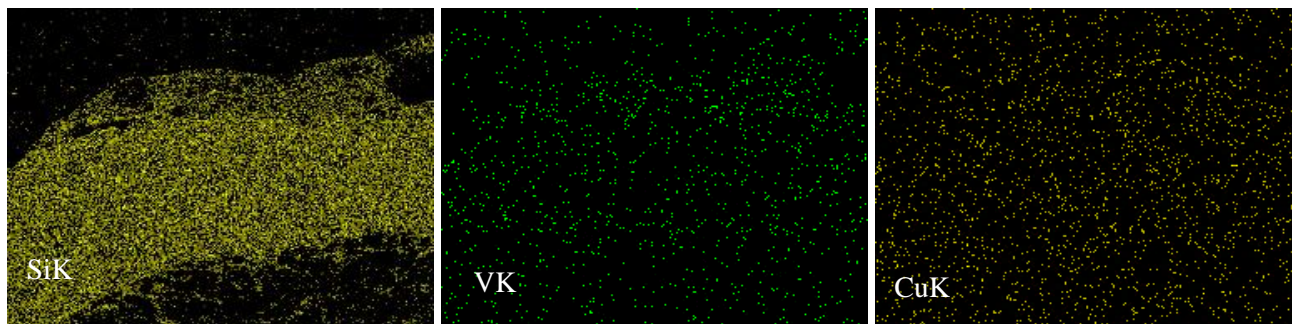
Figure 6.84 Additional X-ray maps of sample 4.1.

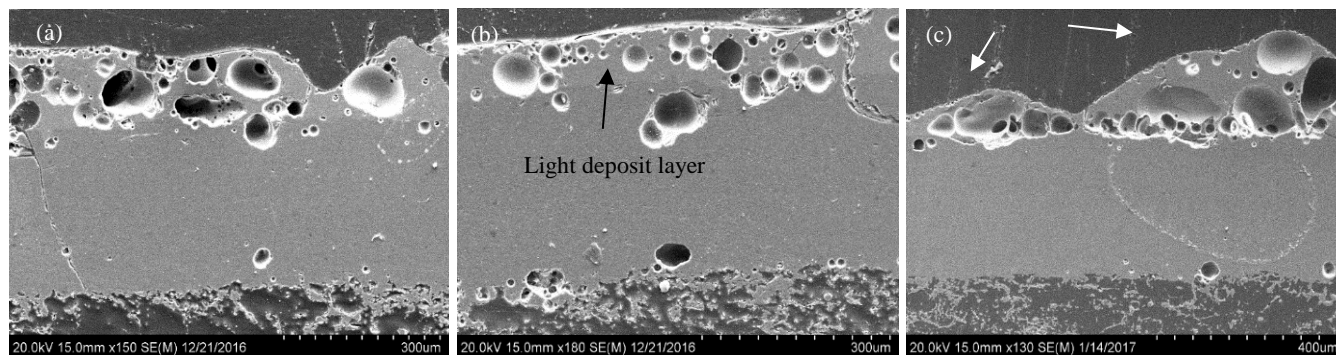
The morphology of sample 4.2 is shown on Figure 6.85a through c. The cross-section in image a contained a variety of pores that were concentrated at the top surface of the sample. The deposited layer is evident on image b and its thickness also varied as illustrated by image c. The differences in compositional results are presented in Figure 6.86. Area a contained 55.26wt% O, 26.65wt% Si, and 14wt% C. Whereas area b contained 44.35 wt% O, 13.84 wt% Si, 13.36 wt% Al, 6.47 wt% Ti, 6 wt% Ca, and 5.22 wt% Mg. The distribution of these elements on the sample contained aluminum near the coating-to-tile interface. Figures 6.87 and 6.88 both confirm this as well as the elements that make up the deposited layer. In both cases, the deposited layer consisted of aluminum, calcium, silicon, oxygen, and titanium. The layer also was comprised of magnesium and vanadium as illustrated in Figure 6.88. Also, dispersed iron was present on Figure 6.87 only. The spherical cavities present at the deposited layer (Figure 6.87) contained oxygen and titanium. This was also evident on the second map on Figure 6.88.

Figure 6.85 Cross-sectional areas a-c of sample 4.2.

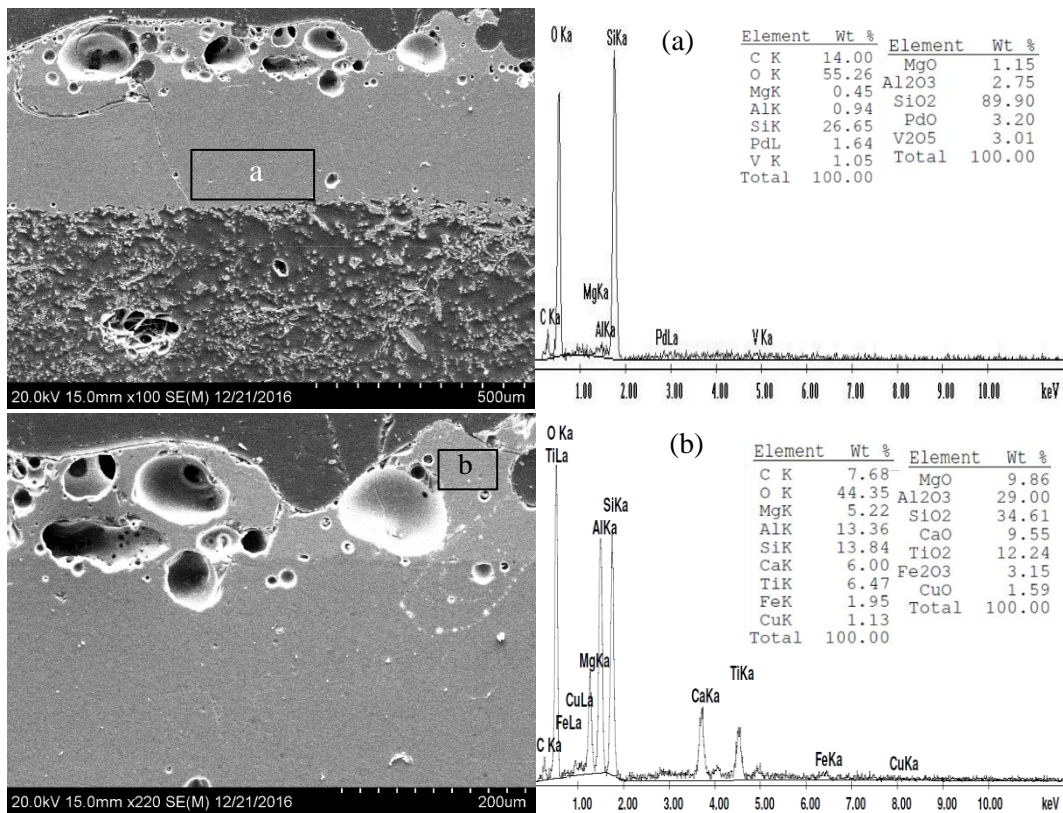
Figure 6.86 Contrasting EDS area measurements (a) and (b).

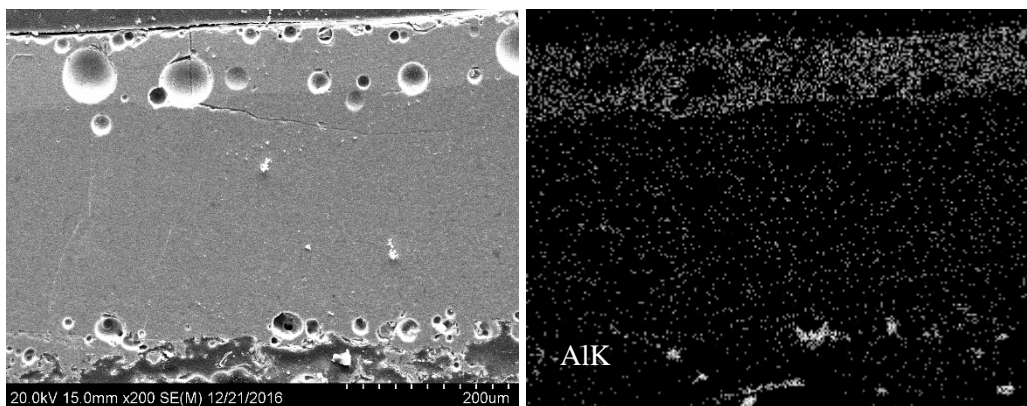
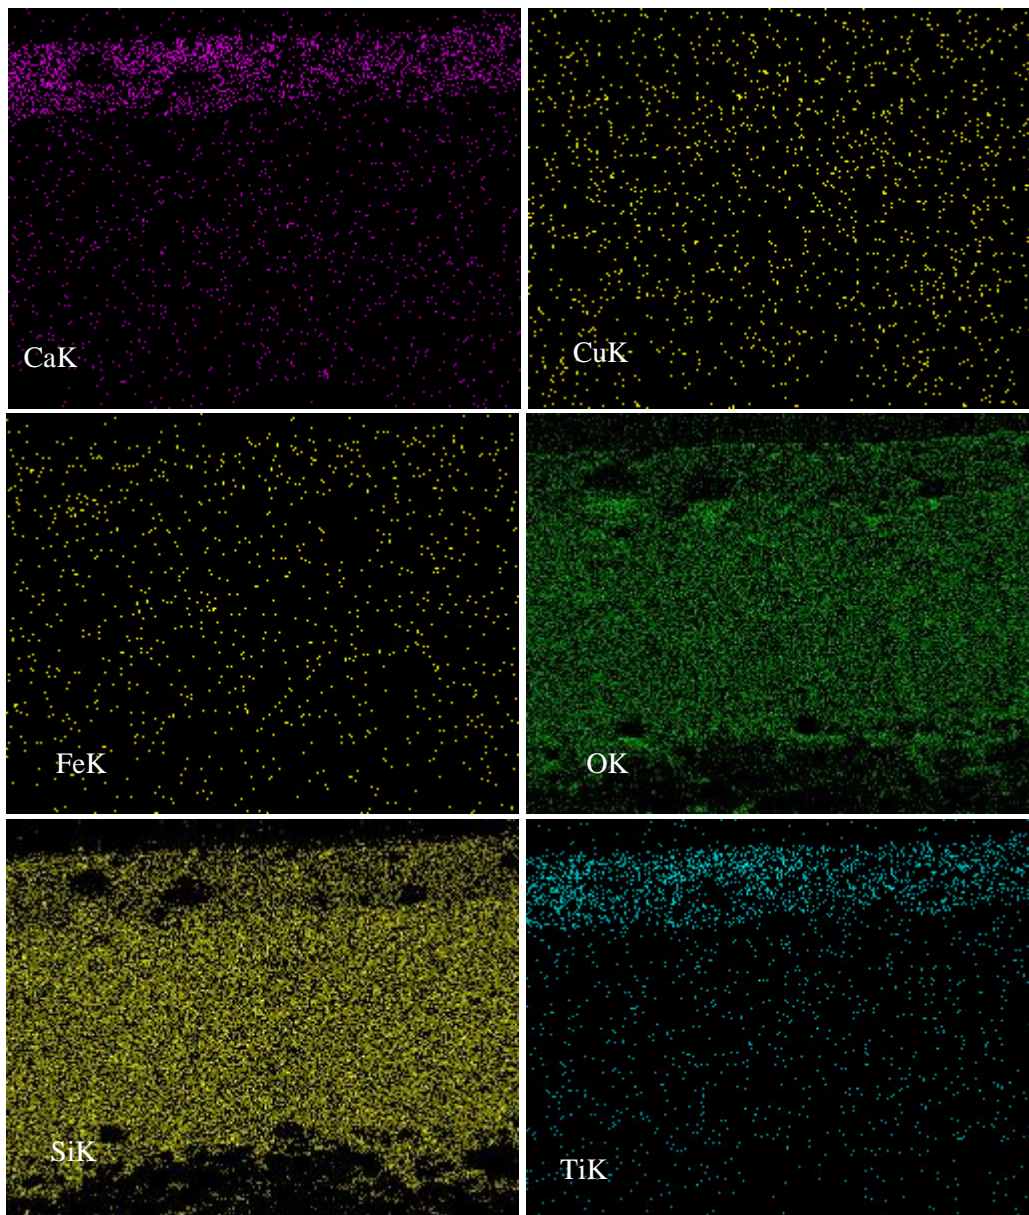
Figure 6.87 Element maps of sample 4.2.

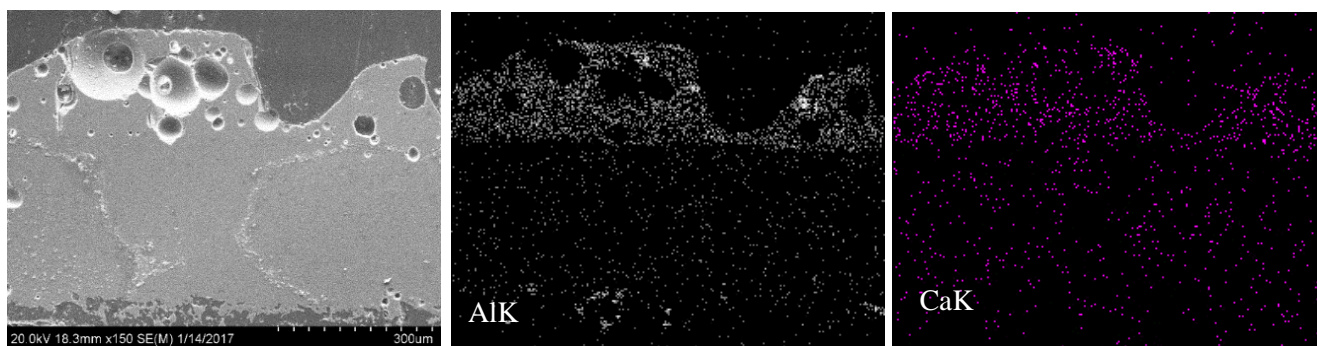
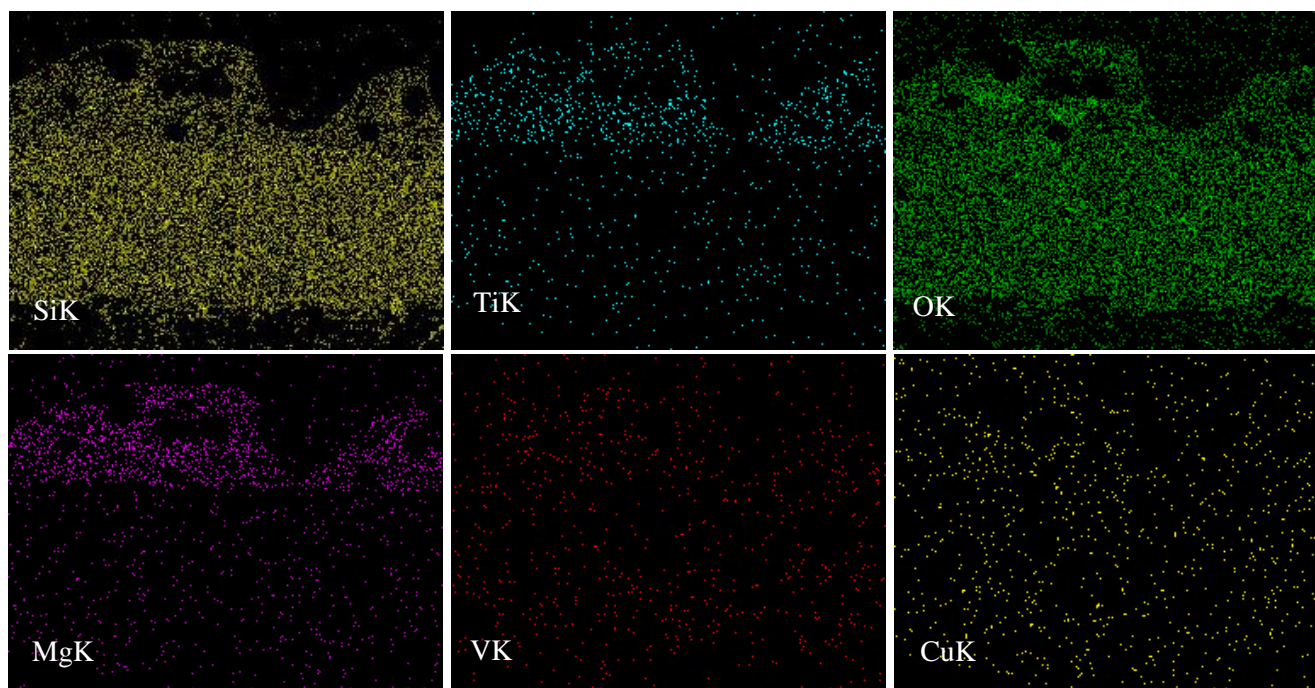
Figure 6.88 Maps obtained showing deposits at the uneven coating.

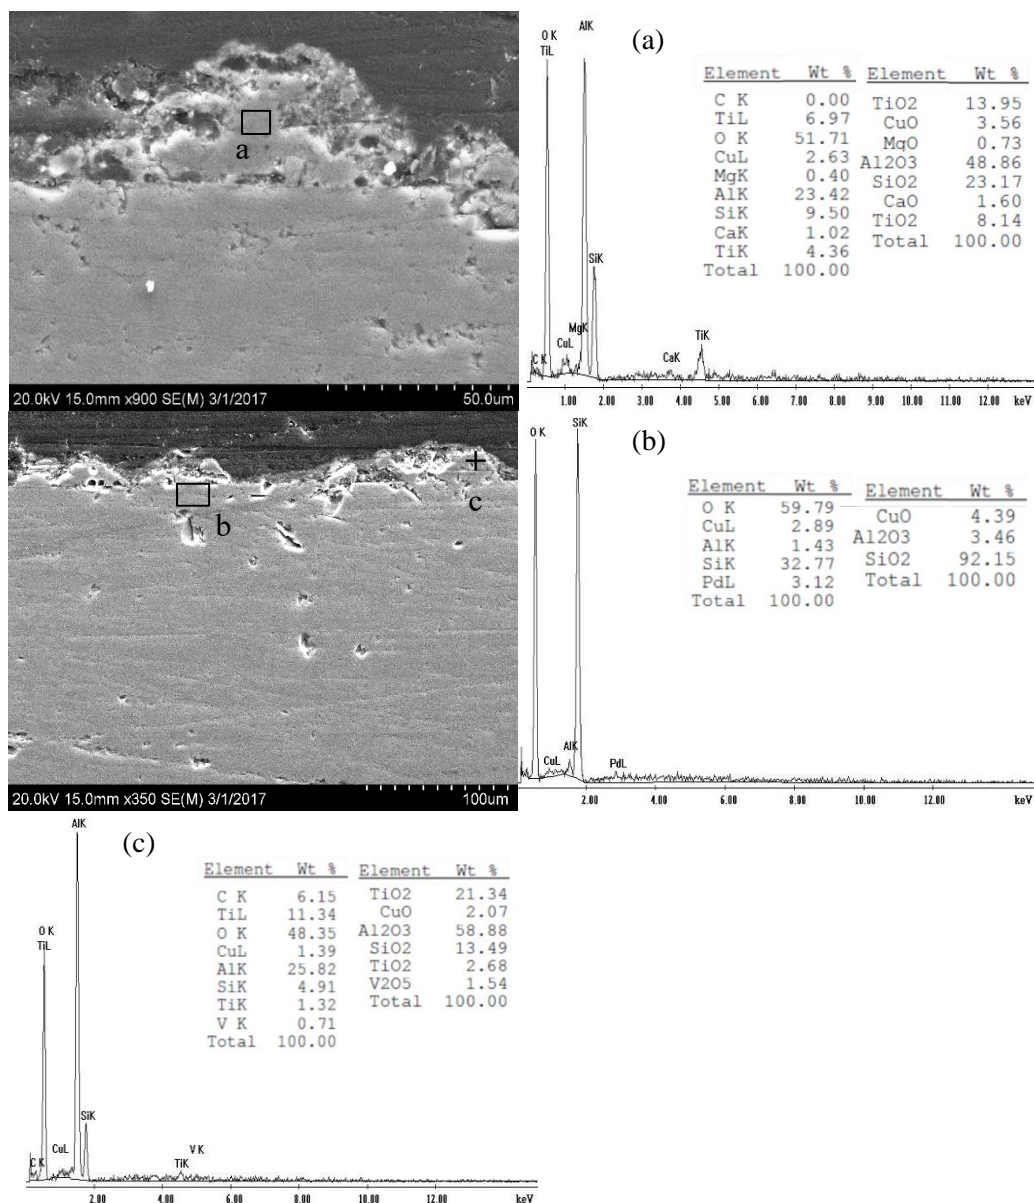
EDS confirmed that the deposits were a combination of different elements. Several examples are demonstrated in Figure 6.90 in which two areas and a spot analysis were measured. The majority of the deposits contained high weight percentages of aluminum. The first area (Figure 6.90a) was comprised of 51.71 wt% O, 23.42 wt% Al, 9.50 wt% Si, 11.33 wt% Ti, 2.63 wt% Cu and 1.02 wt% Ca. Si and O were the main elements detected when measuring an area below the edge of sample (b). Spot c was verified to contain the primary elements of 48.35 wt% O, 25.82 wt% Al, and 11.34 wt% Ti.

Figure 6.90 EDS area measurements (a), (b), and point (c).

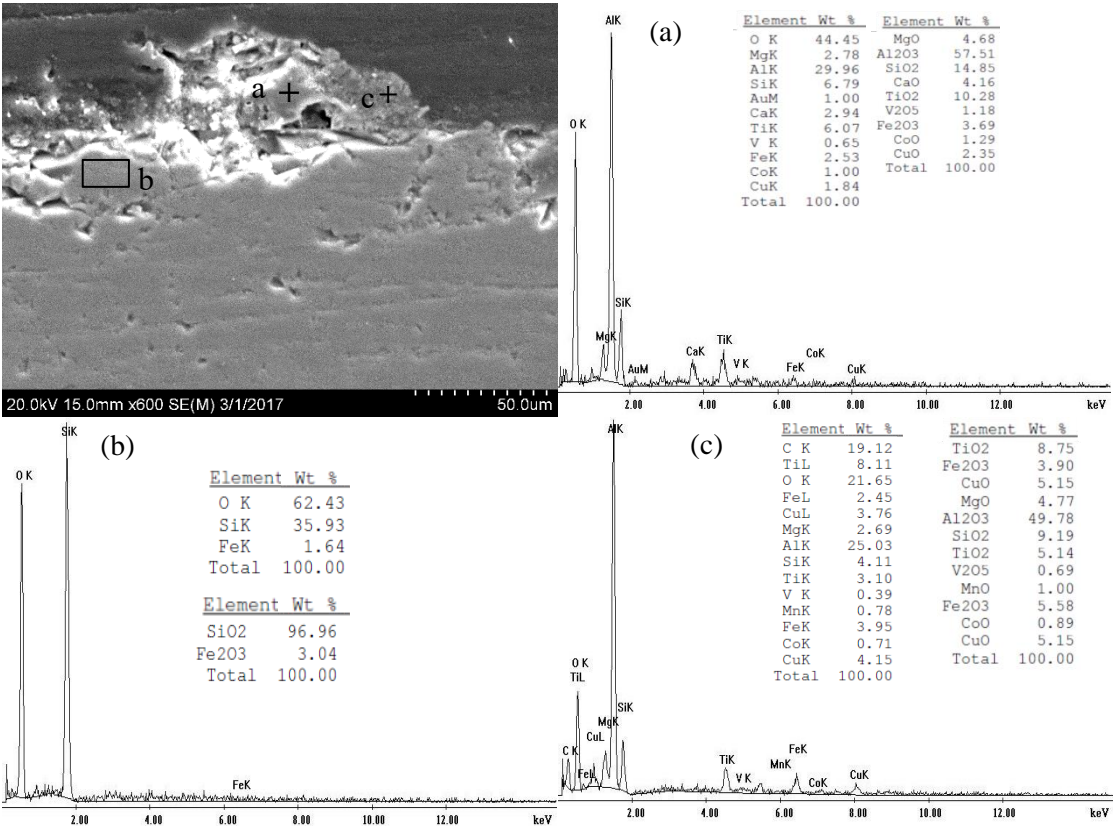
Additional EDS measurements were obtained to distinguish the chemistry of the solid versus the oxide-type morphologies of the deposit. Solid areas a and b in Figure 6.91 show that area b represents the chemistry of the glass with no deposit. The results from point a show that it was rich in aluminum oxide (44.5 wt% O and 29.96 wt% Al). The dark grainy area on c contained 25.03 wt% Al, 21.65 wt% O, and 11.21 wt% Ti. X-ray mapping was used to decipher the distribution of the spot and area EDS readings. Individual maps obtained from the micrograph on Figure 6.92 highlight the irregular deposit layer.

Figure 6.91 SEM micrograph with EDS of (a) deposit, (b) bulk material, and (c) an additional deposit.

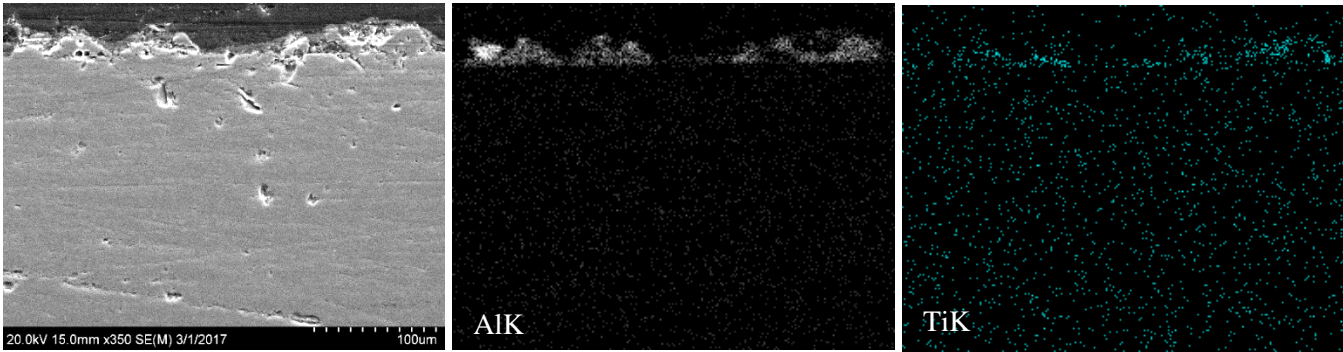
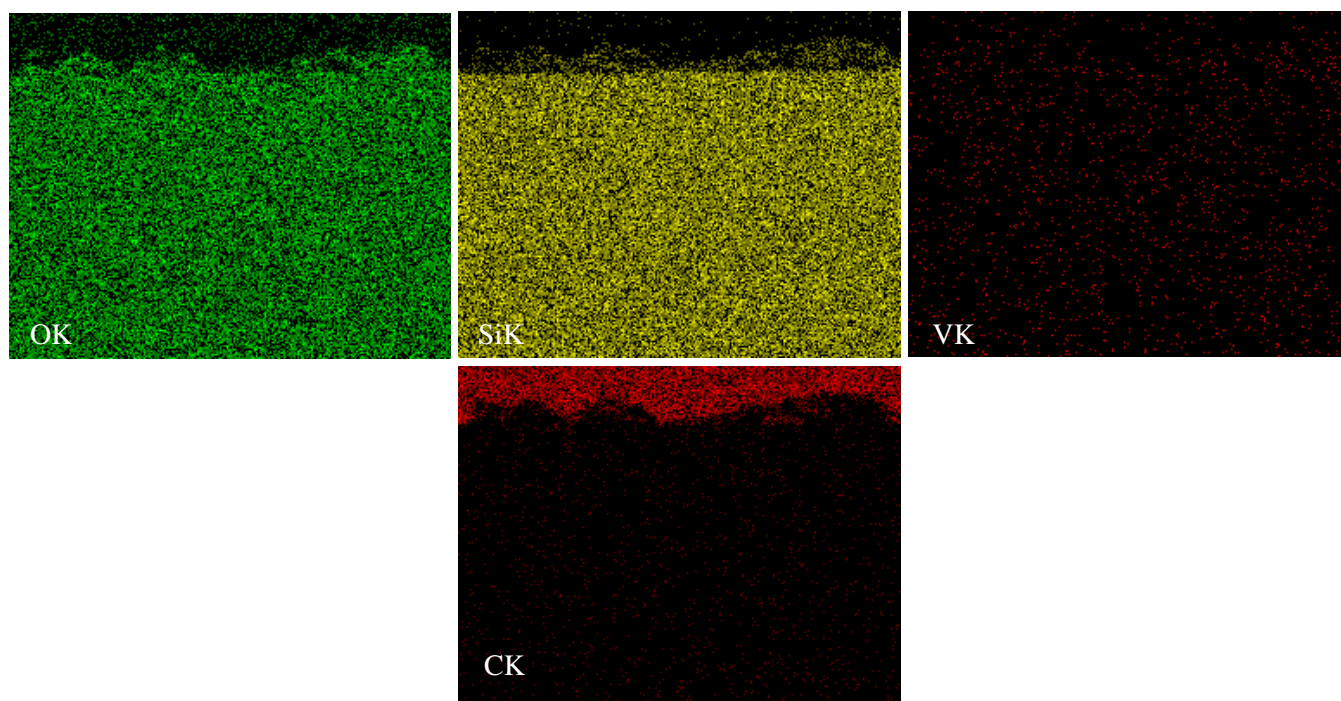
Aluminum, oxygen, silicon, titanium, and some carbon construct the layer. A larger weight percentage of aluminum was applied to the surface of the glass as the brightness of the element map is directly related to the weight percent of the element present. Oxygen was also present in a high weight percentage. The relative amount of titanium was low however, it appeared to collect directly on the surface along with aluminum and oxygen. Vanadium was also randomly dispersed through the cross-section.

Figure 6.92 X-ray map of the micrograph shown.

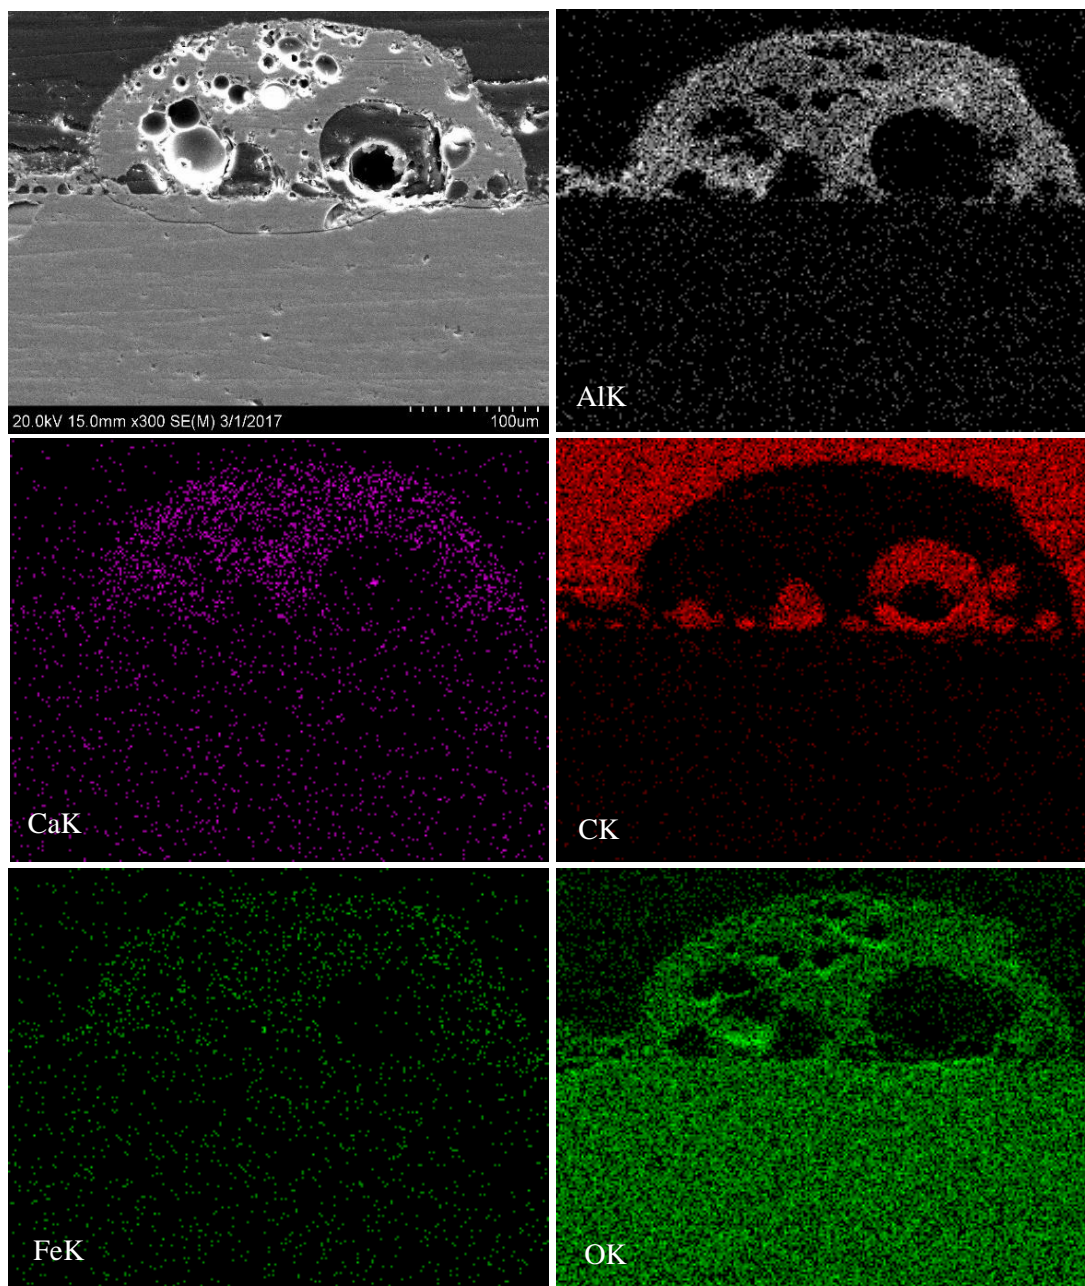
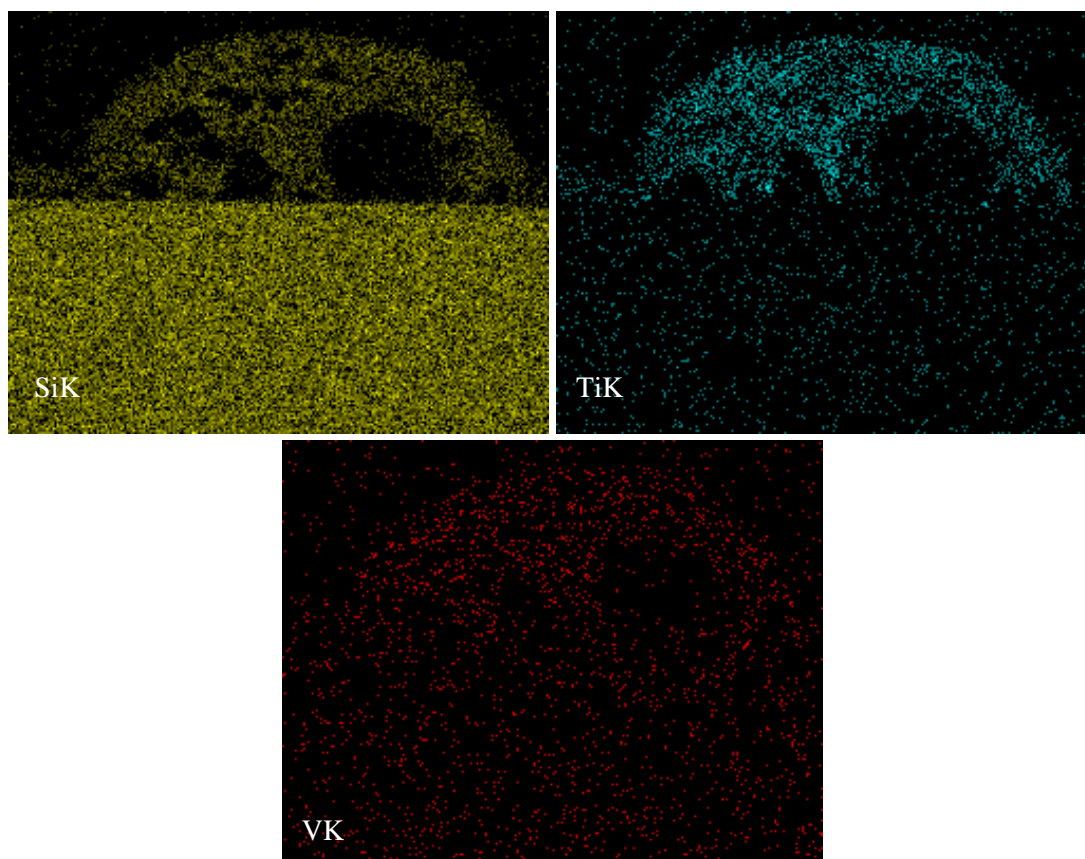
The largest compacted deposit remnant was mapped to characterize the elements present. The elements collected at the surface of the glass were comprised of aluminum, calcium, iron, oxygen, titanium, silicon, and vanadium (Figure 6.93). No clear distinction between different phases in the deposit were present. The deposit in this area contained iron whereas the previous thin deposit (Figure 6.92) did not have any iron present. The spherical cavities on the deposit contained calcium, titanium, and vanadium. The carbon map shows that it was concentrated in the dark areas near the upper surface. Additional deposit residues were also analyzed through X-ray mapping and shown in Figure 6.94. Both areas consisted of a light gray phase surrounded by a darker phase. Figure 6.94a marks the elements present at the locations shown. Most of the light gray phase was a mixture of Al, Ca, O, Si, Ti, and V. Whereas the darker surrounding phase was comprised of Al, O, and C. Some areas of the deposit were not tightly adhered to the glass substrate and small darker areas with high carbon were present. Smaller particles of predominately Ti or Al were applied near the top surface. A smaller deposit was shown to be a mixture of Al, O, and Si. Figure 6.94b also contained a similar deposit with the darker phases consisting

Figure 6.93 X-ray maps of the large deposit.
