Material Behavior of Window 7 Carrier Panel Tiles and Thermal Pane Fragments Recovered from the Space Shuttle Columbia

MATERIAL BEHAVIOR OF WINDOW 7 CARRIER PANEL TILES AND
THERMAL PANE FRAGMENTS RECOVERED FROM THE SPACE
SHUTTLE COLUMBIA

DISSERTATION

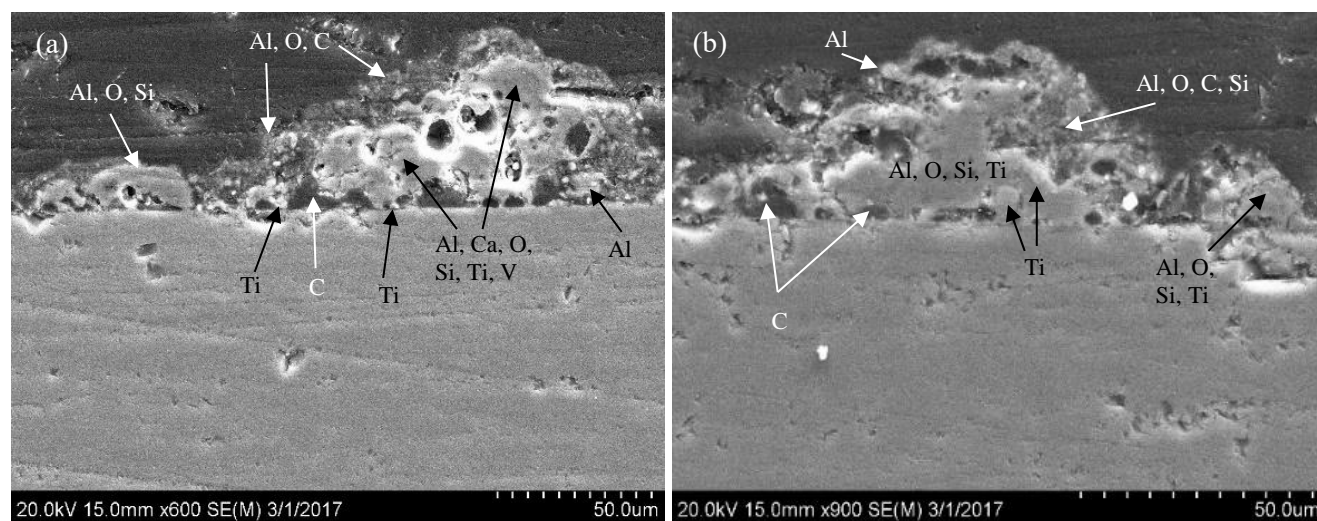
of Al, O, C, and the addition of Si. The more solid deposit contained similar chemistry of the previous deposit except without vanadium. Several light gray spherical particles were rich in Ti as pointed out by the two black arrows. An aluminum particle was observed at the higher point of the deposit. The dark areas where the deposit is not fully attached consisted of carbon. The deposits on the glass contained Al and Si particles that were able to be distinguished in a matrix of Al, O, Si, and Ti.

Figure 6.94 Two micrographs (a) and (b) illustrating the elements of the deposit.

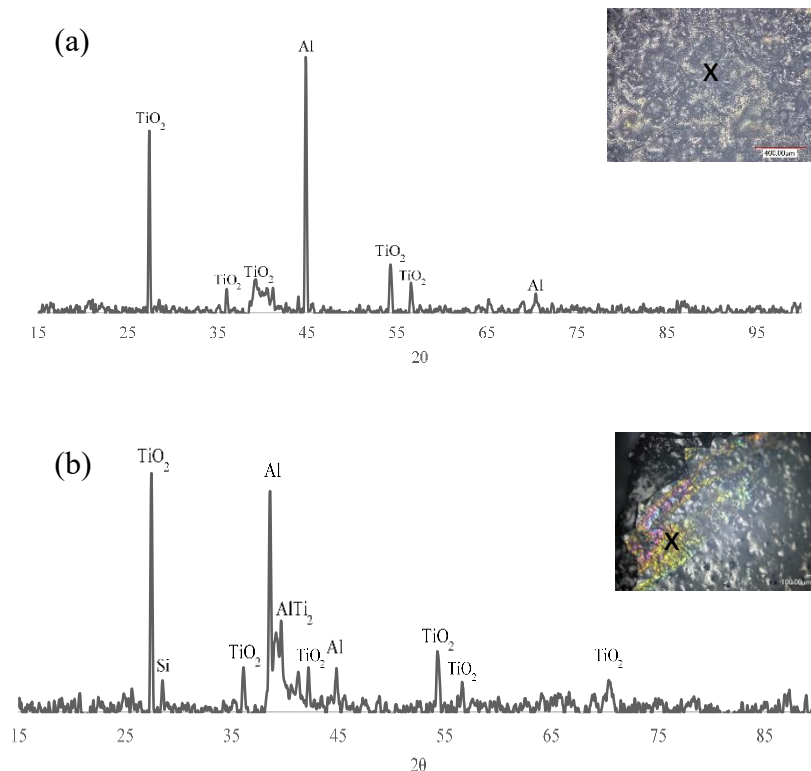
The tile samples obtained from the forward port side carrier panel consisted of four samples (1.1A, 1.1B, 1.2, and 1.3) where each sample was analyzed by XRD. Samples 1.1A and 1.2 contained similar XRD results as both surfaces contained similar characteristics. Sample 1.1B did not contain any flat surfaces for an accurate reading. Figure 6.95a represents the spectra obtained with phase identification including the location of where the measurement was conducted. The composition of these two samples was consistent with TiO_2 and Al. The EDS analysis of these two samples showed predominately aluminum and titanium oxide peaks which show the accuracy of XRD. XRD confirmed that the type of oxide present was the rutile form of TiO_2 . This compound was frequently detected in most samples analyzed. However, the minor and trace elements of Si, Ca, Cu, or Fe was not detected. Most of the minor elements were present beneath the TPS surface. The next sample analyzed contained additional distinct phases present when the spot reading was placed at the colored deposit shown on Figure 6.95b. Besides TiO_2 and Al, Si

and AlTi_2 (aluminum-titanate) were detected. This sample contained visible metallic streaks and EDS experiments show that it contained mostly 25.67 wt% Al and 32.43 wt% O. The surrounding areas of the metallic deposit were high in titanium oxide. The formation of an aluminum-titanium compound may be a result of these mixtures especially since both elements were found at the cross-sections of the sample. These results demonstrate the changes in compounds on different locations of the tile surfaces.

Figure 6.95 XRD spectra (a) representing similar samples 1.1A and 1.2 measured at the location shown. Spectra (b) was measured at sample 1.3 in the spot shown.

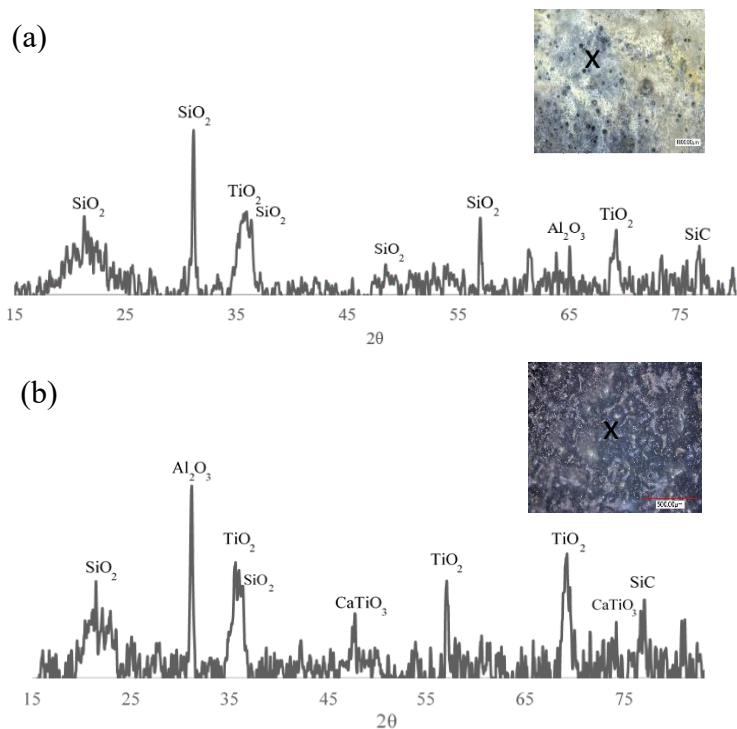
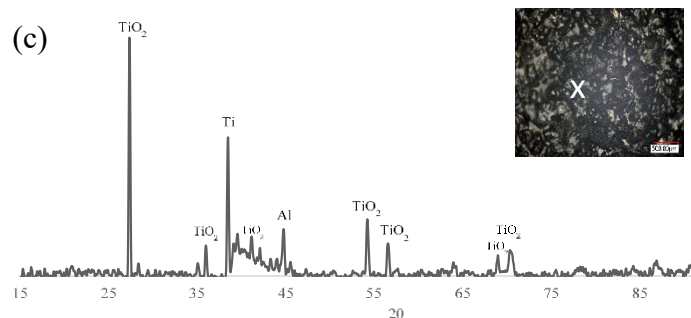
The following samples obtained from the forward starboard side comprised of five samples; 2.1.1A, 2.1.1B, 2.1.2, 2.1.3, and 2.1.4. The entire sample contained visible discolorations that diminished towards the inner side of the tiles. When analyzing all samples through XRD, several noticeable changes were observed. Sample 2.1.1A contained the majority of yellow discolorations with EDS measuring 56.95 wt% O, 15.20 wt% Si, 13.68 wt% Ca, and 4.18 wt% Ti. The corresponding XRD results on Figure 6.96a

show silicon oxide in cristobalite form (SiO_2), titanium oxide in rutile form (TiO_2), aluminum oxide (Al_2O_3), and silicon carbide (SiC). Subsequently, the yellow discoloration was only concentrated on the outer areas of the TPS coating and the discoloration diminishes. Samples 2.1.3 and 2.1.4 possessed similar surface characteristics of dim discolorations. The compositions found on these samples and the location of where the reading was measured is shown on Figure 6.96b. The compounds include SiO_2 , Al_2O_3 , TiO_2 , CaTiO_3 (perovskite form), and SiC . This spectrum directly upholds the results obtained from EDS with similar elements detected. Next, the sample at the inner side of the tile was evaluated as the sample was long enough to provide a flat and stable surface. Originally through EDS, the sample contained titanium oxide, aluminum, silicon, and calcium major peaks. The compounds present on Figure 6.96c on the corresponding image consisted of TiO_2 , Ti (hexagonal), and Al peaks. The results show that the XRD measurements varied when the surface condition was changed. All XRD measurements confirmed the type of the deposits on the tile surfaces consisted of titanium oxide, silicon oxide, aluminum oxide, silicon carbide, elemental Ti , Al , and calcium titanate.

Figure 6.96 XRD spectras of (a) yellow discolorations from sample 2.1.1A, (b) represents the rest of the samples with minimal discolorations, (c) was the inner tile sample 2.2.1.

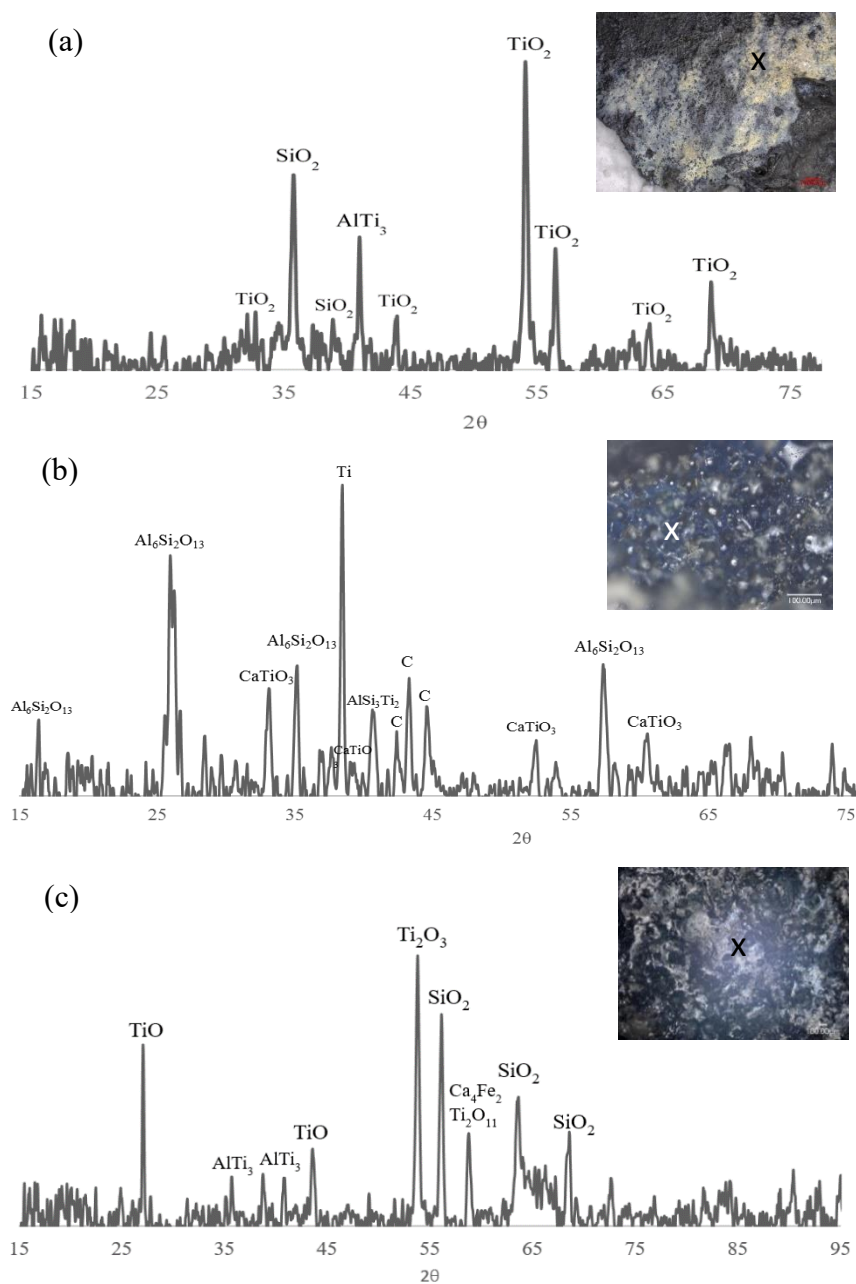
Two samples were collected from the aft tile and the visual inspection showed that they contained similar discolorations and higher degradation of the coating. Samples 3.1A and 3.1B contained coinciding XRD results and the spectra for sample 3.1A was interpreted due to the surface conditions. The spectrum is given on Figure 6.97a where SiO_2 , TiO_2 , and intermetallic AlTi_3 were existent on the point shown. EDS at this location also detected 58.82wt% O, 17.91wt% Ti, 10.68wt% Si, and 6.71wt% Al. These results are plausible as the XRD determined these deposits to be oxides and mixtures of other elements (such as AlTi_3). The following sample did not have any visible bright discolorations but a few dark blue areas as provided by Figure 6.97b. It is evident that this area contained more diverse compounds. The type of phases present is different from this area. The oxides present in this area were $\text{Al}_6\text{Si}_2\text{O}_{13}$ (mullite) and CaTiO_3 . Titanium and carbon were also detected as well as an aluminum silicon titanium compound AlSi_3Ti_2 . These results coincide with the EDS results found at the surfaces which involved 34.92wt% Al, 46.65wt% O, 9.89wt% Si, 2.62wt%Ca, and 3.03wt%Ti. Additional EDS measurements show that the surfaces of sample 3.2 were rich in aluminum and titanium oxide. The final sample obtained from a different location from the aft tile contained dark areas with light deposits under SEM observation. When analyzed with EDS, samples 4.1 and 4.2 held the same elemental compositions. The majority of the surface was high in titanium oxide, silicon, aluminum, and calcium. The spot evaluated for XRD is shown on Figure 6.97c along with its spectrum. The spectrum shows no aluminum oxides but titanium, silicon, and

a calcium iron titanium oxide. An aluminum titanium intermetallic was also present. When XRD is used in conjunction with EDS, results are able to support the oxides and compounds present on the tile surfaces.

Figure 6.97 XRD spectra of sample 3 (a and b), and sample 4 (c).

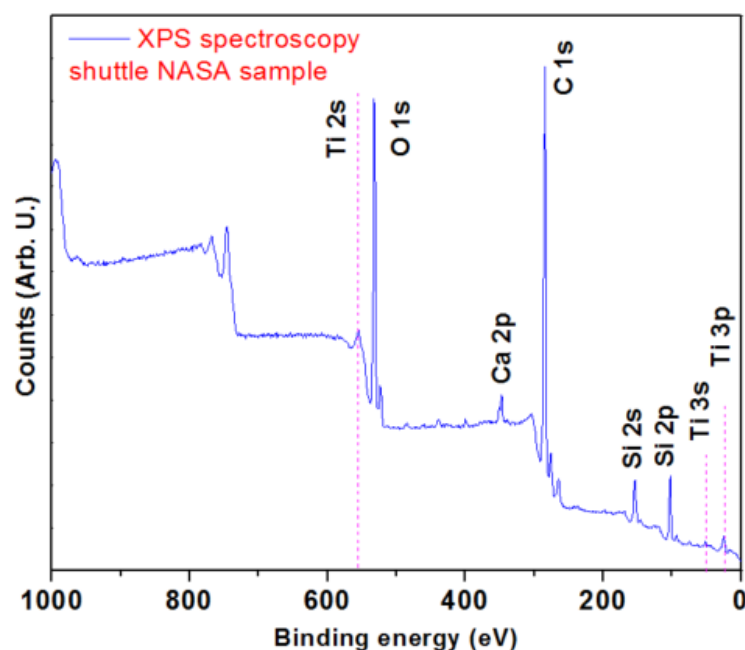
Supplementary samples were sectioned from the forward port side sample 1 for XPS analysis. One sample with minimal surface discolorations is discussed in this section. The spectrum obtained from the sample is shown in Figure 6.98 where intensity versus binding energy is plotted. The elemental identities of this sample confirm that the TPS samples contained similar elements present when compared to EDS and XRD results.

The binding energies found in the sample at the surface by XPS spectroscopy results are related to the electronic orbital structure of titanium (Ti^{+4}), oxygen (O^{-2}), calcium (Ca^{+2}), carbon (C^{+4}) and silicon (Si^{+4}). The binding energies at 555.2 eV, 52.1 and 25.8 eV may be ascribed to titanium (Ti^{22}) 2s-orbital, 3s-orbital, and 3p-orbital, respectively. The binding energy (BE) of 532.1 eV signal is ascribed to oxygen (O^8) 1s-orbital. The binding energy at 348.1 eV is related to calcium (Ca^{20}) 2p-orbital. The carbon 1s-orbital signal was found at 285 eV. The binding energy signals at 103.1 eV and 154.2 eV are ascribed to silicon (Si^{+4}) 2p-orbital and 2s-orbital, respectively. It is worth mentioning that signal at 25 eV is linked to Ti (3p-orbital)-O (2s-orbital) and signal at 51 eV is linked to O_2/Ti (3s-orbital)/Mo (2p-orbital) as suggested by Corneille et al. [43]. The results obtained are comparable to EDS results from the forward port sample.

Figure 6.98 XPS spectra of the additional forward port side sample.
