Materials Characterization of Deposits on Starboard (Inboard) Elevon Actuator Shaft Recovered from Space Shuttle Columbia

MATERIALS CHARACTERIZATION OF DEPOSITS ON STARBOARD
(INBOARD) ELEVON ACTUATOR SHAFT RECOVERED FROM SPACE
SHUTTLE *COLUMBIA*

DISSERTATION

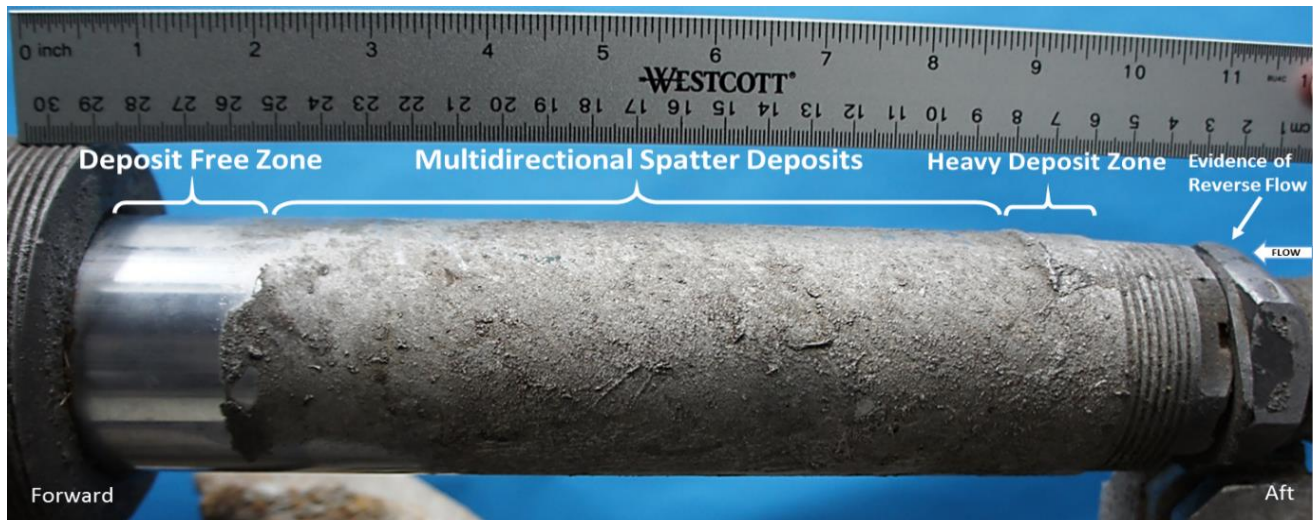
Figure 3.3 Port-side of starboard (inboard) elevon actuator shaft showing three different zones.

In Figure 3.3, a detailed photograph of the port-side of the starboard (inboard) elevon actuator shaft is shown. Visual examination revealed that for the port-side of the inboard starboard elevon actuator shaft there was a deposit-free zone located next to the housing. This deposit-free zone measured a few centimeters and had a plane, smooth, reflective surface. Adjacent to this section, there was a multi-directional spatter deposit zone, which extended through most of the shaft and the transition between these two areas was well defined by a straight vertical line. In this area, deposits seemed to transition from light to heavier deposits from top to bottom and from forward to aft. Also, the multi-directional streaks varied in length while other regions had a granular texture. One thing to note is that the underside of the shaft did not have many depositions. This might be a result of the shaft being shielded by part of the attached elevon actuator rib. Before reaching the end of the shaft, a heavy deposit zone was also identified. Here, thickness increased drastically when compared to the rest of the deposits. Near the end of the shaft, part of the locking nut can be seen where one of the faceted sides deteriorated and the loss of material was evident.

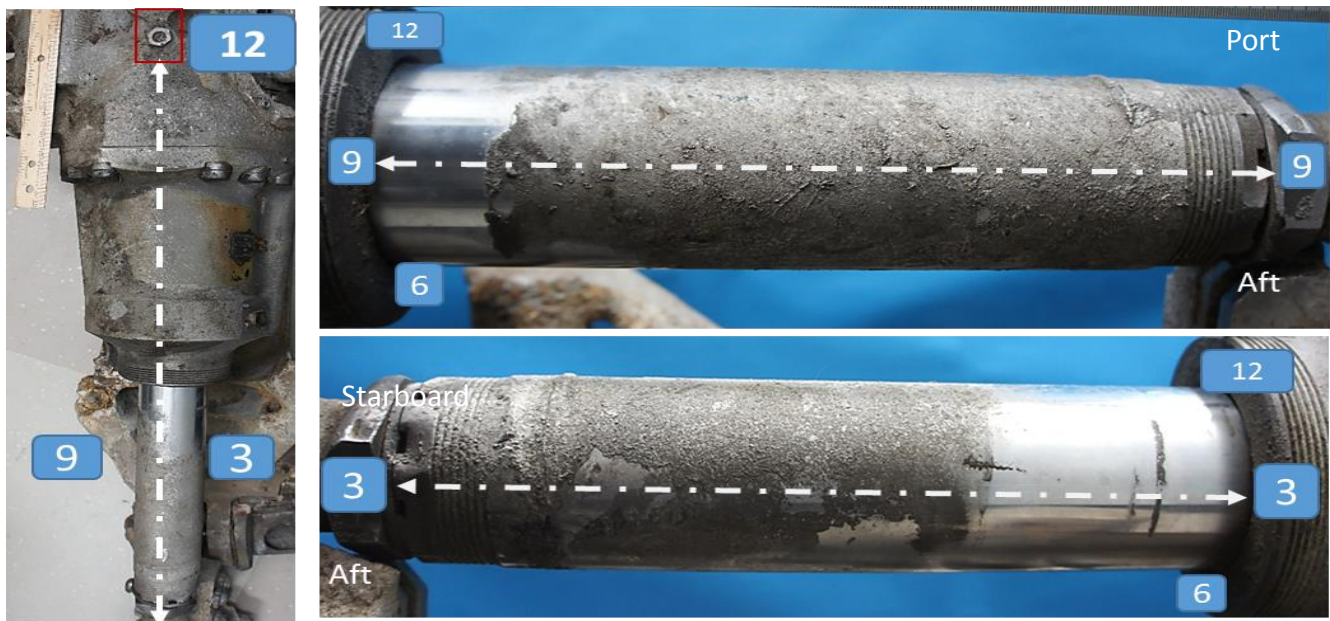
Figure 3.7 Left. 12 o'clock is defined by the nut as shown by the red box. **Top Right.** Port side of elevon actuator shaft showing the 9 o'clock position. **Bottom Right.** Starboard side of elevon actuator shaft showing the 3 o'clock position.

Using the positions of the clock to reference the positions where measurements of the diameter of the shaft were taken, the average diameter was 6.334cm (2.49”) and the average diameter of the shaft with deposits was 6.355cm (2.50”). Several measurements, but not all that were taken are included in Table 3.1 and a general trend was observed when looking at the average diameter of the shaft with deposits. As the diameter is measured from forward to aft, the diameter tends to increase in thickness, meaning that the debris deposited onto the shaft is increasing as it reaches the end of the shaft. The average thickness of deposits found along the rod was approximately 0.011cm (0.004”) and the maximum thickness of deposits found along the shaft was calculated to be 0.066cm (0.026”) which was located before the thermally eroded area pointed out in Figure 3.4.

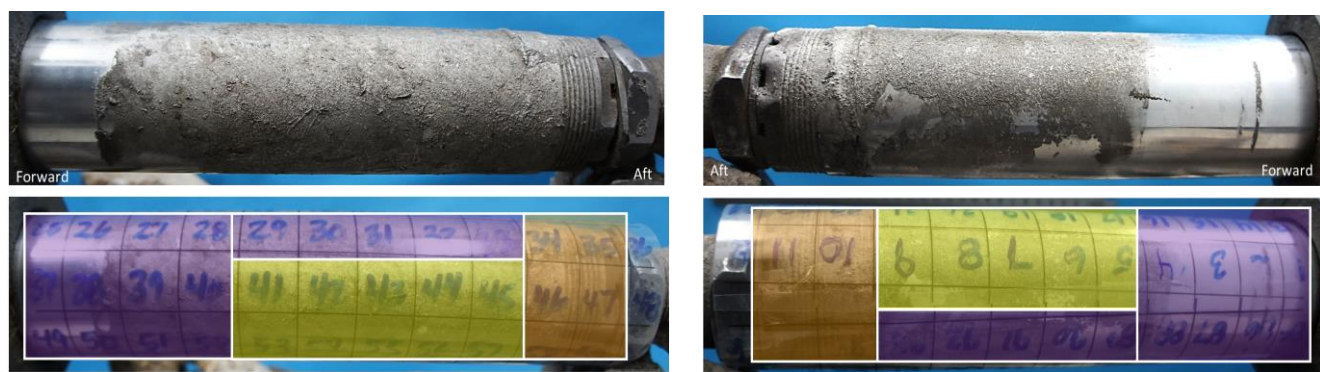
Table 3.4 shows several of the XRF readings taken on the starboard-side of the elevon actuator shaft. Figure 3.8 is a representation of the three different areas where trends were seen on the port and starboard-sides. The purple section represents the area where Cr was dominant. The yellow sections in the middle where the deposit zone begins, major elements like Fe, Cu, and Ni were detected but Al and Cr were found in larger amounts. Adjacent to this yellow section is the orange region which represents the end of the shaft where a heavier deposition was observed as well as an increase in the composition of several of the major element. Chromium no longer dominated in the orange region. The final area that was

Figure 3.8 Left. Port-side of actuator shaft showing the overlay grid designed to provide exact area where readings were taken. **Right.** Starboard-side of actuator shaft showing the overlay grid. Different colored sections show areas where elemental trends were seen.

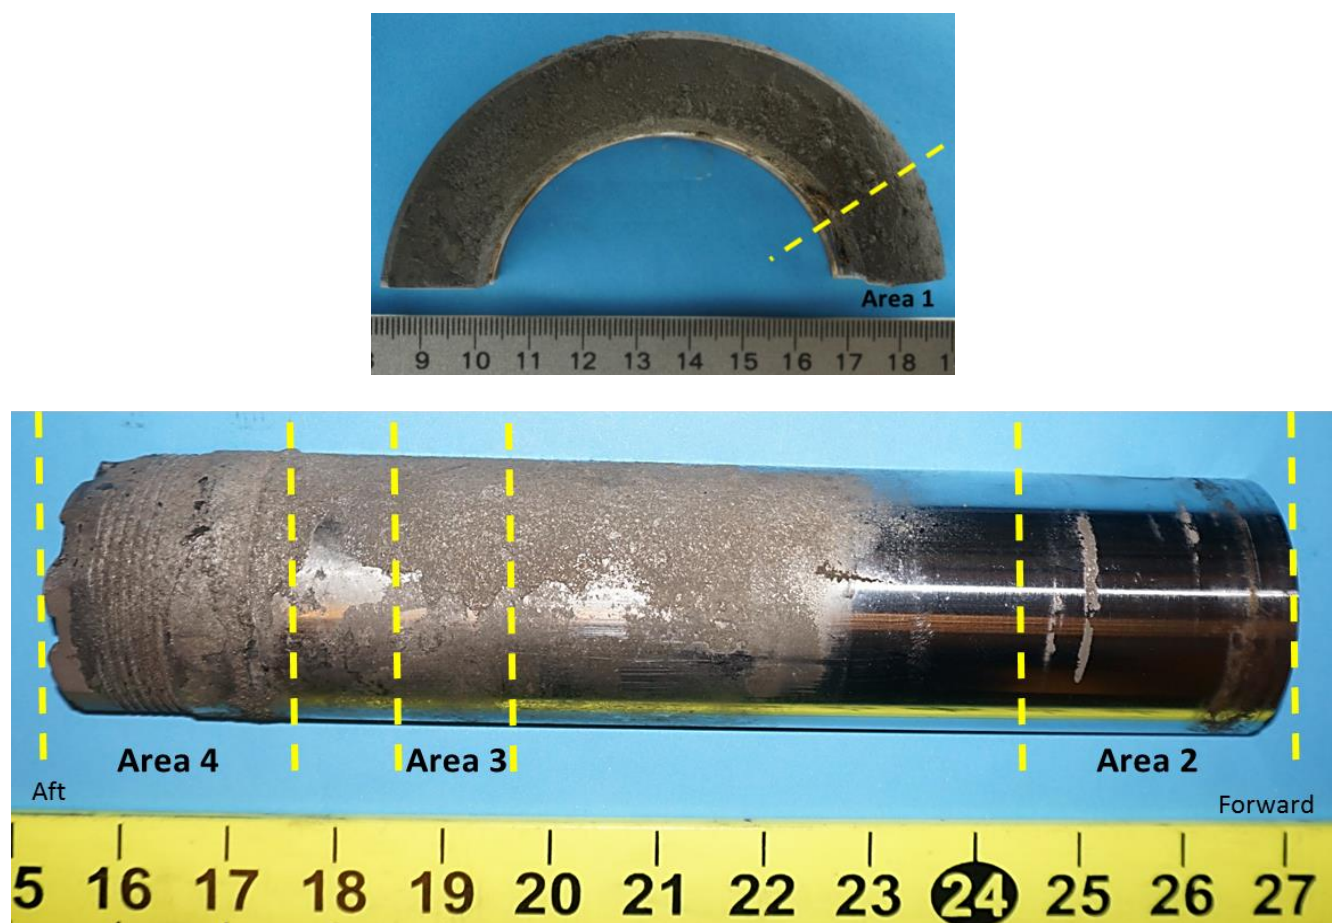
Figure 3.10 Top. Section of the hydraulic assembly housing which will provide sample for Area 1. **Bottom.** Starboard-side of actuator shaft showing areas of interest 2, 3, and 4. Sectioning indicated by yellow dotted lines.

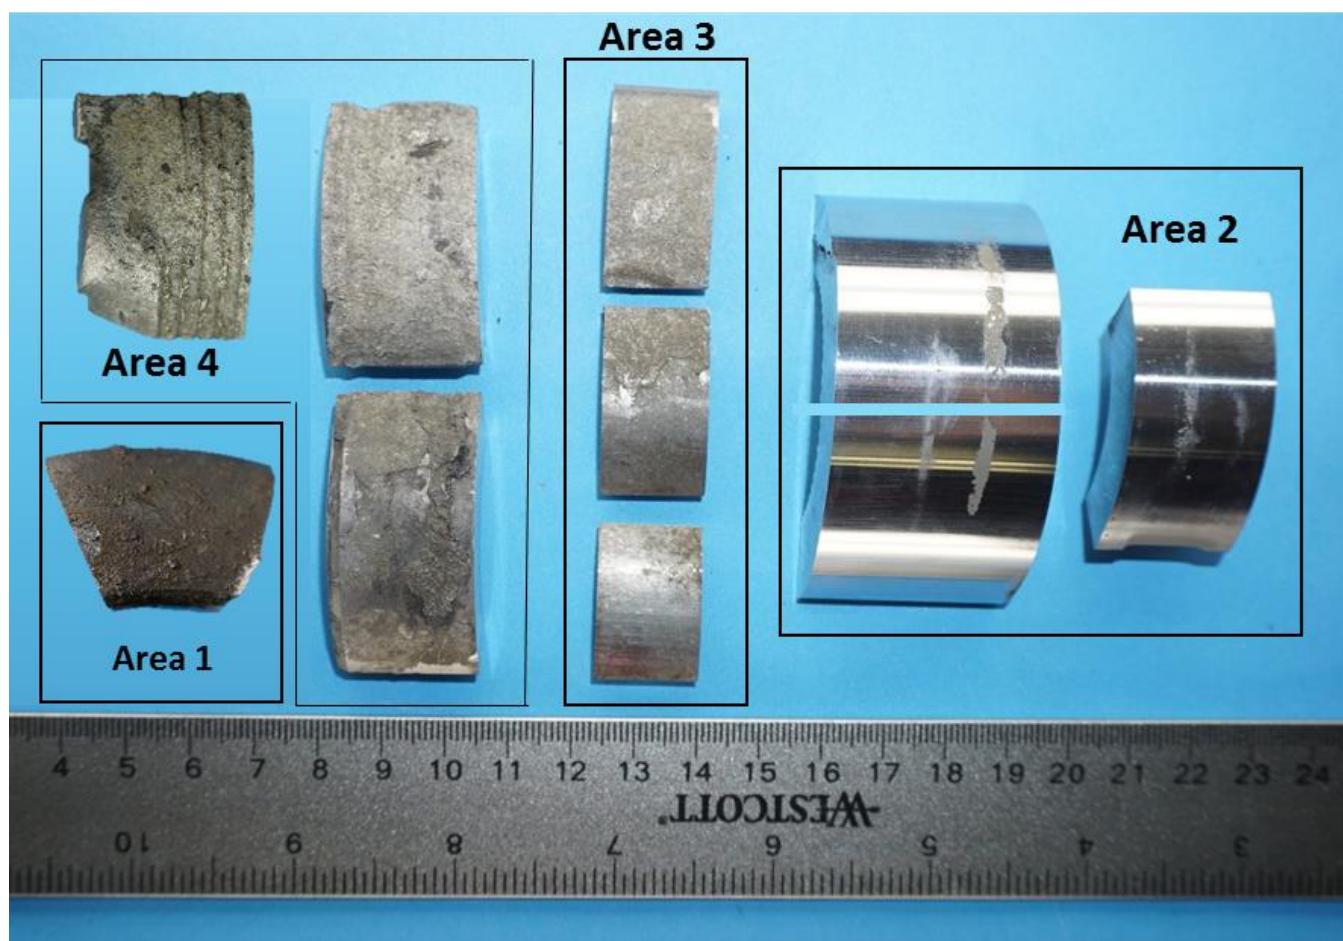
Figure 3.11 Samples obtained after sectioning the starboard-side of the shaft resulting in Areas 1, 2, 3, and 4.

stored away. The samples that were used for this researched can be seen in Figure 3.11, including those in Area 4. With possible signs of thermal erosion showing in one of the samples and heavy deposits adhering tightly to the base metal, investigating this area demonstrated thermal degradation that might have occurred and show again any existing layers that might have developed in denser areas.

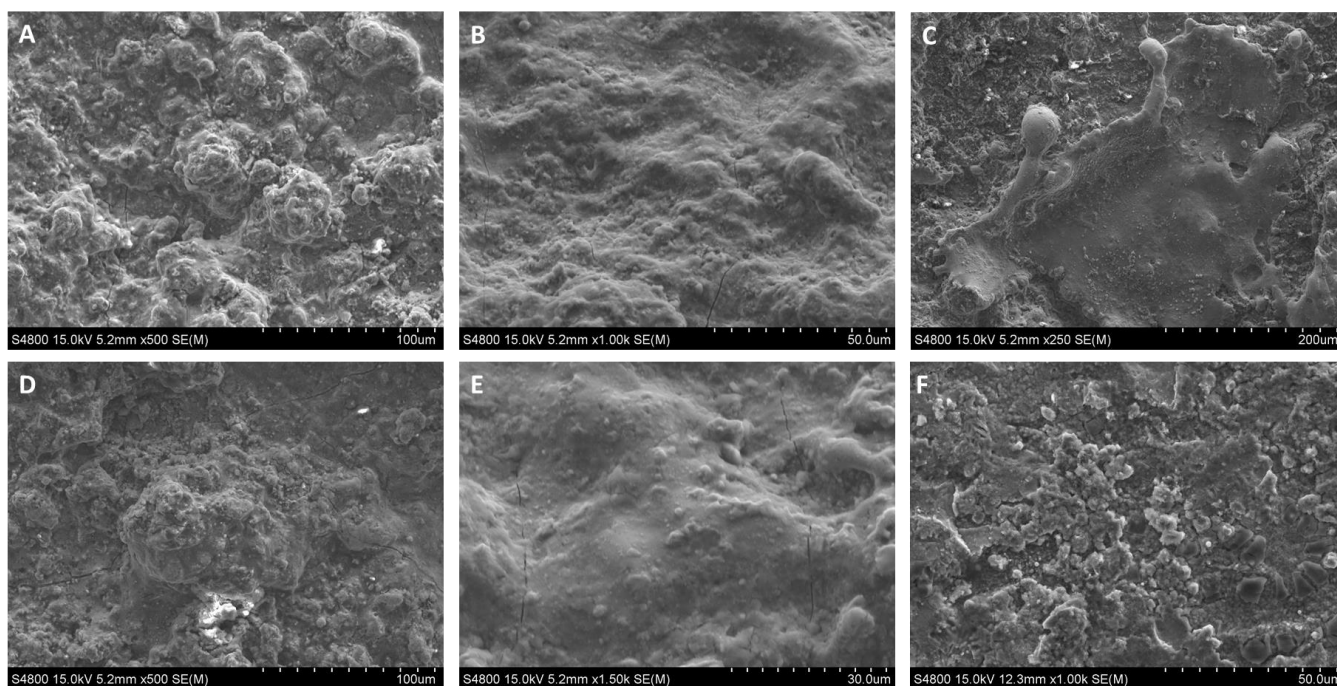
The surface of the aft-facing side of Area 1 was examined at a higher magnification using the SEM for surface morphology and elemental composition. Analyzing Area 1 showed a variety of surface texture, some regions had a rocky texture, others were flat and granular, and there were also regions with a flat smooth surface. Figure 4.2 shows the different regions that were seen in Area 1. About 15% of the terrain had a coarse surface, and deposits clustered in small piles forming column-like structures (Figure 4.2 A and D). These column-like structures varied in height and width and were accompanied by smaller agglomerated deposits that had a “popcorn texture”. Besides this region having a very rough texture and a denser deposition, cracking was observed, which is an indication of rapid solidification of the molten metal upon contact. Another region that was seen in the sample consisted of smooth hills and valleys which were considerably lower in height when compared to the column-like structures seen in the nearby

region. As in the coarser region, cracks could be distinguished in this region as well. There were also areas where the hills and valleys contained spray-like deposits, which made a patchy but smooth layer in the already solidified deposits. This area covered about half of the sample (Figure 4.2 B and E). A thinner layer of deposit, which is found along the top edge on the port-side of the sample, makes up the remainder of the surface. Figure 4.2 C and F shows how the surface is flatter than other regions and a lot coarser as well. This layer had a flaky texture which also demonstrated that the deposits did not have enough time to adhere to the base metal or debris already deposited onto the shaft. Other features seen in this region were spatters being deposited once again on top of an already deposited re-solidified metal but were not seen much throughout the region.

Figure 4.2 SEM micrographs from Area 1 showing different surface morphology seen throughout the sample region. Images are at different magnifications.

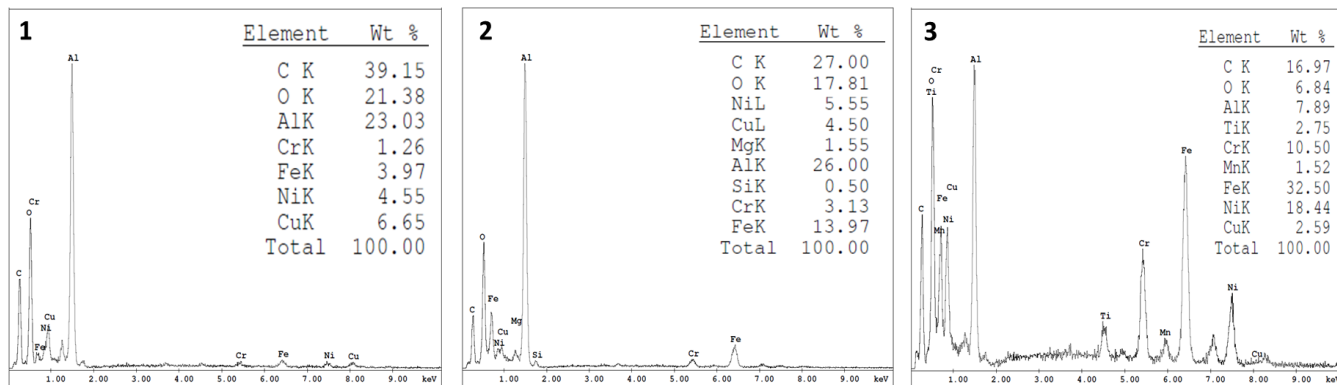
Elemental analysis using EDS was conducted on the surface of the sample from Area 1. These results helped confirm the preliminary results obtained from x-ray fluorescence which was also conducted on the surface. With several limitations encountered when using the XRF, verifying those results with the ones obtained from the EDS would provide accurate results of what elements were present in the surface of Area 1. In Area 1, the predominant element found on the surface was aluminum. Aluminum was

detected on the regions containing hills and valleys as well as the coarser terrain where the column-like structures were located, in amounts of about 25 to 30 wt. % Al. Traces of minor elements were found at the surface as well and amounts varied slightly on the three identified areas. On the region where the surface had a rough texture, copper was found in higher amounts than on the bumpier surface where iron was the dominating minor element. The average of several EDS readings was calculated and showed that Cu and Fe were present in amounts of about 8 wt. %. Elements such as nickel and chromium were also detected but at smaller concentrations of 7 wt. % and 3 wt. %, respectively. Smaller traces of titanium were also identified on the surface but in amounts of less than 2 wt. %. In the spatter that was found on the port-side corner of the sample, the same elements were detected with the exception that composition varied dramatically. These spats were mostly composed of Fe and Ni with concentrations of about 30 wt. % Fe and 20 wt. % Ni. Other elements that were found in the spatter were Cr and Al with 8 to 10 wt. % of each and smaller amounts of Cu and Ti were also detected. Figure 4.3 shows EDS spectra of readings taken from areas shown in Figure 4.2. SEM micrographs A, B, and C on Figure 4.2 correspond to the EDS spectra 1, 2, and 3 respectively. For SEM images A and B, the whole area was surveyed. As for image C, only a part of the spatter was analyzed since the bottom layer had similar results to the ones found in micrographs A and B.

Figure 4.3 EDS spectra from regions taken from Area 1. Spectra 1, 2 and 3 correspond to reading taken from micrographs A, B, and C shown in Figure 4.2.

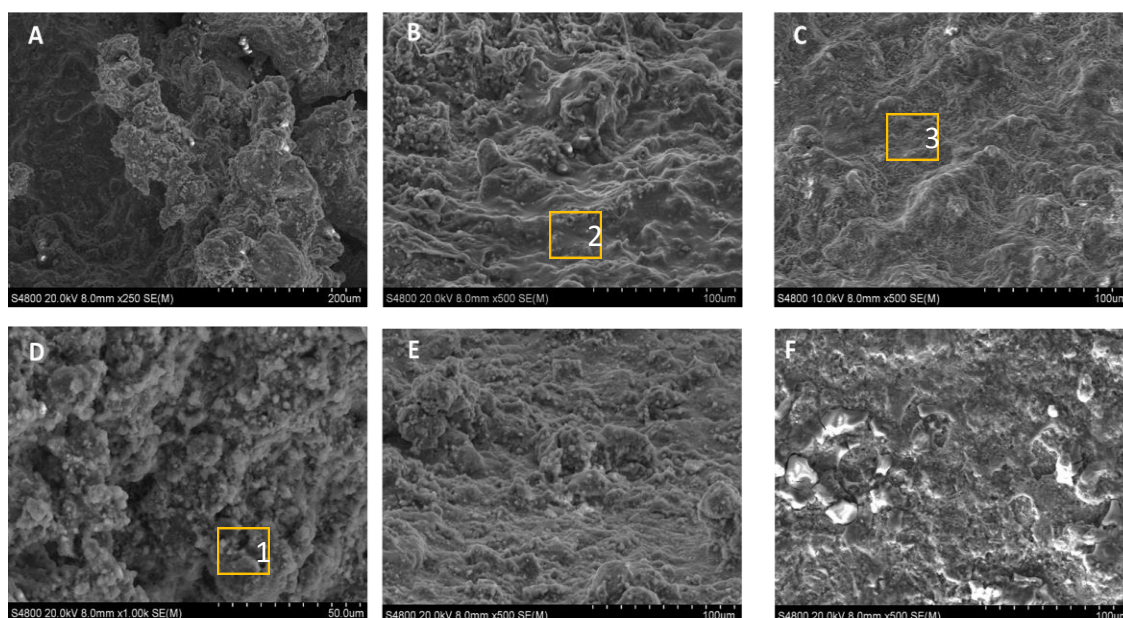
Looking at the surface of the threaded side of Area 1, there were high expectations of finding a different morphology but some regions had similar features to the ones found in the adjacent side. One of the noticeable differences in the deposits found in between the threads was that the surface was a lot rougher. This type of morphology was mostly found on the threaded angle walls where tiny molten metal droplets seemed to agglomerate and form a “popcorn-like” structures with many nooks and crannies. Deposits were found to adhere uniformly against the first three thread angled walls which were located closest to the forward direction of the shuttle. This uniform deposition happening on both threaded faces, the forward and aft-sides, had the same amount of deposits and the root of the threads was where most the debris accumulated. As the threaded region advanced in the aft direction, which is closest to the adjacent side, the amount of deposits adhering to the thread faces decreased and it was observed that they mostly adhered to the aft-side of the threaded face. The morphology found on these thread faces were where the main differences were seen when comparing to the morphology from the adjacent side. The roots and crests by contrast, had similar morphology and also had similarities to the morphology found on the adjacent side. On the root of the threads, for the most part, the surface was even though rough, but did however, have some particle agglomeration occurring. This accumulation of molten metal droplets and splats were found evenly dispersed throughout the surface. Spatter was also detected in the roots of the threads covering a larger area, making the layer thicker than the ones found on the aft-facing side. The morphology found on the crests of the threads had a smoother surface than the one seen at the roots, which might be due to the fact that it was located at the top of the threads where deposits would not encounter problematic geometry unlike depositing into the roots of the threads. One of the major things that was observed in this area was “mudcracks,” which are molten metal that quickly solidified producing to contraction which lead to cracking. Due to these cracks and poor adherence of the deposits, residual cavities within the solidified metal were left behind in several of the mudcracks. Even though there were indications of metal flaking, the already deposited layer below these mudcracks were tightly bonded to

the base metal. Similar to the surface texture found on the adjacent side, hills and valleys of metallic metal were also present. Figure 4.4 show several micrographs taken with the SEM of sample Area 1 where the yellow boxes indicate the spot were EDS readings were taken. Images A and D show the deposit seen accumulating on either sides of the threaded faces, which B and E show micrographs taken at the roots of the threaded regions, and images C and F correspond to the crests of the threads.

Figure 4.4 SEM micrographs taken from the threaded region belonging to Area 1. Yellow outlined boxes designate the area were EDS analysis was performed and correspond to the results shown in

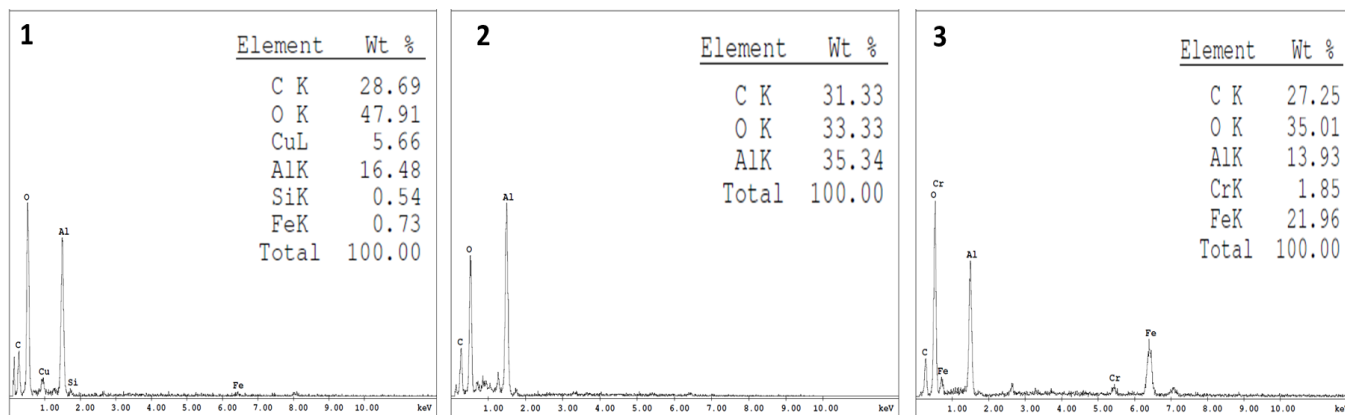
Chemical analysis done on the surface of the threaded region revealed that the major composition of the deposits were aluminum, iron, and oxygen. Due to the angular nature of the thread faces and the surfaces having a granular texture, EDS analysis was difficult, but these areas were mostly composed of aluminum and oxygen. Noting that this area had large clusters of micro-particles agglomerating together, there was a greater surface area which made these particles react at a faster rate and could have led to aluminum oxidation. Figure 4.5 (1) shows the EDS results for this region which are shown on Figure 4.4 D, spot 1. Another element that was detected here but was not present on the EDS spectra in Figure 4.5 was silicon. While examining the thread faces, there were areas where a lot of granular silica particles were occupying space in the cavities seen in these deposits, which created a lot of charging making it difficult to obtain images as well as chemical identify by EDS. The next region that was analyzed by EDS

was the root of the threads. Here, the main elements that were found were once again Al, Fe, and O, but did also contain smaller amounts of Ni and Cu. Within the threaded roots, there was about 30 wt. % Al present, which was the element with the largest concentration in that region. Fe and O were also detected in large quantities with approximately 15 wt. % Fe and 20 wt. % O. Ni was present in concentrations of about 5 wt. % and around 10 wt. % Cu was also detected in this flat, yet patchy deposits. The EDS results for the reading performed at the root of the thread is shown in image 2 of Figure 4.5 and the location of the spot tested is shown by the yellow box in Figure 4.4 B. On the crest of the threads, once again Al, Fe, and O were the major elements except that Fe was the predominate element. Fe was detected in concentrations of approximately 30 wt. % whereas Al only made amount 20 wt. % of the total composition. Aluminum and oxygen were particularly found in areas where there were mudcracks and Fe was mostly present in the flatter surfaces. The chemical composition analyzed by EDS in Figure 4.4 C is shown in Figure 4.5 (3). Note that carbon would appear in most EDS results, but should not be representative of the sample's chemical composition. This high concentration of carbon were due to residue from the hydraulic fluid coming from the hydraulic system or wiring insulation. These artificially high C values would also be due to contamination and the interaction between the E-beam and the sample as well as the surrounding environment in the chamber even with a high vacuum. Carbon can be found in the samples but the amount present should not be very high.

Figure 4.5 EDS analysis conducted on the threaded region of Area 1 in three different sections.

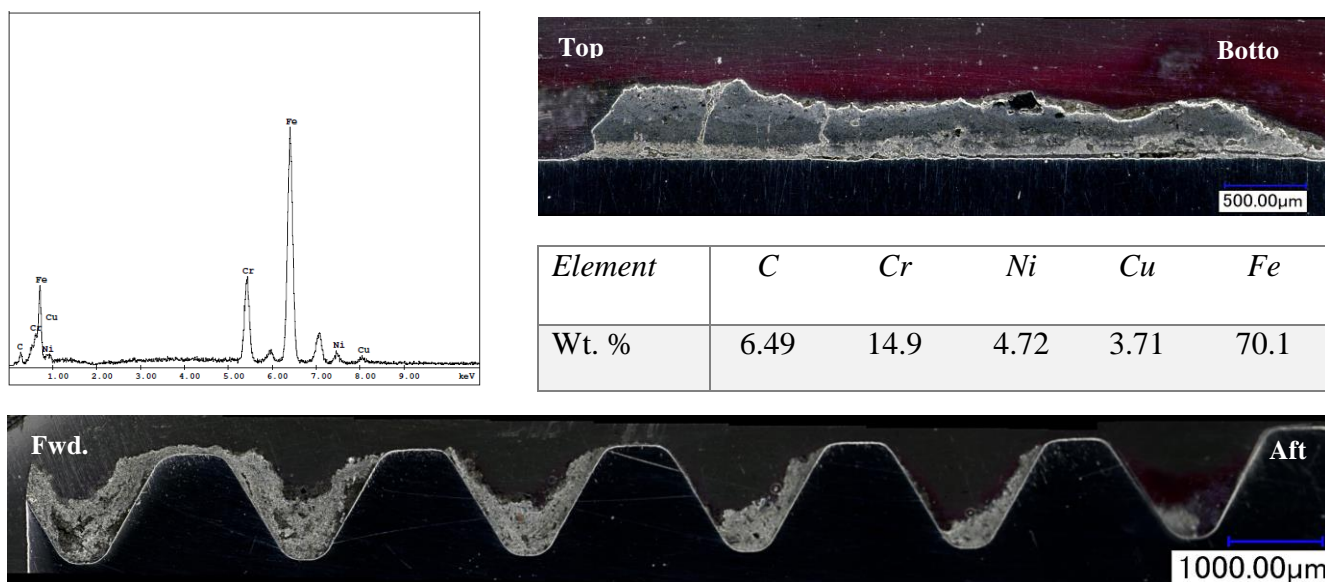
Figure 4.6 Top Left. EDS spectrum of base metal for Area 1 along with the chemical composition shown on middle table. **Top Right.** Keyence micrograph of aft-facing side of Area 1 sample at 200X. **Bottom.** Cross sectional view of threaded region in Area 1 sample taken with Keyence microscope at 150X.

The aft-facing side of the sample consisted of a deposit layer of approximately 460μm in thickness and four distinct layers. The first layer, which is directly above the base metal, is a few micrometers in thickness and contains a combination of the main elements found by XRF in the early stages of the study. A slight deformation at the interface between the base metal and the first layer of deposit was noticeable

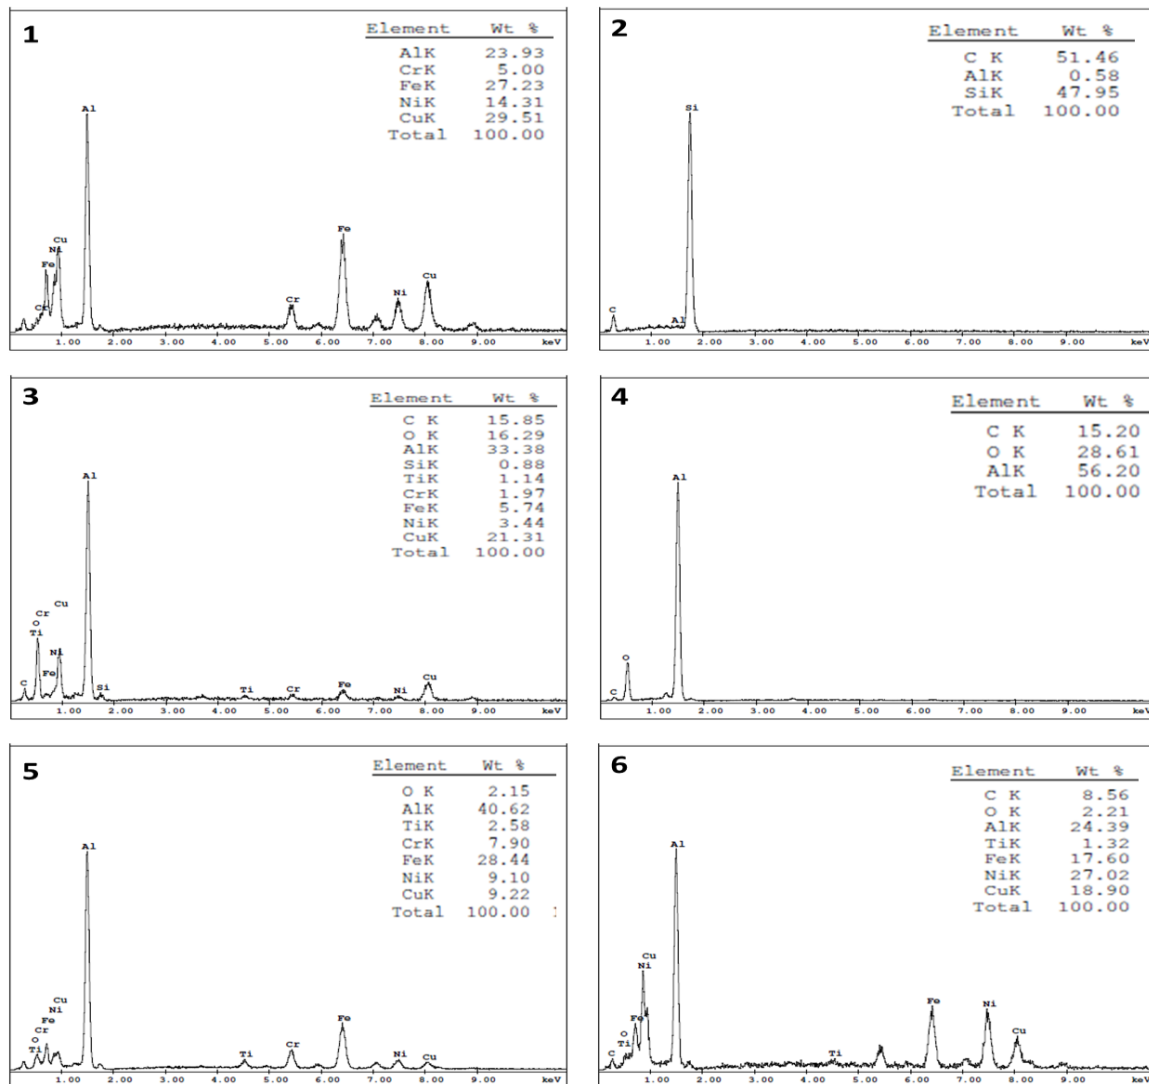
The third layer belonging to the light and dark matrix where mixing of these two materials was merely apparent at higher magnifications, was composed of 30 wt. % Al and 25 wt. % Cu. Again, Al and Cu were the dominating elements found on the layers of Area 1. The presence of Al however did jump from 20 wt. % to 30 wt. % and is possible that this was due to the airframe's temperature increasing dramatically, leading to a higher melting rate and quicker deposition of Al on the hydraulic actuator housing. Copper was still detected in similar amounts than it was detected in the first layer. Nickel and iron were detected in this third layer as well, but were not as high as the amounts found in the first layer. Unlike the first two layers, Ti was detected but only in a small amounts. In the fourth layer, there were three different constituents as they are displayed by a variety of shades of gray. The same dark and light shades of gray found in the third layer were also present here. The dark gray color seen here as well as in the previous layer belonged to aluminum and oxygen enrichments. In this layer traces of Ti, Cr, and Si were also detected by the EDS in concentrations of 2 to 3 wt. % of each of these elements. These areas of aluminum and oxygen were found all over the layer, but do not compose most of the fourth layer, while it does dominate the content in the third layer. The most abundant constituent in the fourth layer consists of 40 wt. % Al. Again, the main element in this layer is Al with the exception that these gray areas contain less than 2 wt. % O. Another major element found in the gray areas of the fourth layer was Fe, which made up approximately 30 wt. % of the elemental composition. There was a sudden decrease in copper composition in this layer, which dropped from about 20 wt. % Cu to 10 wt. % Cu. This drop might be due to wiring and surrounding copper components completely being consumed at this point during the re-entry. Nickel and chromium had similar amounts present in this gray shaded region. Lastly, large light gray areas were seen throughout the fourth layer. These light gray regions were mostly seen at the top of

the fourth layer and correspond to Ni, Fe and Al depositions. Though these three elements were detected in the fourth layer, Ni made up the greatest amount of the chemical composition with about 35 wt. %. Iron then followed with 25 wt. % and Al was present in concentrations of about 20 wt. %. Overall, the second layer was the layer which had the most distinct elemental composition whereas the other three contained the same elements but the concentrations present in each layer differ. Figure 4.8 shows several EDS spectra coming from different regions of the deposit layers found on Area 1. These selected spots are represented in Figure 4.7 by yellow boxes where the numbers correspond to the numbered EDS spectra in Figure 4.8.

Figure 4.8 EDS spectra corresponding to the cross-sectional view of the aft-facing side in Area 1 sample. (1) 1st layer. (2) 2nd layer. (3) 3rd layer. (4-6) 4th layer.

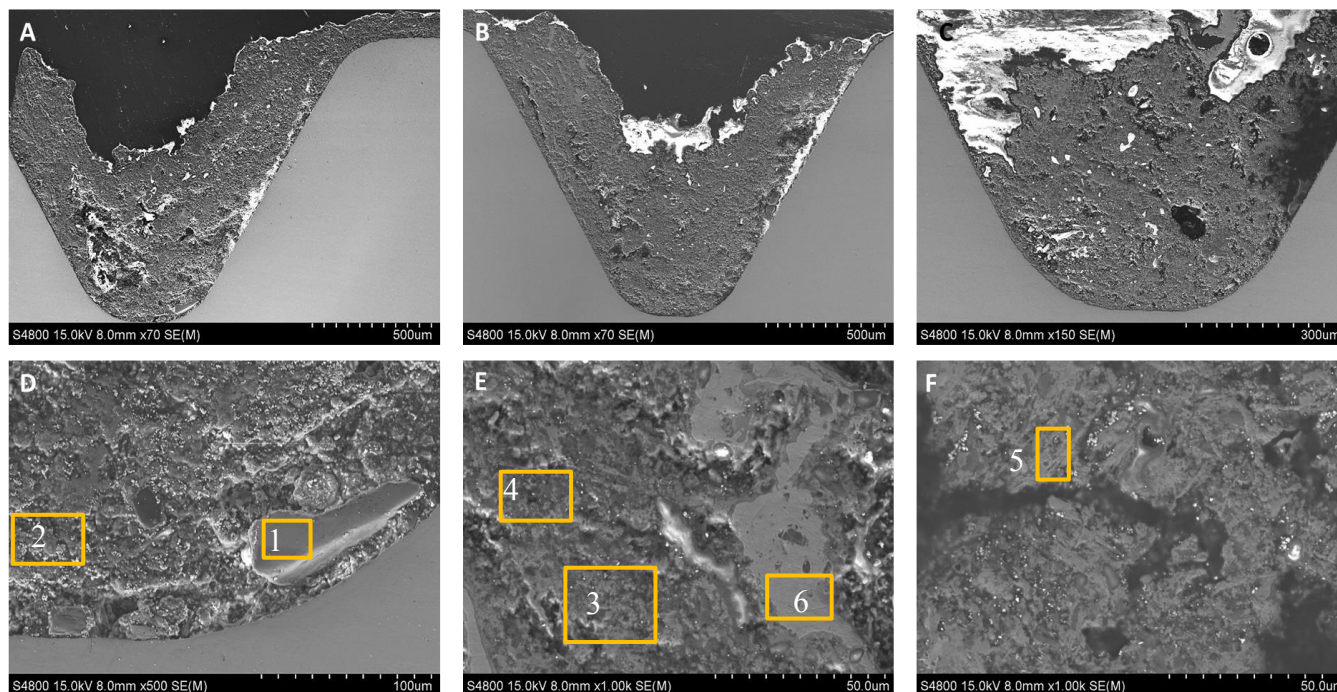
The cross-sectional view of the threaded side of the sample was also analyzed under the SEM with EDS capabilities. SEM micrographs corresponding to this side of Area 1 sample are shown in Figure 4.9. Images A, B, and C show the root and thread faces with deposits on the first, second and fourth threads, which show the topography of the deposit and display areas in the deposits that contained large shrinkage voids, depicted by black areas. The base metal of the hydraulic actuator housing is represented in Figure 4.9 as the smooth and light colored area, whereas the dark colored region on the top corresponds to the epoxy mount of the sample. Along with large voids, the deposit contained spots where it was acquiring a charge build up, which made it difficult to obtain a good image. Charging was shown in Figure 4.9 as bright white regions.

On the threads inspected, it was noticed that deposit decreased from forward to aft which would indicate a directional flow occurring from forward to aft which is expected. Debris first started to deposit uniformly in the first three thread roots but as it advanced further back into the shuttle, the amount of deposits started to decrease and the deposit itself on the right side of the thread faces only. The morphology in this part of the sample was unlike in all the threads, which could correspond to a single material being deposited into the threaded region of the hydraulic actuator housing surface. Images D, E, and F in Figure 4.9, are magnified areas of the morphology found in the threaded region. The morphology seen in the threads consisted of a gray and dark gray matrix where the two constituents were seen in a 1:1 ratio. Though the ratio of these two constituents was similar, the lighter phase had a dendritic morphology and can be seen in Figure 4.9 F. In contrast, the darker phase present in the deposit had a globular morphology.

At a larger magnification, large cavities were observed more often and in most cases, white spherical micro particles would occupy the voids. These granular particles caused the sample to charge, which was readily seen in the magnified images as white specks. Another observation that was noticed while looking at the morphology of the threaded region was sintering of small granular particles, specifically occurring within the thread roots and are shown in Figure 4.9 D. This behavior was not noticed

on the remainder of the deposit. In this same region, embedded debris with irregular shapes was commonly seen as well. Also, observed occasionally throughout the deposit were large regions of a smooth light gray phase, irregularly shaped as well (Figure 4.9 E).

Figure 4.9 SEM images of threaded side of Area 1 sample. (A-C) Lower magnification images showing base metal and deposit as well as portion of epoxy mount. (D-F) Higher magnification images of deposit showing the different morphology found throughout in detail. Yellow numbered boxes correspond to EDS results in Figure 4.10.

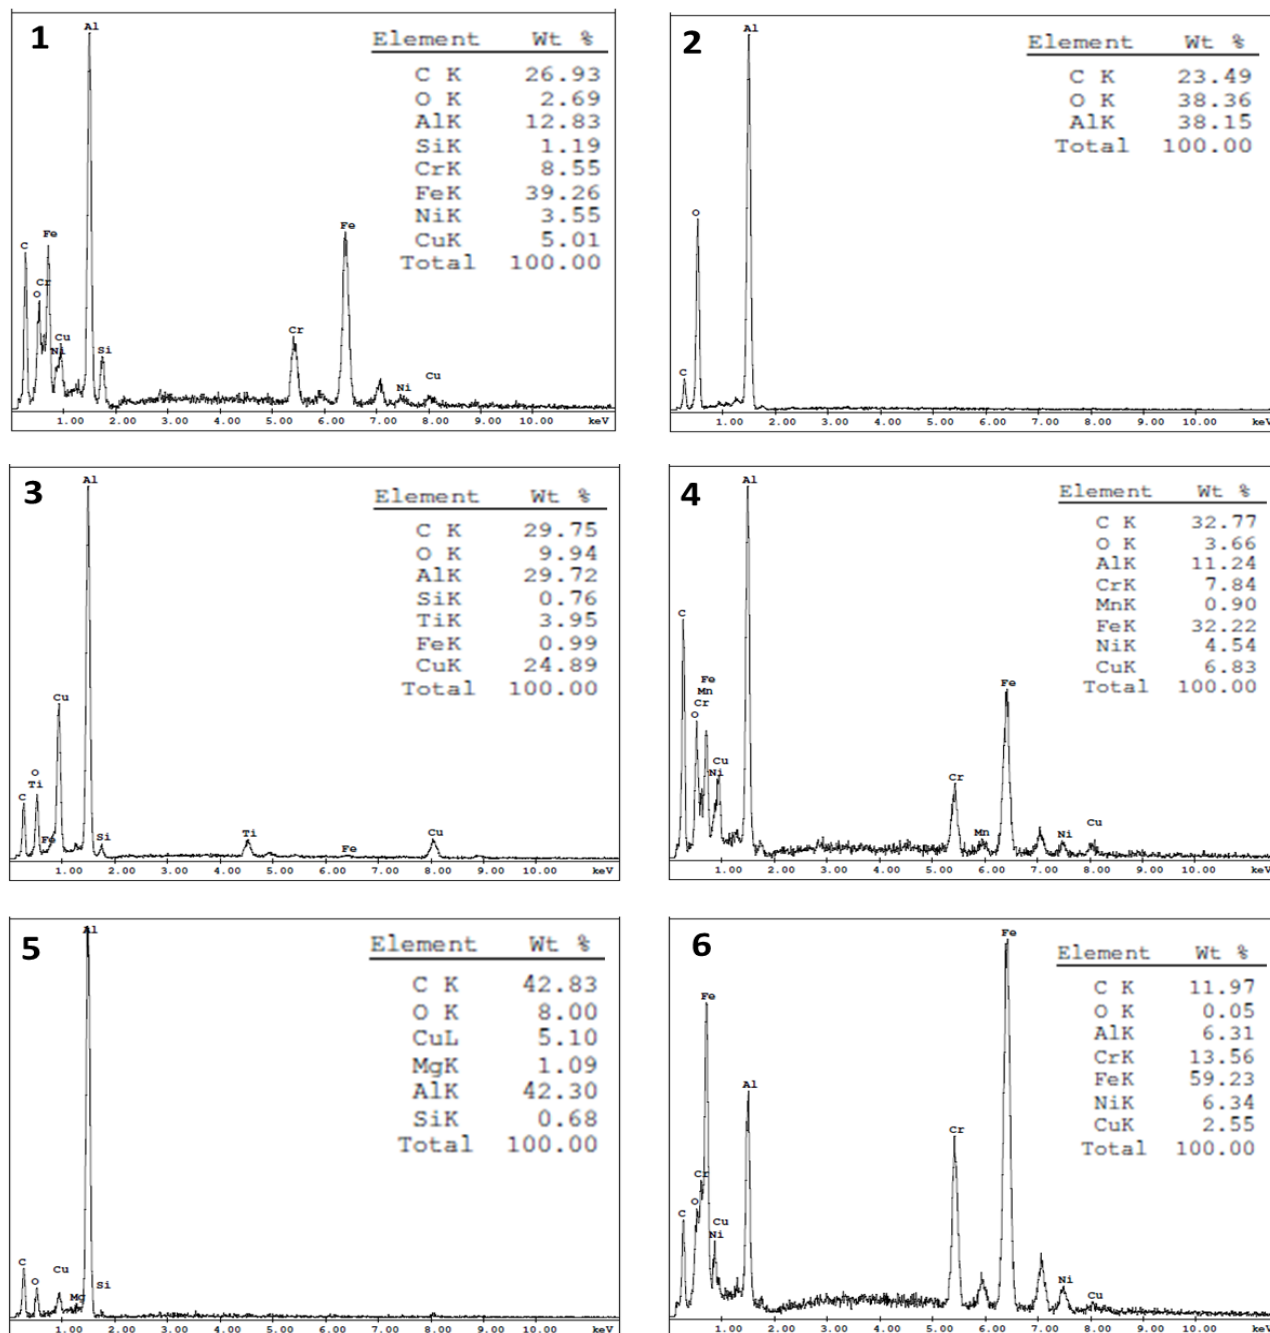
The chemical analysis conducted on the threaded side of Area 1 varied in composition from the other regions that were chosen for analysis from that same sample. The same elements at different concentrations were seen in this area and there were no distinct layers as there were in the aft-facing side. These elements were Al, O, Cu, Cr, Fe, and Ni. Figure 4.10 shows EDS results for several spots that were tested. The particles found on the bottom of the roots of the threads corresponded to either silica particles or in the case of larger debris, it was mostly composed of Fe. The bigger irregular chunks contained approximately 25 wt. % Fe, 20 wt. % Al, and lesser amounts of O, Ni, and Cr, all between 3 wt. % and 8 wt. %. Because these types of debris were a lot bigger in size, had sharp and irregular edges, and were mostly composed of Fe and Al, it is probable that these little pieces of debris suddenly broke off from

nearby components before the component reached its melting temperature and deposit themselves in the thread roots. These deposits contained some differences of what was found within the rest of the deposits as pointed out earlier. In this area, close to the root, the deposit had high concentrations of Al and O.

Figure 4.10 EDS spectra corresponding to the cross-sectional view of the threaded region in Area 1 sample. (1) Particle (2) Granular deposit found close to root (3) Matrix (4) Dark Phase (5) Gray Phase (6) Light regions found on top layer of deposit. Exact locations of were EDS readings were taken area shown in Figure 4.9, with corresponding numbers.

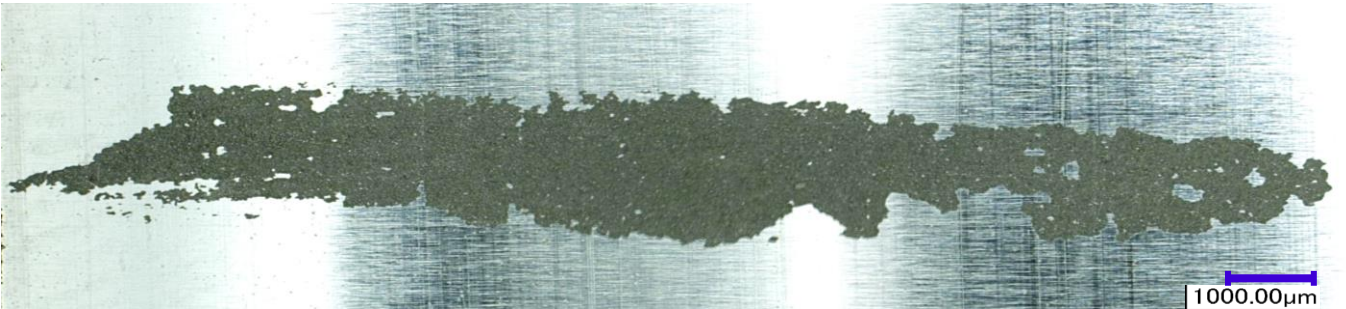
Concluding the surface and cross-sectional analysis done on the hydraulic actuator housing, the examination of the shaft which was connected to the hydraulic actuator proceeded. Area 2 corresponds to the first of three areas of the shaft that were analyzed by the SEM with EDS capabilities. In Area 2, the presence of three thin deposit lines were of interest and three samples from this same area were obtained for analysis. Only one of the samples was used for SEM and EDS analysis since these three deposit lines were composed of the same material and had similar texture. In the earlier stages of the project, XRF analysis conducted on the surface detected mostly aluminum and chromium, as explained earlier, the chromium was being detected from the base metal coating which was applied to it for wear and corrosion resistance. Analyzing Area 2 under the SEM and being able to conduct a second chemical analysis would verify the XRF results and micrographs of the surface and cross-sectional view of the deposit line would be taken as well. A micrograph taken with the use of the Keyence microscope is shown in Figure 4.11 of the sample that was analyzed under the SEM and its chemical composition obtained by EDS analysis. As

Figure 4.11 Keyence micrograph of sample D_2.1 from Area 2 which will be used for SEM and EDS analysis. 30X.

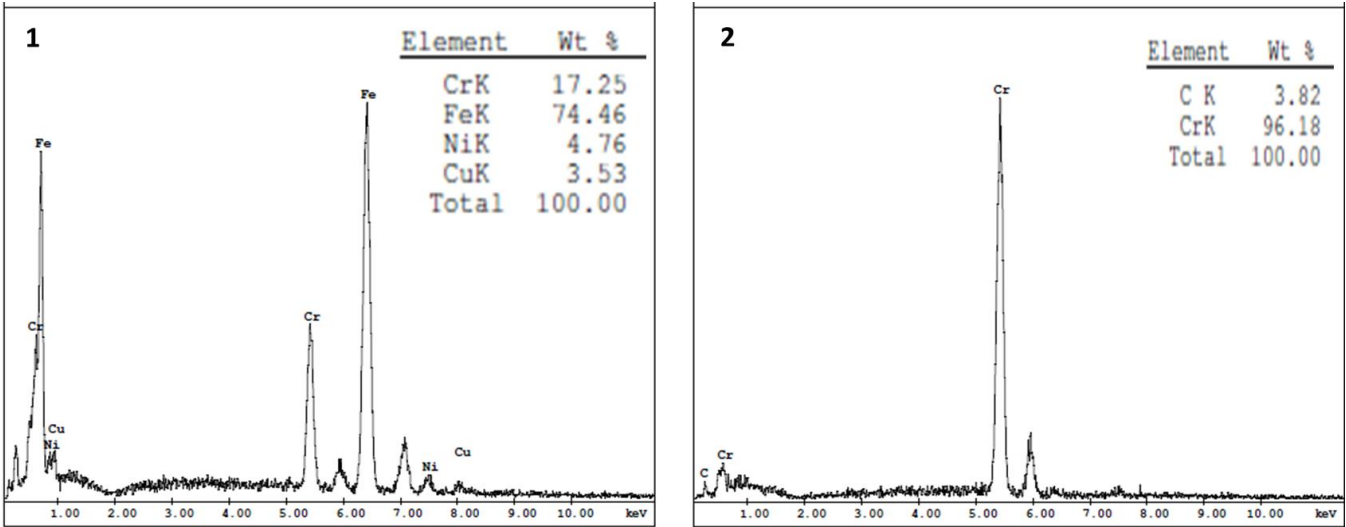
seen in this image, the deposit line seems to be very thin and uniform throughout. The base material of the shaft was also analyzed by EDS, since it was a separate component of the hydraulic actuator housing. The EDS results of the shaft's base material and coating is seen in Figure 4.12 where composition is consistent to that of a 17-4 precipitation hardening stainless steel with approximately 17wt. % Cr and 4wt. % of Ni and Cu each, with most of the remaining balance being Fe. The coating of this material as projected by the XRF results was a Cr (electroplated) coating with about 96wt. % Cr.

Figure 4.12 EDS spot analysis of (1) base material and (2) coating of actuator shaft.

Earlier EDS results showed how the base metal of the shaft is in fact a 17-4 PH stainless steel which was coated with a hard chrome for wear resistance. The deposit lines seen in Area 2 on the shaft were analyzed to identify the elements present. In most of the deposit, which consisted of a granular texture, Al was the element present in higher concentrations. Along with aluminum, there were a lot of tramp elements such as K, Ca, and Cl, which were detected. Since the deposits are very small thin deposits, ultrasonication was done for a shorter amount of time to prevent any of the deposits flaking off while the sample was being clean which led to elements such as Cl and Ca to be detected, most likely coming from residue obtained while the shaft was being sectioned. Besides these tramp elements, small traces of Ni, Ti, Fe, and Cu were detected. Figure 4.14 (1) shows EDS results obtained when the FEI Quanta 400 SEM was used and quantitative results were unavailable for this reading. Other regions on the 2nd deposit line were analyzed with the Hitachi S-4800 SEM and EDS results of two spots are also shown in Figure 4.14. The other regions where chemical composition was obtained from Area 2 were the spherical particles seen in areas where the topography seem to be more rough but smoother in other areas. These particles were mostly composed of copper and oxygen and once again the presence of other contaminants was seen but in negligible quantities. There was about 46wt. % Cu present and 10wt. % O along with 5wt. % Al (Figure 4.14 (2)). Spats being deposited on top of another layer of deposit were also analyzed by EDS and the chemical composition also showed a high presence of Cu. This spats were mostly composed of aluminum

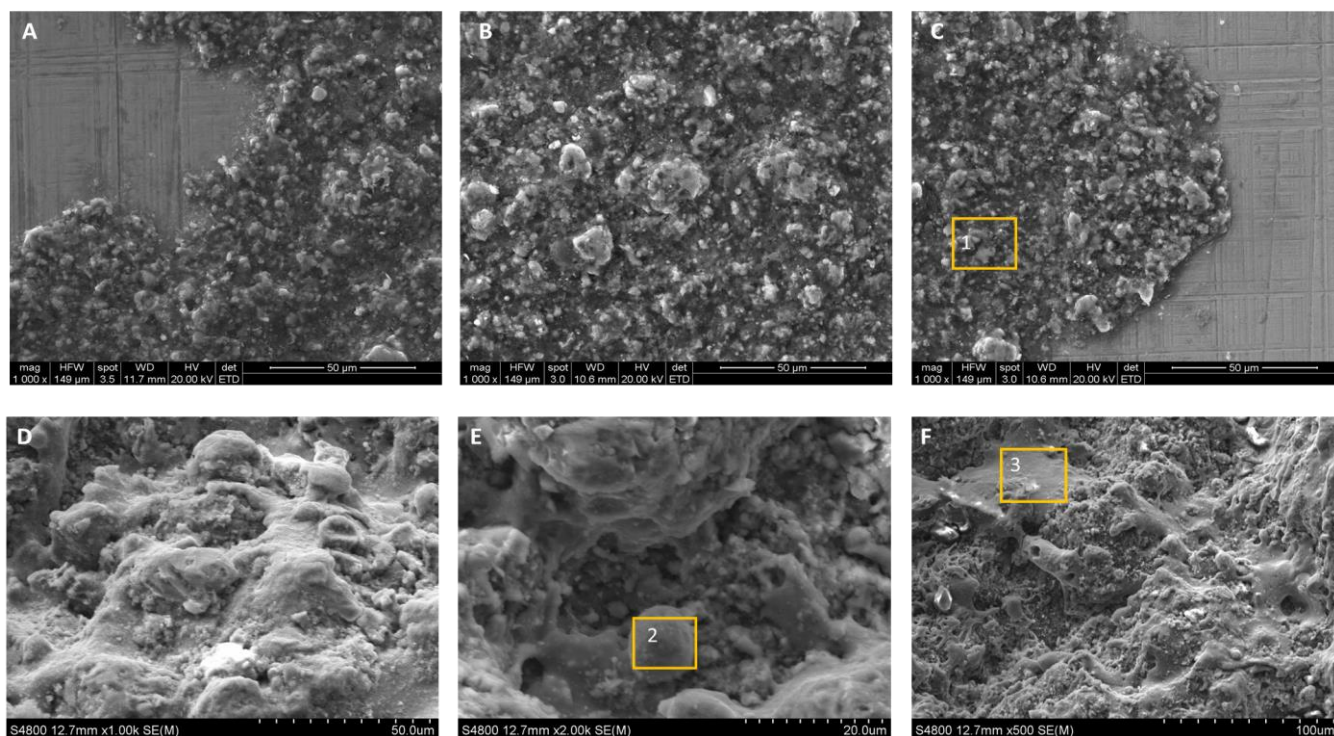
globular regions along with other sections showing agglomeration of smaller, rougher, globular particles. SEM images showing surface features found in Area 2 are shown in Figure 4.13. Most of the deposit line contained crusty, flat, granular surfaces all throughout the deposit as shown in Figure 4.13 A through C. In this region, agglomeration of particles was apparent and there were regions where some of these particles accumulated enough to make larger masses of deposits; these were usually found in small clusters. This behavior can be seen on Figure 4.13 B as well as in image E at the upper region at a higher magnification. This same image contained a very spherical particle as well, which was commonly seen in this sample. A few areas were found where the deposits had a smoother surface as if liquation occurred and molten metal deposited onto the debris that had already adhered to the base metal (Figure 4.13 F). Here, agglomeration of micro-particles was also evident and along with these particles, there were areas that contained many small cavities. The morphology found on the deposit lines was very similar throughout which should correspond to a uniform elemental composition.

Figure 4.13 SEM micrographs showing the surface morphology of the 2nd deposit line found on Area 2 at different magnifications and locations on throughout the deposit line. Note, images A through C were taken using a FEI Quanta 400 SEM whereas images D through F were taken using the Hitachi S-4800 SEM. Yellow numbered boxes correspond to EDS spectra shown in Figure 4.14.
