Materials Characterization of Deposits on Starboard (Inboard) Elevon Actuator Shaft Recovered from Space Shuttle Columbia

MATERIALS CHARACTERIZATION OF DEPOSITS ON STARBOARD
(INBOARD) ELEVON ACTUATOR SHAFT RECOVERED FROM SPACE
SHUTTLE *COLUMBIA*

DISSERTATION

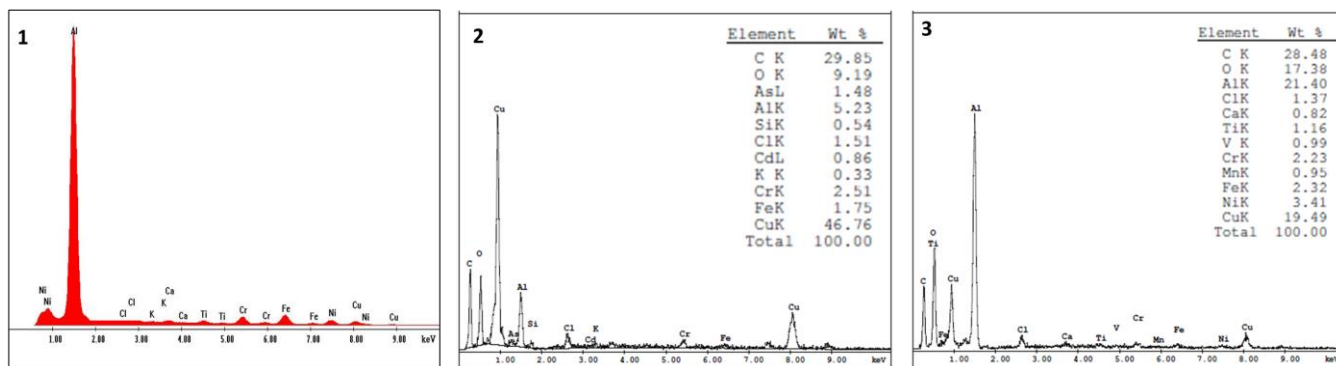
Figure 4.14 EDS spectra for regions located in Area 2 of the actuator shaft. (1) Granular surface [FE Quanta 400 SEM used] (2) Spherical particles (3) Spat [Hitachi S-4800 SEM used on spectra 2 and 3]. Location of EDS spot analyzed can be found on Figure 4.13.

Overall, results from the EDS spectra show that the deposit was in mostly aluminum with a minimal amount of iron and nickel. The results from the chemical analysis conducted on the lines of deposit found in the deposit-free zone go along with the XRF data, corroborating that they were aluminum. Because more than 25% of the entire space shuttle structure is structural aluminum, deposits found in this area are most likely coming from the surrounding airframe [7]. As for the presence of Cu found areas of the deposit line and in Area 1, which is found in close proximity to Area 2, it is possible that Cu is coming from the same source. Most likely, Cu is coming from electrical wiring from the hydraulic actuator.

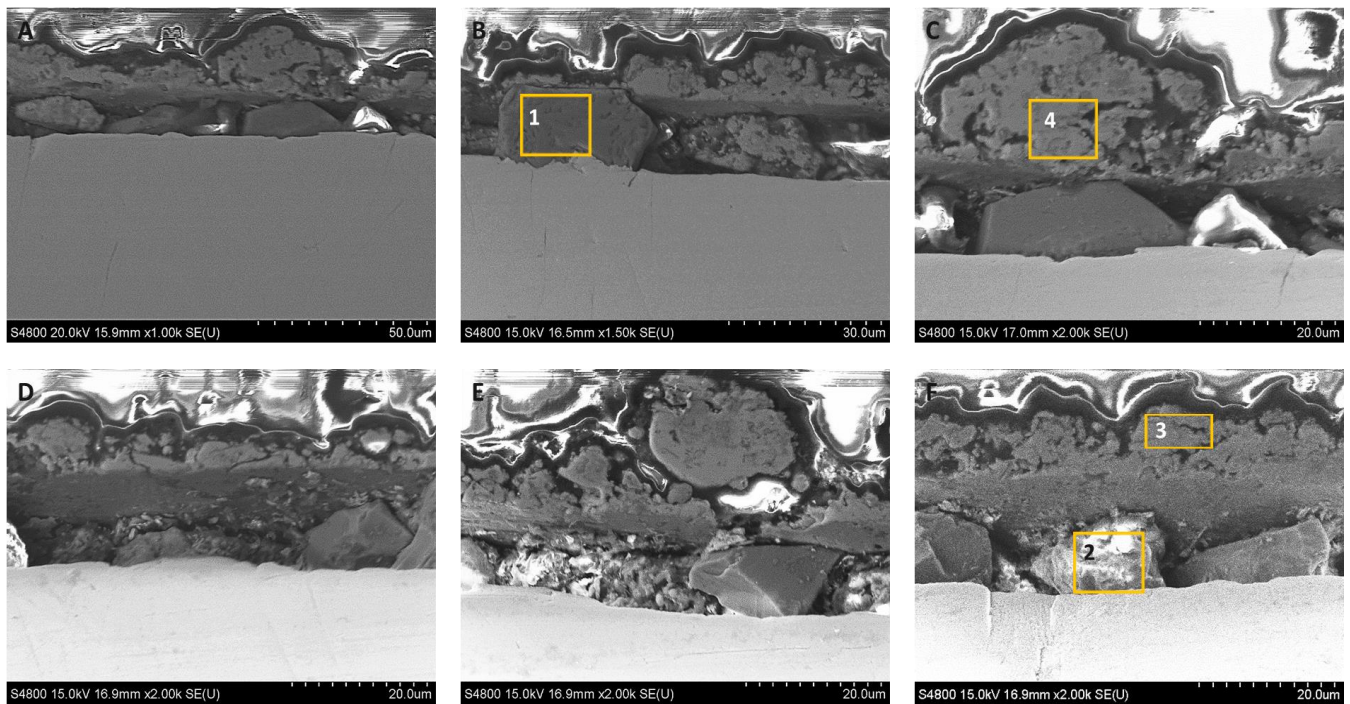
Looking at the cross-sectional view of the 2nd deposit line under the SEM was accomplished by mounting the sample once all surface analysis was completed. Images obtained from the cross-section of the deposit line are presented in Figure 4.15. Over all, the morphology was very similar throughout and consisted of two layers. The bottom layer contained a discontinuous segment of polygon-shaped particles. These particles sat on top of the chromium layer, which can also be seen in the SEM images in the lower portion of the micrograph, in Figure 4.15. Most of these particles were solid and multi-faceted measuring from 10 to 15 μ m in height and twice as much in length. In areas where particles were discontinuous, there was micro-particles that had clustered together to form a small mass of deposit. The second layer and last one found on the deposit line mostly consisted of a solid single phase layer with some areas containing small cavities, especially seen near the surface of the deposit. The topography was coarse all along the cross-section but generally maintained the same thickness throughout. There were some occasions where the deposit accumulated a lot more, making it a lot thicker but did not make a significant difference when averaging the thickness. This deposit had an average thickness of approximately 23 μ m from the surface of the chromium coating to the surface of the thin deposit. Note that from Figure 4.15, a darker shade of

gray appears to be a layer in the middle between the particles and the top layer. Obtaining images from the SEM in this area were particularly difficult since deposits were so thin and the cross section of this deposit line only covered a couple of millimeters. Due to this, small particles were continuously charging as well as part of the epoxy mold. Charging of the mold is evident in all images along the top, just above the deposit, seen as a bright glossy glare and charging of the particles is displayed by white regions in the bottom layer of the deposit.

Figure 4.15 SEM images of cross sectional view of 2nd deposit line found on the free-deposit zone of the actuator shaft.

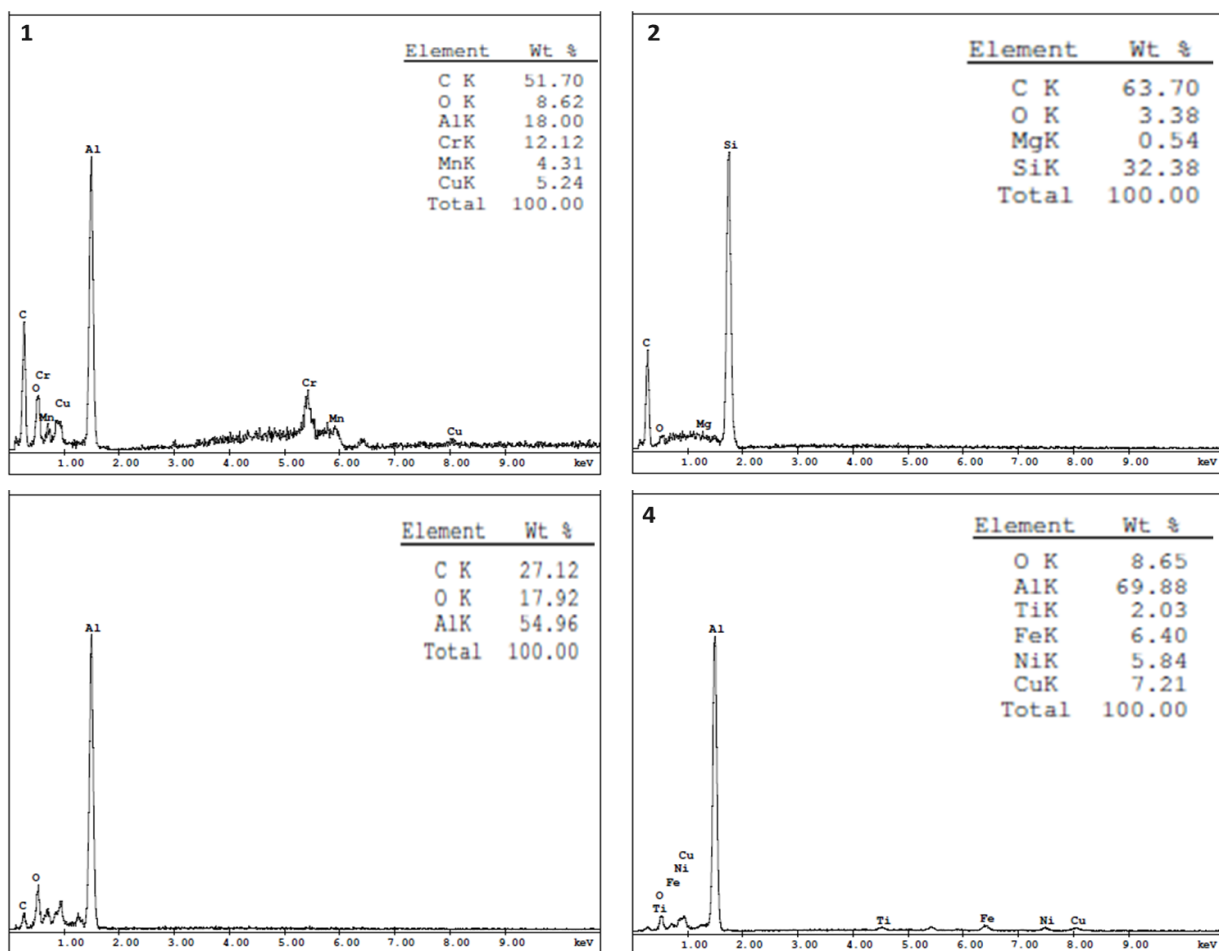
The first layer of this deposit line which consisted of the multi-faceted particles was analyzed with the EDS capabilities provided by the SEM and two different chemical compositions were detected for these particles. When conducting spot analysis on different embedded debris, silicon and carbon were the main elements found to make up most of the particles. The EDS spectra for the particle analyzed in Figure 4.15 F, which is shown in a yellow box with a number 2, can be seen in Figure 4.16 (2). Results show a high presence of Si and O. Other particles that were analyzed were mostly composed of aluminum and chromium. About 5 wt. % Cu was also detected on these particles, which is an element that was commonly

detected at the surface of the deposit line. The second layer also had two distinctive compositions. When obtaining EDS reading from the top surfaces, aluminum and oxygen were the elements that was detected whereas for regions tested closer in the center of the second layer, other element made up the composition. Besides aluminum found in lower areas of the second layer found on the deposit line, Cu, Fe, and Ni were present in amounts as high as 10 wt. %, though aluminum was present in amounts as high as 60 wt. %. Titanium was also detected in most the readings taken in this area but only constituted less than 2 wt. % of the total. Figure 4.16 (3) and (4) show EDS spectra of two areas where readings were taken on the second layer of the deposit line.

Figure 4.16 EDS spectra of the cross sectional view of 2nd deposit line. (1) and (2) show EDS results for the bottom layer. (3) and (4) show results found on the top layer. Exact location of area analyzed can be found on Figure 4.15.

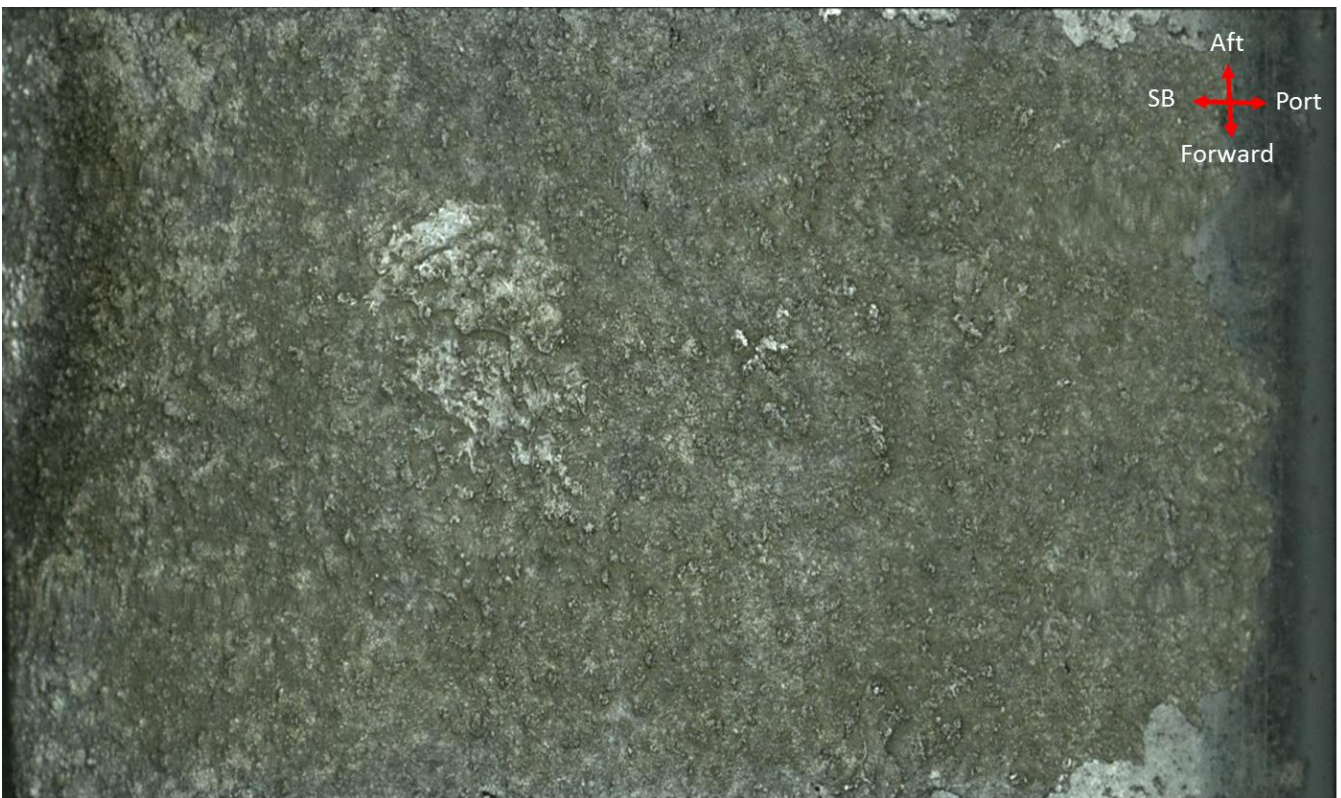
Figure 4.19 Sample A3.3 belonging to Area 3 where heavier deposits can be seen covering the whole sample with a large metallic splat deposited on top of the heavy deposit layer. (30X)

The final sample in this area, A3.3, was completely covered in heavy deposits and was also directly above sample A3.2. It was expected to see the same morphology and chemical composition of this thicker layer of deposit as the ones detected in the second sample analyzed from Area 3. Looking at the surface under the SEM, the large splat visible in the center of the sample was analyzed first (Figure 4.24 A and B). It was evident that the material that got deposited in this area was in a liquid phase due to the morphology observed under the SEM. A smooth, flow texture was seen through the whole area that consisted of the splat and was noted that silicon particles were embedded in this deposit as well. The

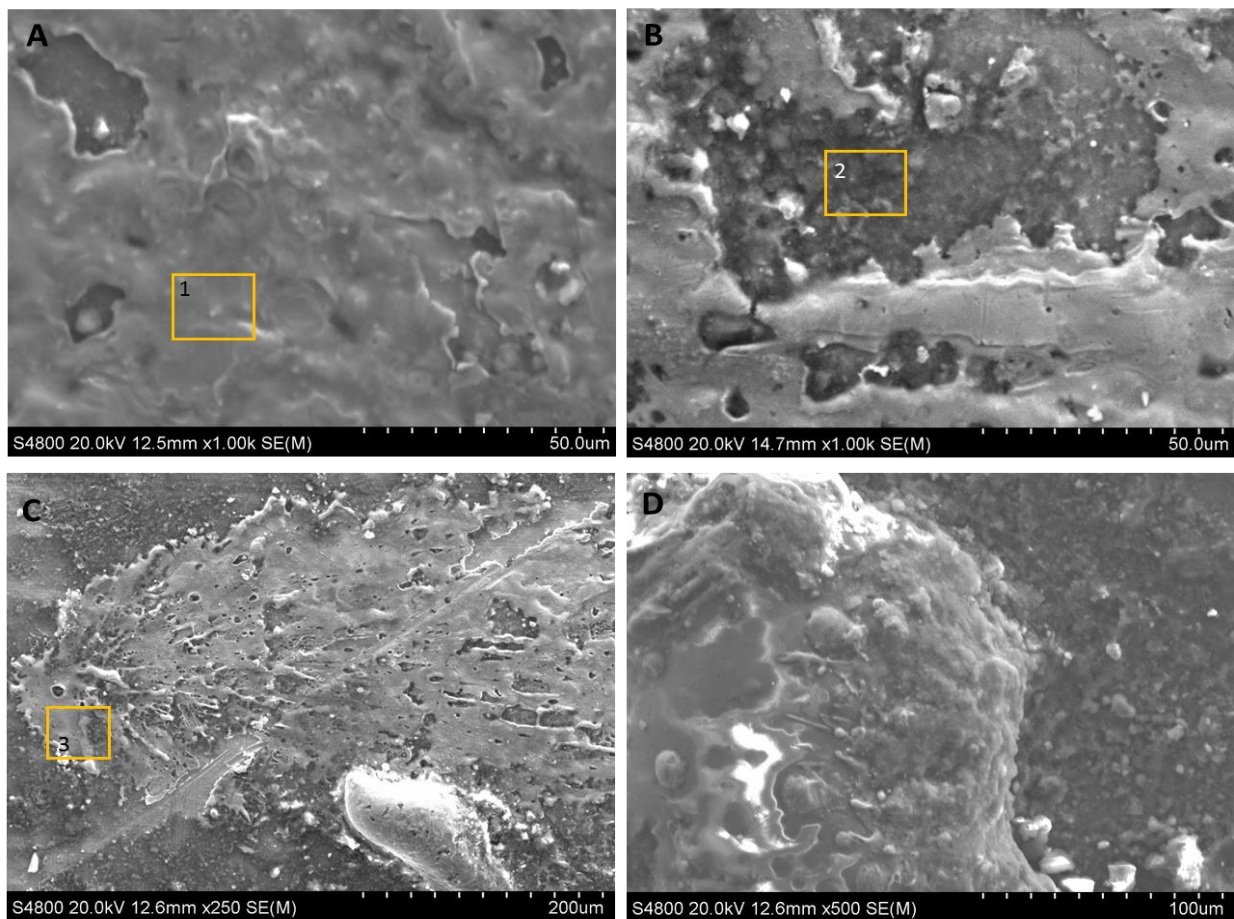
Figure 4.20 SEM images of surface deposits found on sample A3.1. EDS spot analysis is indicated by yellow squares in images A through C.

Analyzing the sample under the SEM, it was observed that the sample contained two layers. The first layer had a very granular texture where agglomeration of small particles was seen. This bottom layer was mostly seen on the starboard side of the sample. The second layer, which was observed to be deposited on top of the thin granular layer, was a lot thicker than the first layer and consisted of splats and thicker granular deposits. Several of the surface features seen in this sample are shown in Figure 4.20 and consist of the agglomeration of small particles along with large metallic splats. Splats observed in Figure 4.20 A and B were smooth and flat as if the molten metal flowed freely as it was being deposited; before it solidified completely. These splats were located on the forward-starboard side of the sample. In Figure 4.20 C and D deposits, which were coming from the upper corner, starboard-aft location with respect to the shuttle, showed the presence of large, thick deposits, the thinner layer of deposits, and a splat deposited in a direction going from starboard to port. Splats in this area were thinner than the ones seen in the upper region of the sample and had a rougher texture and porous areas due to entrapped gas bubbles (Figure 2.20 C). The thick, bulky deposits seen in the area had mostly a globular shape and did not appear to be deposited in a particular direction.

EDS spot analysis in this area revealed that the splats seen in the area were composed of what appeared to be two different material systems. Figure 4.21 1 shows the EDS results for one of the splats analyzed in the sample and are shown in Figure 4.20 A. Splats deposited in the surrounding areas consisted of approximately 85 wt. % Ti as EDS results showed. On areas in the starboard-aft corner, splats differ in chemical composition and were mostly composed of Fe and lesser amounts of Cr (Figure 4.21 2). Similar chemical composition from the upper and lower starboard-side of the sample was seen on the first layer that was observed in sample A3.1. The thin spray-like layer, where large splats of Ti, Cu, and Fe were deposited on top of it, was composed of Fe, Cu, and Al. This composition was similar to the thinner splats seen in the sample at the upper starboard corner. Around 60 wt. % Fe was present in the thin layer with about 15 wt. % Cr and 5 wt. % Al as indicated by the EDS results in Figure 4.21 3 taken from the

area indicated by a 3 in Figure 4.20 C. Due to results showing Ti splats and the Fe deposits, it can be concluded that two material systems were being deposited in this area during the break up. It also suggests that splats were deposited at a later time after the first thin layer that was observed.

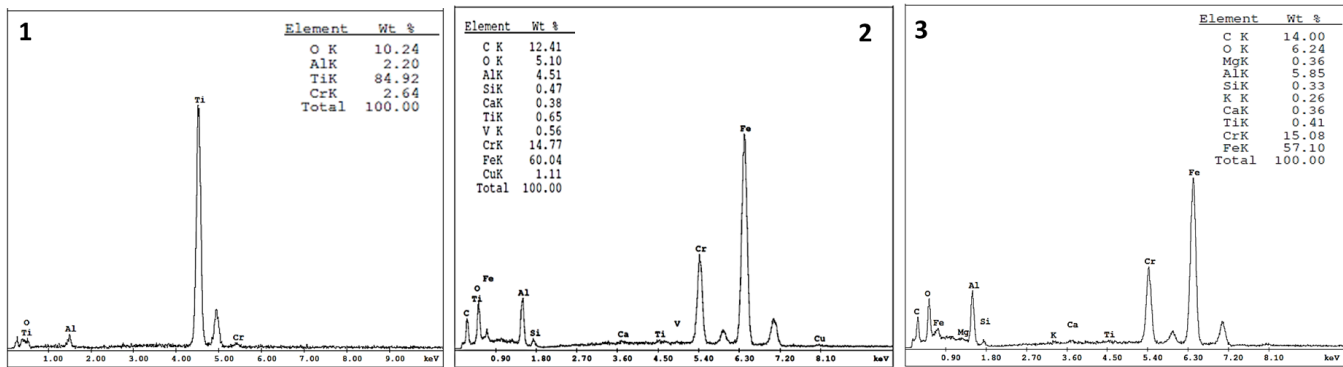
Figure 4.21 EDS spectra from sample A3.1 of first and second layer of deposits found at the surface. EDS 1 and 2 show chemical composition of splats and EDS spectrum 3 is the composition of the thin layer of deposit observed in the sample.

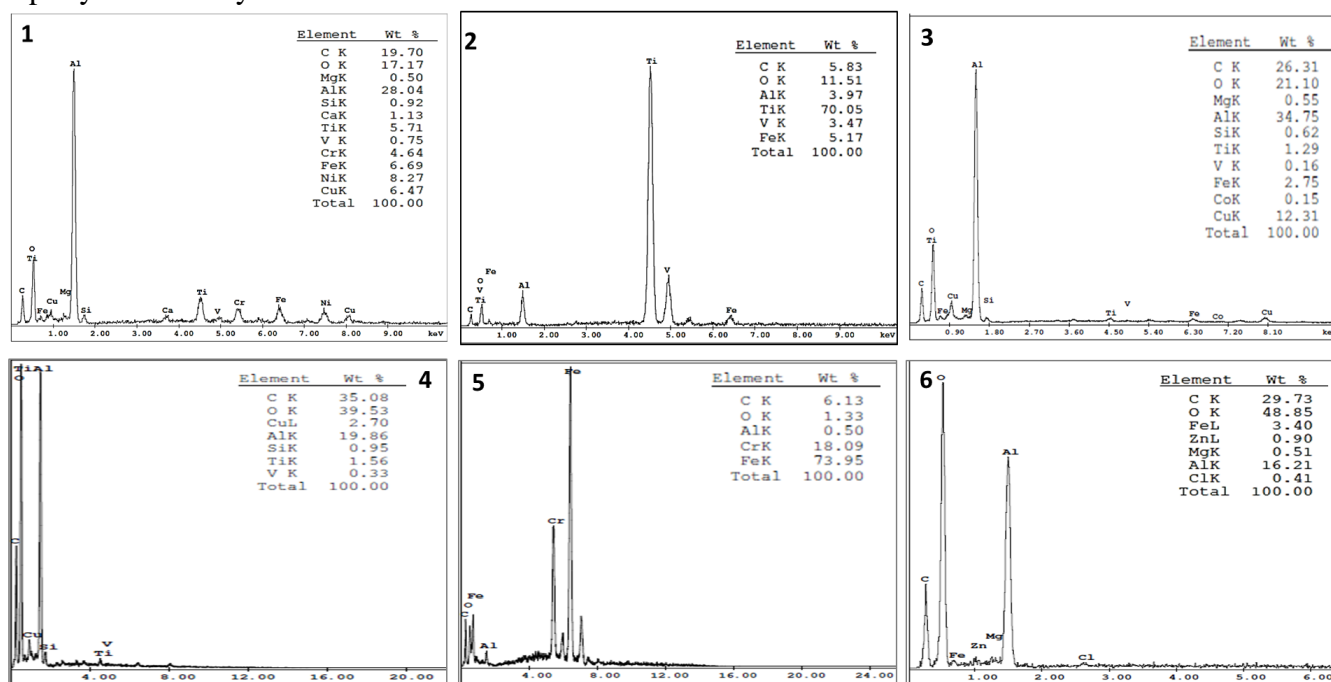
Examining these same areas for their chemical composition indicated that the thin layer of deposits was different from the one identified on sample A3.1. The areas analyzed for the thin layer showed that the layer was mostly composed of Al and O. In addition to Al and O, about 5 to 9 wt. % of elements such as Cr, Fe, Ti, Cu, and Ni were detected (Figure 4.23 1). The splats in these areas were composed of Ti and had similar composition to the splats found on sample A3.1. Smaller amounts of V, Al, and Fe were found in these splats as well. EDS results belonging to the splats area shown in Figure 4.23 2. On the heavier deposits seen, EDS spectra showed that the main composition of this layer was composed of Al and O with smaller amounts of Cu as seen in Figure 4.23 3 and 4. EDS results on Figure 4.23 5 and 6

belong to spot analysis done on the metallic droplets seen in sample A3.2. Two major elements in different locations that were analyzed were detected, Al and Fe. These solidified droplets were located all throughout the thicker layer of deposit and there was no particular location where Al and O or Fe droplets dominated. The globular droplets of Fe made up about 70 wt. % of the total composition followed by approximately 20 wt. % Cr. Results for these Fe droplets are shown in Figure 4.23 5. As for EDS results of the aluminum droplets, about 50 wt. % of O was present meaning these aluminum droplets could have rapidly and heavily oxidized.

Figure 4.23 EDS results for surface analysis belonging to the heavily deposit area on sample A3.1. Exact location of where readings were taken in sample are shown in Figure 4.22.

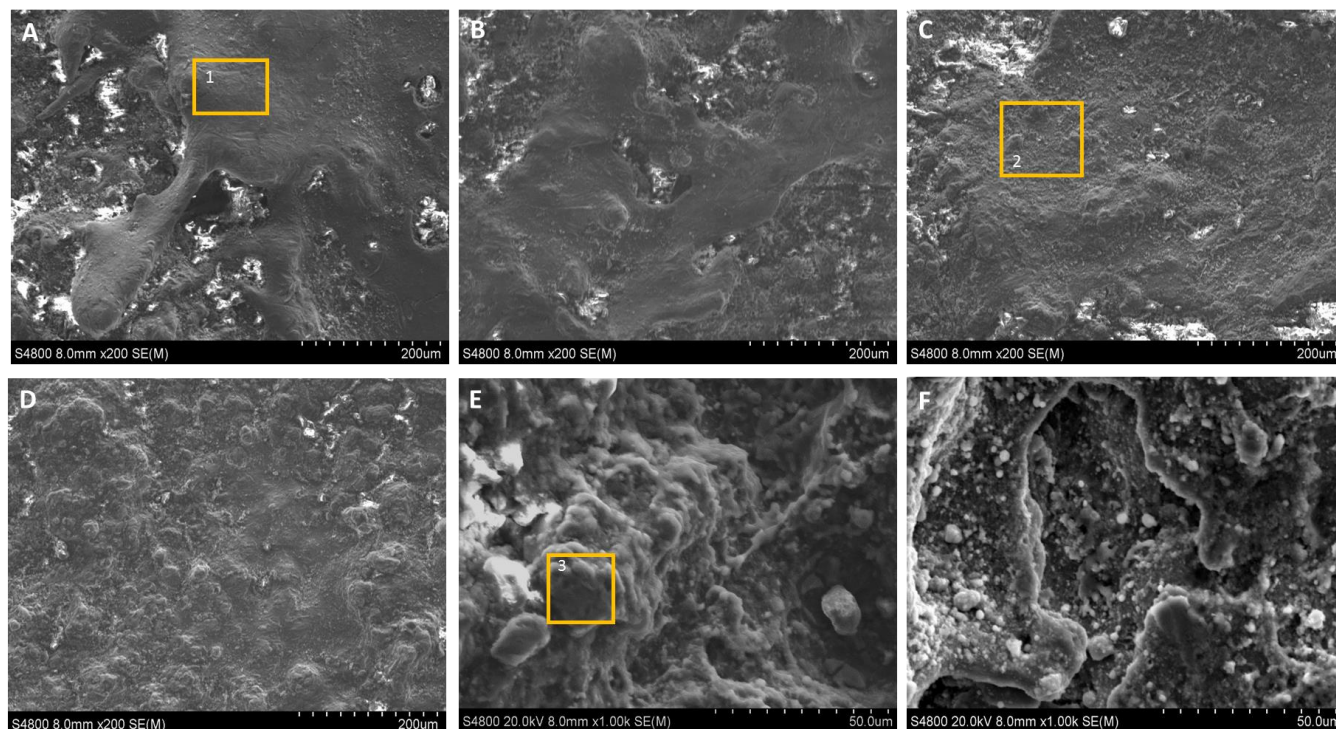
silicon particles can be seen in images A and B on Figure 4.24. The morphology in other regions was similar to sample A3.2 with bumpy rough surfaces. There were areas where the surface textured changed and different particle sizes clustered together forming larger particles or the particles stayed as one and deposited on the top surfaces of the deposits. SEM images of the behavior seen in sample A3.3 are shown in Figure 4.24 E and F.

Figure 4.24 SEM images of sample A3.3 surface analysis where a smooth surface was found on a large metallic splat. Rougher surfaces and clustering of particles were also detected.

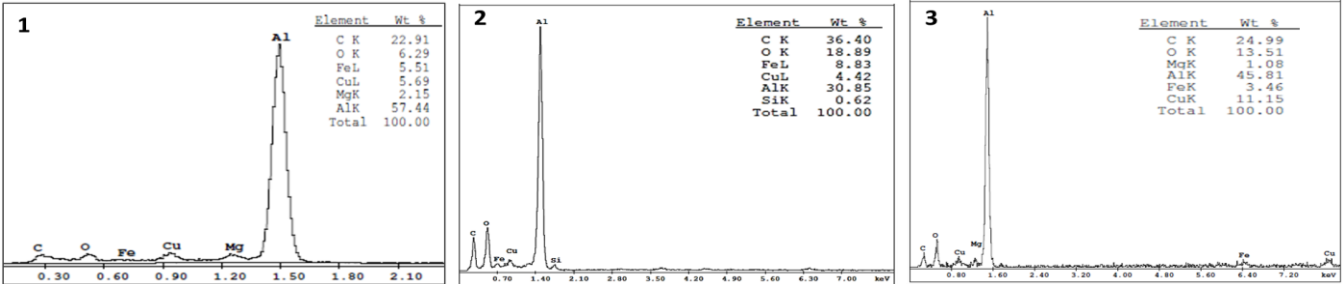
Much of the chemical composition of the deposits found on this sample were Al and O. This is expected due to the Al airframe surrounding the hydraulic system. EDS spot analysis in areas shown in Figure 4.24 detected approximately 40 wt. % Al in deposits and around 60 wt. % Al in the large metallic splat that was found on the sample. Minor elements that were detected by the EDS were Fe and Cu. Cu was found to be present in concentrations as high as 11 wt. % and Fe was detected in quantities of 9 wt. % when different readings were taken around the sample (Figure 4.25). Less than 3 wt. % Mg was also found to compose the heavy deposit found on the sample. Comparing the composition of samples A3.2 and A3.3, Al and O enriched areas dominated the deposits and both samples also had lesser amounts of

Fe and Cu which was expected since the deposit is coming from the same area. The only difference in composition was that Ti was not detected in sample A3.3, which might be because this sample was located at the upper region of the shaft, whereas A3.2 was located on the side of the shaft and was where most the Ti splats and streaks were found.

Figure 4.25 EDS results from surface of sample A3.3 of Area 3 showing the majority of the deposit were AlO. Area of spot analysis is shown in Figure 4.24.

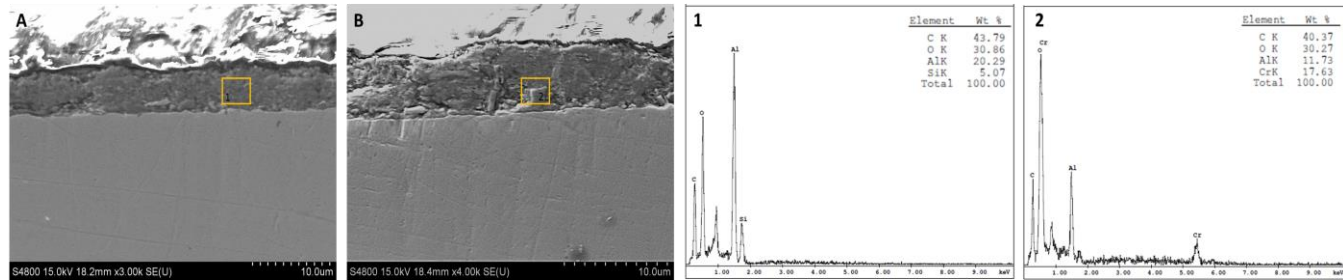
All three samples analyzed from Area 3 were mounted in a transverse direction to examine the cross-sectional view of the deposits morphology and elemental composition. Sample A3.1 did not have many features and mainly consisted of a flat thin layer that ranged from approximately 50μm to 88μm in thickness. This layer was mostly Al and O enriched deposits and about 20 wt. % Cr was also detected in the deposit, but is mostly likely due to the Cr layer that is found directly below the deposits. Note that Ti deposits were detected in this area as well. Due to the deposits being very thin, charging of the sample was occurring and was difficult to focus on thinner deposits which most probably belonged to the Ti streaks observed during surface analysis. Results of EDS analysis done on this thin layer and particles found on the sample are shown in Figure 4.26 1 and 2.

Figure 4.26 SEM cross-sectional view of sample A3.1 from Area 3 area shown in A and B. EDS spectra of areas shown in A and B area shown in 1 and 2, respectively.

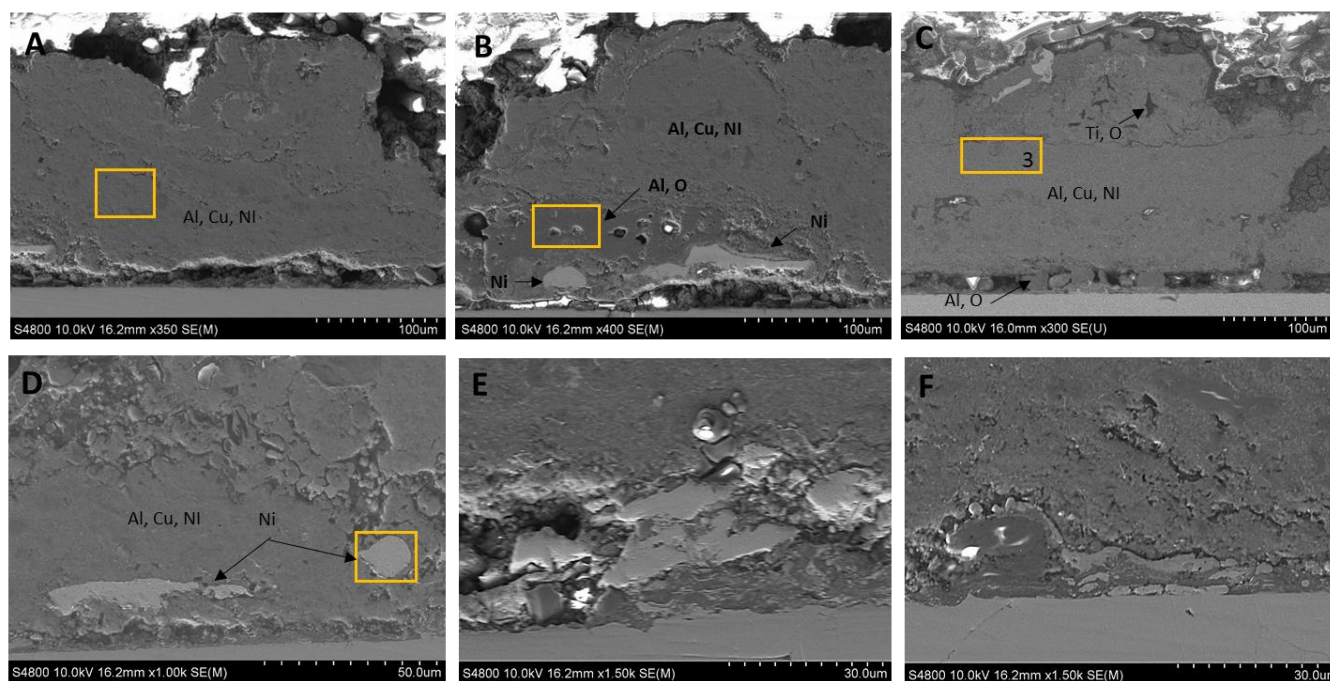
Sample A3.2 which consisted of the same thin layer shown in Figure 4.26 and a thicker layer of continuous deposits was examined for any layers or particles embedded under the top surface of the deposits. The average thickness of deposits found on the area where chipping was occurring was 230 μ m compared to 88 μ m for the thinner layer exposed due to spallation. The chromium coating applied to the shaft for additional protection was also measured and had an average thickness of 103 μ m. The coating did not show any indications of thermal alterations. Seen throughout the entire length of the deposits was a porous area located just above the chromium coating. In some regions, the discontinuous cavity contained individual particles about 20 μ m wide which was approximately the same width as the cavity. The particles seen in the hollow region were identified as Al and O enriched particles. Above this region, a compacted solid deposit with few porous areas was observed. Figure 4.27 show SEM micrographs of the cross-sectional view of the deposits found on A3.2.

Figure 4.27 SEM cross-sectional view of sample A3.2 from Area 3 area showing dark and light deposits surrounded by dark gray matrix which makes most the deposits.

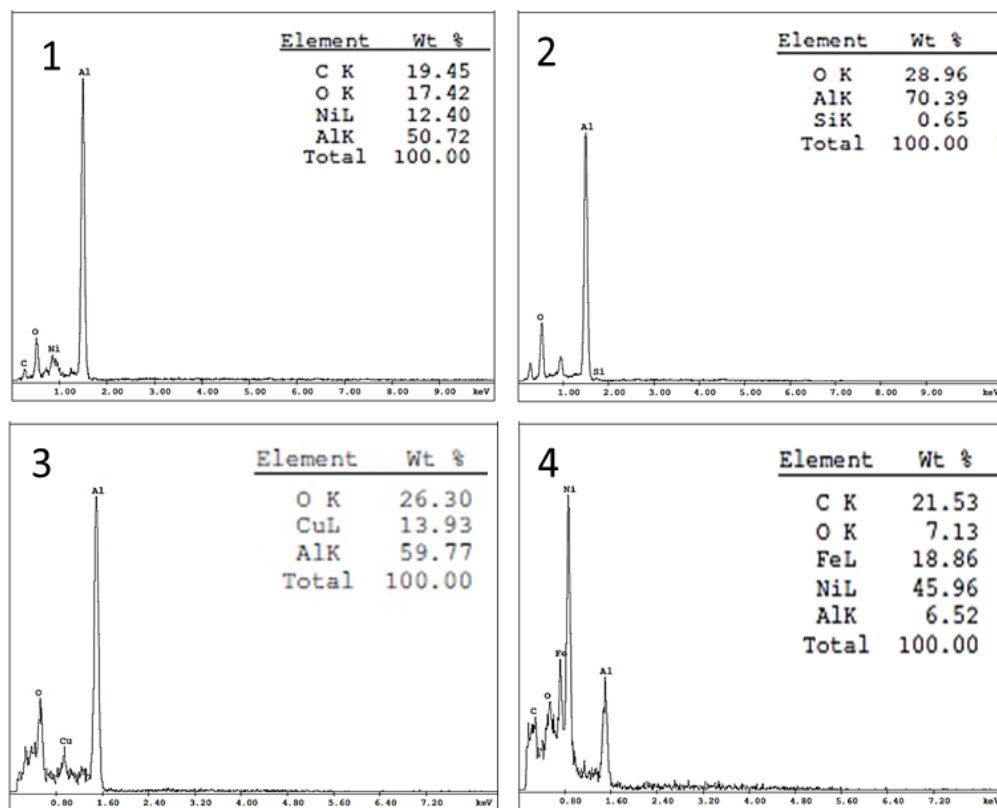
consisted of Al, Ni, and Cu (Figure 4.27). The second deposits were observed at the bottom and top surfaces of the deposits. These dark color deposits were found usually larger in size but were present in fewer quantities when compared to lighter deposits seen in the cross-section. The dark areas as shown in Figure 4.27 B, E, and F consisted of Al and O. EDS results can be seen in Figure 4.28 2. Other darker regions found in the deposits were analyzed by EDS and corresponded to Ti being dispersed throughout the entire area of the deposit (Figure 4.27 C). The final embedded deposits analyzed were light deposits that were usually seen also embedded at the bottom or top surfaces of the deposits. EDS spot analysis conducted on the light deposits demonstrated that they were composed of Ni with smaller amounts of Fe (Figure 4.28 4).

Figure 4.28 EDS results for the three distinct layers observed in sample A3.2. Location of where reading was taken is shown in Figure 4.27

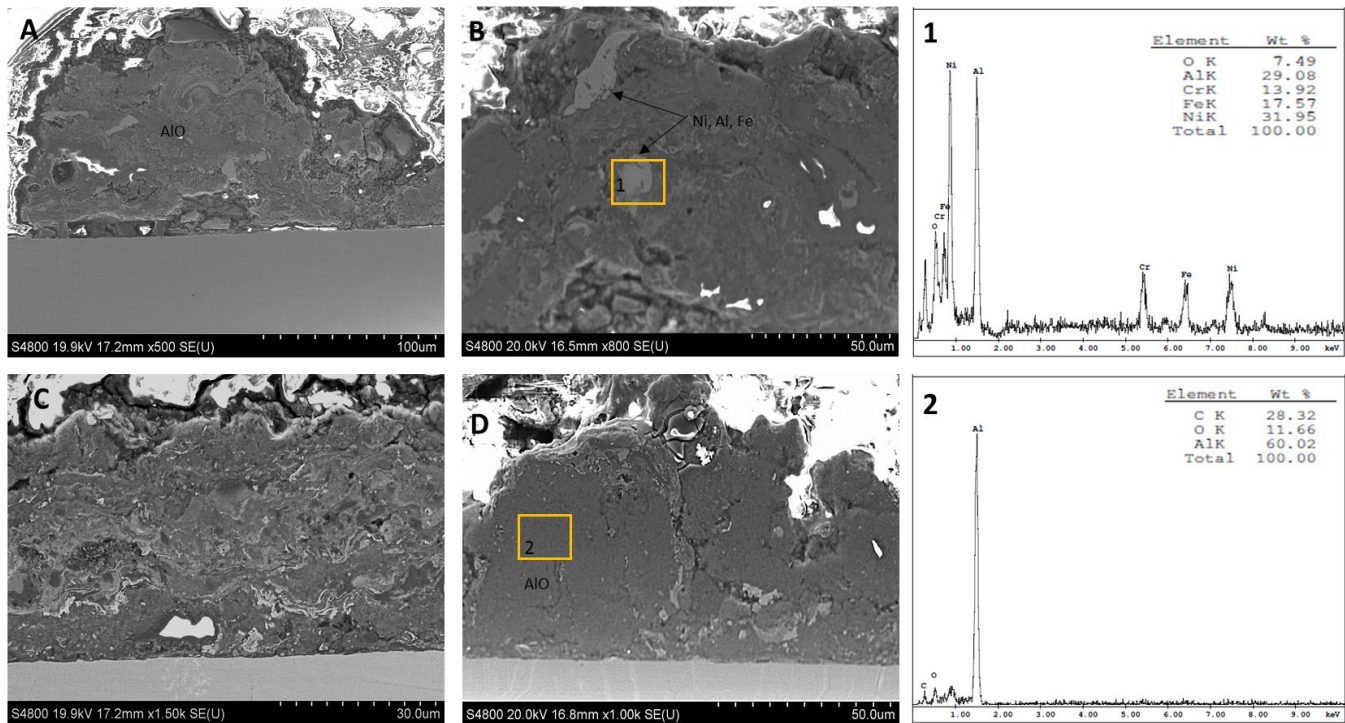
The third and final sample of Area 3 was analyzed and showed similar light deposits being present in this area. These lighter deposits were found in larger quantities in sample A3.3 and were seen mixing with the darker gray matrix as shown in Figure 4.29 A and C. The light deposits had a swirling flow

texture while mixing with the rest of the deposit and might be due to molten metal being deposited in a more dynamic manner. This type of behavior was observed in the port-side of the sample, whereas on the starboard side, closer to the location of sample A3.2, larger irregular areas of the light deposits embedded themselves in the matrix as in sample A3.2. An EDS reading for the light deposits seen in this sample is shown in Figure 4.29 1. Also, noticed in this sample was the amount of porosity present as compared to the porosity seen in A3.2. This increase in porosity, again, could be due to the more violent way the deposits adhered to the shaft with more rapid solidification expected. The elements found in the deposit were Al and a smaller amount of Cu than the ones detected in sample A3.2. Overall, the thin layer of deposits seen in sample A3.1 and portions of A3.2 were Al and O and the thicker layers of deposits contained major amounts of Al, Ni, and Cu.

Figure 4.29 SEM images of cross-sectional view of sample A3.3 A through D showing areas where EDS spot analysis was conducted, depicted by the yellow boxes. EDS spectra of readings taken in sample A3.3 area shown in 1 and 2.

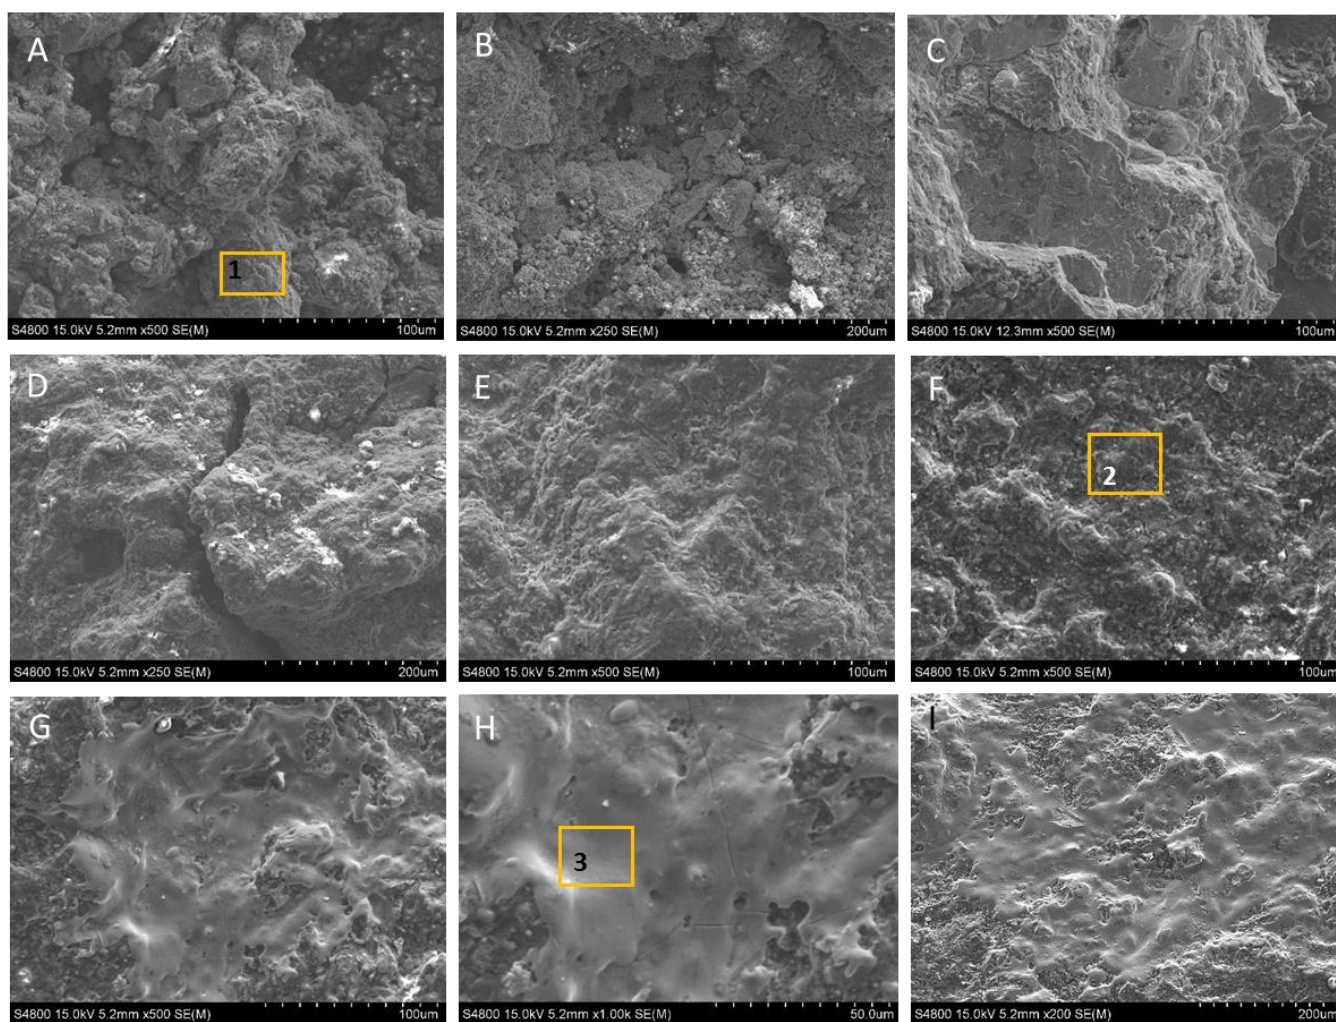
While analyzing A4.1, particle agglomeration and re-solidification were seen in several regions where popcorn-like texture, with many crevices, was observed and is shown by the SEM images in Figure 4.33 A and B. In this same region, faceted surfaces were also noticed but were most likely caused by mechanical damage to the deposits after they had solidified. This surface morphology is shown in Figure 4.33 C. Deep cracks in the deposits were observed as well as in the region where the accumulation of deposits was the greatest and tiny silica particles were seen throughout the sample. These silicon and oxygen enriched particles were mostly detected in the crevices where rough surface textures were observed. Other regions such as those seen in Figure 4.33 E and F consisted of bumpy surfaces but much smoother than regions observed earlier. Deposits appeared to adhere tightly to the shaft's base metal and small particles were also noticed on top surfaces of the deposits but were found in a smaller amount than in areas where porosity and crevices were seen. These deposits were observed in the starboard-side of the sample where a thinner layer of deposits was present. The final surface feature that was detected when analyzing sample A4.1 was splats, which were also present in Area 3. The splats found in sample A4.1 were also very like the splats seen in Area 3 and were deposited on to sections where flatter surfaces were present. SEM images in Figure 4.33 G through I show several splats found on the sample. These splats were deposited on the surface when they were in a state of liquation since the texture was smooth and appeared to have liquefied quickly. Splats seen in this sample appeared to have deposited in smaller amounts since they were thinner than splats on Area 3. Cracking of these splats was also noticed and is most likely due to the splats oxidizing rapidly making them very brittle and susceptible to cracking upon impact.

EDS spot analysis on deposits as those shown in Figure 4.33 A through C revealed that they consisted of approximately 40 wt. % Al and 20 wt. % Ni. Smaller quantities less than 10 wt. % of Fe and Cr were also detected in these popcorn-like surfaces and about 3 wt. % Ti was present as well. The EDS

Figure 4.33 SEM surfaces analysis conducted on sample A4.1. (A-C) Popcorn-like texture with small Si particles present found on area where the heaviest deposits were present. (C-F) Thinner deposits present where a bumpy surface can be observed. (G-I) Splats seen deposited on top of re-solidified deposit.

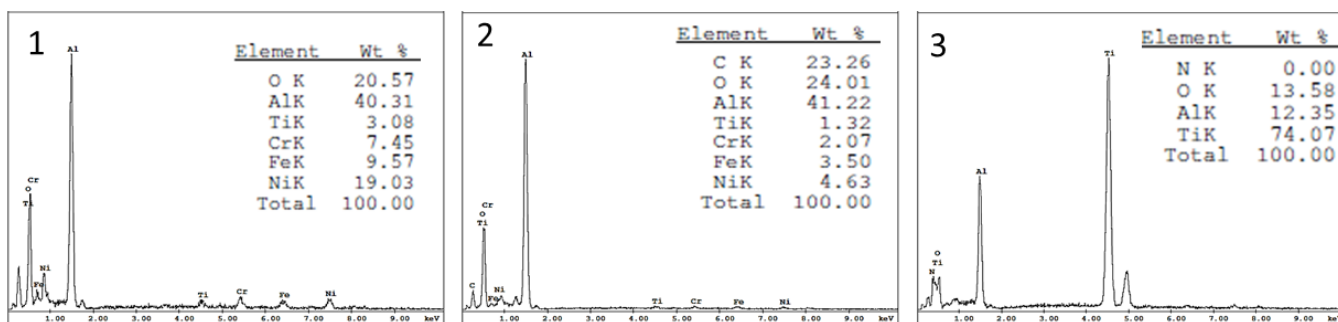
spectrum of this area, where higher quantities of deposits accumulated, is shown in Figure 4.34 1. In areas where a thinner and smoother layer of deposits were found, a similar elemental composition as the one found on the rougher surfaces was detected. Al was present in quantities of about 40 wt. % and Fe, Ni, and Cr were all detected but were in quantities of approximately 5 wt. % (Figure 4.34 2). Metallic splats like those observed in Area 3 were analyzed by EDS and several splats indicated that these were also coming from a titanium component just as those in Area 3. Deposits consisted of an average of 68 wt. % Ti, 15 wt. % O, and 13 wt. % Al. EDS spectra of deposits and splats found in A4.1 are shown in Figure 4.34 3 and 4.

Figure 4.34 Elemental analysis of sample A4.1 conducted by EDS. Results for spot analysis done on areas in Figure 4.33 are shown 1 through 3.

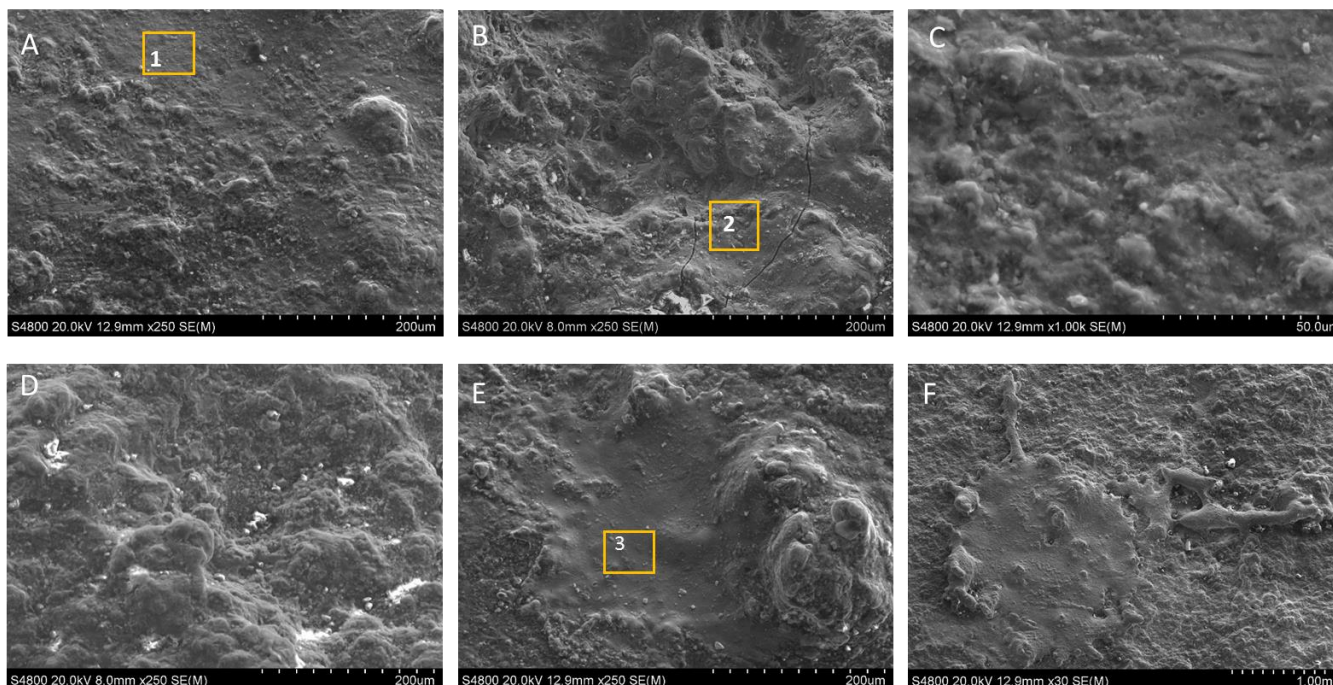
Figure 4.35 SEM images of sample A4.2 surface analysis. Large clusters of deposits can be seen throughout the sample along with Si and O enriched particle and splats.

Sample A4.2 which was found directly above sample A4.1 was analyzed for surface morphology and elemental composition was analyzed in this area. The presence of Si and O enriched particles was more apparent than other areas. Small particles that deposited on to the shaft's surface seemed to have clustered together and formed larger clusters, which protruded from the deposits. These protrusions were observed in different sizes and covered most of the surface of the sample (Figure 4.35). In the area where the change in diameter occurs at the shaft, the texture of these deposit becomes a lot smoother but agglomeration of particles was still present and the clusters were smaller in size (Figure 4.35 A). As seen in deposits from the adjacent sample, cracking occurred in the area as well but on this occasion, cracking

was observed in the deposit itself as shown in Figure 4.35 B and not on splats like seen in other samples. The silica particles can be visible in Figure 4.35 C and splats again were seen on this sample as well. Some of the splats seen on the sample are shown in Figure 4.35 E and F.

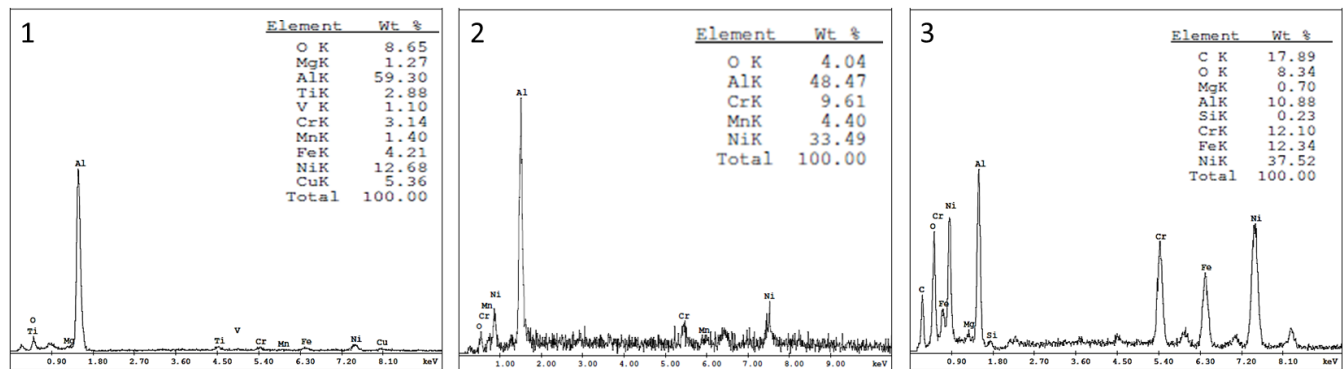
The elemental analysis conducted in this area showed that the deposits consisted of a large mixture of elements with Al having the largest content in the deposit. Al was found to make up as much as 60 wt. % of the deposits (Figure 4.36 1). Ni, which is also found in large quantities in other samples was present here in concentrations of about 30 wt. %. EDS results for deposits, which contained large amounts of Ni, are shown in Figure 4.36. One major difference seen in the splats on Area 4 was that the major element found to compose the splats was Ni. In these splats, approximately 40 wt. % Ni was present in these deposits and the EDS spectrum of a splat analyzed in sample A4.2 is shown in Figure 4.36 3. Other elements in the splats were Fe and Cr which made up about 12 wt. % each. Al and O regions were present but again, Ni was the major element found in the splats on this sample.

Figure 4.36 Elemental analysis of sample A4.2 conducted by EDS. Results for spot analysis done on areas in Figure 4.35 are shown 1 through 3.

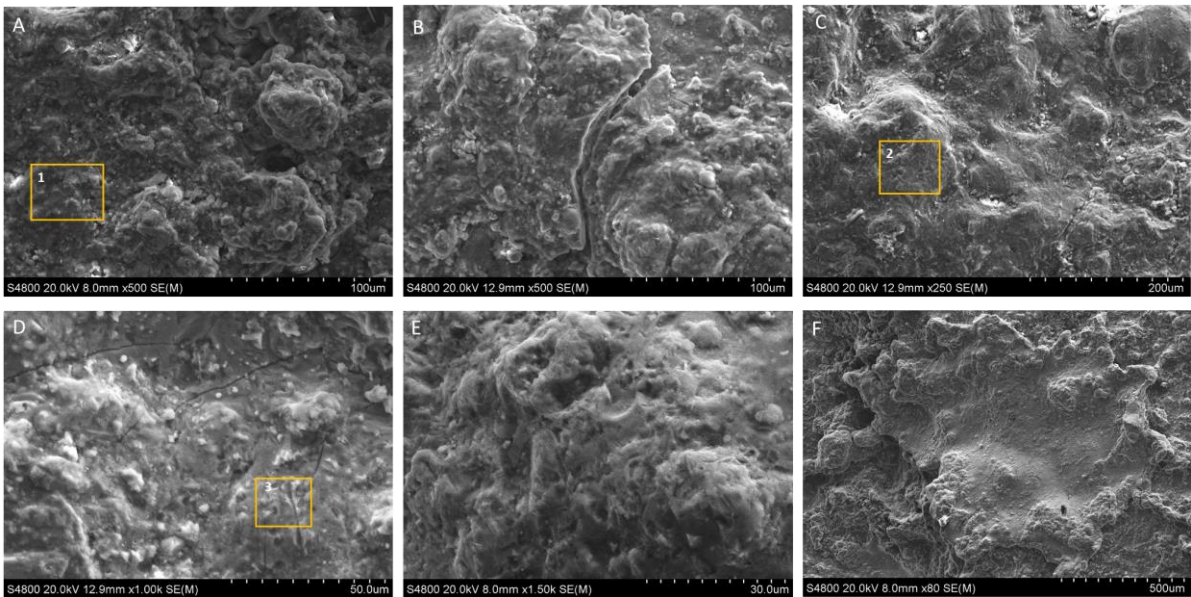
The final sample analyzed was sample A4.3 and was located directly next to sample A4.2. This sample contained many metallic spats and very rough surfaces. SEM images belonging to this area are shown in Figure 4.37. The surface texture in the threaded region was observed to be a lot rougher than any other sample analyzed. As molten metal and small metallic particles deposited onto the shaft, agglomeration occurred all throughout the sample. Images in Figure 4.37 A and B show many particles that came together to make clusters. Loose small particles were also seen in these deposits and most likely

solidified in a quick manner, preventing further agglomeration with the bigger clusters present. Other regions had smoother surfaces but small hills and valleys of deposits could still be observed in these large smoother surfaces on the sample. Figure 4.37 C shows these textures seen in the sample as well as deep cracks. Cracks that were not as deep as others in the area were also present in deposits that appeared to be tightly adhered to the base metal and are shown in Figure 4.37 D. In the threaded regions, a different type of texture was observed which had a very granular and rough surface. Along with the granular surfaces, Figure 4.37 F shows cavities and splats present in the threaded areas. The deposits found in this area were Al with small amounts of Ni, Fe and Cr. EDS spot analysis conducted on several areas in sample A4.3 are shown in Figure 4.38 1 through 3. In this sample, not much Ti was detected and reduced amounts of Ni or Fe were present in the sample.

Figure 4.37 SEM surface analysis of sample A4.3 which shows particles clustering along with loose smaller particles in images A through F. Cracks can also be seen in C and D. Splats also seen in the sample are shown in image F.

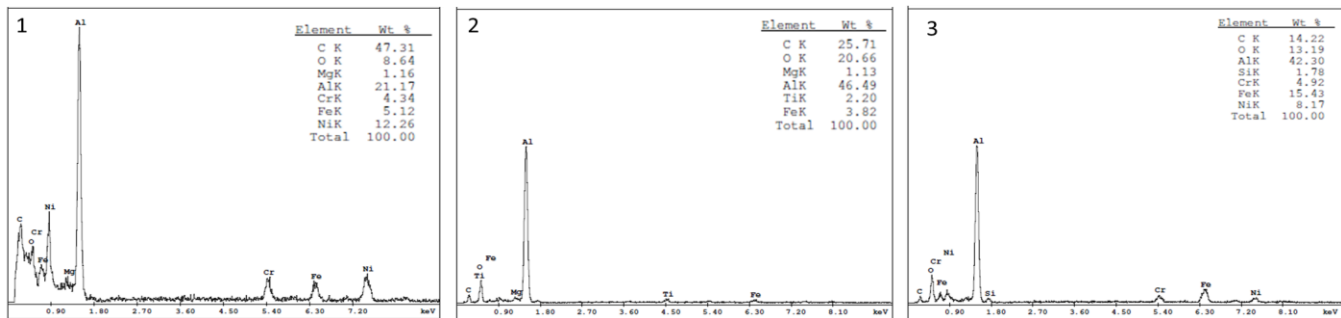
Figure 4.38 EDS spectra of sample A4.3 of areas shown in Figure 4.37.
