Materials Characterization of Deposits on Starboard (Inboard) Elevon Actuator Shaft Recovered from Space Shuttle Columbia

MATERIALS CHARACTERIZATION OF DEPOSITS ON STARBOARD
(INBOARD) ELEVON ACTUATOR SHAFT RECOVERED FROM SPACE
SHUTTLE *COLUMBIA*

DISSERTATION

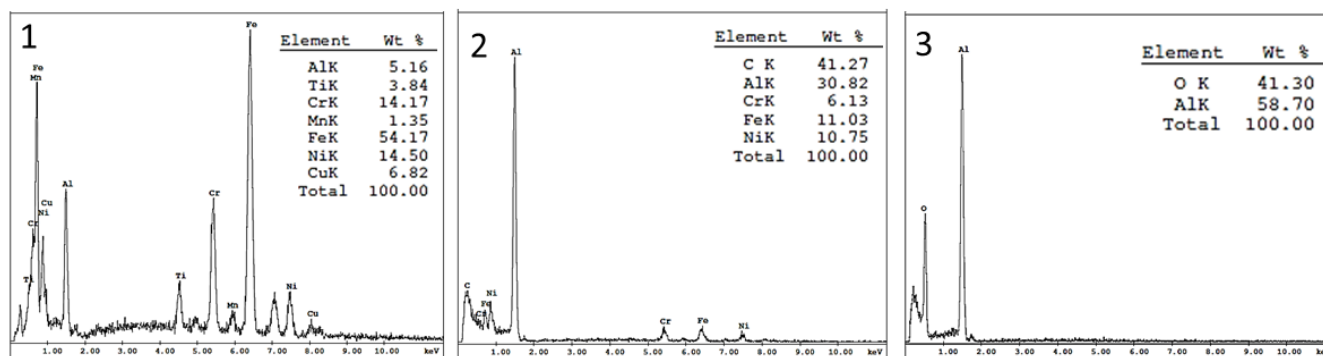
For the chemical analysis performed in sample A4.1 on the light deposits observed in the lower areas of the deposits, EDS results detected large amounts of Fe as well as Cr and Ni in the light deposits (Figure 4.40 1). Approximately half of the composition of these light deposits was Fe and about 15 wt. %

of Cr and Ni each, was detected in this sample's cross-sectional view. In other areas, Fe deposits were mixed with the darker colored deposit. EDS reading of the gray deposit, which can be seen at a higher magnification in Figure 4.39 C and D showed that it was composed of approximately 26 wt. % Al with about 12 wt. % of Fe and 11 wt. %Ni. Other elements detected in this deposit were Ti and Cr but were only in concentrations of 5 wt. %. One of several EDS readings taken from this area of the deposits is shown in Figure 4.40 2. The dark colored deposit seen in sample A4.1 was identified as Al and O. The chemical composition of the dark colored deposits is shown by the EDS spectrum in Figure 4.40 3.

Figure 4.40 EDS spectra of the cross-sectional view of sample A4.1 are shown. Spectrum 1 corresponding to the light layers of deposit seen in the sample. Spectrum 2 indicates the chemical composition of the matrix deposit which have a gray coloration. The final spectrum belongs to the dark colored deposits.

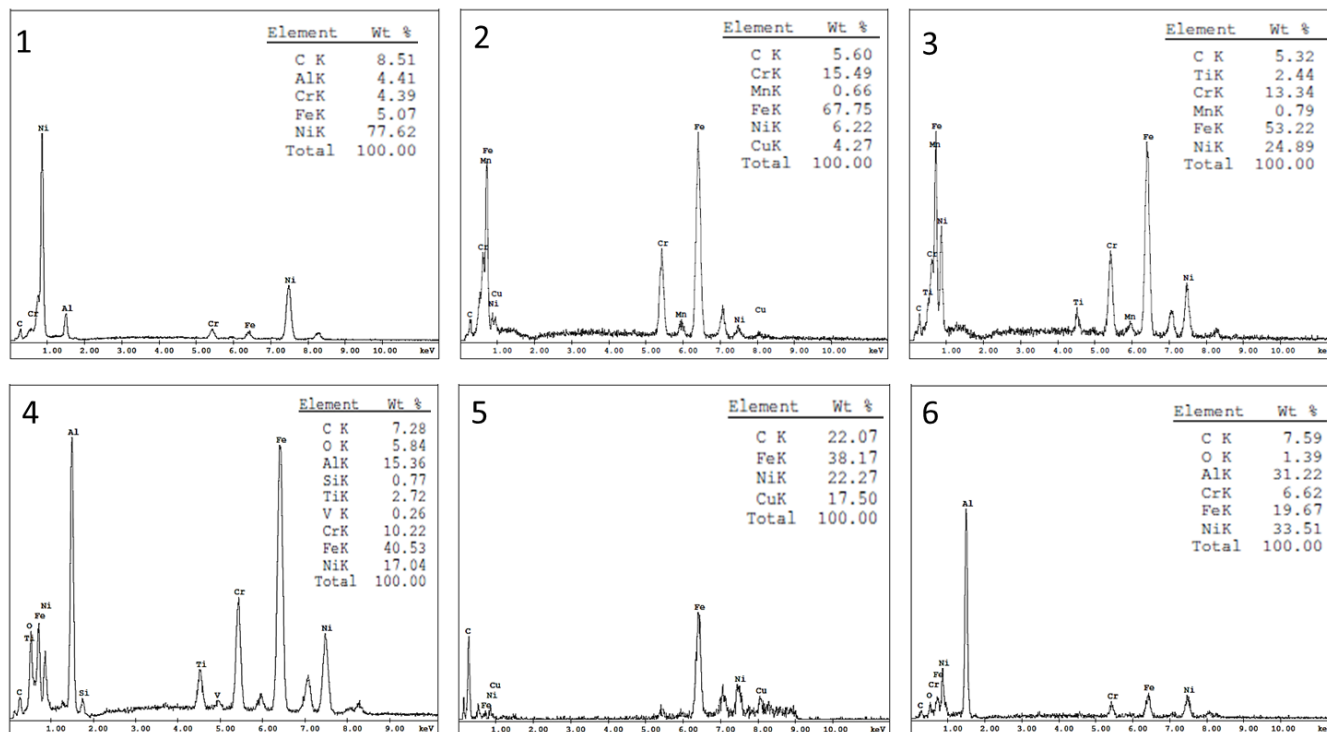
The EDS spectra for these light deposits is shown in Figure 4.42 3. Analyzing the gray deposits, which made up the bulk, revealed that about 40 wt. % Fe was present along with 15 wt. % of Al and Ni, each. Chromium was also detected but only consisted of about 10 wt. %. EDS results for these gray deposits are shown in Figure 4.42 4. Titanium in this sample was found in quantities less than 3 wt. % at the subsurface of the deposit. Lastly, the dark gray deposits were identified as a mixture of Fe, Ni, and Cu (Figure 4.42 5).

Figure 4.42 EDS spectra of the cross-sectional view of sample A4.2 are shown. Location of where readings were taken are shown in Figure 4.41 by the yellow squares.

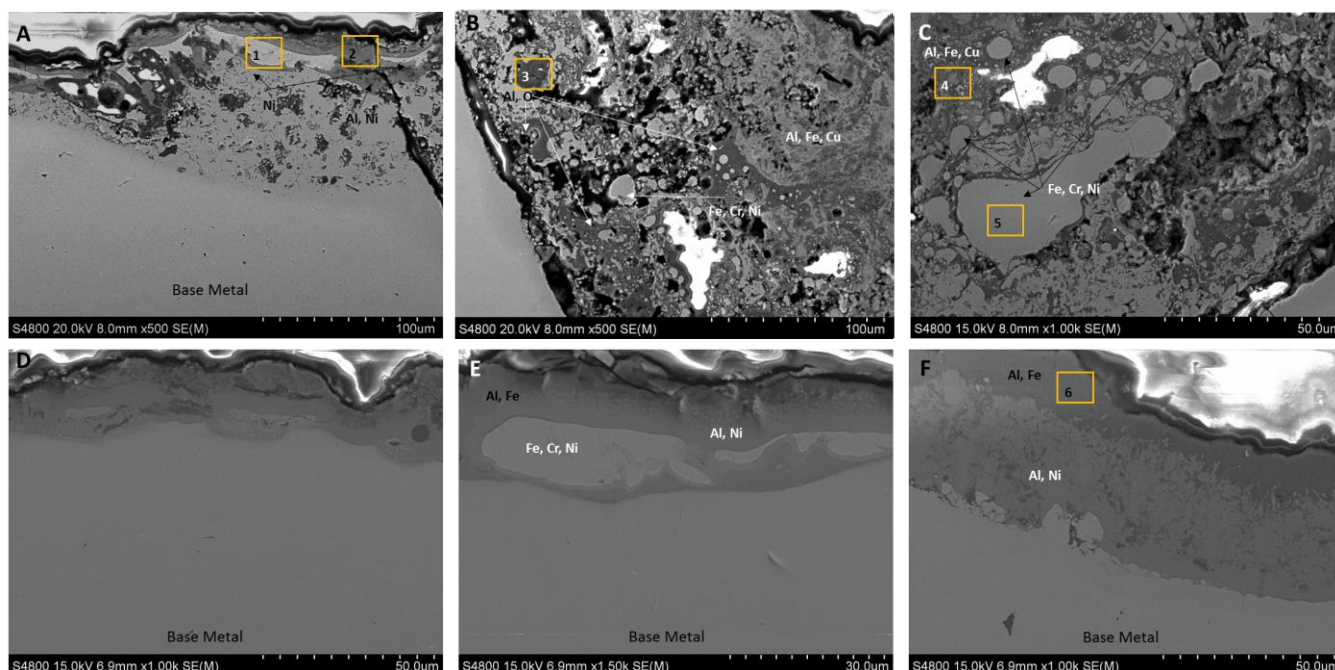
In sample A4.3, no chromium layer was detected and in the threaded region, most of the thread crests had eroded. When examining the threads, only three of the five threads that were examined had a defined crest and root, the other two were not as deep within the root as others were. In Figure 4.43 A, deposits located at the crest of the thread can be seen and show again a mixture of a light deposits found at the top surfaces, which are surrounded by a gray deposit. Below these two layers, the base metal mixed with dark gray deposits which was similar to the behavior that was seen in sample A4.2. Measurements of these deposits were approximately 130µm. These deposits then moved toward the roots of the threads

and their morphology changed to a more turbulent flow of light gray deposits mixing with the dark gray deposits as seen in Figure 4.43 B. Light gray circular deposits were seen in the thread roots. These circular deposits had different shapes and sizes. This behavior is shown in Figure 4.43 C at a higher magnification and large cavities with granular textured walls can be observed. On the threaded edges, a very thin narrow strip of chromium coating can be seen but is only present over the threaded length and not on areas where threads have been damaged by high temperatures of deposits that adhered to their surface. Deposits found on the rooted parts of the threads were around 480 μ m in thickness.

Figure 4.43 SEM images of the cross-sectional view of sample A4.3 on Area 4. (A-C) Area showing deposits found on the threaded length of the sample. (D-F) Deposits found in non-threaded area of sample A4.3.

deposit, and as it reached the surface, a dendritic formation was noticed. The nucleation of dendrites is observed in Figure 4.43 F as this layer advances towards a darker layer at the surface.

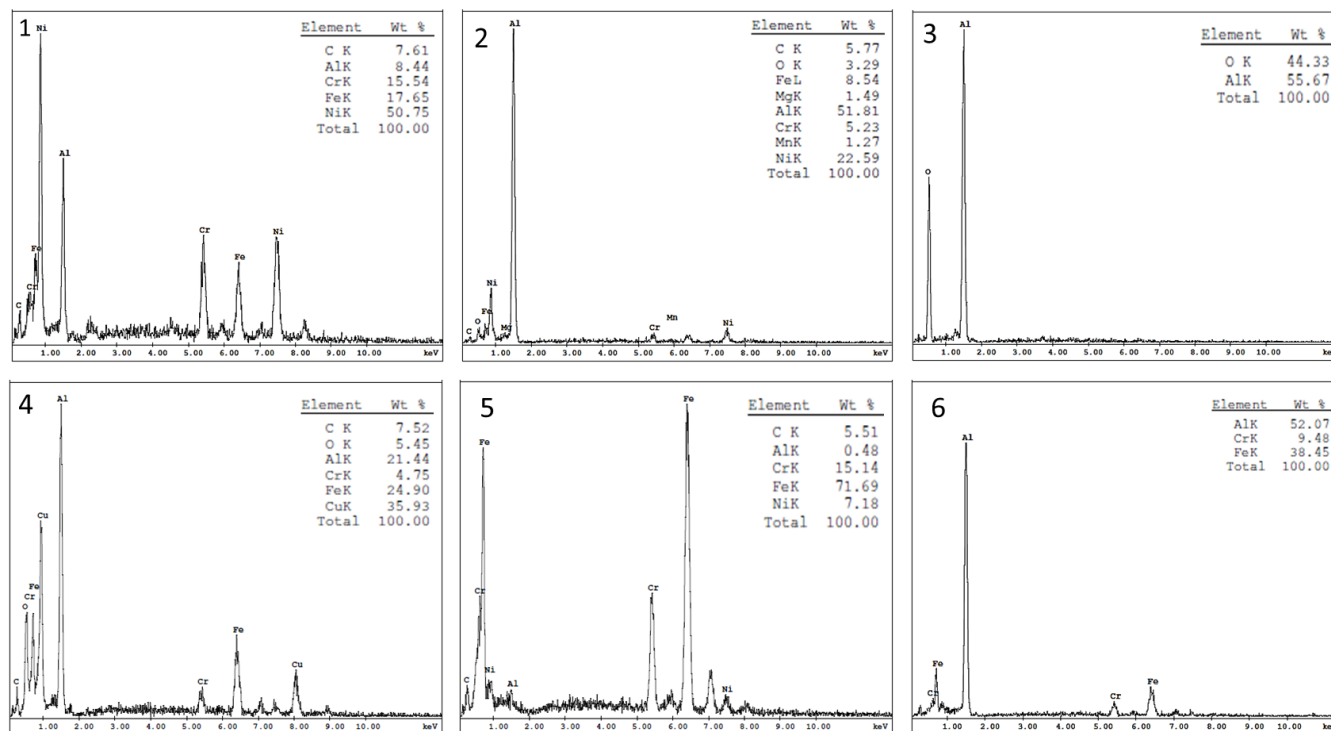
Figure 4.44 EDS spectra of the cross-sectional view of sample A4.3 are shown. Location of where readings were taken are shown in Figure 4.43 by the yellow squares.

As seen in most of the samples that were analyzed from Areas 3 and 4, the light deposits which have been found mostly on the bottom surfaces of the deposits and in this case at the top surfaces, have been identified as Ni deposits as seen by the EDS spectrum in Figure 4.44 1. Nickel deposits were making up nearly half of the light deposit and Cr and Fe make up about 30 wt. % together. Identification of the chemical composition of the gray deposit that surrounded the light deposits was the conducted by using EDS. The results showed in Figure 4.44 2 that these gray deposits that encapsulated the light deposits were mostly aluminum but also contained about 20 wt. % of Ni. These deposits can be seen in the SEM images in Figure 4.43 A, D, E, and F. The dark gray deposits, which were seen in Figure 4.43 A through C were identified as being Al and O as the EDS spectrum in Figure 4.44 3 shows. The matrix of the deposit, which has a mixture of gray and dark gray deposits, had a mixed composition of Al, Fe, and Cu as presented in Figure 4.44 4. Other gray deposits, this time having a circular morphology, were composed

mostly of the base metal which contained about 70 wt. % Fe, 15 wt. % Cr, and around 7 wt. % Ni (Figure 4.44 5). The last layer of the deposit that was analyzed in A4.2 was another dark layer that was only seen at the top surfaces of the non-threaded area. This layer was analyzed by the EDS and showed that it was mostly Al with about 50 wt. % present and 40 wt. % Fe. Chromium was also detected and made up 10 wt. % of this dark gray layer found in the non-threaded region.

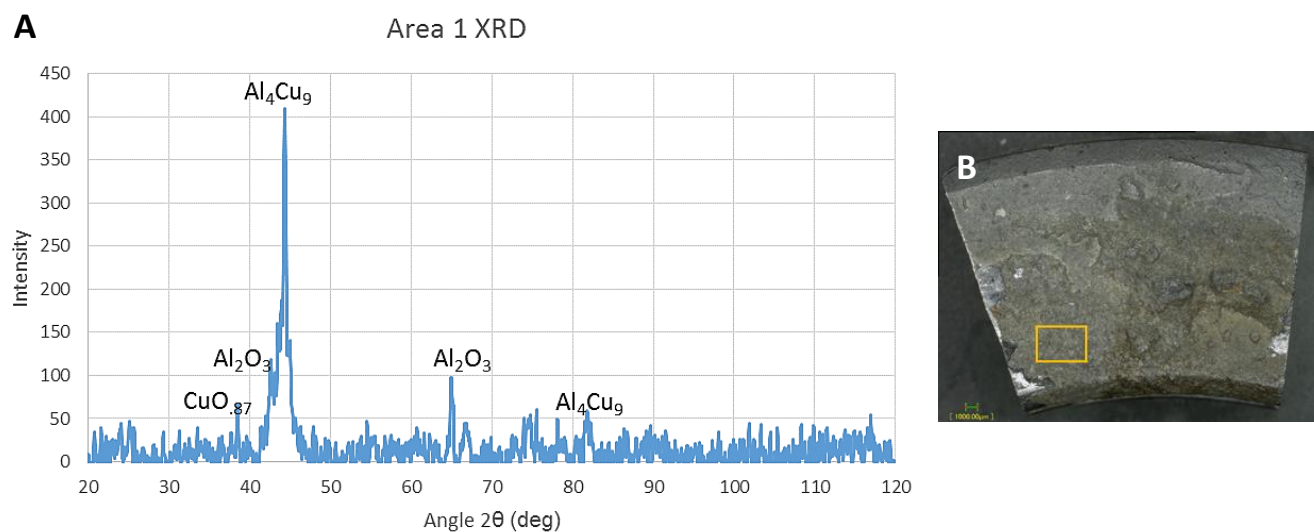
In Area 1, two surfaces were analyzed under the SEM, the top surface and the threaded region, due to the XRD requiring a flat surface for better results, only the readings on the top surfaces will be discussed. In this area, XRD detected compounds such as Al_4Cu_9 , Al_2O_3 , and CuO .⁸⁷ The XRD spectrum for one of the areas that was analyzed in this sample is shown in Figure 4.45 and the location of where the analysis was conducted can be seen in this same figure as well. EDS analysis that was conducted on the surface of this sample showed the presence of mostly aluminum and oxygen, which were identified by the XRD as being Al_2O_3 or alumina. This aluminum oxide compound is the most common one of all of them. Another phase that was detected in the deposits was Al_4Cu_9 , and even though not much Cu was detected

Figure 4.45 XRD spectrum in (A) of spot shown in (B) of Area 1 sample's top surface.

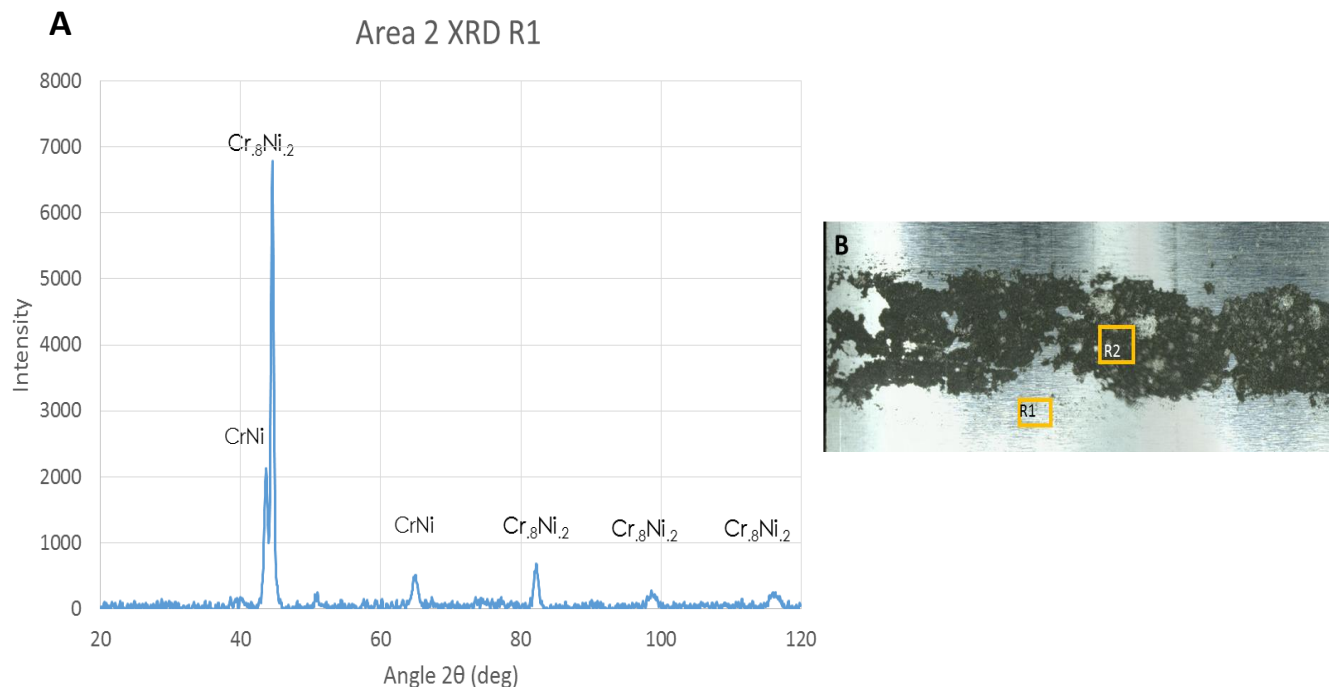
Figure 4.46 XRD spectrum in (A) belonging to deposit-free area shown in (B). Image B shows location of where reading 1 (R1) and reading 2 (R2) were taken.

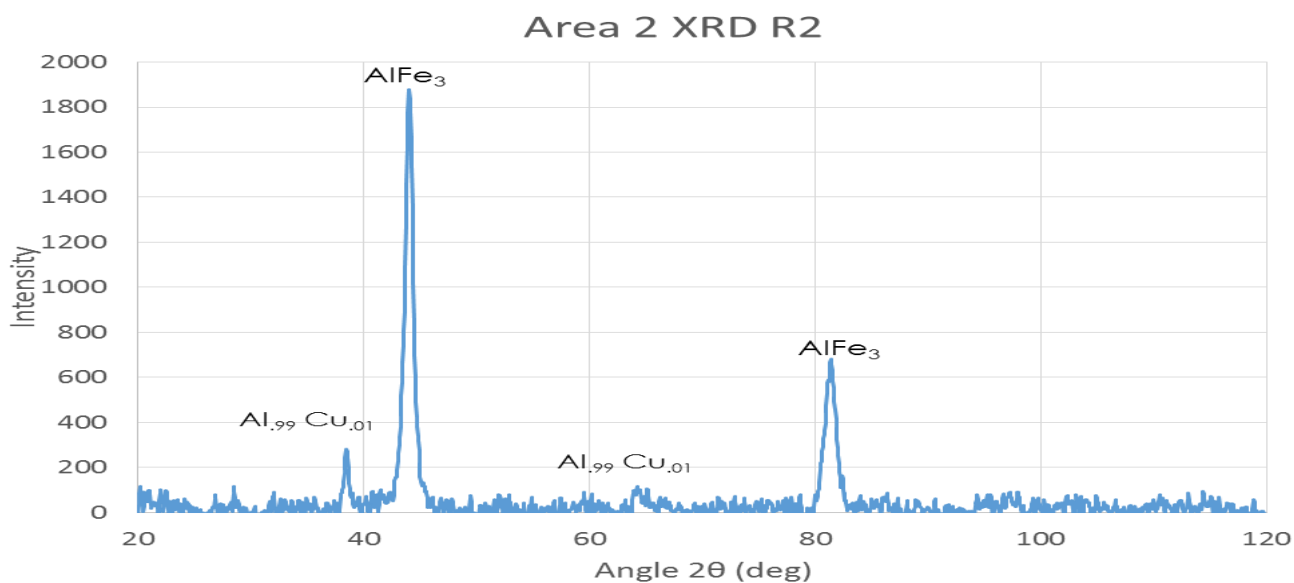
has a certain depth of penetration and is greatly dependent on the density of the materials. AlFe_3 was also detected in the deposit for this sample and small concentrations of Fe also appeared in the EDS spectra. The spectra for the second reading (R2) done on this sample is shown in Figure 4.47.

Figure 4.47 XRD spectrum of deposits found in Area 2. Location of where reading was taken can be found in Figure 4.46 B, R2.

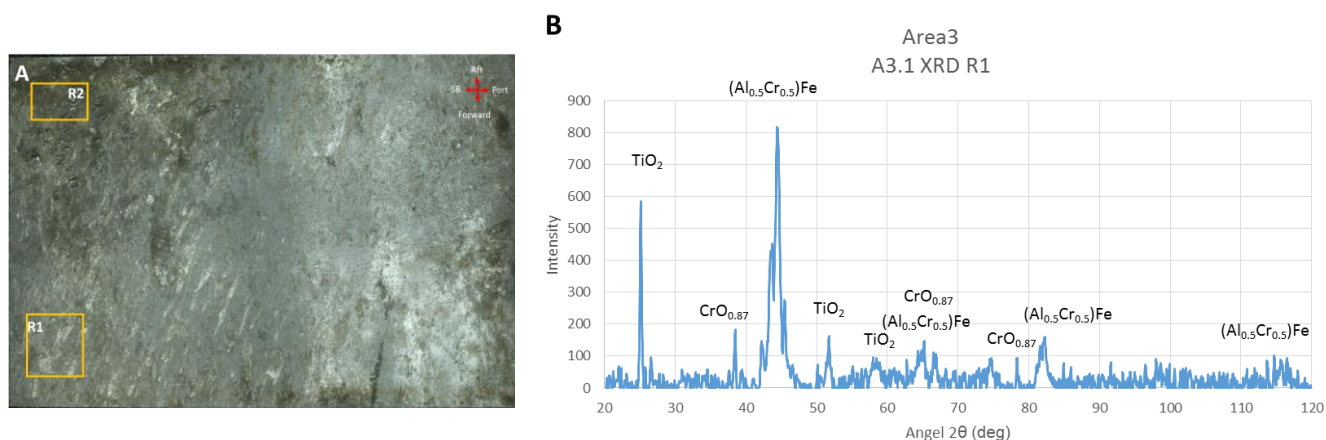
For Area 4, samples A3.1, A3.2, and A3.3 were analyzed for their surface chemical composition. Two readings for sample A3.1 were performed, which included an area where visible streaks were present in the sample. The second reading was taken from the uniformly thin layer of the deposit also for this sample. Location of these two areas that were examined are shown in Figure 4.48 A. For the first reading, R1, which is where the streaks were seen, the XRD spectrum detected several compounds such as $(\text{Al}_{0.5}\text{Cr}_{0.5})\text{Fe}$, TiO_2 , and $\text{CrO}_{0.87}$. These results are shown in Figure 4.48 B. Due to TiO_2 being detected in this sample, the streaks that were being analyzed by the XRD were most likely the same Ti streaks that were identified by EDS. Since these streaks were seen to deposit on top of a thin layer of deposit and in other occasions on the base metal itself, the detection of the $(\text{Al}_{0.5}\text{Cr}_{0.5})\text{Fe}$ and $\text{CrO}_{0.87}$ are most likely coming from the deposits and the chromium coating.

Figure 4.48 Location of where the two reading of sample A3.1 from Area 3 are shown in A. XRD spectrum of compounds identified in the deposits of sample A3.1 are shown in B.

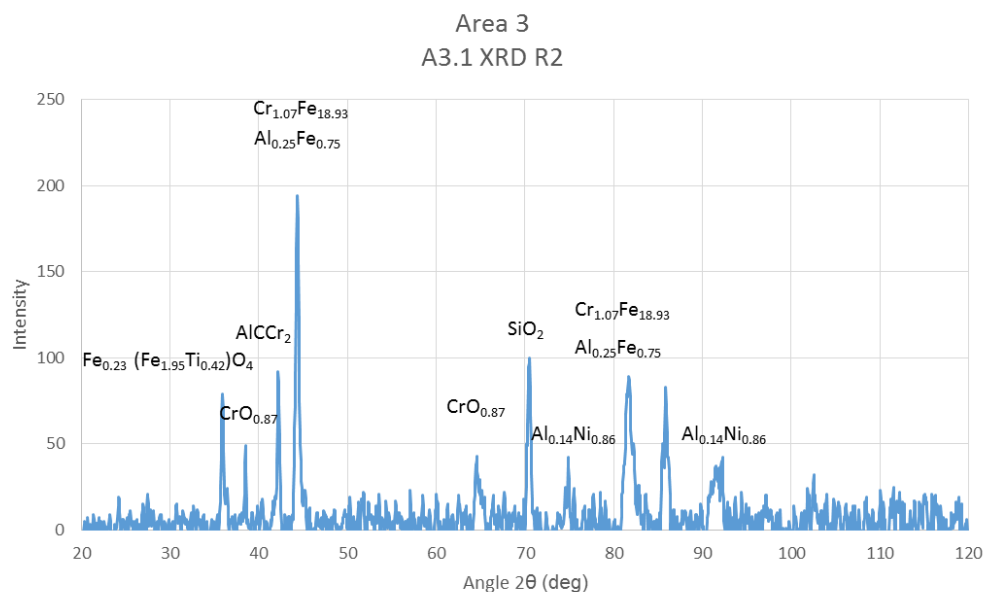
The second reading, which belongs to the thin layer of deposits, had compounds that were not very common but included elements which were also detected by EDS. Compounds such as $\text{Fe}_{0.23}(\text{Fe}_{1.95}\text{Ti}_{1.42})\text{O}_4$, $\text{Al}_{14}\text{Ni}_{86}$, $\text{Al}_{25}\text{Fe}_{75}$, and $\text{Cr}_{1.07}\text{Fe}_{18.93}$ were some of the compounds that were detected in sample A3.1 for the thin layer of deposit. Results for this area are shown in Figure 4.49. Even though these phases are non-stoichiometric, they were coming from AlNi , and AlFe compounds as well as TiO . It is probable that the

Figure 4.49 XRD spectrum of thin layer of deposits found in Area 3. Location of where reading was taken can be found in Figure 4.48 A, R2.

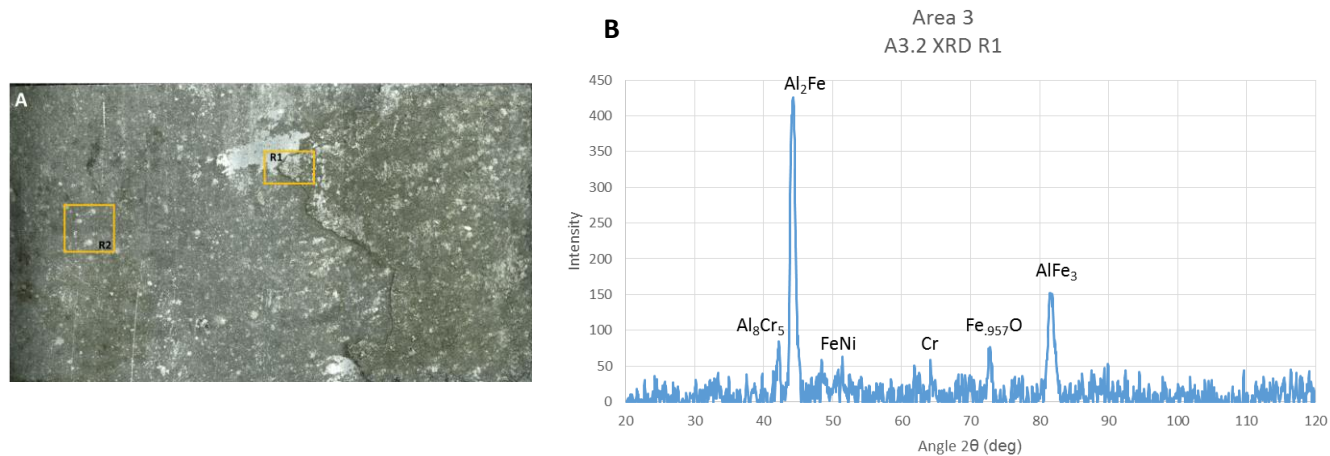
Sample A3.2 had two layers of deposits, a thin layer and a thicker uniform layer. The thin layer, which was analyzed in the previous sample of Area 3, had very similar peaks as the ones found in sample A3.1 and were not be presented for sample A3.2. The thicker layer of uniform deposits had peaks such as Al_2Fe , FeNi , and AlFe_3 which were detected when XRD analysis was conducted (Figure 4.50 A). These compounds are coming from an AlFe component. EDS results for this area were mostly composed of an Al, O, and Cu but did have splats that were mostly Fe, which is why Fe was being detected here. Unlike the EDS results for the thicker layer of deposits in A3.1, Cu peaks were not present in the area tested by the XRD. The second reading in this sample came from a big splat that could be seen in the sample. This splat like the one found in sample A3.1 was a Ti splat. AlNi and AlFe_3 compounds were also seen in the XRD spectrum in Figure 4.51. About 70 wt. % Ti was present along with 4 wt. % Al and V which confirms

Figure 4.50 Location of where the two reading of sample A3.2 from Area 3 are shown in A. XRD spectrum of compounds identified in the uniform deposits of sample A3.2 is shown in B.

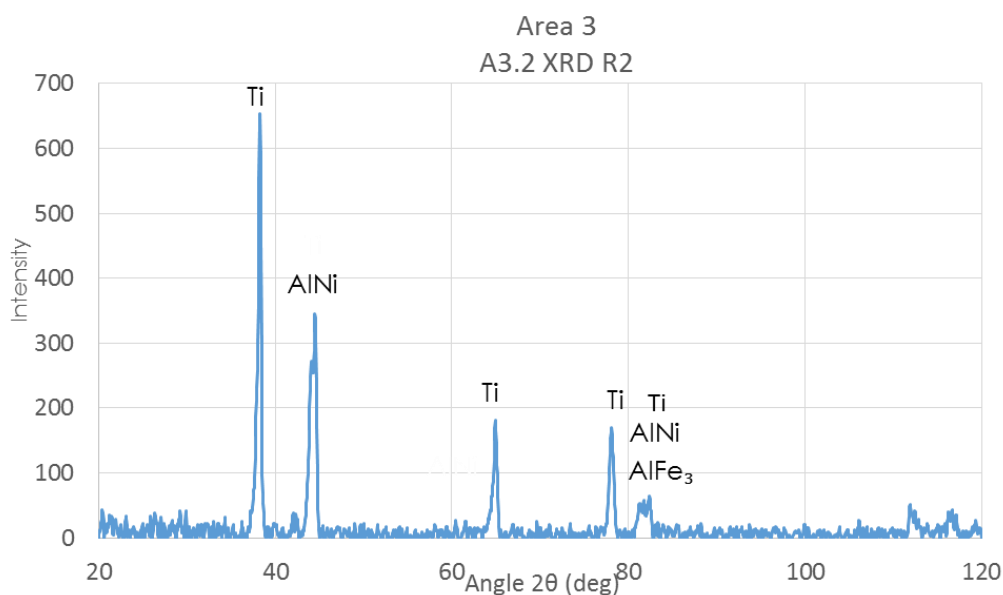
that this splat was coming from a Ti-6Al-4V component. XRD results for these two readings went along with EDS results from surface analysis of sample A3.2.

Figure 4.51 XRD spectrum for second reading done on splats seen in sample A3.2.

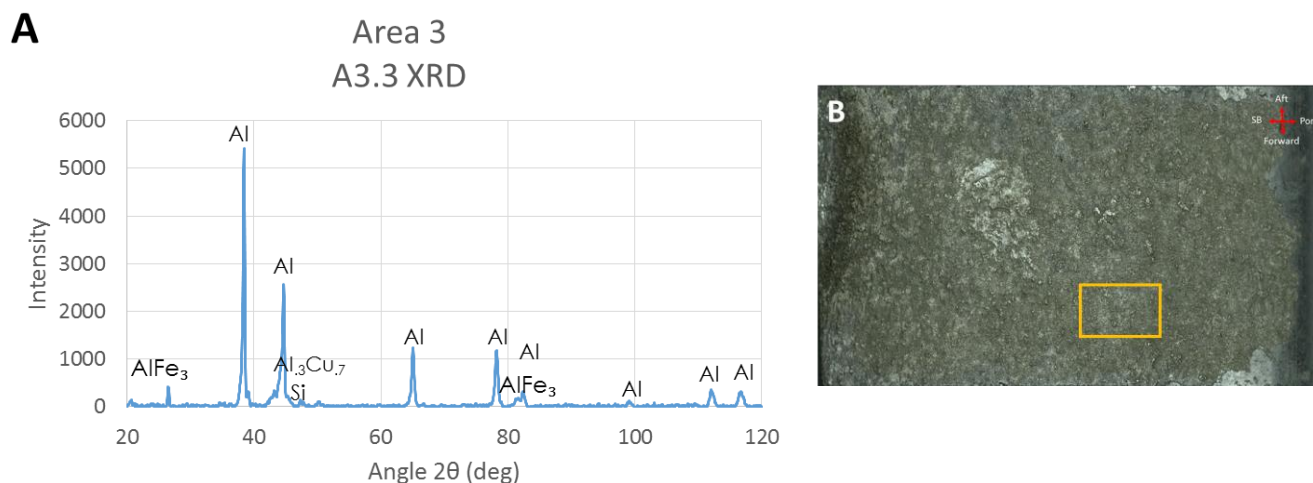
The last sample analyzed for the Area 3 was sample A3.3, which had a uniform deposition of metallic materials. Analyzing areas in this sample showed that mostly pure Al with compounds seen in other samples, such as AlFe_3 and AlCu along with Si, were present at the surface (Figure 4.52 A). When this sample was examined under the SEM, globular silicate particles were observed in the sample and was the reason why a Si peak was detected in the XRD spectrum. As for the presence of AlFe_3 and AlCu , EDS

Figure 4.52 XRD spectrum of sample A3.3 is shown in A. Location of reading taken in sample A3.3 from Area 3 is shown in B.

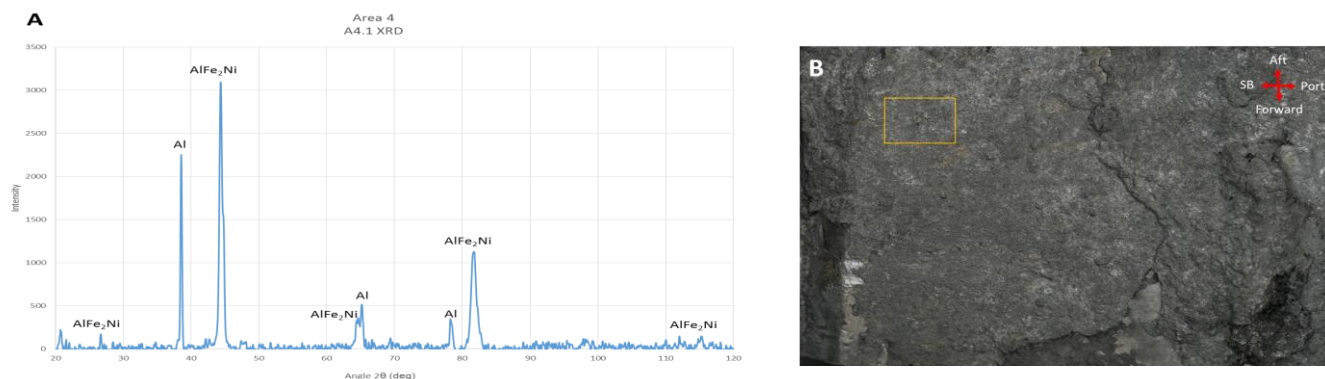
Samples for Area 4 had heavier amounts of deposits and rougher surfaces which made it difficult to get a good XRD readings. Several good readings were obtained, but did include a lot of background noise in the spectrum. For sample A4.1, XRD results in Figure 4.53 A showed a AlFe_2Ni phase present and Al metal, which matches with the EDS surface results for this area. EDS results showed A4.1 deposits consisted of about 40 wt. % Al, 20 wt. % Ni, and around 10 wt. % of Fe and Cr, each. Only one reading from sample A4.1 was taken since there were a lot of rough surfaces present and accurate results were difficult to obtain. In sample A4.2, two areas were analyzed, one included the adherent thick deposits and another was an area where a splat was deposited. Results for the first reading can be seen in Figure 5.54 A which belong to the deposits in close proximity to where the erosion damage was observed. The area

Figure 4.53 XRD spectrum of sample A4.1 is shown in A and location of where reading was take is shown in image B.

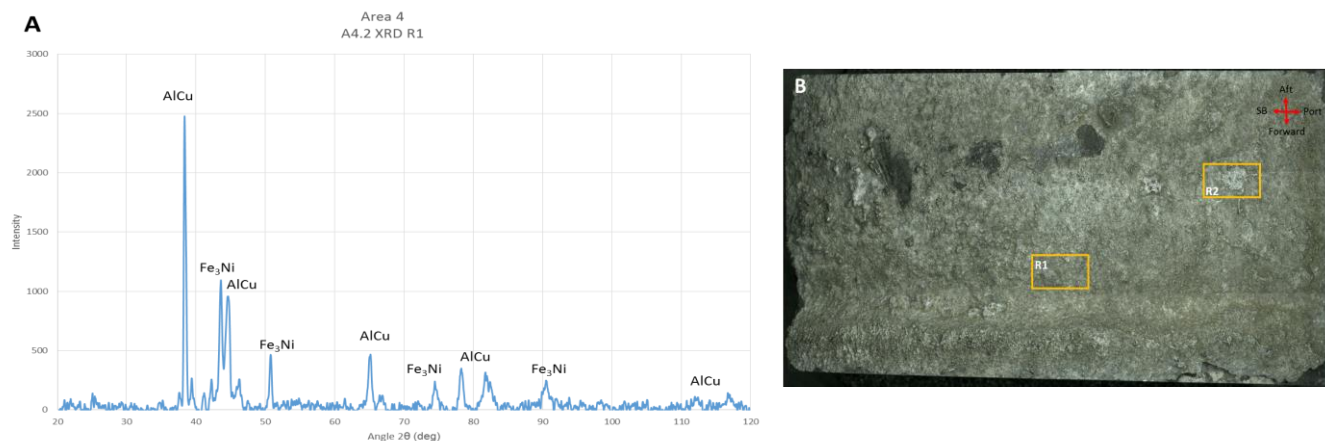
for the first reading, R1, is shown in image B of Figure 4.54. The spectra showed that compounds such as AlCu and Fe₃Ni were detected. In this area when analyzed under the SEM and EDS was conducted, approximately 60 wt. % Al was present and smaller amounts between 12 wt. % and 6 wt. % of Ni, Cu, and Fe were detected. The accuracy of the XRD results in this area are very accurate since peaks were readily identified and coincided with the EDS results as well. Several splats were visible in the sample but results for only the splats shown by R2 in Figure 4.54 B were discussed. XRD spectrum confirmed that the splat was coming from a Ni rich component since most the peaks were NiO and ESD results showed 40 wt. % Ni present in the same area. Other compounds that were detected in sample A4.2 were SiC, Fe₄Al₁₃, and Al(CrNi) and the spectra are shown in Figure 5.55. Elements that make up these compounds were also present in the EDS spectra.

Figure 4.54 XRD spectrum of the first reading in sample A4.2 is shown in A and location of where reading was take is shown in image B.

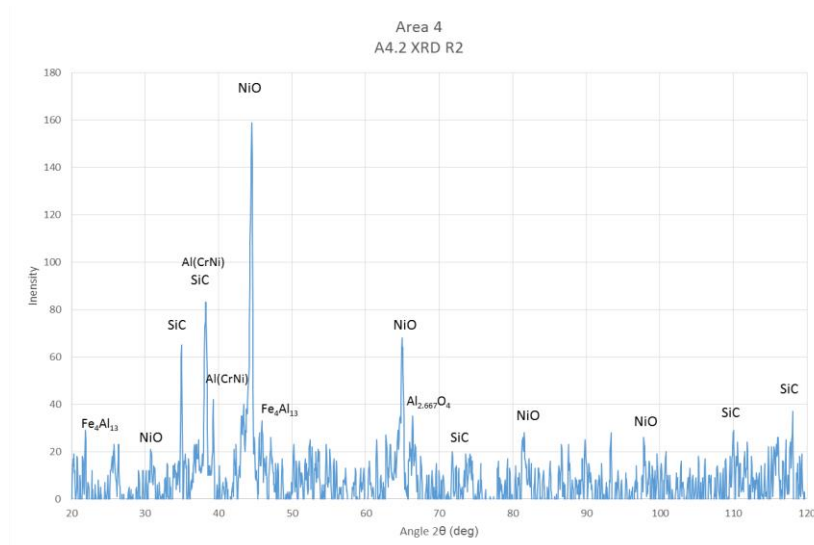
Figure 4.55 XRD spectrum of second reading in sample A4.2. Location of R2 is shown in image B.

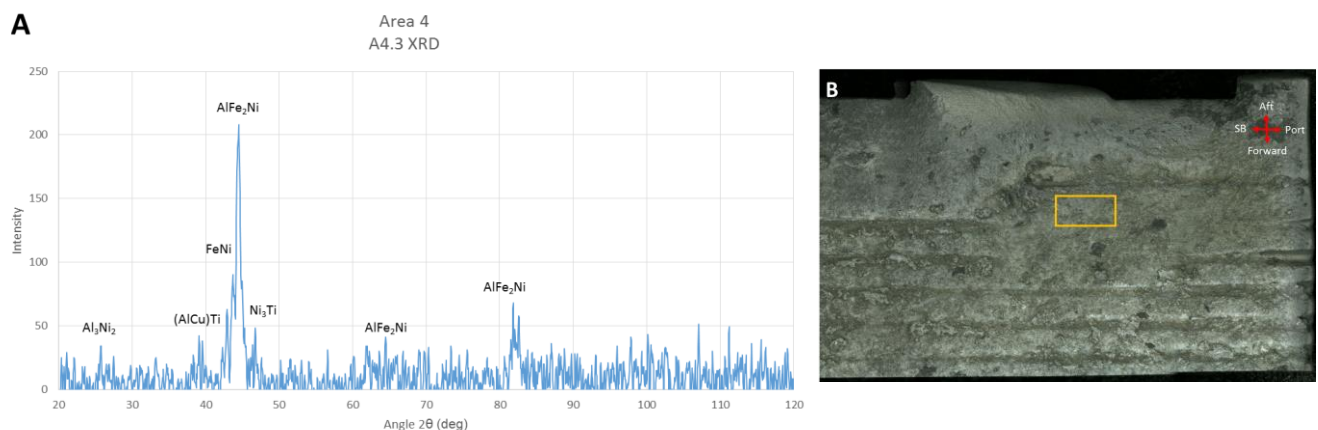
Conducting XRD analysis on Sample A4.3 was difficult, so since this sample had a threaded area but a region where erosion of the threads had occurred was selected for analysis. The XRD peaks were identified to be AlFe_2Ni , $(\text{AlCu})\text{Ti}$, Ni_3Ti , and FeNi compounds that were present in the deposits for sample A4.3 (Figure 4.56 A). In this area, EDS detected mostly Al and O but did contain approximately 12 wt. % Ni and less than 5 wt. % Ti, Cr, and Fe, which go along with XRD results. EDS was unable to detect any presence of Cu but a $(\text{AlCu})\text{Ti}$ peak was detected by the XRD. Overall, XRD served to verify the chemical composition with results found while performing EDS surface analysis on all the samples and identification of phases was also accomplished by obtaining the XRD spectra.

Figure 4.56 XRD spectrum of sample A4.3 is shown in A and location of where reading was take is shown in image B.

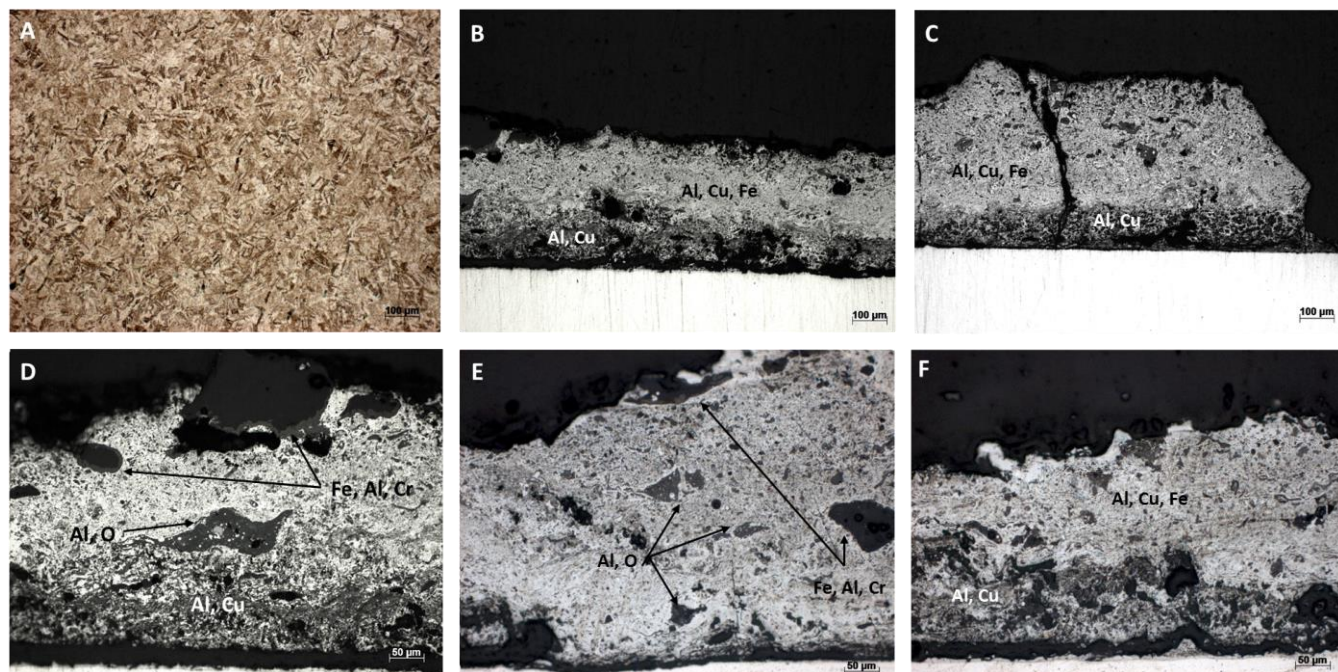
Figure 4.57 A) 15-5 PH stainless steel microstructure for Area 1 sample. Magnification for (A) is 150X. (B-F) Optical micrographs of Area 1 aft-facing side sample showing several inclusions in the deposits as well as shrinkage and oxidation layer. Magnification for (B-C) is 150X and (D-F) is 200X.

Examining the aft-facing side under the optical microscope revealed more detail on how the inclusions and layers of the deposits. Figure 4.57 B and C shows two distinct layers, a darker layer at the bottom and a lighter layer at the top surface. Though they appear as two distinct layers, the composition was not very dissimilar. EDS results showed that the top layer contained higher concentrations of Fe while the bottom layer was mostly Al with a combination of Cu in both layers of the deposits. The small irregularly shaped islands of Al and O enrichments and bilayer deposits seen at the surface of the deposits are also more visible with the optical micrographs and are shown in Figure 4.57 D and E. The cavity between the chromium layer and deposits was another feature that was clearly defined. In Figure 4.57 C, a deep crack can be seen running down the deposits until it hits the base metal. Cracking was seen throughout the deposits. In many cases, cracks lead to the surface of the base metal forming a long

continuous hollow space between the base metal surface and deposits as described in earlier sections. These tunnels are shown in Figure 4.57 D through F. On the threaded side of the Area 1 sample, similar deposit morphology could be seen (Figure 4.58). The main difference that was noticed in these deposits was more porosity most likely due to trapped gas. Deposits that were embedded in the matrix and were identified as being mostly Fe deposits are shown in Figure 4.58 A and B. Optical microscopy on Area 1 verified that there were no thermal alterations on the aft-facing side as well as the threaded side of the sample belonging to the housing material of the elevon's hydraulic system.

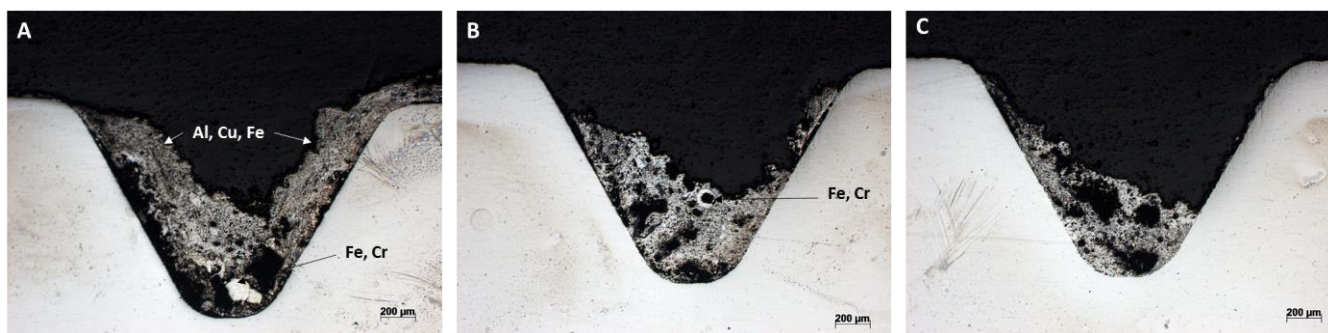
Figure 4.58 Optical micrographs of threaded side of Area 1 sample showing deposits and porosity. Magnification of (A-C) is 500X.

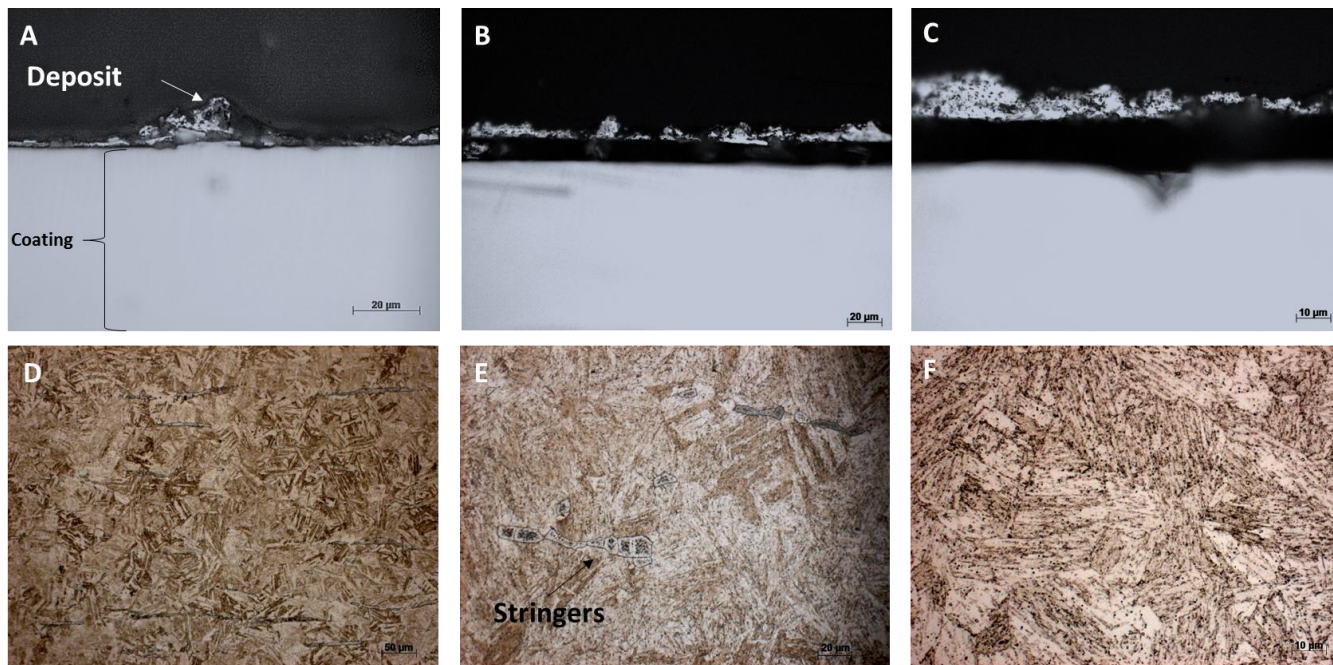
Area 2 is the first area of the shaft that was examined and contained very thin and narrow deposit lines. One sample from this area was used to obtain the microstructure of the base metal, which would serve as a control to detect any microstructural changes on Areas 3 and 4 since most of the sample in Area 2 was unaffected by deposits. Part of this area was covered for most of the event which led to deposit-free areas that were thought to be free of thermal damage. Due to the deposits being very narrow and thin, capturing good micrographs was difficult. Figure 4.59 A through C show how irregular and thin deposits were. Copper colored inclusions were seen in Figure 4.59 A but were not detected by the EDS, instead Cr was found in the deposits along with Al, which comprising most of the deposit. The same gap along the base metal surface was also seen in the deposit with Al and O concentrated particles dispersed discontinuously throughout (Figure 4.59 B and C). The chroming coating was also detected and no

damages seemed to have occurred. As mentioned before, the base metal of the shaft is a 17-4 PH stainless steel which would have a martensitic microstructure. Figure 4.59 D through F shows several micrographs that were taken of Area 2 sample once it was etched with Kalling's No. 2 reagent. A martensitic microstructure with long delta-ferrite stringers is seen in Figure D and E, where image E shows delta-ferrite stringers with clusters of Cu precipitates enclosed within them. At a higher magnification, Cu precipitates can be seen throughout the whole martensitic microstructure. A uniform martensitic microstructure with approximately 5% delta-ferrite stringers was seen in the sample and verified that the microstructure could be used as a control when identifying microstructural changes due to excessive heat.

Figure 4.59 (A-C) Optical micrographs of Area 2 sample deposits as well as Cr coating. Magnification at 500X for (A) and (B) and 1000X for image (C). (D-F) 17-4 PH stainless steel microstructure which will be used as a control since no heat damaged was caused in Area 2. Magnification for image D is 200X, for E is 500X, and image F is 1000X.

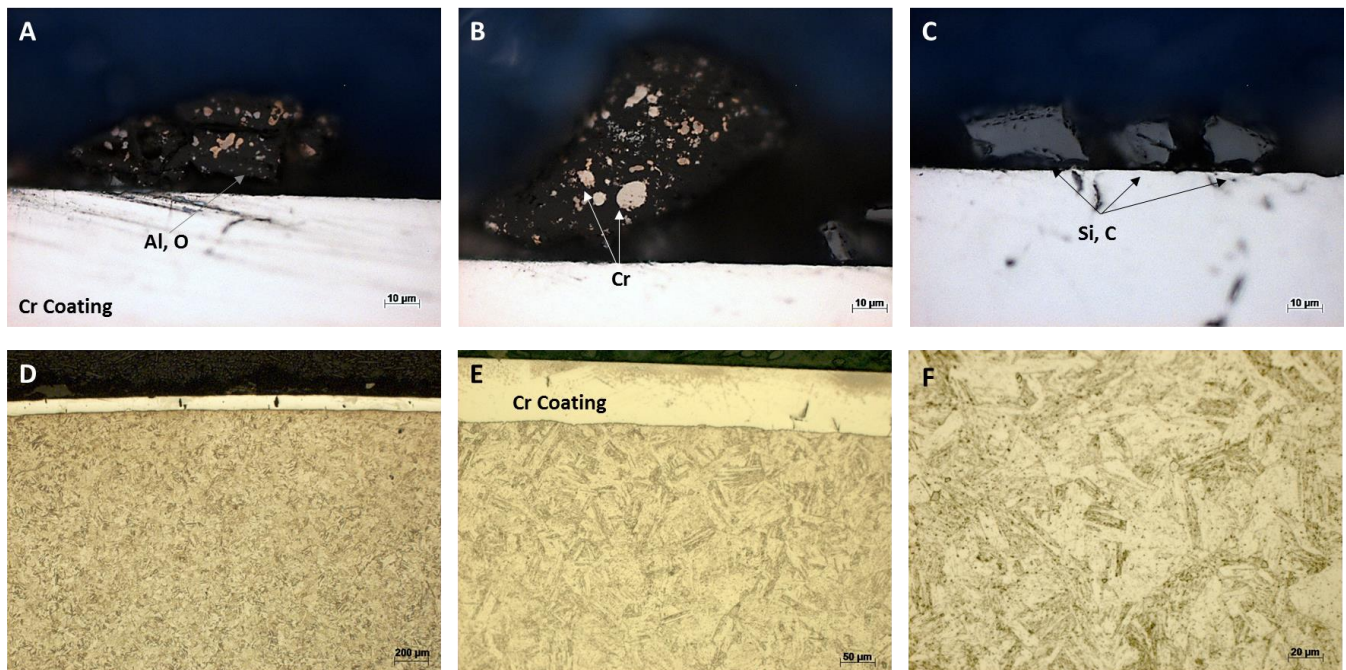
The same three samples that were used for surface and cross-sectional analysis were used for optical microscopy. Figure 4.60 shows optical micrographs of the deposits of sample A3.1 as well as the microstructure of the 17-4 PH stainless steel in Area 3. While examining sample A3.1, only small discontinuous deposits were observed and seemed to have oxidize very quickly due to the dark color of

the deposits. Embedded in this Al deposits were shiny metallic copper colored deposits. EDS showed that these deposits were rich in Al and Cr only and no Cu was found in this sample, which leads to these metallic particles being Cr (Figure 4.60 A and B). Chromium could be coming from the coating in the nearby eroded area since the Cr coating in Area 3 was intact. Along with these deposits, shown in Figure 4.60 C, Si particles with high concentrations of C were seen deposited on the chromium coating surface but was probable that some of these particle adhered to the sample during metallography and did not detached during the ultrasonic cleaning done afterwards. The microstructures of Area 3 seen in Figure 4.60 D through F showed the same martensitic microstructure as the control seen in Area 2 with not damage to the coating or the undelaying base material due to high temperatures.

Figure 4.60 (A-C) Optical micrographs of sample A3.1 on Area 3 showing oxidized deposits with metallic particles. Magnification for images (A-C) is 1000X. (D-F) Microstructure as seen in Area 3 with an unaffected chromium layer and martensitic structure. Magnification of (D) is 50X, for (E) magnification is 200X, and for (F) is 500X.

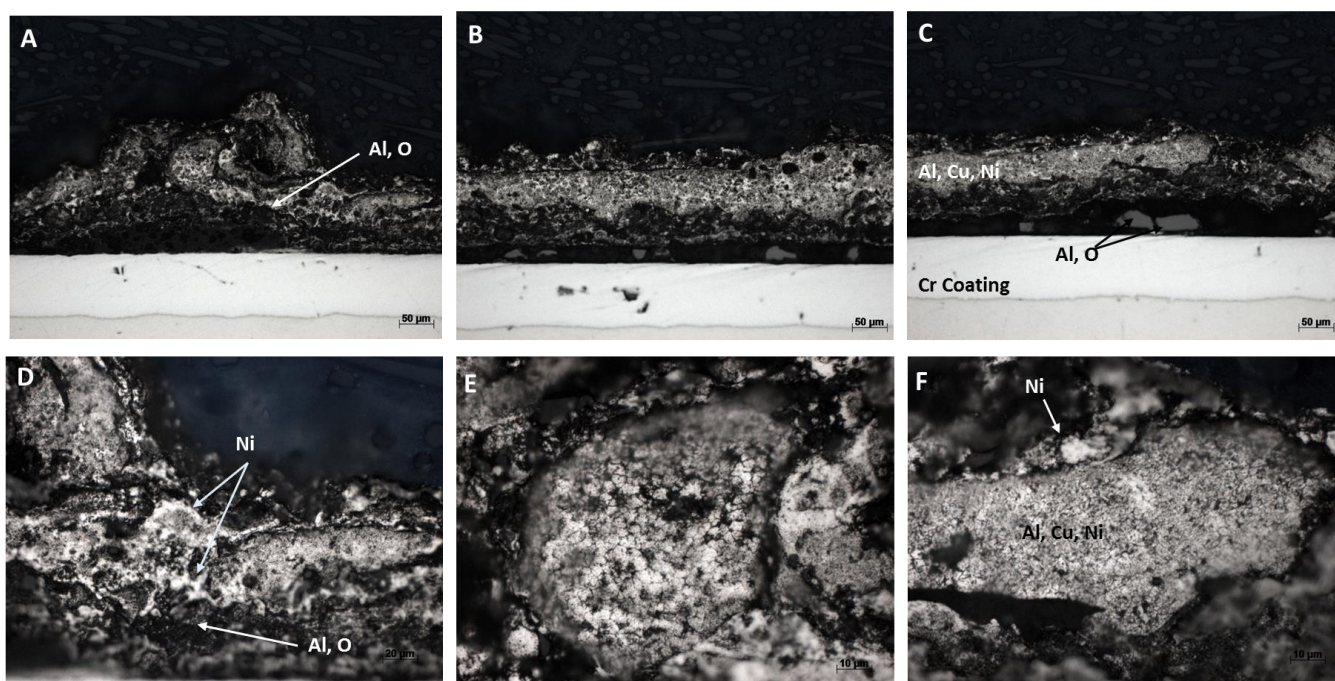
In sample A3.2, the presence of the a darker colored layer at the bottom surface of the deposits and cavity at the surface of the base metal that was seen on Area 1 were detected on the deposits for this sample and can be seen in Figure 4.61 A through C. In the Al and O enriched layer, a lot of porosity was seen and particles laying on the top surface of the chromium coating that were seen in sample A3.1 were

also present but differ in composition with the majority of these particles being Al and O. Cracking was particularly seen in the top layer of the deposits and helped define a flow pattern in some areas of the deposits (Figure 4.61). The top layer which can be seen in Figure 4.61 D through F at higher magnification show how thin, narrow streams of Ni deposits were found mixed with the matrix of the deposits, which was composed of Al and Cu or were also seen as small embedded islands. When looking at the metal matrix of the deposit, a webbed texture was observed with porosity throughout this top layer and is shown in Figure 4.61 E and F.

Figure 4.61 (A-C) Optical micrographs of sample A3.2 on Area 3 showing oxidized deposits with metallic particles close to the surface of the base metal. Magnification of (A-C) is 200X. (D-F) Higher magnification of deposits where embedded nickel deposits can be seen and the morphology that the metal matrix of the deposits took as it solidified. Magnification for (D) it is at 500X, and for (E-F) it is 1000X.

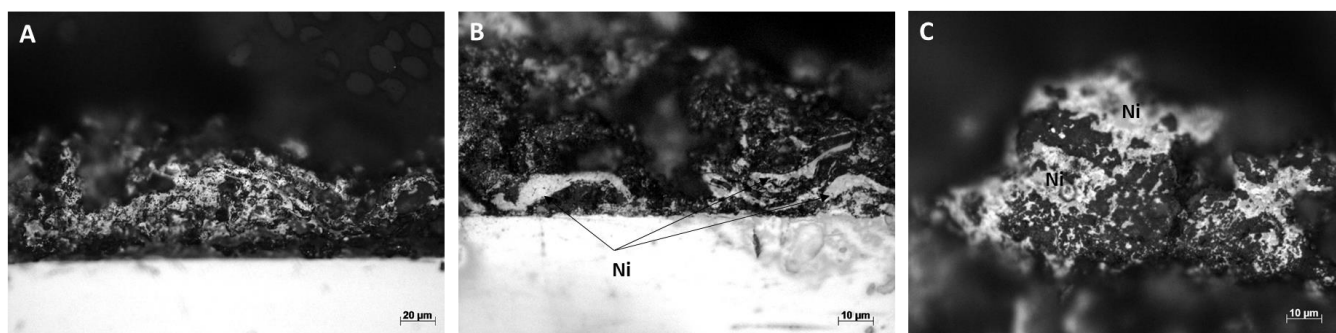
Sample A3.3 had the same features as sample A3.2 which was expected since they were coming from the same area and texture did not appear to change. On difference that was noticed in sample A3.3 was that there were a lot more cavities found in this area, which made it difficult to focus on deposits. Once again, Ni deposits were found mixing with the matrix (Figure 4.62 A to C). In Figure 4.62 B, Ni deposits were found in the bottom of the deposits in large quantities and appeared to have a discontinuous flow pattern as well. In other areas, large islands of both Al and Ni deposits, which did not mix as much

as deposits in the lower layers of the sample where turbulence was more aggressive were observed (Figure 4.63 C). Area 3, which made up the area where spray-like deposits were found on the elevon actuator shaft was analyzed for thermal damage and was confirmed that not alterations occurred to the chromium coating and the base material.

Figure 4.62 (A-C) Optical micrographs of sample A3.3 on Area 3 showing oxidized deposits with Ni deposits embedded between the Al and O concentrated deposits. Magnification of (A-C) is 500X.

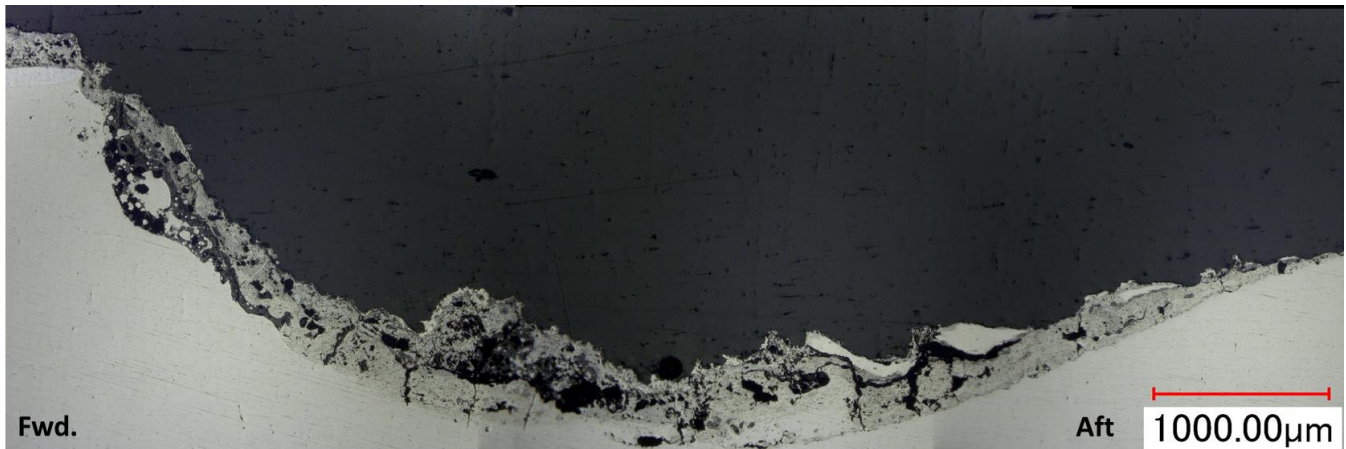
Figure 4.64 shows a magnified micrograph of the profile view of sample A4.2 taken with the Keyence digital microscope at a magnification of 300X. As seen in Figure 4.64, the loss of shaft material was significant and unlike sample A4.2, no chromium coating could be seen along the walls of the eroded area. Only a small portion of the Cr coating can be appreciated on Figure 4.64 in the forward direction where the beginning of localized melting occurred. Cracking in varies places throughout the deposit's

length can be seen as well as embedded light and dark deposits in the matrix. In this sample, depth of loss of material was almost double that of sample A4.1, with this area approximately 2 millimeters in depth.

Figure 4.64 Profile view of sample A4.2 of Area 4 taken with the Keyence microscope showing different features found in the deposits.
