Materials Characterization of Deposits on Starboard (Inboard) Elevon Actuator Shaft Recovered from Space Shuttle Columbia

MATERIALS CHARACTERIZATION OF DEPOSITS ON STARBOARD
(INBOARD) ELEVON ACTUATOR SHAFT RECOVERED FROM SPACE
SHUTTLE *COLUMBIA*

DISSERTATION

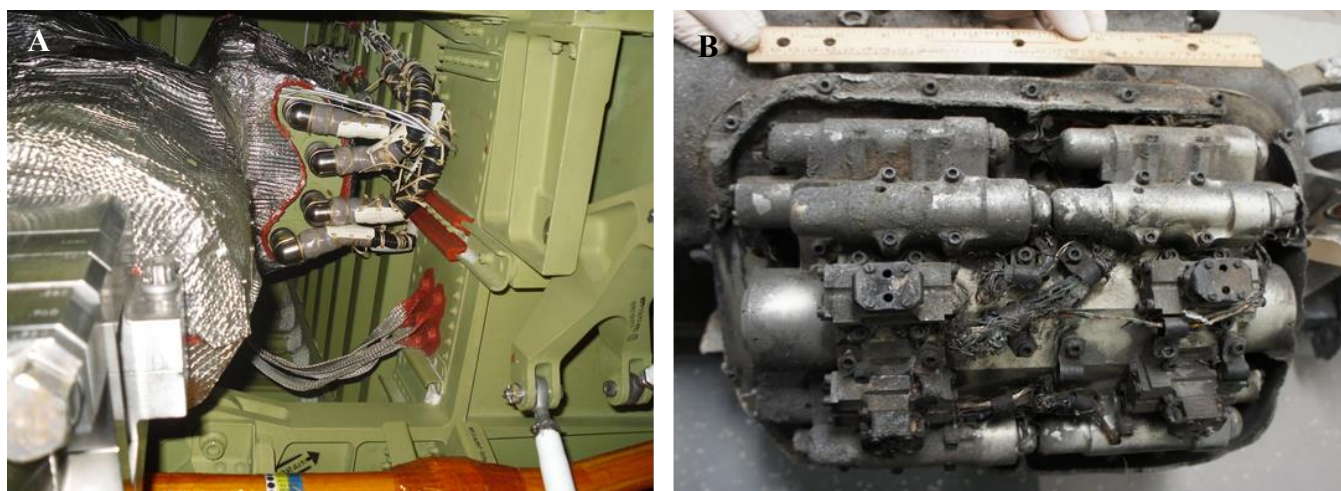
XRF analysis in these two areas revealed to have about 6 wt. % Cu present in the deposits, which is not a large amount of Cu but increased to around 40 wt. % when EDS analysis was conducted in these two areas. The finding of Cu in Area 1 and 2 in such large quantities by EDS and identifying phases such as Al_4Cu_9 and CuO by XRD was not expected. While examining the elevon actuator debris and looking at some of the damages in the surrounding areas of the debris, the electrical junction box attached to the hydraulic system, which had damages of melted and burnt components was possible source of Cu since a lot of wiring was located in this area. With Cu having a melting temperature of 1085°C (1984°F) and being the lowest melting temperature known of surrounding materials besides Al, the source of the Cu deposits was coming from surrounding wiring on the electrical junction box of the hydraulic system (Figure 5.1).

Figure 5.1 A) Side view of electrical junction box of hydraulic system from Space Shuttle *Endeavor*. B) Front view of electrical junction box of hydraulic system from Space Shuttle *Columbia* debris showing damages of wiring and other components.

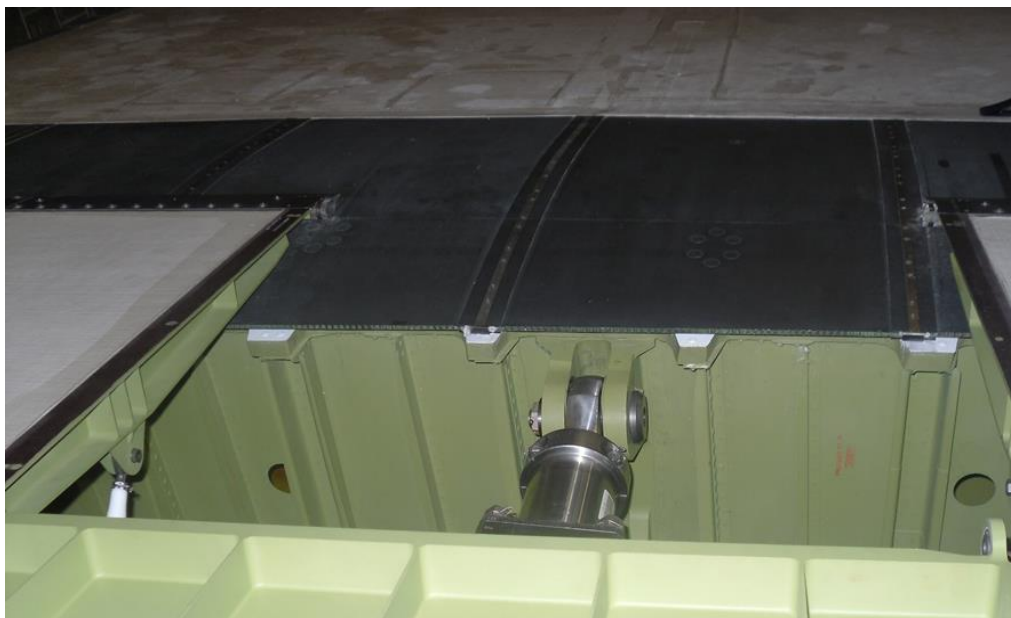
Area 3 was distinct from other areas when looking at the surface texture of the deposits. Sample A3.2 did not have many continuous deposits and streaks were mostly analyzed. The metallic streaks and smaller splat deposits found in this sample were coming from Ti and Fe components. The Ti streaks that were seen in the deposits which had a directionality of forward to port, were most likely coming from the

Ti panels which provide a closeout of the wing-to-elevon cavity and would be located behind the elevon actuator shaft. (Figure 5.2). Melting or possible combustion of this Ti panels occurred and deposited in to the shaft in a forward to port direction, which is what is expected if the shuttle was flying from forward to aft since the location of the sample was on the side in a 3 o'clock position. Other small deposits found in the area were mostly composed of 60 wt. % Fe and around 15 wt. % Cr, which was possible these deposits were coming from the eroded area of the shaft since they were found in multiple directions and were only seen in a small area in the aft-starboard direction in close proximity to Area 4. For sample A3.2, Ti splats were found deposited on to of a thin layer of deposit and showed signs of cracking or had already cracked and detached from the base metal. This cracking was due to the fact that these thin Ti splats oxidized and became very brittle. For thicker layers of Ti that completely cracked, impact with other components during the break-up or while transferring debris from recovered location to Kennedy Space center could have been the reason why these splats suffered from spallation. The fact that Ti splats were found at the top surfaces of Areas 3 and 4 indicated that the deposits found on the shaft had a lower melting temperature than Ti and had time to solidify before Ti got deposited onto these deposits.

Figure 5.2 Titanium honeycomb sandwich construction panels from Space Shuttle *Endeavor*.

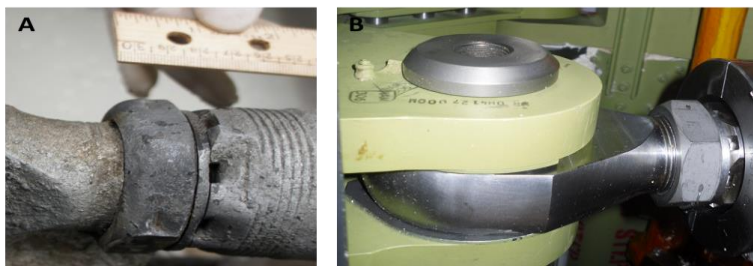
The thinner layer of deposits found in this area had a spray-like texture which make the thin Al deposits readily oxidizable because of the larger surface area of the small particles. This layer being mostly Al with large quantities of O and exposed due to the chipping of deposits in Area 3, meant that Al in this location of the shaft which was midway from the total length of the shaft, was deposited first. In the thicker layer of deposit that chipped off due to impact, to unveil the thin layer, Al, Fe, and Cu were the main compounds that were found in the samples, which differ from Areas 1 and 2 where not much Fe was present. The matrix of these heavy deposits were mostly Al and Cu oxides as detected by XRD. These results also coincide with XRF results showing some concentrations of Cu in Area 3 which were conducted at the beginning of the study. Only about 12 wt. % Cu was present in the deposit, which is reasonable if these Cu deposits were coming from surrounding wiring as well as small concentrations that were present in the alloying metals around the area such as Al 2024 and 2219 and Type 304 stainless steel, which made parts of the hydraulic system and locking nut and clevis pin. The locking nut and clevis showed signs of erosion, which can be seen in Figure 5.3 A when compared to how it should look, which is shown in Figure 5.3 B. Due to the melting of the locking nut and clevis pin, temperatures around this point in the event where surpassing 1455°C (2650°F) since this is the melting temperature for Type 304 stainless steel. Image B from Figure 5.3 B is coming from the retired Space Shuttle *Endeavor* which is on display in the California Science Center. Splats with large concentration of Fe and smaller amount of Cr were seen at the surface deposits of Area 3 as well and with about 75 wt. % Fe and 18 wt. % Cr, the source of these deposits were from Type 304 stainless steel components, most likely the locking nut and clevis pin.

Figure 5.3 A) Locking nut and a portion of clevis from the Space Shuttle *Columbia* debris showing erosion in the locking nut. B) Locking nut and clevis pin from Space Shuttle *Endeavor* without any damages.

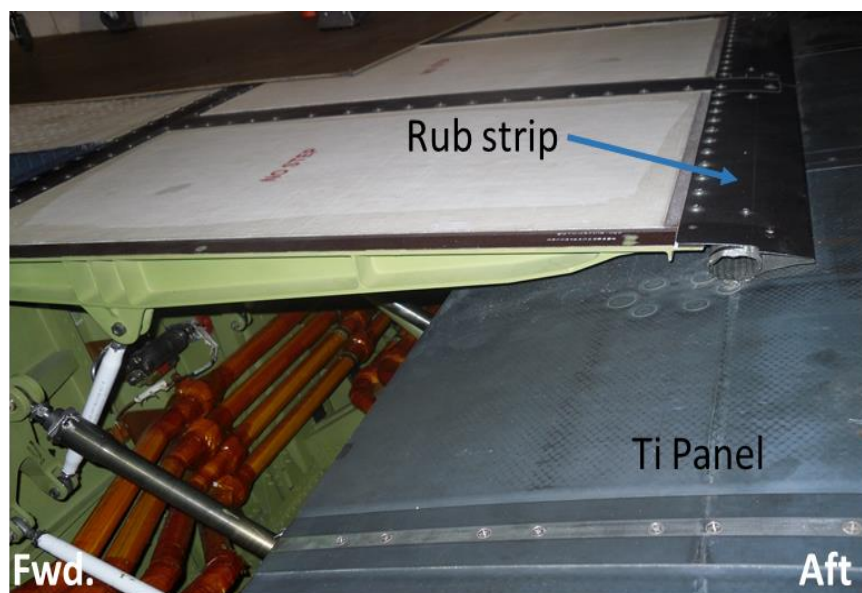
For Area 4 only a few similarities on surface topography were comparable to those of Area 3. As seen in Area 3, Ti splats were still visible in Area 4. These Ti splat were mostly likely coming from rub strips and panels, which were located behind the shaft and can be seen in Figure 5.4. Another similar feature that Area 4 exhibited like Area 3 was the texture in some areas of the deposits where for the most part, chunky deposits had a rough but uniform surfaces. This chunks of molten metal that cluster together indicated that at the time of deposition, the debris was solidus enough that it adhered to other debris that were also accumulating in the area. The continuous uniform surface also indicated that the rate of deposition was constant. Even though different textures in Area 4 were seen, the deposits were mostly composed of different combinations of Al, Fe, and Ni compounds. EDS results showed approximately 60 wt. % Al present in the deposits with around 12 wt. % Ni and 6 wt. % Cu, Fe, and Cr, each. The main matrix of this deposits was then coming from the Al airframe. In Area 4, there were also Ni splats, which helped increase the Ni composition found in this area. These Ni splats, which were identified to contain about 40 wt. % Ni, and about 13 wt. % of Cr and Fe, each, indicated that it was coming from Inconel 718 components, which were most likely the Inconel struts found on the sides of the shaft as seen in Figure 5.5 and panels which were on the outboard of the wing.

Figure 5.4 Titanium rub strip and elevon panel on the port side of Endeavor's wing.

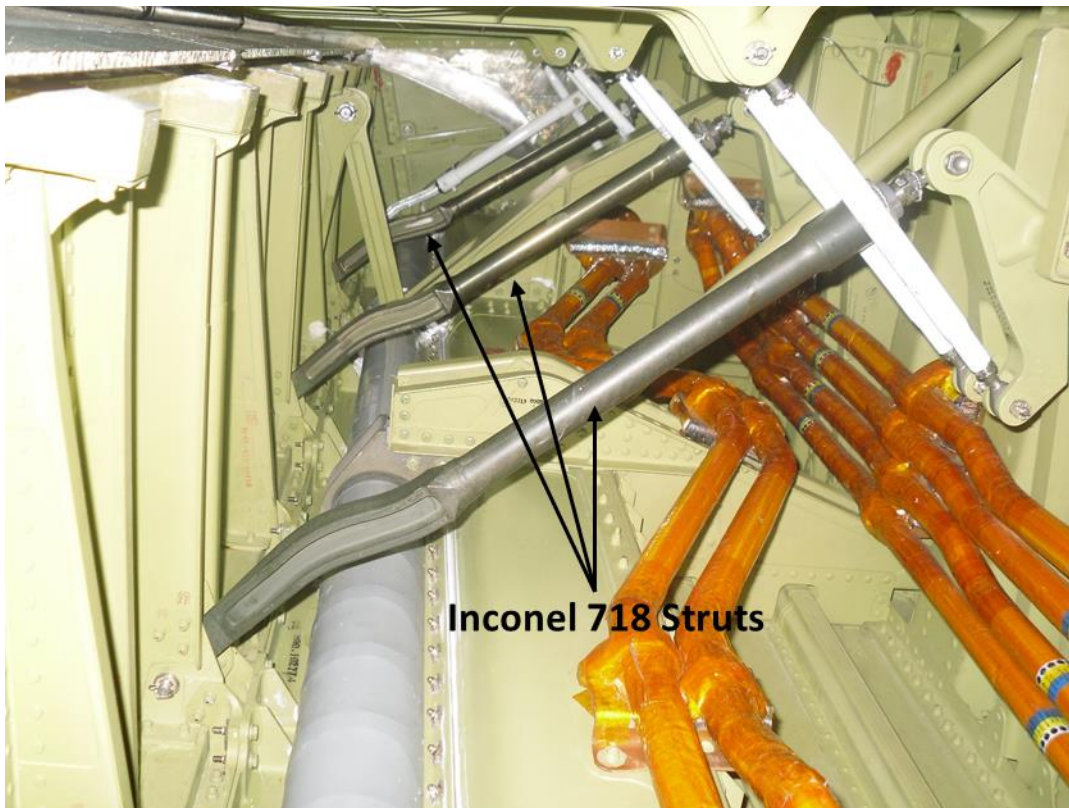
Figure 5.5 Inconel 718 struts on the *Endeavor's* wing/elevon interface.

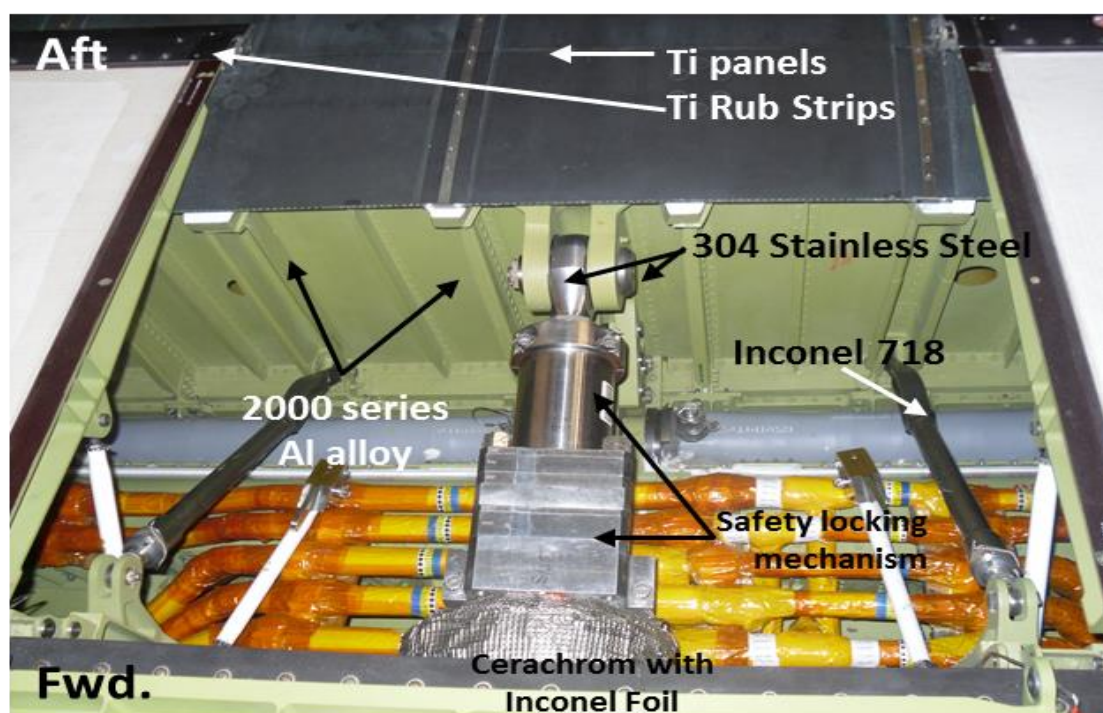
Figure 5.6 Surrounding components and material systems of the elevon actuator shaft of *Endeavor* which has the same construction as *Columbia*. Note actuator shaft is being covered by a safety locking mechanism which comes off during use of the Space Shuttle.

and Ti-6Al-4V along with copper wiring. The components where these material systems were found and their proximity to the elevon actuator shaft is shown in Figure 5.6. In Figure 5. 6, the Inconel struts can be seen as well as the Type 304 stainless steel locking nut and clevis pin. Shown in Figure 5.6, is the Ti-6Al-4V rub strips and the aluminum honeycomb skin. From the information obtained from these studies, the surrounding regions saw temperatures that ranged from 638°C (1180°F) to above 1660°C (3020°F) since deposits ranging from Al to Ti were seen deposited onto the shaft.

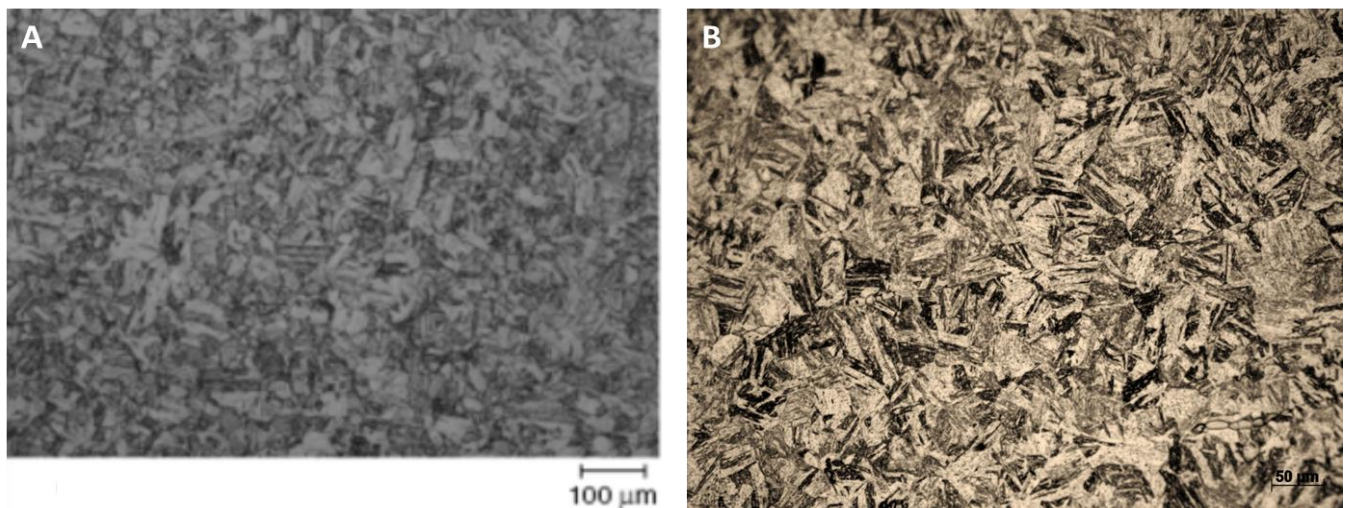
of a H925 condition for a 17-4 PH stainless steel (Figure 5.7 A). The microstructure in Figure 5.7 B had a mixture of plate and lath martensite with several delta-ferrite stringers present and was coming from Area 2. These delta-ferrite stringers were shown in the micrograph at the lower right hand corner and were not present in the H925 condition image shown in Figure 5.7 A but, can be found in the microstructure with this heat treatment. Retained austenite was also present which is shown as the light-colored islands in the microstructure whereas martensite was depicted in a darker shade. At higher magnifications of the microstructures, copper precipitates were seen all through the microstructure. Not shown in Figure 5.7 B was the chromium coating, approximately 103 μm in thickness, which coats the base material. Due to the high temperatures that were sustained at the surface of the shaft on Area 4, the protective chromium layer was completely eroded in two of the samples and exhibited degradation in one of the samples. A typical microstructure for a 17- 4 PH stainless steel H925 condition will show a martensitic microstructure with minimal fine copper precipitates, delta-ferrite stringers, and retained austenite as shown in Figure 5.7 A [13]. With features closely resembling those of the unaffected microstructure belonging to the elevon actuator shaft, it was very likely the stainless steel went through a H925 heat treatment. In a H925 heat treatment, the steel is solution treated at 1038°C (1900°F), air cooled, aged at 496°C (925°F), and air cooled once again [44].

Figure 5.7 A) General microstructure of 17-4 PH stainless steel in a H925 condition showing a martensitic structure [13]. B) Martensitic structure of the shaft's base metal, 17-4 PH stainless steel with no thermal alterations. Magnification at 200X.

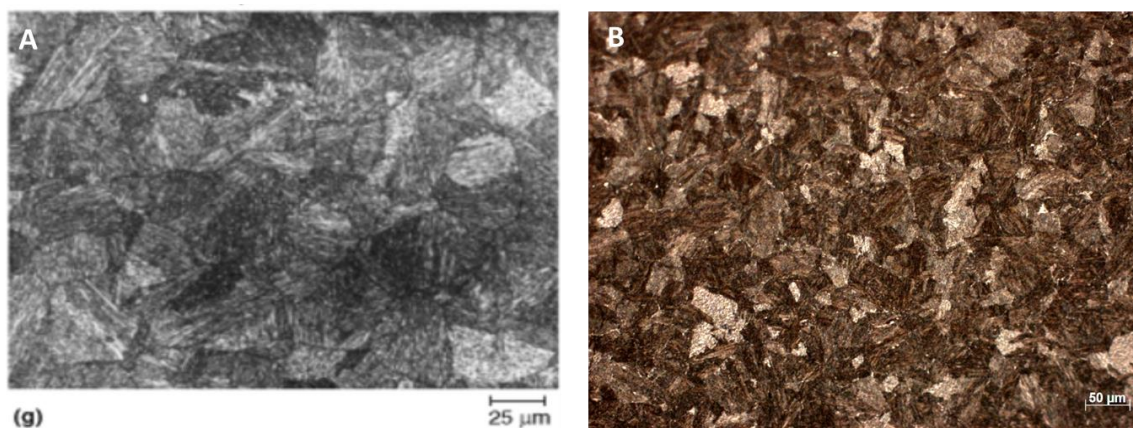
As the formation of tempered martensite started to dominate the region, less delta ferrite at the boundaries was observed. When taking a look at aging conditions performed on a 17-4 PH stainless steel, an H1150 temper was comparable to what was seen in Area 4 micrographs. An H1150 heat treatment will have martensite and retained austenite. Having a microstructure similar to that of an H1150 age treatment suggests that at this midsection of the sample, temperatures reached around 621°C (1150°F). The heat treatment to obtain an H1150 condition on the 17-4 PH stainless steel consists of the material experiencing temperatures around 621°C (1150°F) before it is air cooled which suggests this area of the shaft also experienced this temperature since similarities in microstructure were found [44]. Tempering the martensite will allow the trapped carbon to be released and in turn reduces the hardness and strength of the base material which is probable that this area of the shaft experienced this changes as well [48]. Figure 5.8 A shows the general microstructure that is expected from an H1150 age treatment and Figure 5.8 B shows a micrograph from sample A4.2 in Area 4 which has a similar microstructure to that of the H1150 condition found on a 17-4 PH stainless steel.

Figure 5.8 A) General microstructure of 17-4 PH stainless steel in a H1150 condition showing martensite and reversed austenite [13]. B) Microstructure of sample A4.2 from Area 4 showing similarities to that of an H1150 condition. Magnification at 200X.

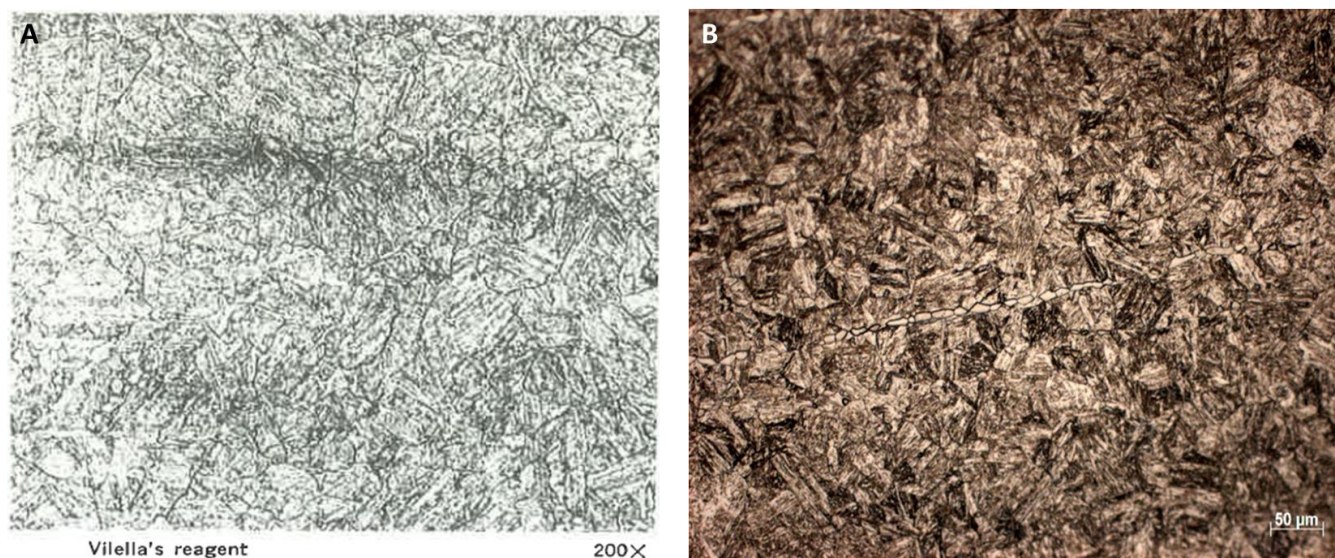
Since there was a rapid decrease in temperatures from 1220°C (2228°F) to 621°C (1150°F), rapid cooling occurred and the higher temperatures were not sustained for long periods of time. Toward the bulk material, lath martensite microstructure was seen just below the tempered martensite. The martensite now appeared to have a lath morphology which is due to the lower carbon content this material contains. Banding in this area was also present and occurs when alloying elements segregate during solidification and appear as darker sections or bands on the martensitic matrix [49]. This microstructure is typical of a H1075 temper for a 17-4 PH stainless steel and approximates the temperatures of this area to be around 580°C (1075°F) since comparable microstructures were seen in Area4. The typical microstructure of an H1075 condition as well as a similar microstructure belong to Area 4 of the 17-4 PH stainless steel shaft are shown in Figure 5.9. At this depth, less heat was being transferred to this region and microstructural alterations were less noticeable as the unaffected microstructure was reached.

Figure 5.9 A) Typical microstructure of 17-4 PH stainless steel in a H1075 condition showing martensitic microstructure with banding [45]. B) Last microstructural change seen on Area 4 showing martensite along with banding. Magnification at 200X.
