Microstructural Investigation Of Vintage Pipeline Steels Highly Susceptible To Stress Corrosion Cracking

DISSERTATION

Metallurgical and Materials Engineering
THE UNIVERSITY OF TEXAS AT EL PASO

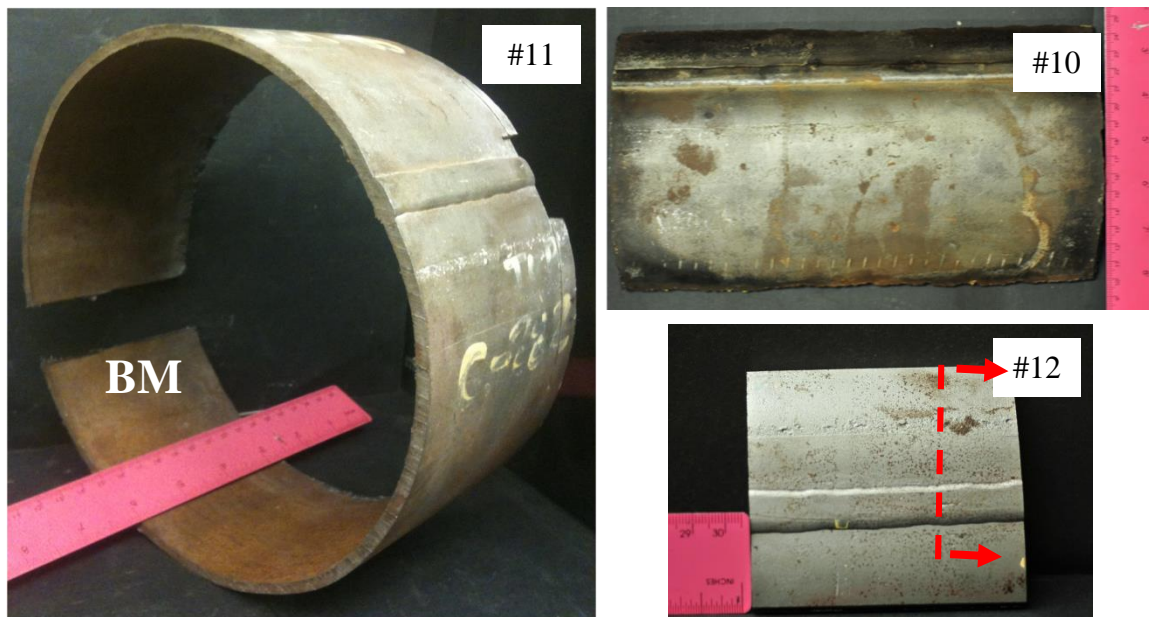
Figure 8. As-received sections from pipeline #1.

The pipeline #1 (Figure 8) was constructed to API Spec 5L requirements by Cal-Met in 1949; it was not hydrostatically tested during installation. This single submerged arc welded pipe was built from grade A steel, with a 220 mm (8 5/8") O.D., a nominal wall thickness of 4.5 mm (0.180"), and a specified minimum yield strength (SMYS) of 208MPa (30,000 psi). Pipe was coated with coal-tar enamel, and impressed-current cathodic protection (CP) was applied. In 1991, multiple cracks were found in different sections of the pipeline, the maximum crack length measured 43 mm (1.7") and the maximum crack depth was thru-wall. Analysis of the soil in this region revealed a pH of 9. For purposes of this research this pipeline was identified as pipeline #1, Figure 8 presents the as-received sections of this pipeline and Table 7 summarizes the pipeline attributes and operating conditions.

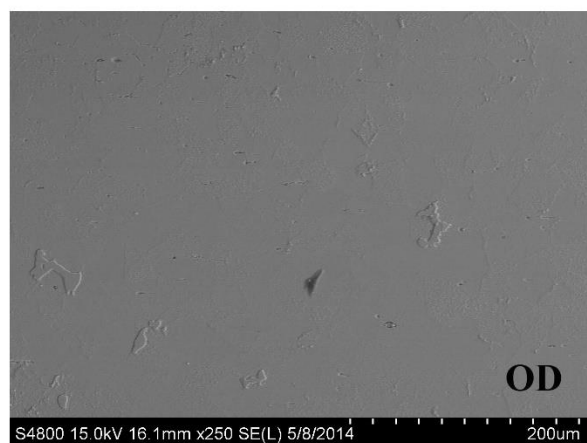
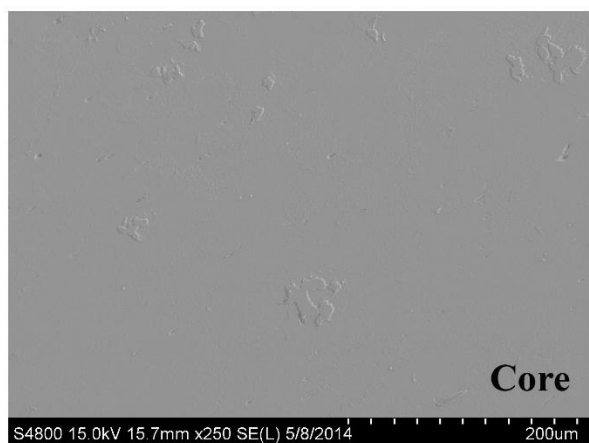
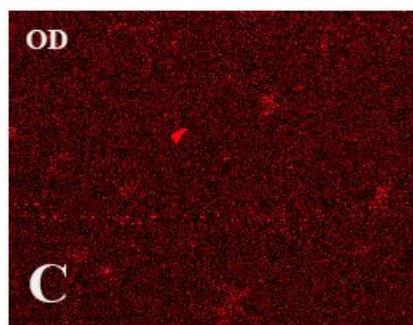
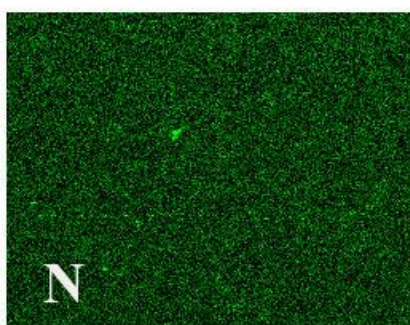
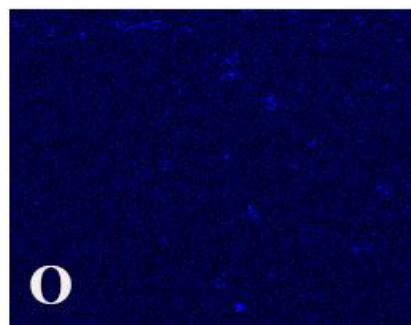
Figure 16. Elemental mapping from a region near the OD (left) and the core (right).

Figure 16 and Figure 17 present the elemental mapping images from two distinct regions—an area adjacent to the OD and from the core region from pipeline #2. Each chemical element is represented by a specific color and the brightness corresponds to its concentration. The OD region exhibited some small carbonitrides aligned along the rolling direction (Figure 16) and less elongated MnS inclusions as compared to the core region (Figure 17). Furthermore, the OD region also exhibited an apparently slightly higher Si, Mn, and S content (Figure 17). Lastly, carbon content appears to be slightly higher near the core region, nevertheless no quantitative analysis was carried-out.

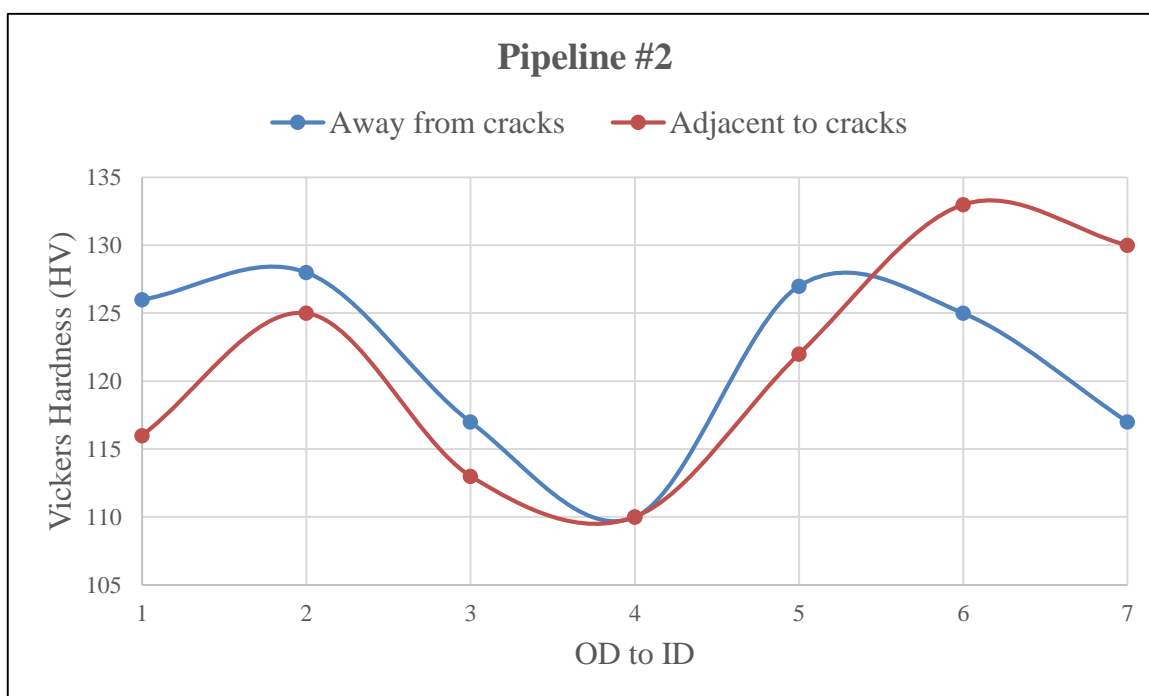
Figure 18. Pipeline #2 microhardness profile.

Figure 18 present the hardness profile from the OD to ID from crack containing and crack free regions from pipeline #2. The hardness profile from SCC and SCC-free zones exhibited a similar pattern with a lower hardness in the core region. Additionally, the region containing SCC cracks exhibited slightly lower values near the OD as compared to the SCC-free zone however, differences were minor. The average Vickers hardness and equivalent HRB and tensile strength for each of the analyzed sections are shown in Table 6.

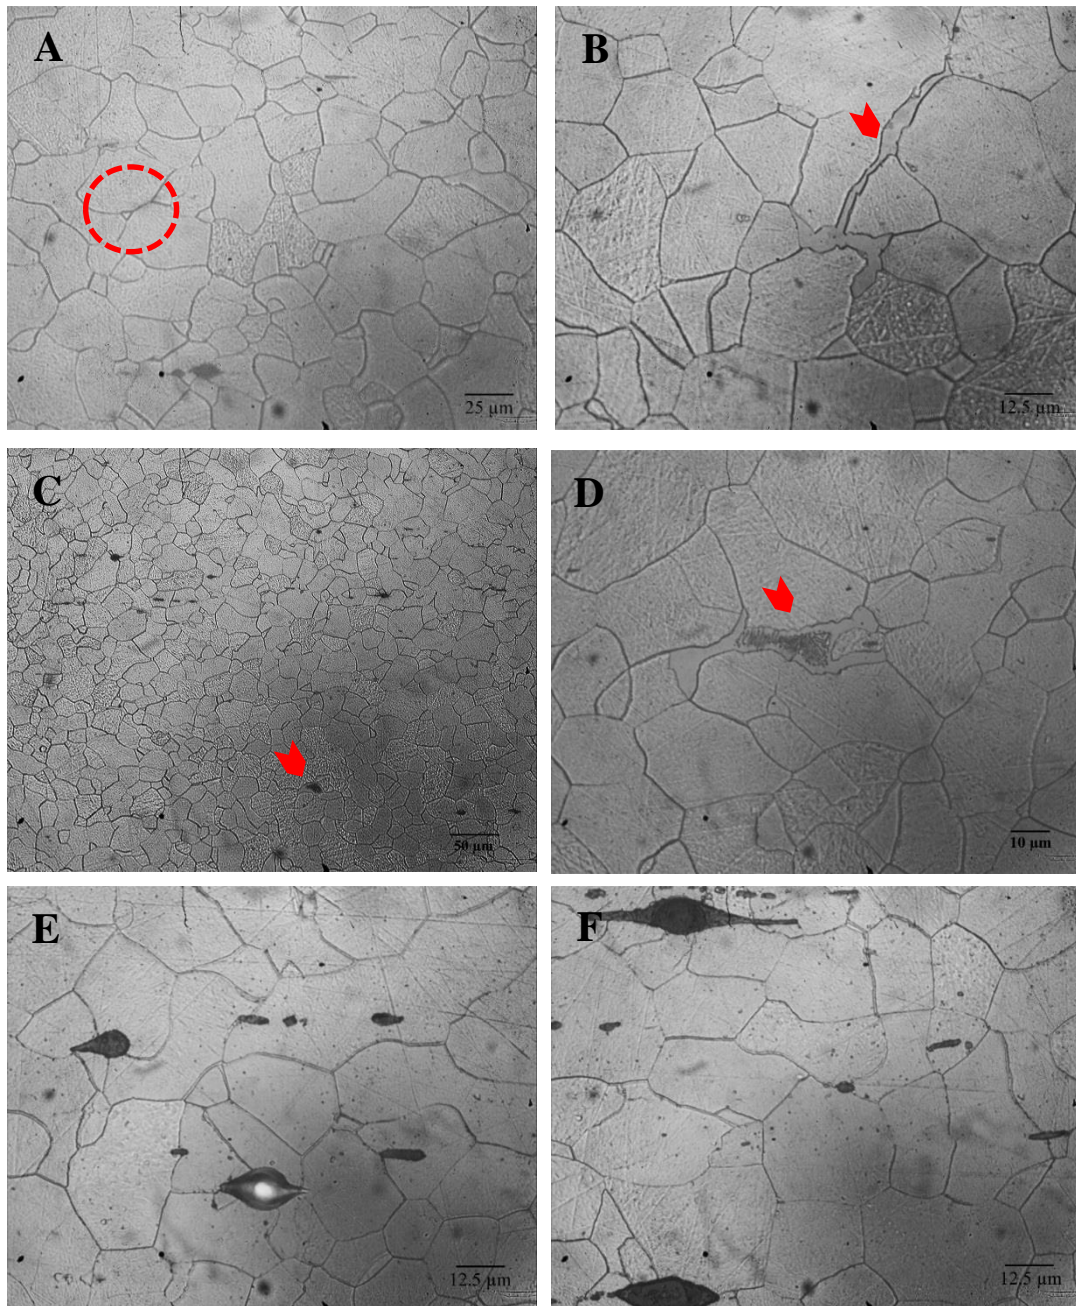
The optical images (Figure 20) taken from pipeline #2 indicate that the primary microstructural constituents are polygonal ferrite (Figure 20A), cementite films at ferritic grain boundaries (Figure 20B), and small and random pearlite colonies—approximately 0.5-1% volume fraction (Figure 20C-D). The edge and centerline regions of this pipeline exhibited a uniform microstructure with no evidence of banding. Furthermore, the grain size was characterized by very fine grains surrounded by larger grains (Figure 20A). The average grain size was 20 μm (ASTM G No. 8) with no significant grain size differences between rim and core were detected. The microstructure also exhibited inclusions of varying sizes (Figure 20E-F) including smaller more globular inclusions; ogee-shaped and elongated manganese sulfides (MnS) with a maximum aspect ratio of 5 (observed in the core region), and disconnected inclusions (Figure 19D).

Figure 20. Light micrographs of the microstructural features of pipeline #2 showing (A) polygonal ferrite with a combination of small and large grains, (B) cementite films at ferritic grain boundary, (C-D) small and random pearlite colonies, and (E-F) elongated manganese sulfides. 2% Nital.

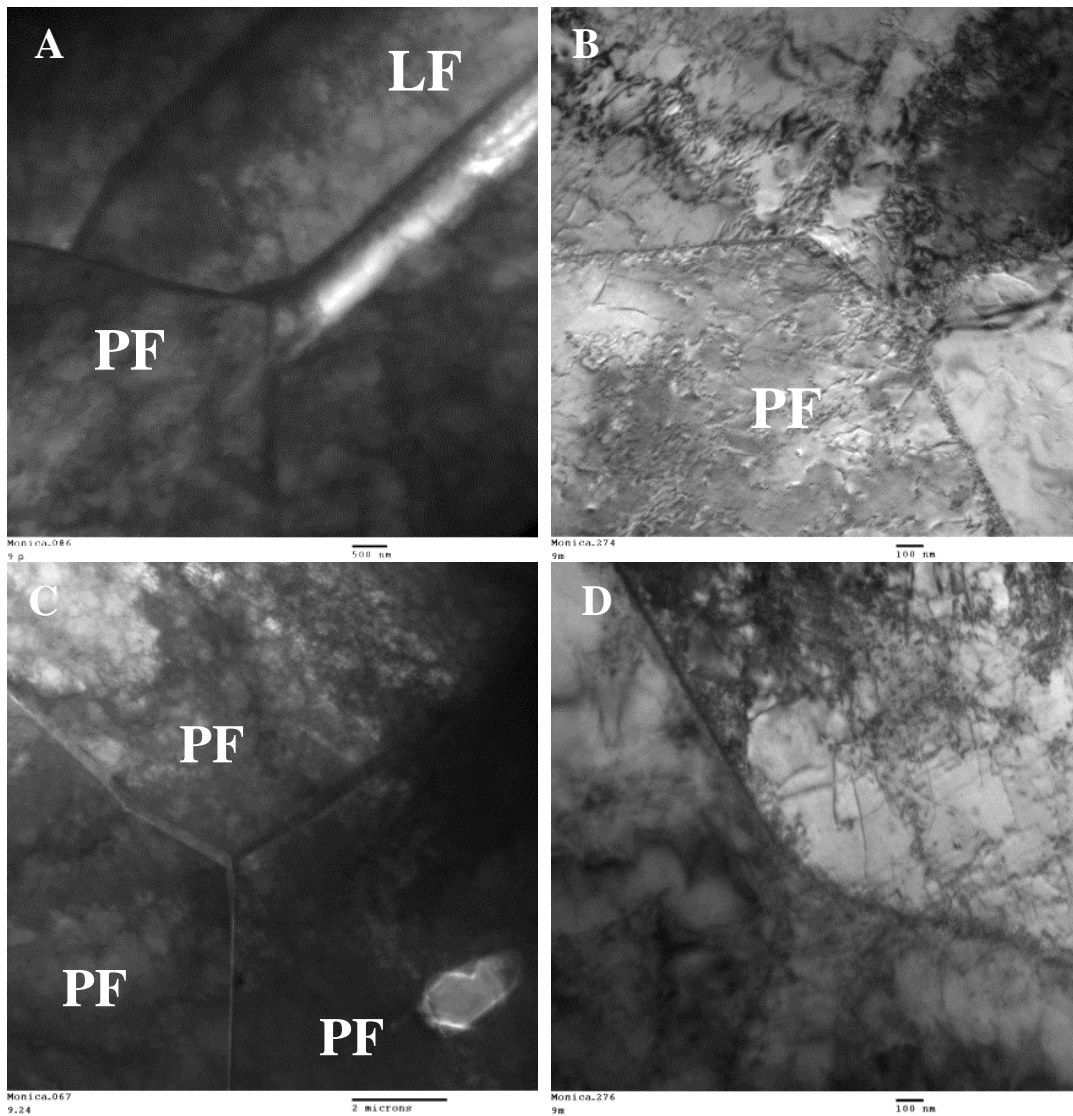
The representative bright field TEM images showing the general microstructure of pipeline #2 is presented in Figure 21. Micrographs exhibit what appears to be large polygonal ferrite (PF) grains with dislocation structures (Figure 21 C-D) and small amounts of lath-shaped ferrite. Additional images from the dislocation structure near the grain boundaries and within the ferritic grains are shown in Figure 22- Figure 23.

Figure 21. Bright field micrographs suggest that the microstructure is predominantly characterized by polygonal ferrite (PF) grains with dislocation structures.

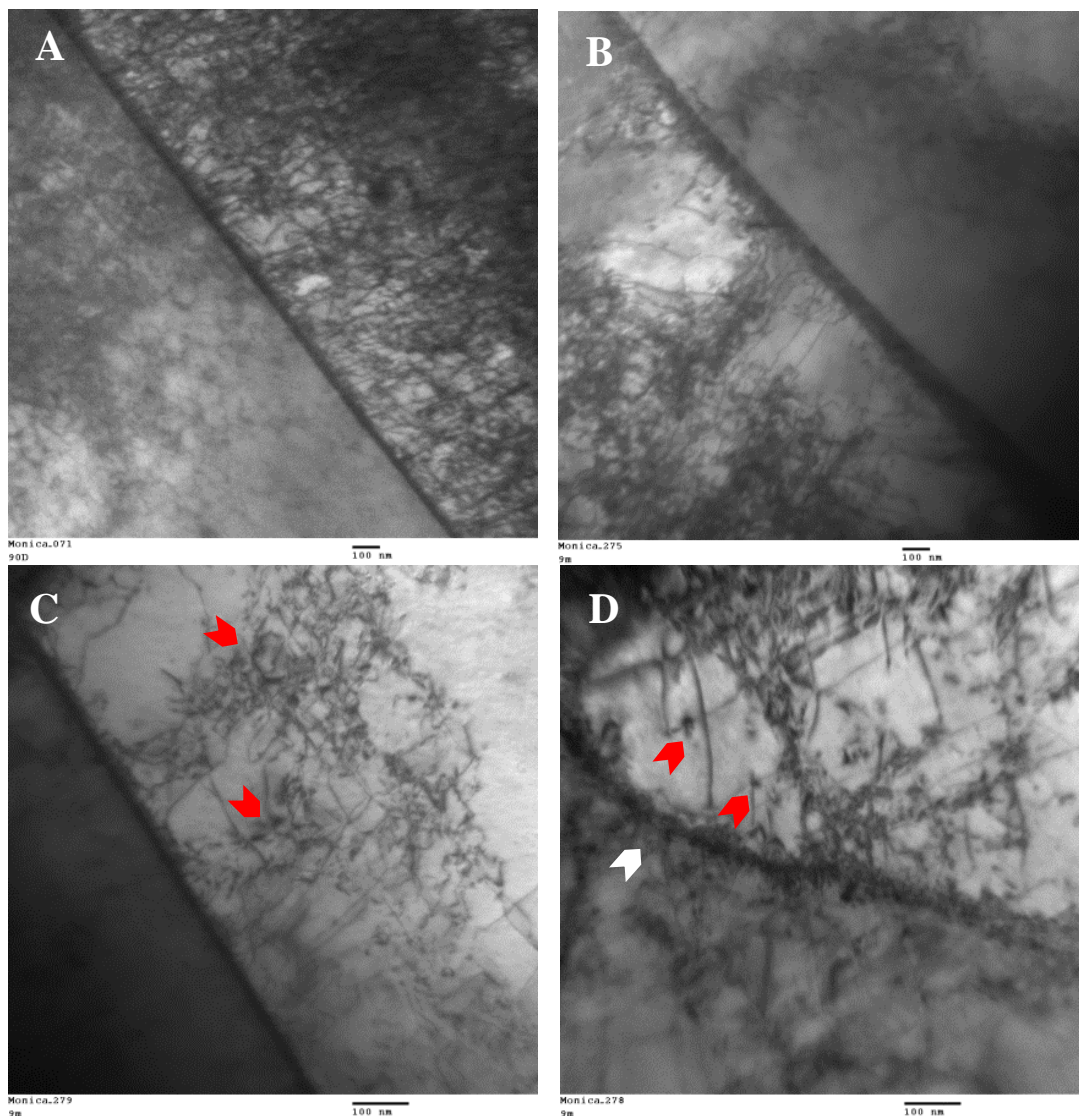
Figure 22 presents TEM micrographs of ferrite grains that contained a significant number of dislocations in the vicinity of the grain boundary and what appears to be fine precipitation on dislocation lines (Figure 22C-D) and on some grain boundaries (Figure 22D). Figure 23 presents high magnification TEM images from dislocation cells within the ferrite grains. Two distinct dislocation cell morphologies were observed; larger dislocation cells with an approximate diameter of $0.70\ \mu\text{m}$ (Figure 23A-B) and smaller cells with heavy walls (Figure 23C-D). Coarse cuboidal-shaped particles ($\sim 0.6\text{-}2\ \mu\text{m}$) were also observed within the ferrite grains (Figure 24).

Figure 22. Transmission electron micrographs of pipeline #2 showing (A-D) dislocation near the grain boundary, (C-D) precipitation on dislocations (red arrow) and (D) on the grain boundary (white arrow).

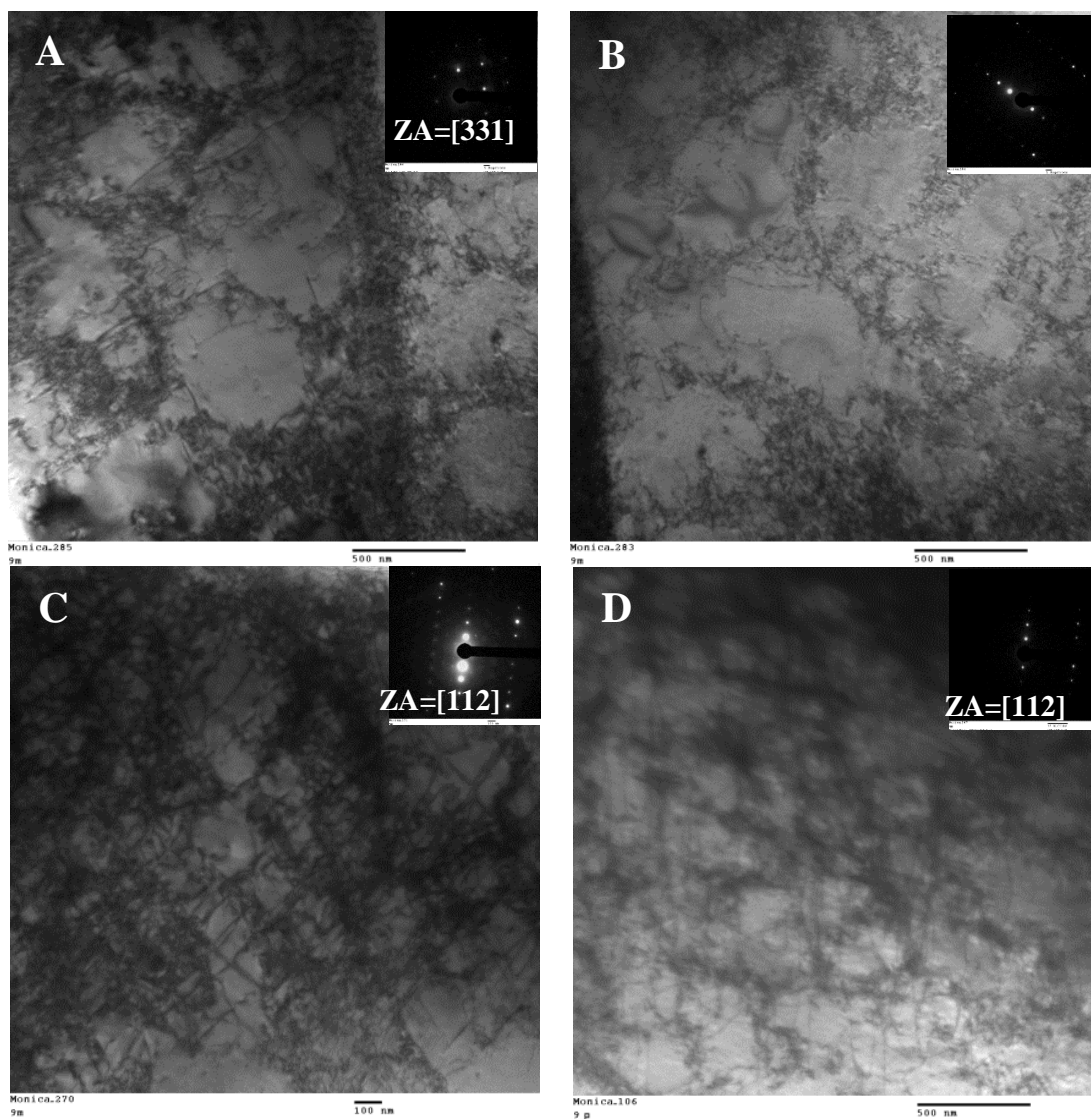
Figure 23. Transmission electron micrographs of pipeline #2 showing (A-B) dislocation cells (C-D) and cells with heavy walls.

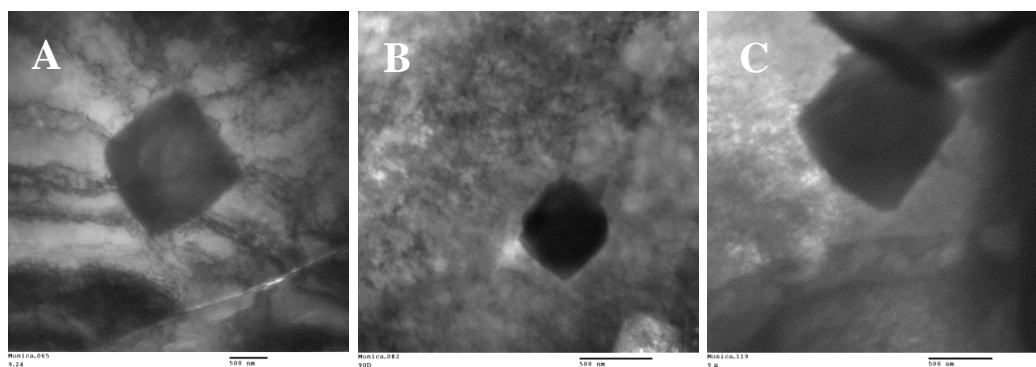
Figure 24. Bright TEM micrographs showing coarse cuboidal-shaped precipitates (A) 2 μ m, (B) 0.62 μ m, and (C) 1.3 μ m within the ferritic grains.

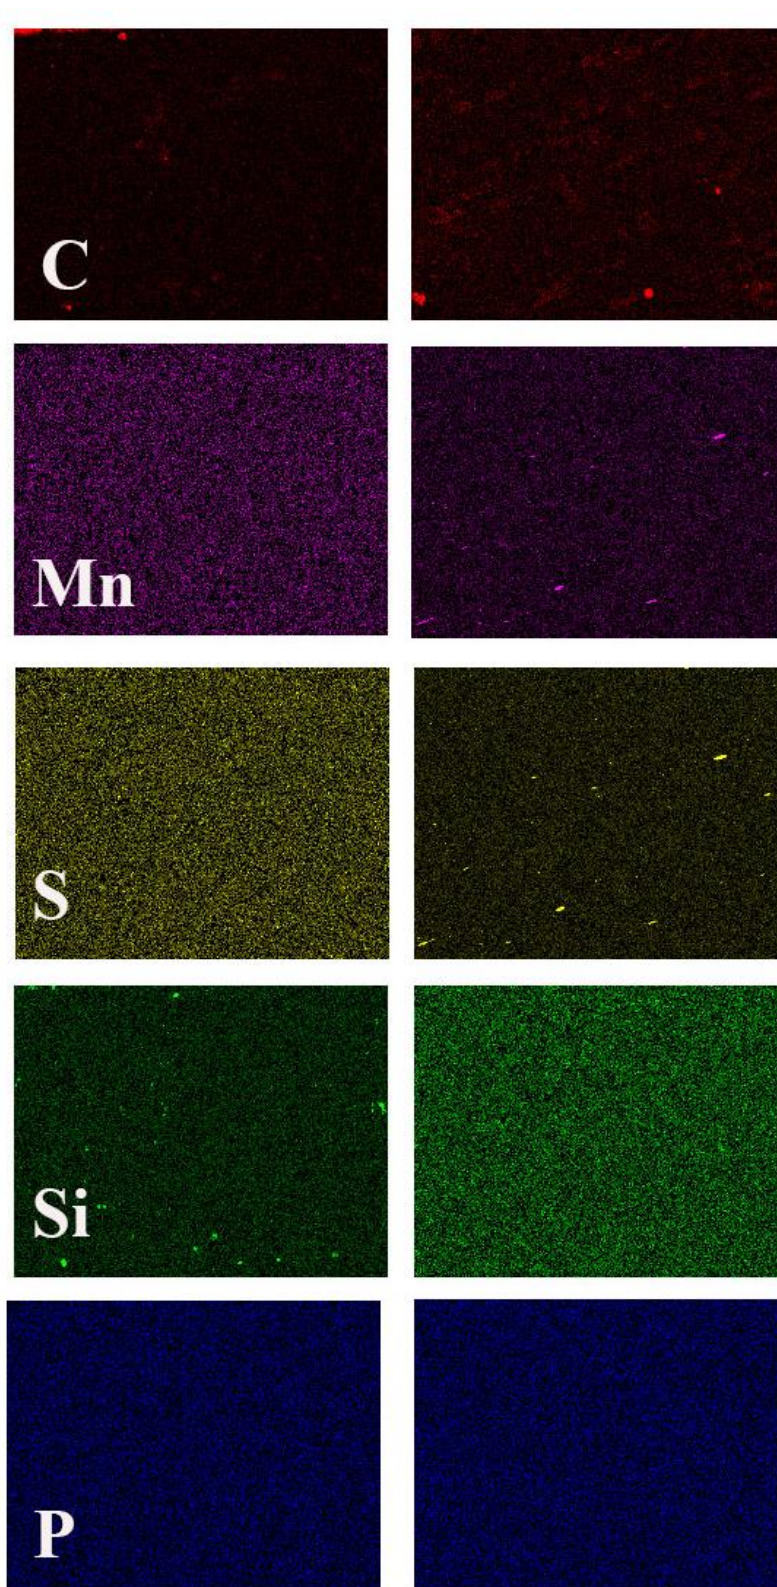
Figure 27. Elemental mapping from a region near the OD (left) and the core (right).

Figure 26 and Figure 27 present the elemental mapping images from two different regions, near the OD (left column) and from the core region (right column). Each chemical element is represented by a specific color and the brightness corresponds to its concentration. Therefore, from Figure 27 it can be seen that the core area exhibits a slightly higher C and Si concentration as compared to the OD, as well as larger MnS non-metallic inclusions. On the other hand the OD was characterized by small particles containing Si and a higher concentrations of Mn and S. No significant differences were observed in the P content.

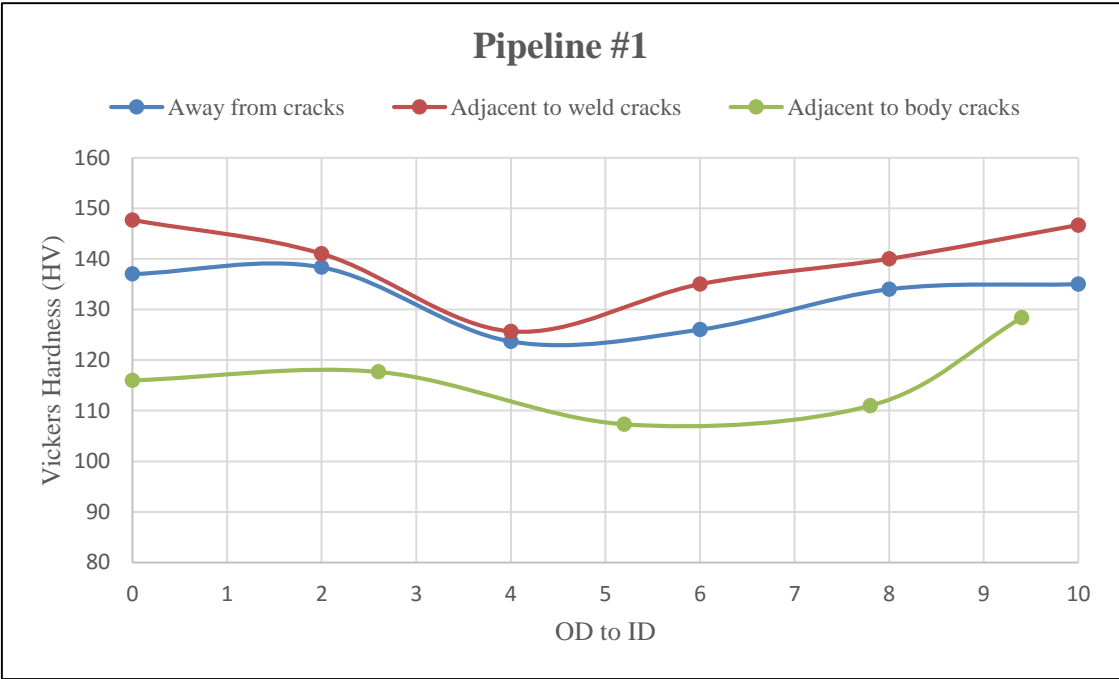
Figure 28. Pipeline #1 microhardness profile.

Figure 28 present the hardness profile from the OD to ID from two crack containing sections— weld region and body of the pipe— and from a crack free zone. Table 9 the average Vickers hardness (HV) and equivalent HRB and tensile strength. Hardness results indicate that while SCC-free region exhibited slightly lower hardness than the weld-SCC zone the region in the body of the pipeline containing SCC cracks exhibited a significantly lower hardness profile. Additionally, all regions displayed a lower hardness in the core zone.

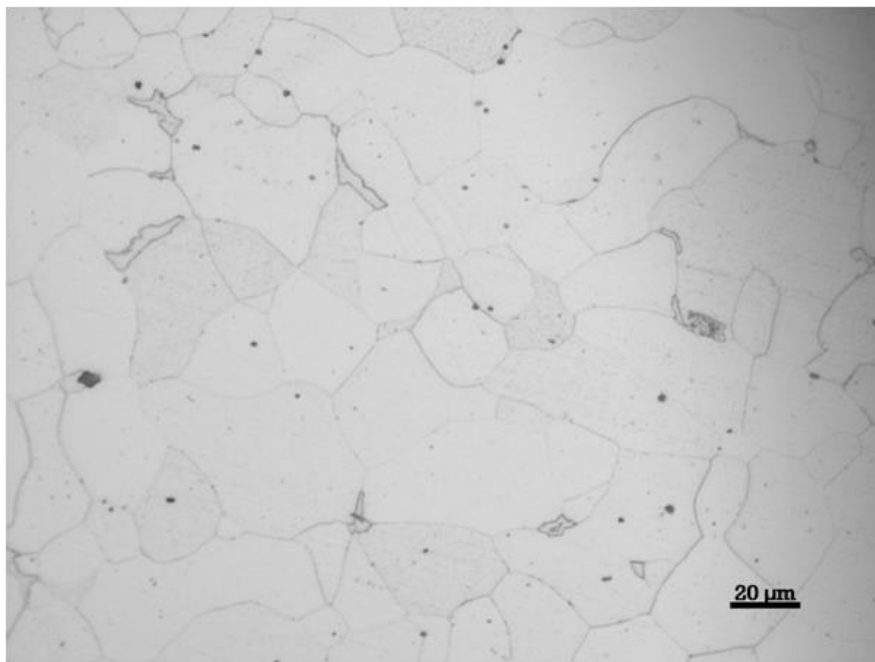
The microstructure of pipeline #1 (Figure 30) exhibits polygonal ferrite grains with small and random colonies of pearlite (dark constituent) and cementite films at ferritic grain boundaries. Randomly distributed inclusions were observed within the ferrite grains and intersecting grain boundaries.

Figure 30. Microstructure of pipeline #1 showing a ferritic grain structure, cementite films, and small pearlite colonies. 2% Nital.

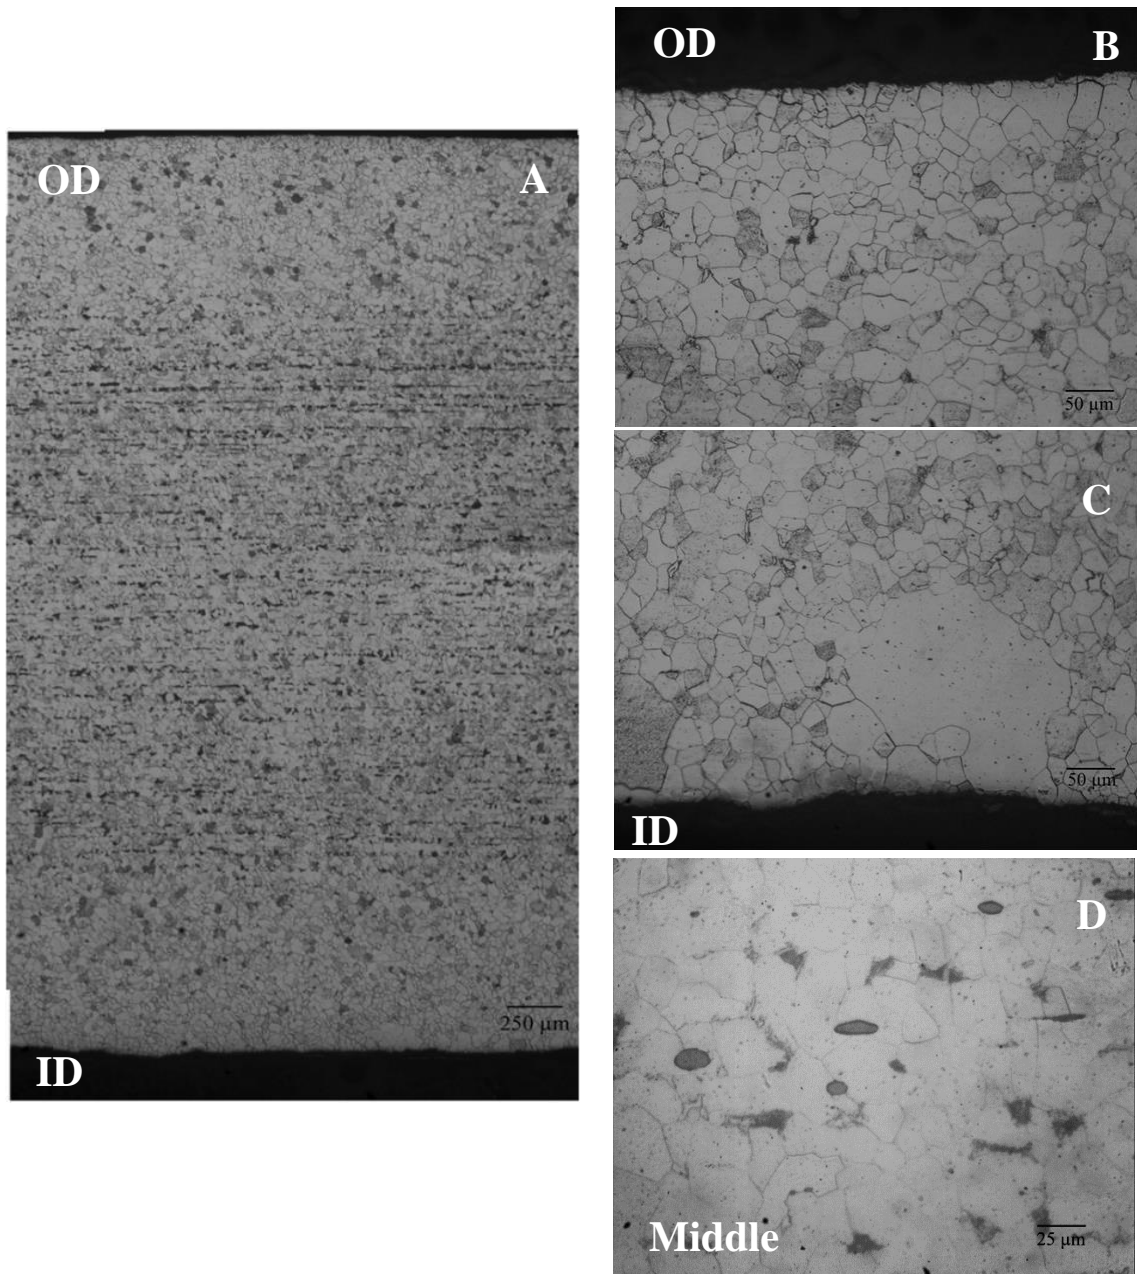
The core area from the base metal exhibited regions with a banded structure of alternating ferrite-pearlite bands (Figure 31). The pearlite volume fraction in the core region was about 5% as compared to 0.5-1% in the rim area. A closer examination of the OD, ID, and core microstructures (Figure 31B-D) revealed a bimodal grain size distribution in which fine and coarse grains were observed, this was more evident on the ID where the largest grain was approximately 10 times the average grain size which was about 22 μm (ASTM G No. 7.5-8). The centerline area also exhibited a higher volume fraction of gray and oblong shaped MnS inclusions (maximum aspect ratio 4).

Figure 31. Light micrographs from the base metal showing (A) banding, (B-C) grain coarsening and (D) MnS in the core region. 2% Nital.

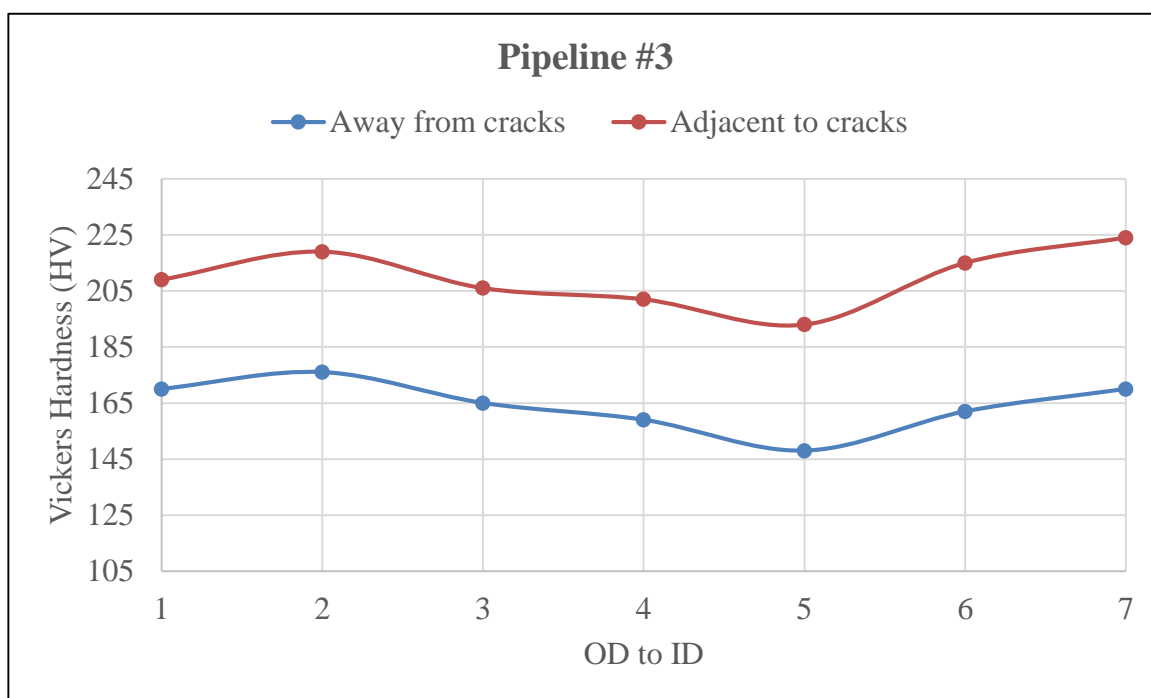
Figure 38 present the hardness profile from OD to ID from crack containing and crack free regions and Table 12 shows the average Vickers microhardness and the equivalent HRB and tensile strength. The thru-thickness hardness profile from SCC and SCC-free zones exhibited a similar pattern with the lowest hardness observed in the core region. However, the crack containing region exhibited a higher hardness as compared to the SCC-free zone.

Figure 38. Pipeline #3 hardness profile.

Region	Average Vickers (HV)	Converted Average HRB	Equivalent Tensile Strength MPa (psi)
Away from cracks	164	83	526 (76289)
Adjacent to cracks	210	93	668 (96885)

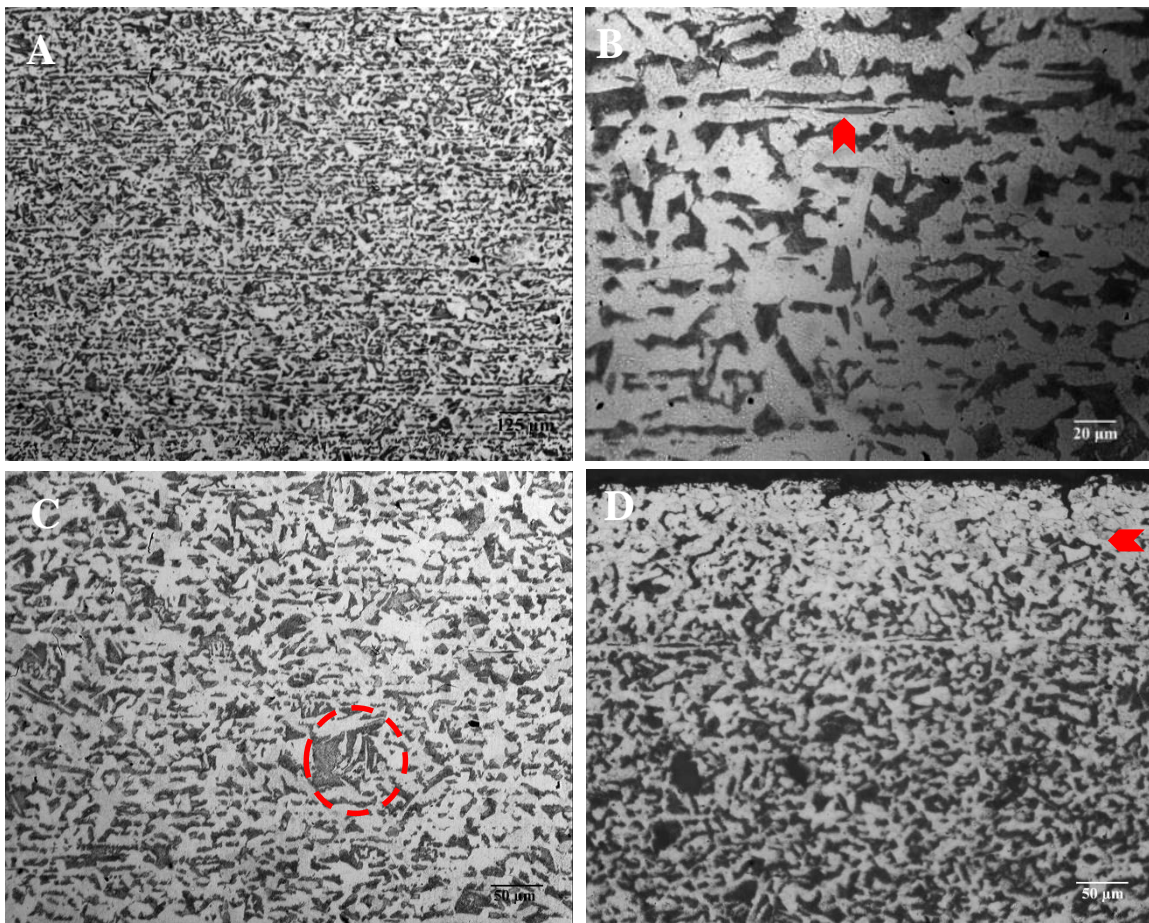
Optical microstructure shown in Figure 40 reveals ferrite bands (white) with elongated and disconnected inclusions (aspect ratio 8 or more) (Figure 40B), and pearlite bands (dark constituent)—the pearlite volume fraction was approximately 24%. The ferritic grain structure was characterized by polygonal and/or quasi-polygonal ferrite with some needle-shaped ferrite (Figure 40C). The average grain size calculated by the linear intercept method is 12 μm (ASTM G No. 9.5); no significant differences between rim and core grain size were observed. Furthermore, what appears to be a decarburized layer near the OD is shown in Figure 40D.

Figure 40. General microstructure of the pipeline #3 indicate (A) banding, (B) elongated inclusions, (C) mixed ferrite morphologies, and (D) a narrow decarburized layer near the outer diameter (arrow). 2% Nital.

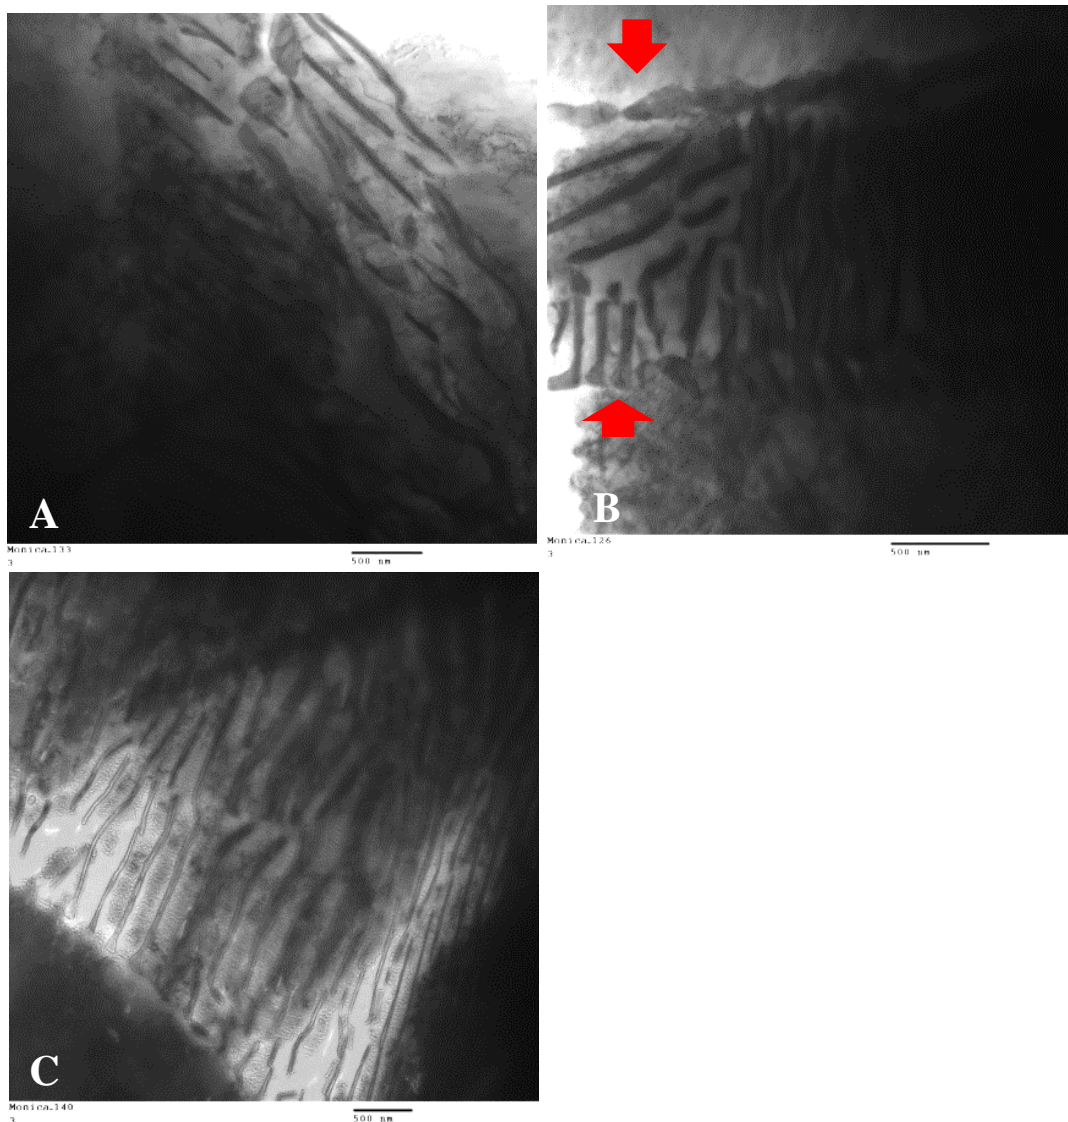
Figure 43 show representative TEM bright field images from the pearlite colonies observed in pipeline #3. Figure 43A-B exhibit a more degenerate pearlite morphology characterized by an irregular lamellar structure with broken-up, mostly non-parallel cementite platelets, and some roughly spheroidal cementite particles. Furthermore, Figure 43B also exhibits “bulged-pancake” cementite (grain boundary allotriomorph) and cementite with a dog-bone termination. A more lamellae pearlite structure is presented on Figure 43C.

Figure 43. Bright field TEM micrographs showing (A-B) degenerated pearlite and (C) lamellae pearlite in pipeline #3. (B) Arrows indicated “bulged-pancake” cementite and cementite with a dog-bone termination.

The tendency for the development of degenerated pearlite—usually observed in low carbon steels transformed at high temperatures—is related to manganese content, deoxidation practice, and transformation temperatures [142]. Manganese content $>0.5\%$, especially in the $0.4\text{--}0.7\%$ range—considered the Mn critical range—leads to spheroidal cementite instead of long thin cementite films, this can partially explain why pipeline #3 with an 0.80% Mn content exhibits more degenerated pearlite colonies as compared to pipeline #4 which had about 1.3% Mn. On the other hand silicon-deoxidized steel tend to develop highly lamellar structures while aluminum deoxidized steels result in degenerated pearlite [142]. The dog-bone cementite termination shown in Figure 43 is a form of degeneracy and a typical feature of aluminum deoxidized steels [142]; nevertheless, the low aluminum content in #3 indicates that this is not an aluminum deoxidized steel.

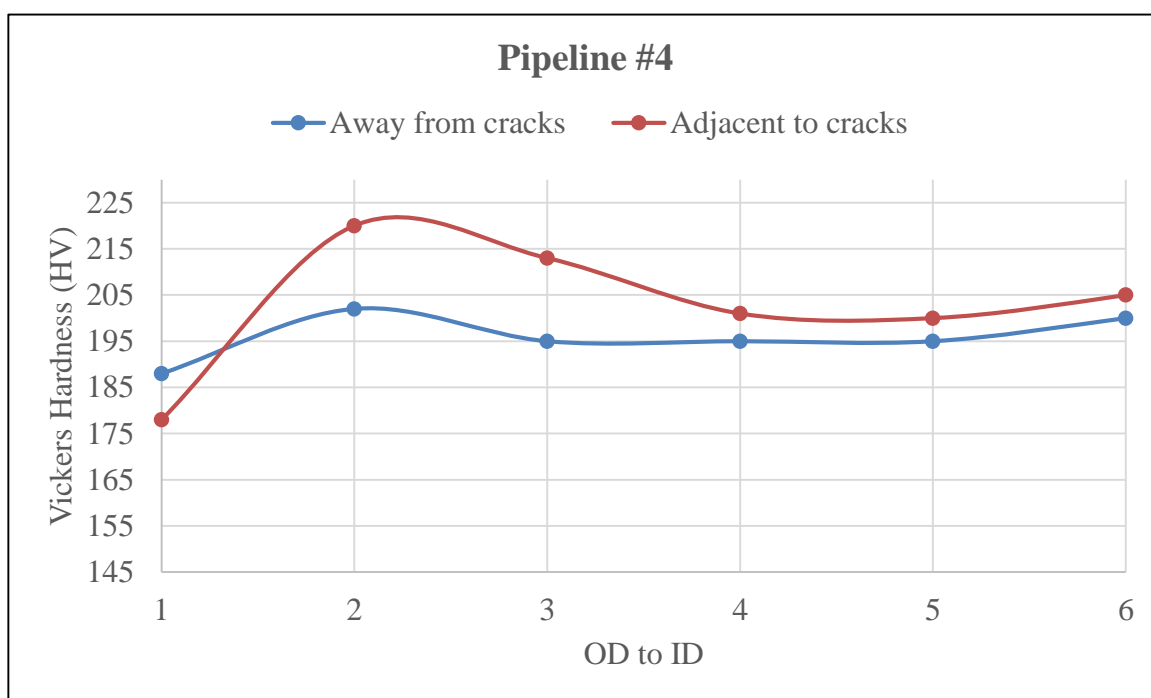
Figure 47 present the hardness profile from the OD to ID from crack containing and crack free regions and Table 15 the average Vickers microhardness and equivalent HRB and tensile strength. The hardness profile from both areas followed a similar pattern with a slightly higher hardness in the SCC crack containing region. Additionally, the region close to the OD exhibited higher hardness values for the SCC-crack containing zone.

Figure 47. Pipeline #4 harness profile.

Region	Average Vickers (HV)	Converted Average HRB	Equivalent Tensile Strength MPa(psi)
Away from cracks	196	91	627 (90939)
Adjacent to cracks	203	92	649 (94129)

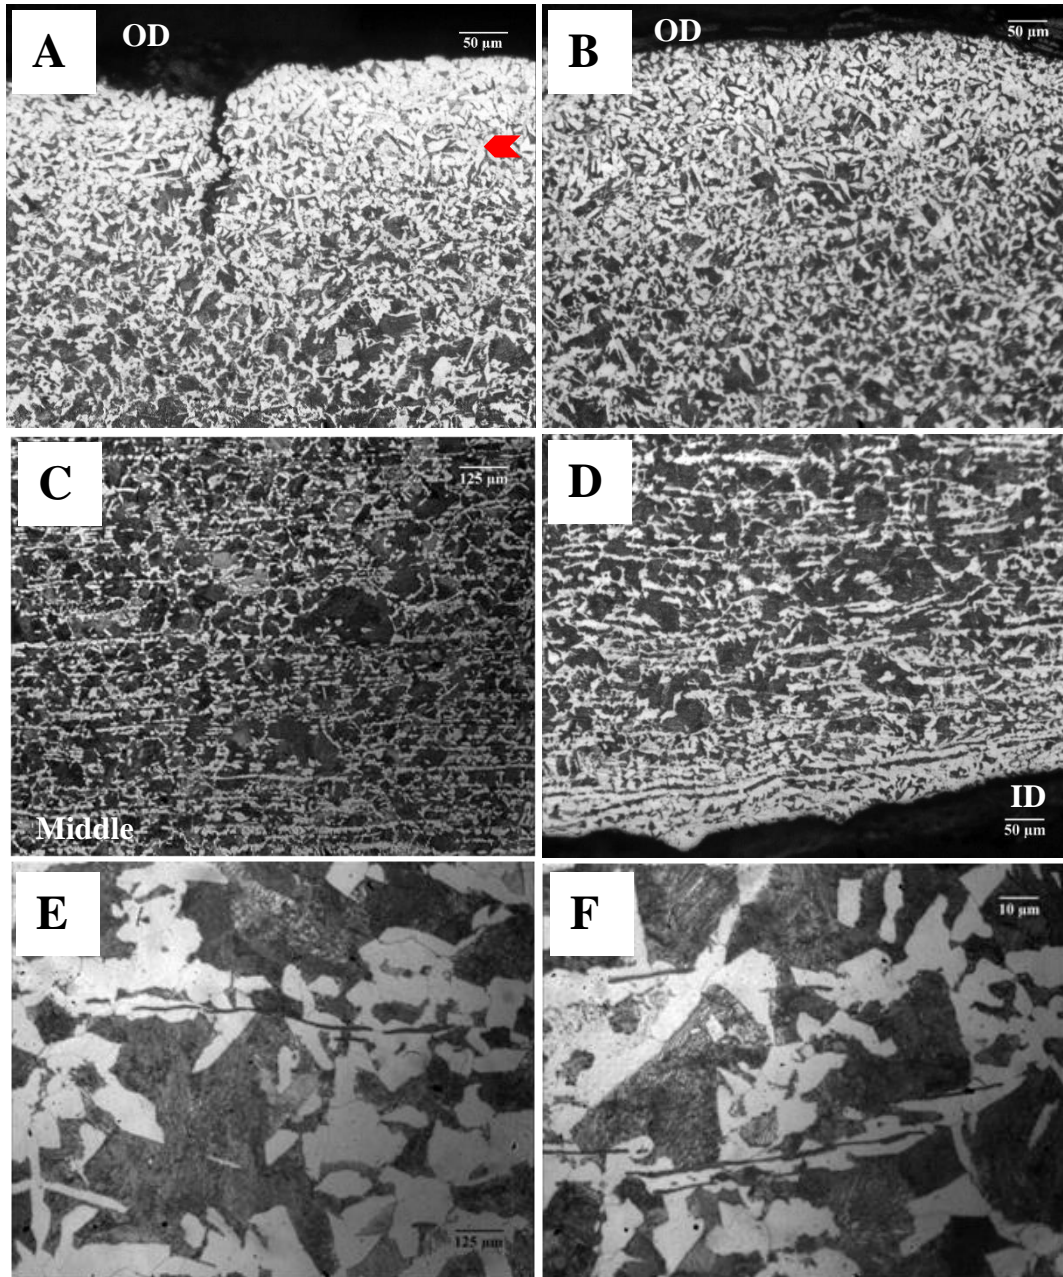
The microstructure of pipeline #4 exhibited what appears to be a decarburized layer near the OD (Figure 50A-B) and a banded structure (Figure 50C-D) characterized by alternating layers pearlite (dark microconstituent) and ferrite with elongated inclusions (some with aspect ratios greater than 20) (Figure 50E-F). The banded structure was more evident in the core region and near the ID (Figure 50B and D).

Figure 50. Light micrographs of the general microstructure of pipeline #4 showing (A-B) a narrow decarburized layer on the outer diameter, (C-D) evident banding on the core region and inner diameter, and (E-F) elongated inclusions. 2% Nital.

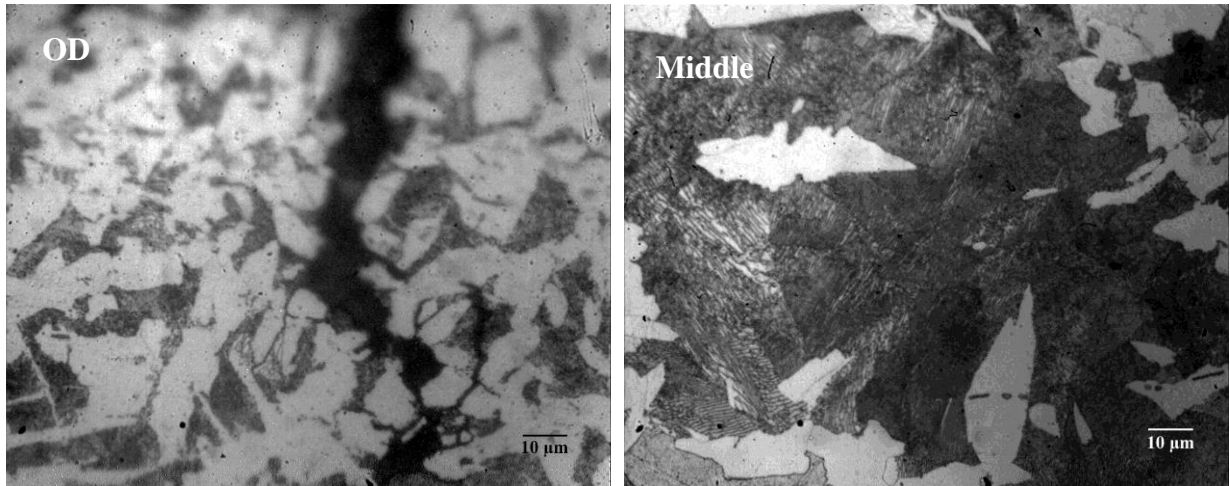
Furthermore, the microstructure near the OD exhibited a more needle-shaped ferrite and smaller pearlite colonies as compared to the core region which was characterized by polygonal or quasi-polygonal ferrite and coarser pearlite colonies. The core grain size calculated by the linear intercept method was about 12 μm (ASTM G 9.5), while that on the OD was 9 μm (ASTM G 10.5). The microstructural difference between rim and core is shown in Figure 51.

Figure 51. Light micrographs exhibiting the differences in ferrite and pearlite morphology and size between rim and core region. 2% Nital.

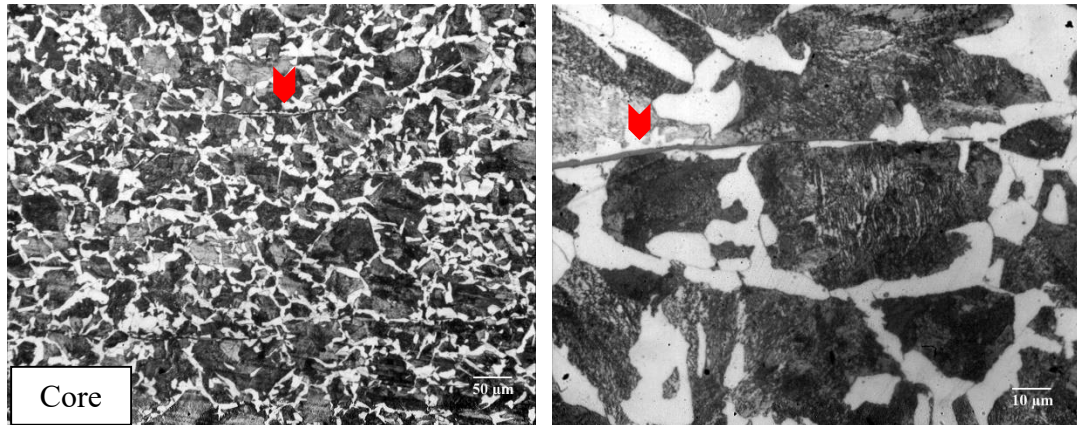
Lastly, the microstructure in the core region (Figure 64) was characterized by quasi-polygonal ferrite, larger pearlite colonies (volume fraction about 62%), and elongated inclusions with aspect ratios greater than 20. The average grain size calculated by the linear intercept method was 20 μm (ASTM G no. 8).

Figure 64. Light micrographs from the core region of pipeline #5 revealed a quasi-polygonal ferrite morphology with elongated inclusions and pearlite colonies. 2% Nital.

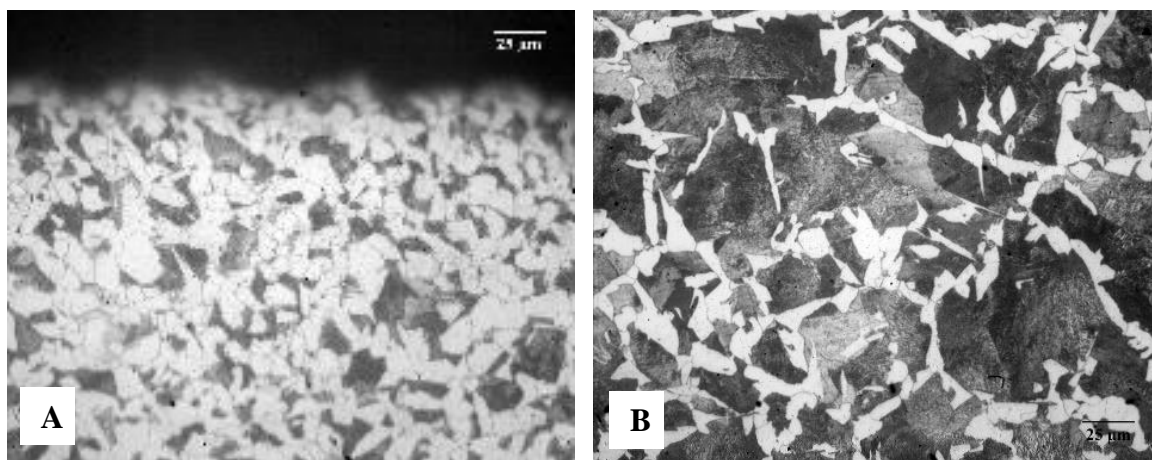
During this investigation, five different pipelines were analyzed. Pipeline #5 (Figure 73) was removed from service after 45 years because “smart pigs” detected pitting, however after this long service period no SCC were developed. The remaining four service components analyzed (#2, #1, #3, and #4) were removed from operation due to stress corrosion cracking (Figure 74). In this manner, the aim of this investigation was to expand our knowledge on what constitutes a susceptible microstructure. Therefore, a systematic microstructural characterization was carried-out to uncover the main microstructural features as well as the conditional state of the region near the surface layer from SCC susceptible pipeline materials.

Figure 73. Light micrographs from SCC-free pipeline #5. (A) Outside diameter and (B) core microstructure. 2% Nital.
