Microstructural Investigation Of Vintage Pipeline Steels Highly Susceptible To Stress Corrosion Cracking

DISSERTATION

Metallurgical and Materials Engineering
THE UNIVERSITY OF TEXAS AT EL PASO

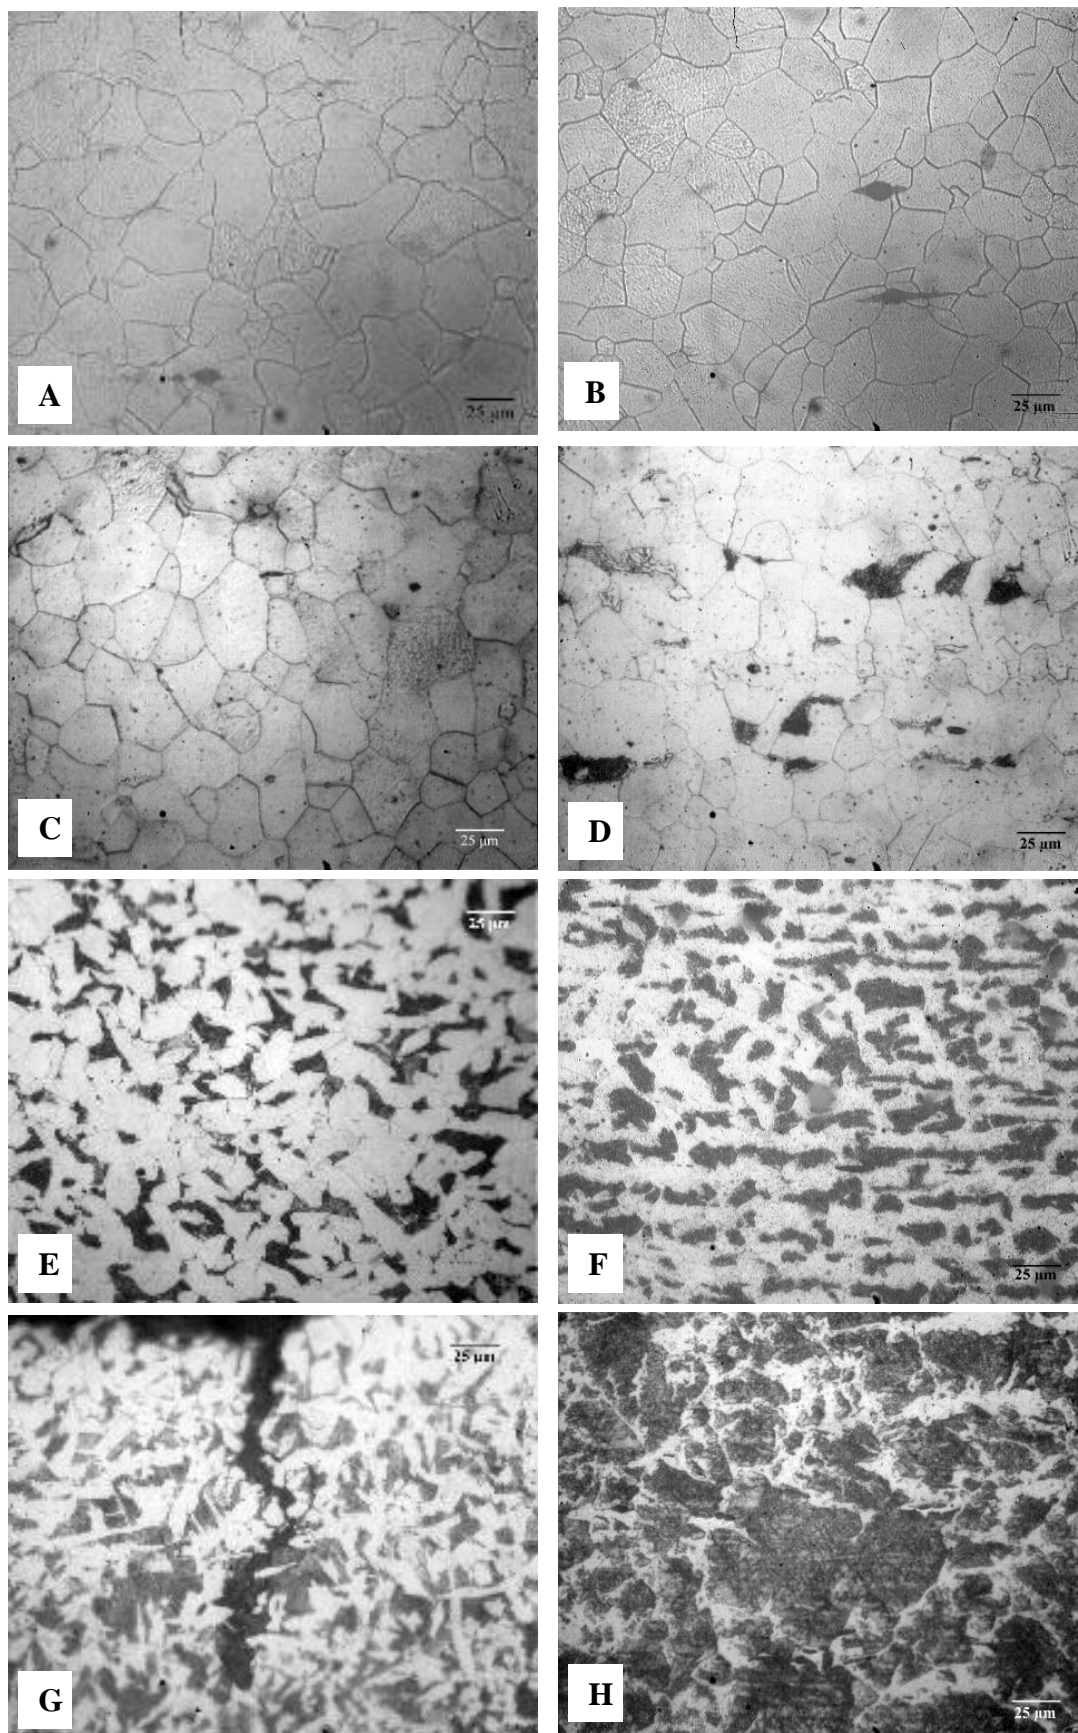
Light micrographs from each pipeline (rim and core) are shown in Figure 73 and Figure 74. During this investigation different microstructural features were observed, such as banding (pipelines #1 and #3), a decarburized layer on the OD region (pipelines #5, #4, and #3), and pitting (pipeline #5). Additionally, majority of the pipelines exhibited pro-eutectoid ferrite and in the case of higher carbon content X52 grade steel pipes more pearlite colonies. The ferrite morphology observed was primarily polygonal ferrite and some needle-shaped ferrite in addition to some grain boundary carbides for grade A pipelines but not for grade X-52 pipes.

Figure 74. Light micrographs from service pipelines that exhibited SCC. (A) pipeline #2 OD and (B) core microstructure, (C) Pipeline #1 OD and (D) core, pipeline #3 (E) OD and (F) core, and pipeline #4 (G) OD and (H) core microstructure. 2% Nital.
