Failure Analysis and Materials Characterization of Hip Implants

FAILURE ANALYSIS AND MATERIALS CHARACTERIZATION
OF HIP IMPLANTS

Department of Metallurgical and Materials Engineering

THESIS

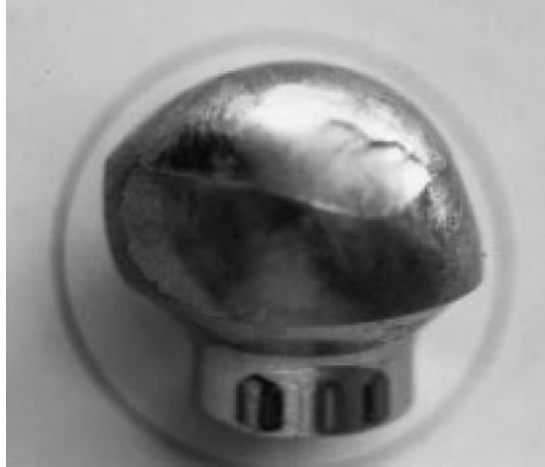
As all biomaterials eventually fail, the key failure modes associated with stainless steel are wear, fatigue, and corrosion. The mechanism of wear, which will be further discussed in a later chapter, involves the break-down of a softer surface due to contact with another harder surface. The following case represents the effects of wear particles on stainless steel. Upon a second revision surgery of a 54 year old THR patient, severe deformation of the stainless steel femoral head was discovered [26], Figure 2.1. The substantial and rapid abrasion of the stainless steel occurred because released alumina particles (from the previous ceramic head) in the surrounding tissue and joint cavity came between the PE liner and stainless steel [26]. This case goes to show that the wear of some biomaterials can be the ultimate cause of failure for others. As far as corrosion is concerned, research has revealed that the fretting corrosion product of austenitic steel can cause undesirable reactions in both the implant and the human body [25]. From these corrosion products, Xulin and Ito et al. discovered nickel concentrations as high as 2% in tissues around retrieved stainless steel orthopedic implants by histological analysis [25]. Aside from implant failures due to fabrication and manufacture, a healthy and none-too-strenuous lifestyle is the optimal setting for stainless steel implants with increased lifetimes.

Figure 2.1: Severe deformation of a stainless steel femoral head caused by PE and alumina wear debris at the interface between the cup and femoral head. [26]

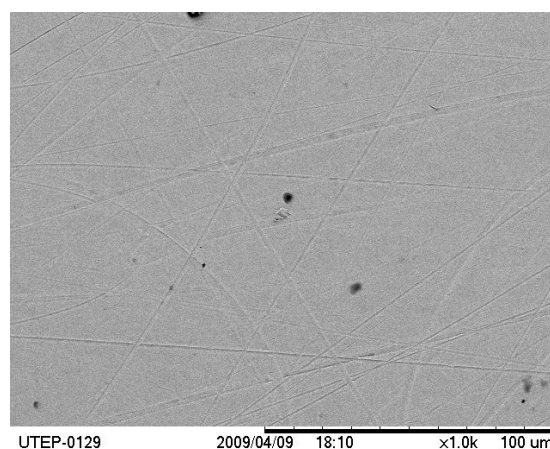
Adhesive wear occurs when two smooth bodies are slid over each other and fragments are pulled off one surface, thus adhering to the other due to the strong adhesive forces between the atoms [37]. The interface of the femoral head and PE liner is a prime area where adhesive wear occurs. Over a period of time, loose particles (i.e., three-body particles) come between the articulating surfaces and have the ability to create wear tracks such as those in Figure 2.4. If there is poor lubricant, or no lubricant, in the interface, the adhesion between the two surfaces will rapidly increase and the formation of wear scars may occur, with the possibility of overheating due to friction [38].

Figure 2.4: Wear tracks on Patient W femoral head at a magnification of 1000x.

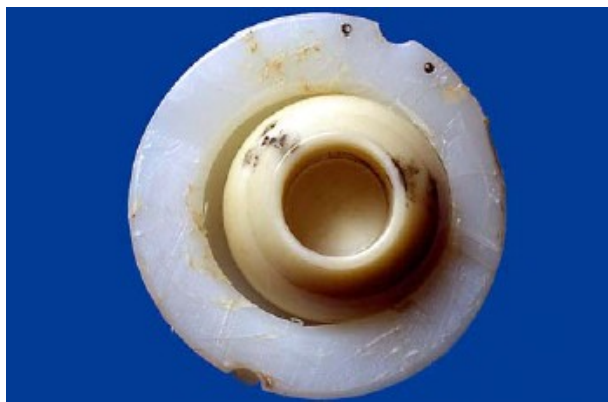
In subgroups of the chief wear mechanisms, damage modes such as burnishing, pitting, scratching, delamination, and plastic flow, can quite often be found on THA components [34]. Such damage modes were found in research performed by Ohnsorge et al. at the Department of Orthopaedic Surgery in the University of Aachen, Germany. Over a period of 13 years, 148 total hip arthroplasty (THA) cases were studied and controlled, concluding with 111 prostheses sufficient enough for clinical and radiologic follow-ups due to various reasons [42]. Upon final follow-up appointments, 47 of the reviewable 111 x-rays revealed prostheses with decentralized heads, suggesting a considerable amount of PE wear [42]. As stress can hold a key factor in PE damage, Figure 2.7 displays an insert explanted after 6 years that revealed material loss at the inner circumference with an analogously floating prosthetic head [42]. Through this macroscopic image, multiple surface scratches can be viewed and dull areas on both the PE liner and ceramic femoral head suggest issues of friction [42].

Figure 2.7: PE wear with articular gap formation. [42]

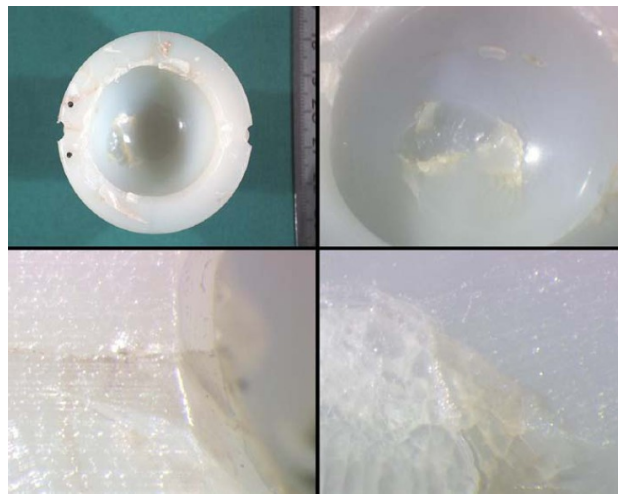
From the same Ohnsorge study, another insert explanted after 10 years revealed PE at the rim and at the bottom of the liner to be discolored and brittle [42]. Figure 2.8 provides concrete evidence of plastic flow at the center of rotation, burnishing (polished areas), delamination and multiple cracks on the rim of the insert, and predominant asymmetric cold flow of PE near the holes in the metal backing [42]. Similarly accounted for in THA components are fatigue cracks that result in the removal of material in chunks or flakes as soon as the cracks grow to the surface of the polymer [38].

Figure 2.8: PE insert looking brittle in the rim, showing multiple continuous cracks, local polishing, and subsurface delamination of the articular surface. [42]

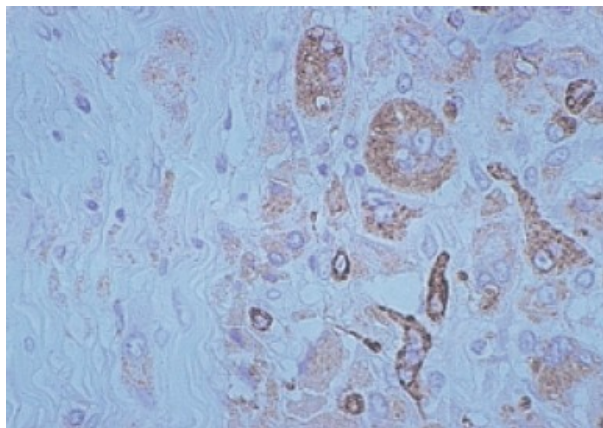
between the bone and implant [44]. The most common metal sensitizers found in biomaterials are nickel, cobalt, and chromium, and hypersensitivity can spur from titanium and vanadium [43]. Research performed at the Yamagata University School of Medicine in Japan focused on interface biology and implant-related osteolysis in which wear particles were found in neighboring prosthesis tissues [44]. Biological analyses on a tissue sample from the interface of a loose total hip joint with periprosthetic loosening displayed foreign-bodies, Figure 2.9 [44]. As metals are indestructible, chronic inflammation of the surrounding prosthesis area may take effect due to the release of such ions and molecules [43,45].

Figure 2.9: Metallic- or ceramic-type giant cells from the interface of a loose total hip joint. [44]

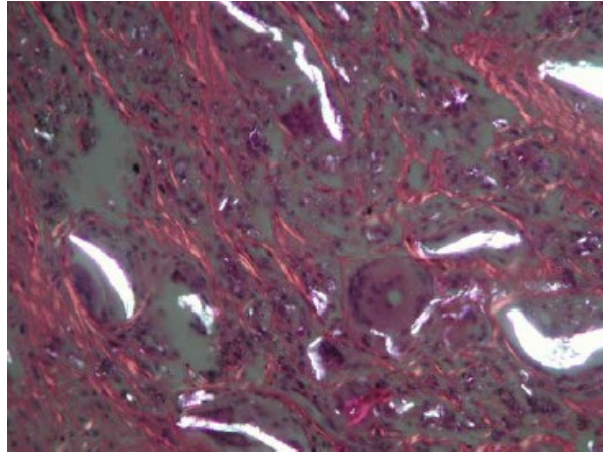
The biggest problem of UHMWPE in THRs is the production of wear particles, which tend to become points of bacterial infection and can act as three-body particles [38]. It is possible that more than 51 billion polymer particles are produced each year and after the elimination of most of these particles by the body's host response, large numbers of them still remain in the body tissues, Figure 2.10 [35]. Aside from physical wear particles, toxic unreacted

Figure 2.10: PE wear particles in the surrounding tissue of an implant. [42]

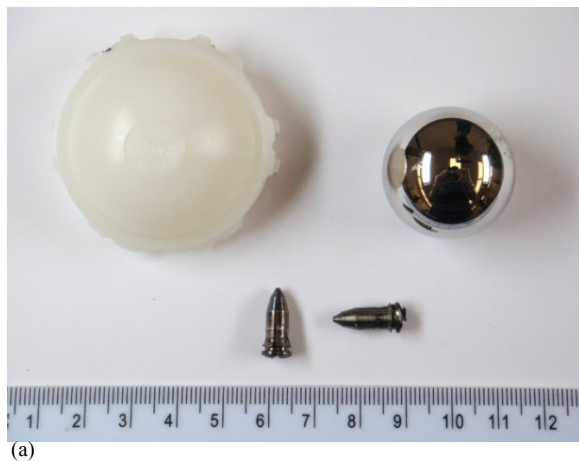
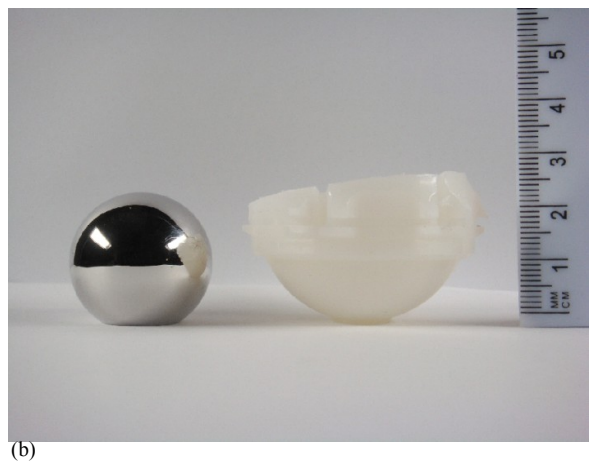
Figure 3.1: Patient E liner, head, and screws.

Upon visual examination of the Patient E components in Figure 3.1, the liner had many surface scratches and areas of plastic deformation on the outer rim. In the socket two fixed, metallic particles were also located. The femoral head was fairly unimpaired save for an area heavily situated with scratches and a possible surface deposit. The hollow of the femoral head (i.e., bore) also displayed burnishing. Patient W liner, Figure 3.2a, had a large area of plastic deformation on the surface of the liner with few scratches. Though wear tracks were visible on the femoral head, Figure 3.2, nothing atypical was discovered. The Patient H liner in Figure 3.3 was the only component with an area of visible abrasive wear in the socket where the liner is in direct contact with the femoral head. The outer rim of the liner also displayed an area of plastic deformation. The corresponding Patient H femoral head displayed only a few scratches and burnishing of the increased neck area. The Patient U femoral head in Figure 3.4 had the greatest amount of damage. The surface was completely dulled from the overwhelming amount of surface scratches and defects. Many areas of the femoral head displayed large indentions similar

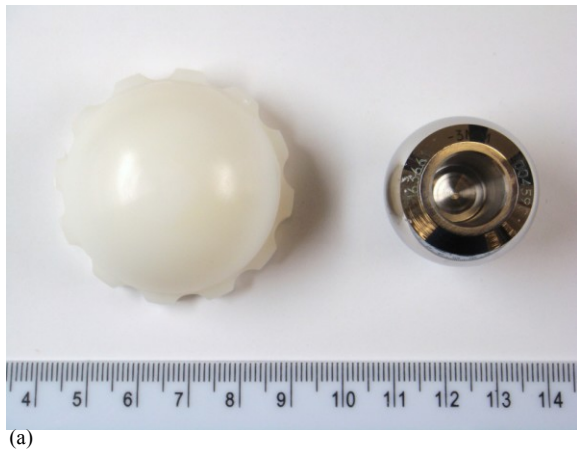
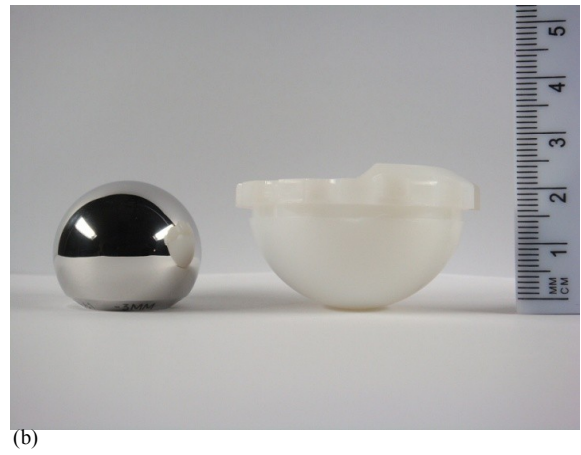
Figure 3.2: Patient W liner and head.

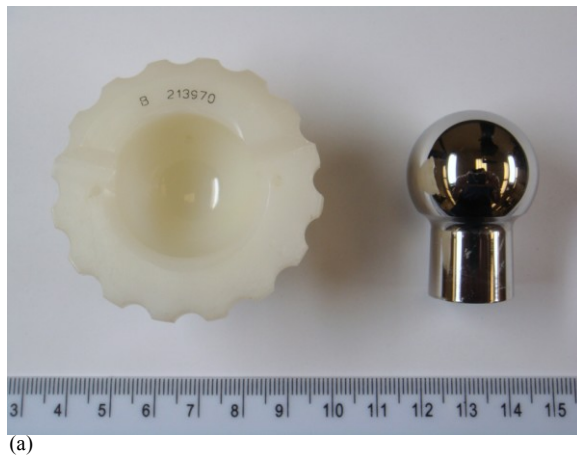
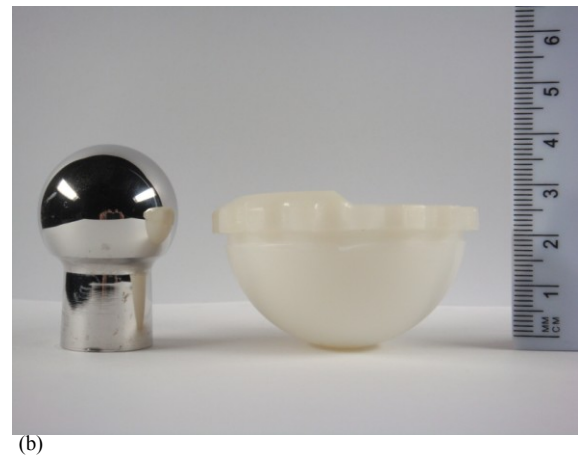
Figure 3.3: Patient H liner and head with an increased neck length.

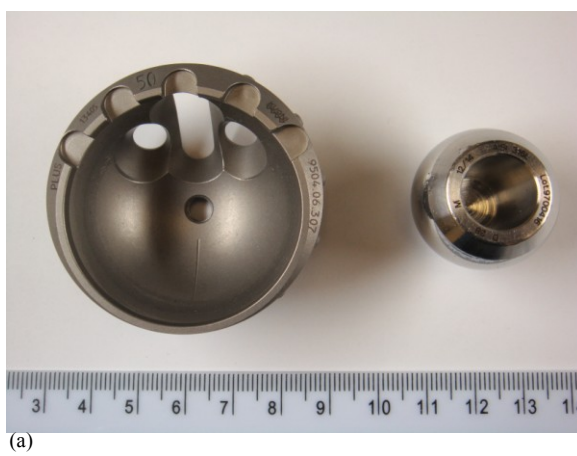
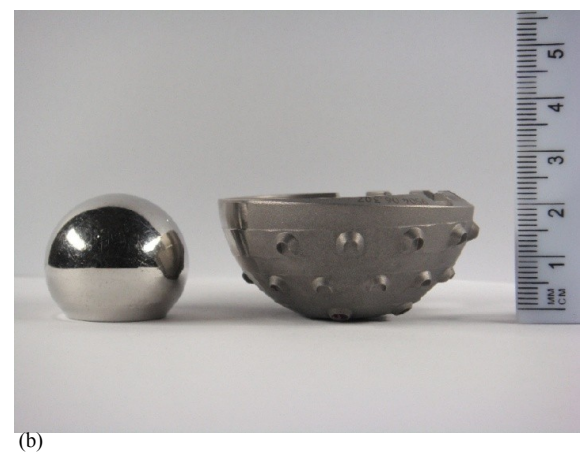
Figure 3.4: Patient U acetabular socket and head.

to those created by Brinell or Rockwell Hardness Testing. In the socket of the acetabular shell, a ring of burnishing and areas of deformation were observed.

Initially found during the visual examination of the components, the engravings on the Patient U femoral head, Figure 3.4a, indicated the component as a 316L stainless steel. The composition produced by XRF confirmed the elemental weight percentages with 316L. As seen in Figure 4.16, the microstructure for this surgical alloy consisted of variable grain sizes with annealing twins. In order for the formation of twins, the alloy must have undergone an annealing heat treatment.

Of all four femoral heads, the Patient U femoral head displayed the most severe deformation. As seen during the visual examination, Figure 3.4 displayed an incredibly dull component with questionable mechanical damage. In comparison with the wear tracks found on the Patient W femoral head, the Patient U femoral head consisted of densely filled scratches and abrasions with variable wear track sizes, Figure 4.33a. Crevices were also found dispersed throughout the surface, Figure 4.33b.

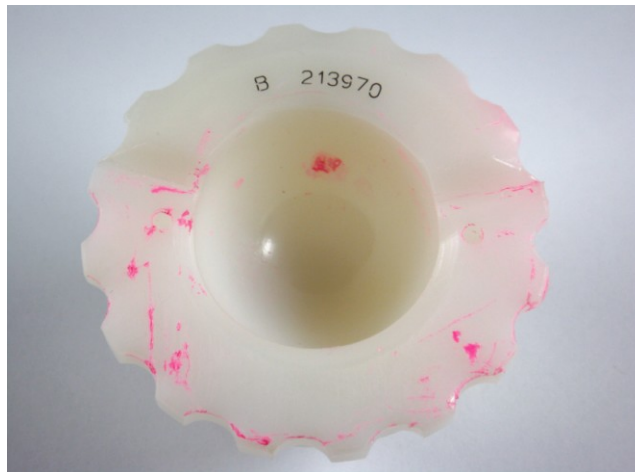
Figure 3.8: Patient H, UHMWPE liner after Dye Penetrant Inspection (DPI).

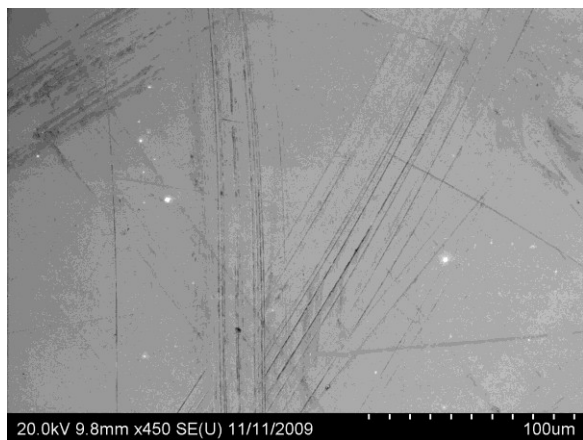
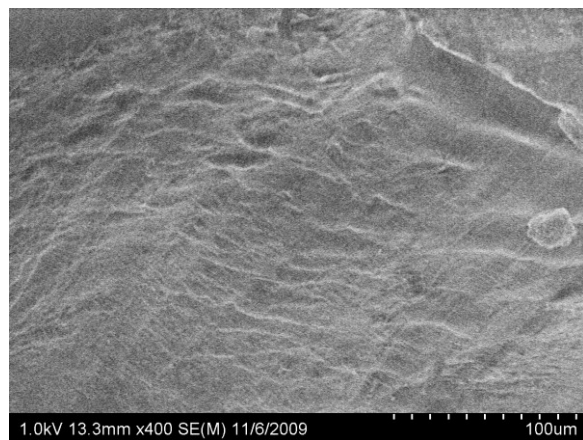
Figure 3.11: (a) Patient E femoral head with wear tracks at a magnification of 450x, (b) Patient W liner, area with plastic flow at a magnification of 400x.

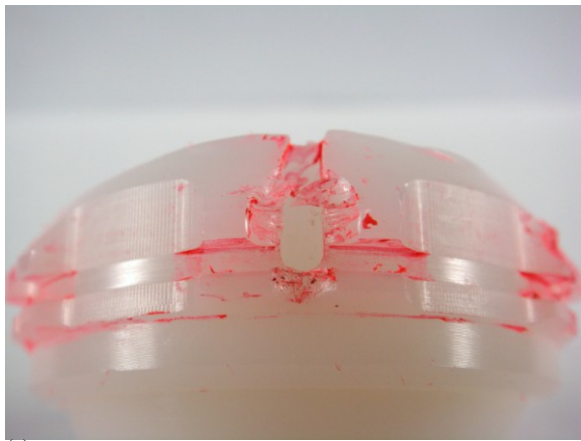
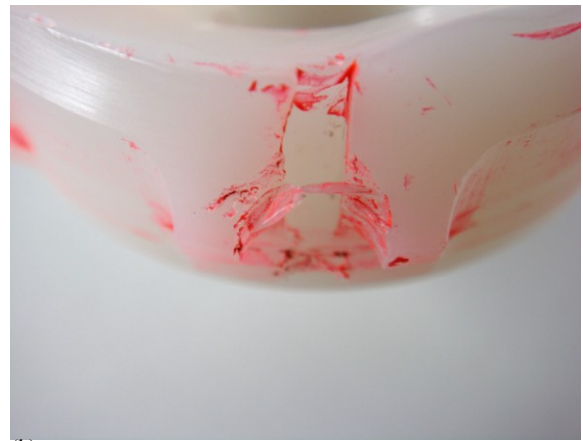
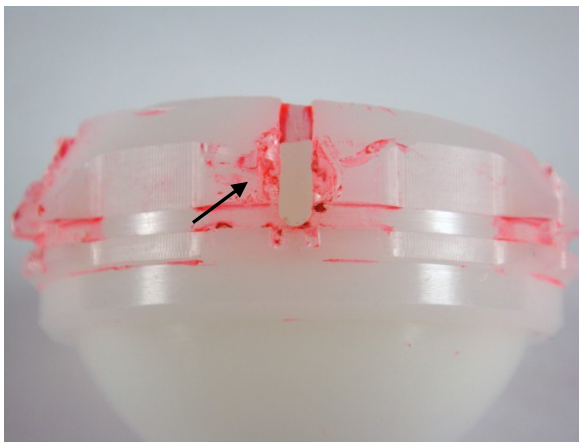
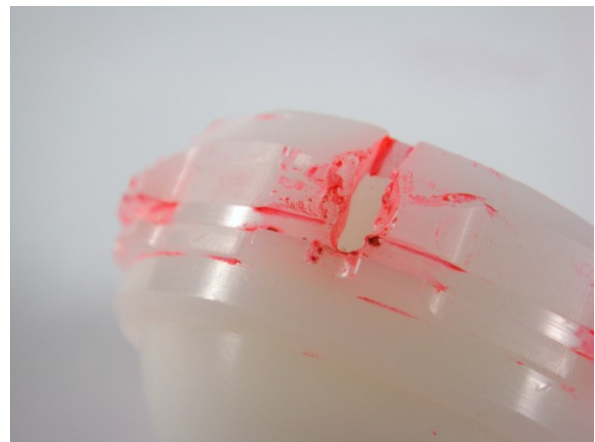
Plastic deformation occurred in the areas where the PE liner locks with the ceramic acetabular shell. Figure 4.8a and b displays the severe deformation of these regions. Though the center should remain hollowed out, the PE was so plastically deformed that material came together and flapped over itself. Figure 4.8c and d displays another similar area with deformation on the sprocket portion of the rim.

Figure 4.8: Patient E liner: (a) frontal view of plastic deformation, (b) deformed material that flapped towards the center from the two sides, (c) deformed sprocket with plastic flow indicated by arrow, (d) right-hand view.

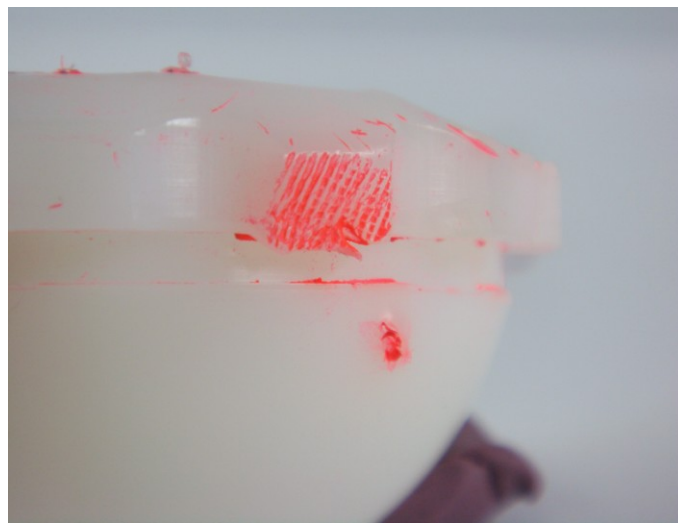
Similar to Figure 4.10, more rim damage was found on the other side of the component, Figure 4.11. The capillary action of the red dye clearly presents hash marks in at least 3 directions. It is obvious that the deformed area sits lower than the surrounding “sprocket” arms. Plastic flow of the PE is also evident in the downward sloping crack. Beneath the hash marks is a puncture in the PE. As the PE and acetabular shell are only in contact with the bone/cement, the damage sustained may have been due to implant insertion or retrieval by the surgeon.

Figure 4.11: Patient W liner: (a) frontal view of rim deformation and puncture, (b) side view.

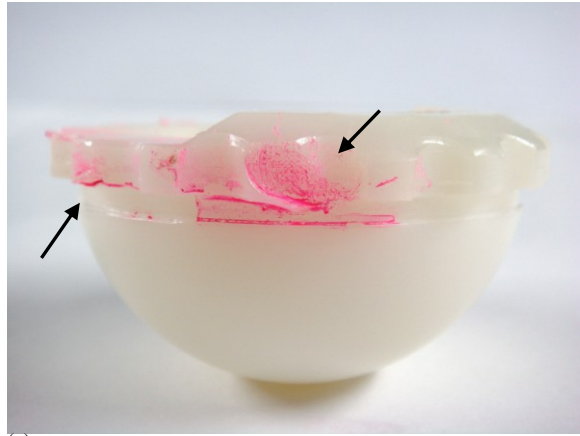
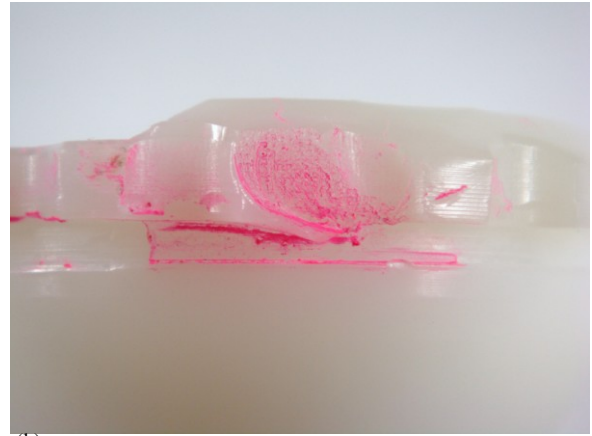
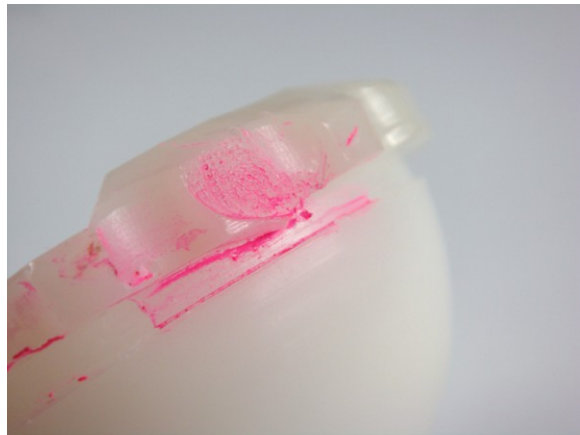
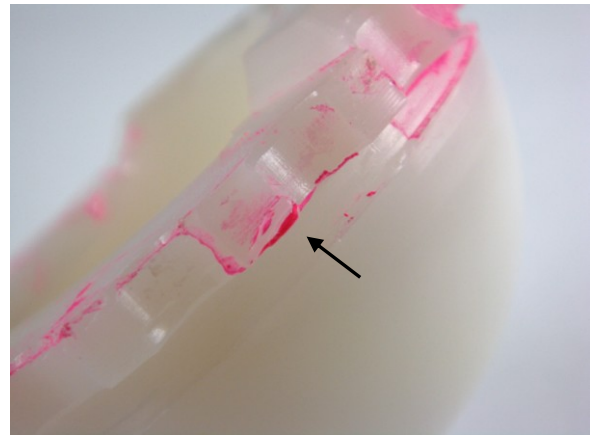
Deformation of the outer rim was a similar feature in all three PE liners. Figure 4.13 indicates a large area of plastic flow and a radial crack. In service, bending and flexing loads continuously act upon the acetabular components every time the patient walks, runs, sits, etc. It is possible that such repeated actions may have produced such a crack and plastic flow.

Figure 4.13: Patient H liner: (a) plastic deformation, plastic flow, and radial crack, (b) closer image of plastic deformation, (c) side view of plastic deformation, (d) side view of radial crack.

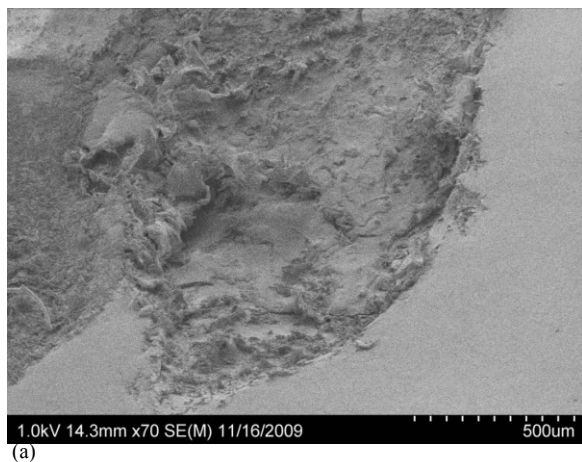
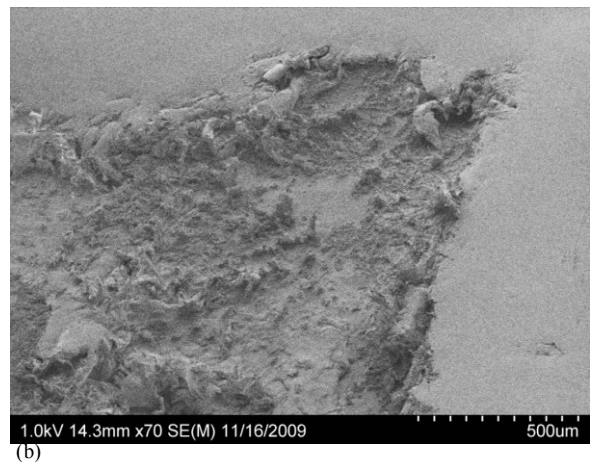
In another unique case, the Patient H liner also contained a large area of abrasive wear. Aside from the previously mentioned burnished areas, the remaining liner socket was fairly unimpaired as seen in Figure 4.27. It appeared as though PE material may have been ripped off, base on the ductile fracture surface, Figure 4.28. Semicrystalline polymers, such as PE, are known to exhibit considerable post-yield plastic deformation, thus resulting in a ductile classification [38]. Yet, in the areas indicated by arrows, remnants of the original PE surface still remained.

Figure 4.28: Patient H liner: (a) and (b) ductile fracture surfaces.

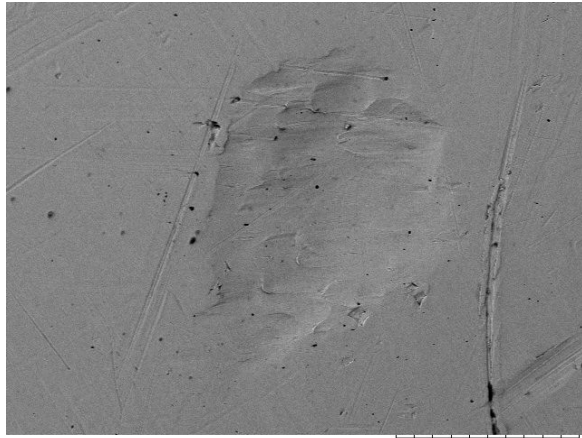
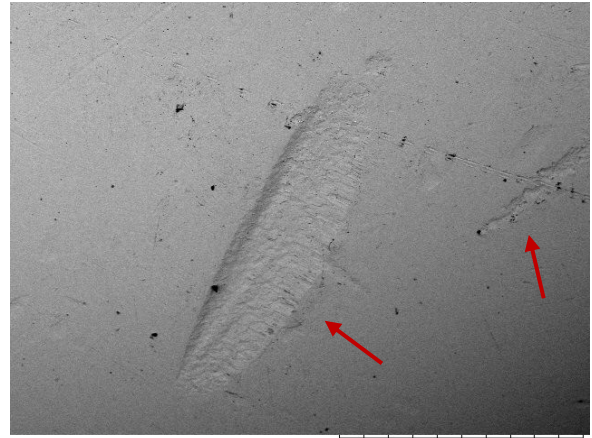
Additional deformation features remain unique to the Patient U femoral head. In Figure 4.36 to 4.39, the images display damage modes in the forms of crevices, bulges, scarring, and areas containing an unknown surface deposit. The damage associated with this component had to have been the result of metal-on-metal contact because there is no way that the PE liner could produce these results. In Figure 4.40, EDS of the product revealed a composition of oxygen, aluminum, magnesium, and silicon. The possible magnesium aluminosilicates may be the surface contaminant.

Figure 4.37: Patient U femoral head: (a) bulge with neighboring pits, (b) large bulge, smaller crevice, and wear tracks.

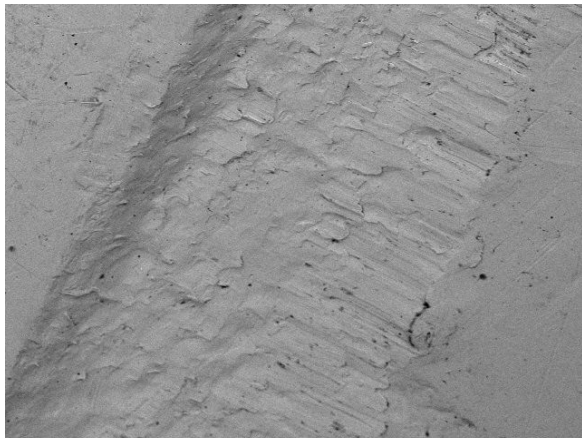
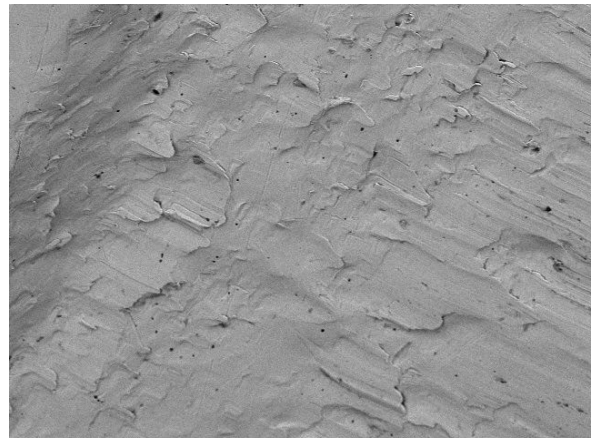
Figure 4.38: Patient U femoral head: (a) bulge with wear scars, (b) bulge at higher magnification.
